# Arrowhead Stadium Assessment | 2014

## JCSCA + Burns & McDonnell

This document contains information pertaining to the condition of Arrowhead Stadium as documented by the Jackson County Sports Complex Authority, including descriptions, conditions, and exhibits which have been written and verified by Burns & McDonnell.

2 / 14 / 2014

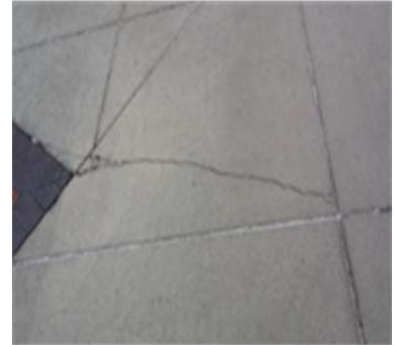
- Walls and Stairs
  - No significant deterioration was observed.
- Concrete Walkways
  - Minor cracking was observed throughout the facility on walkways and concourses. Routine maintenance with sealant should be performed in the near future. Refer to Flatwork Images: [Exhibit A1.1](#) and [A1.2](#) (right).

- Site
  - Perform routine maintenance to seal and repair minor cracking observed along walkways and concourses.
  - Significant cracking and deterioration of planter curbs on the east and west side of the stadium. Repair concrete in the near future to prevent additional damage.

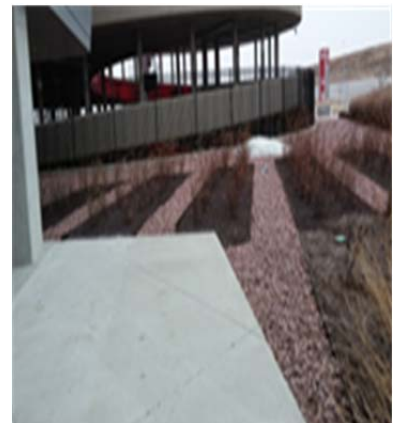
- All landscaping observed was in a dormant stage at the time of observation, but appears to be well maintained and in good condition. Refer to Landscaping Images: [Exhibit A2.1](#) (right).
- Significant cracking and deterioration of planter curbs on the east and west side of the stadium has occurred, particularly at corners as shown

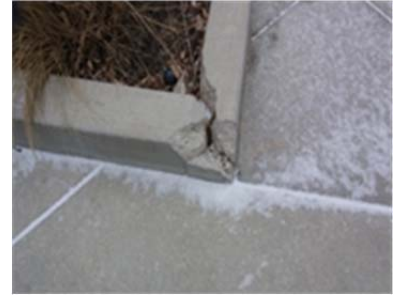
under Landscaping Images: [Exhibit A2.2](#) (right). This curbing should be repaired in the very near future.

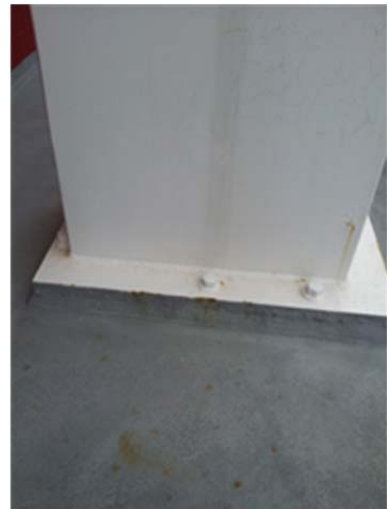
excellent condition. No corrosion was observed. Column base plate connections are in excellent condition. Refer to Superstructure Images: [Exhibit B2.5](#) (page 6).

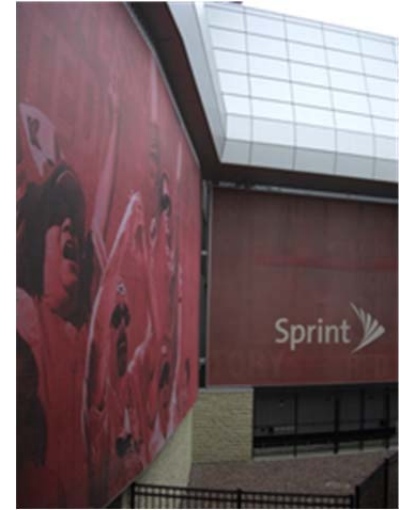
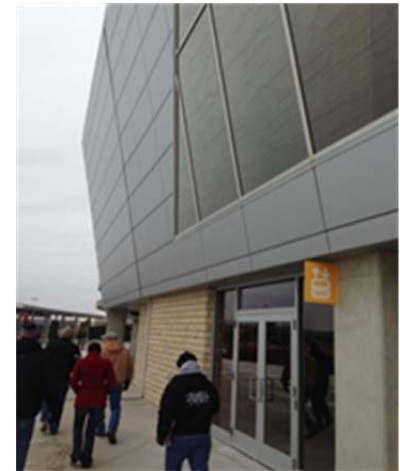
- Refer to Façade Images: [Exhibits B3.1 and B3.2](#) (page 7) for typical façade conditions.

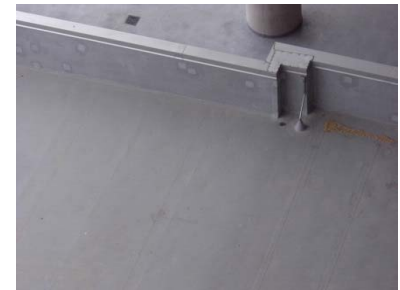
- Roofing membranes appear to be in good condition and do not show signs of rips, tears, or other failures.
- All observed copings, flashings, etc. appear to be in excellent condition.
- Metal roofing appears to be in good condition and does not show any signs of rust or staining.
- Refer to Roofing Images: [Exhibit B4.1](#) (page 7) for typical roofing condition.

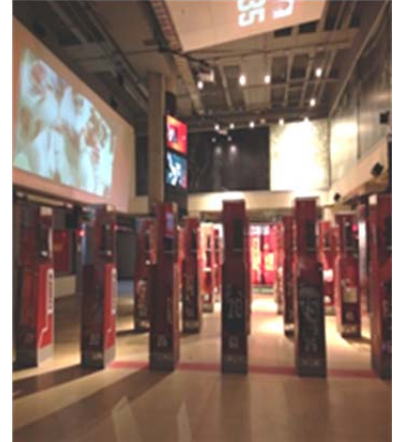
- Flooring surfaces are generally in excellent condition.
- Epoxy floors are showing excellent resistance to wear and tear. Refer to Flooring Images: [Exhibit C1.1](#) (page 8) for typical conditions at epoxy flooring.
- Sealed or painted flooring appears to be in good condition with no visible chipping or flaking of finish.
- Ceramic tile floors appear to be in excellent condition. Refer to Flooring Images: [Exhibit C1.2](#) (page 8) for typical conditions.
- Minor carpet rips and tears were found in the visiting locker room, as shown under Flooring Images: [Exhibit C1.3](#) (page 8). Bunns & McDonnell recommends considering carpet replacement within the next one to three years.

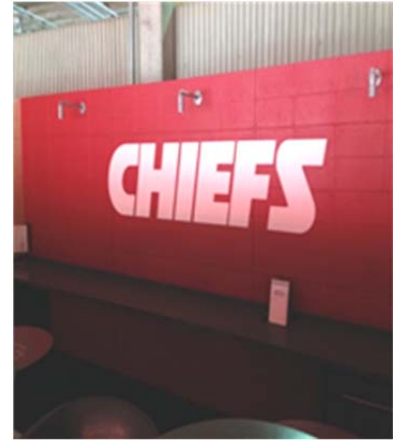
- Painted and exposed block walls appear to be in excellent condition with no visible chipping, flaking, or cracking of the applied paint system. Refer to Interior Wall Images: [Exhibit C2.1](#) (right) for typical condition.
- Painted gypsum board walls appear to be in excellent condition and do not show signs of punctures or holes in the gypsum board

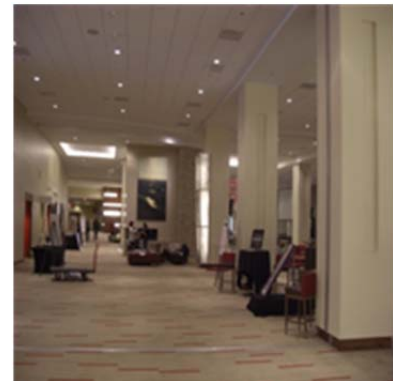
material. Minimal scuffing was observed in various locations back of house spaces due to normal wear and tear. Refer to Interior Wall Images: [Exhibit C2.2](#) (page 9) for typical condition.

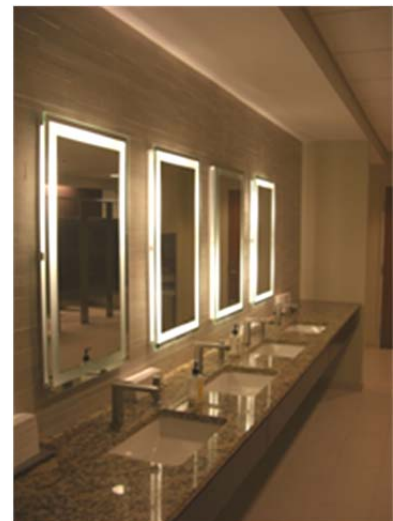
- Glazed storefront systems appear to be in excellent condition and do not show signs of staining, fading, or degradation of any kind. Seals around storefronts appear to be in good condition.
- Ceramic Tile in high end bathrooms appear to be in excellent condition and do not show signs of chipping or cracking. Mortar joints appear to be in good condition and do not show signs of dirt, grime, or chipping. Refer to Interior Wall Images: [Exhibit C2.3](#) (page 9) for typical condition.

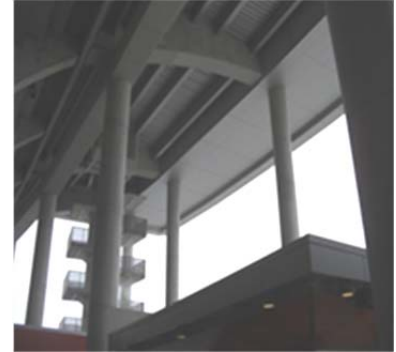
- Exposed and painted ceilings appear to be in good condition. Refer to Ceiling Images: [Exhibit C3.1](#) (right) for typical condition.
- Gypsum board ceilings appear to be in excellent condition, in general. Refer to Ceiling Images: [Exhibit C3.2](#) (right) for typical condition.
- Acoustic ceiling tile appears to be in excellent condition, in general. Several back of house spaces, including kitchens and pantry areas, contained warped, drooping, or stained ceiling tiles. Refer to Ceiling Images: [Exhibit](#)

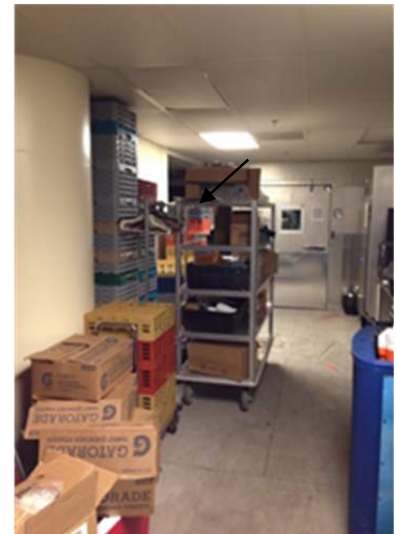
[Exhibit C3.3](#)

C3.3 (right) as an example. Consider replacing ceiling tile at such locations in the near future.

- Sagging or damaged ceiling tiles in several back of house space were observed. Consider replacing damaged tiles to avoid ceiling tile falling or damaging items located under the ceiling.

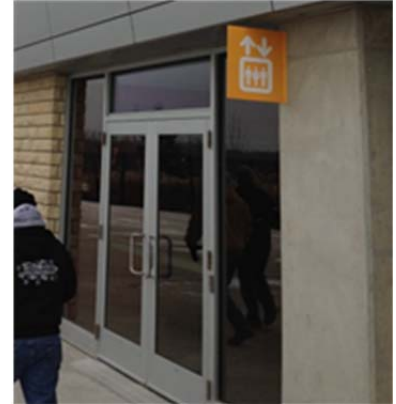
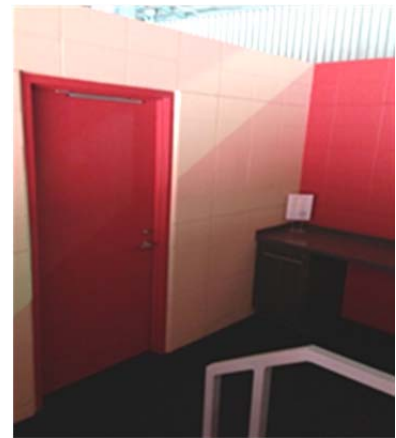
- All doors, in general, are in excellent condition. Refer to Door Images: [Exhibit C4.1](#) and [C4.2](#) (right) for typical condition.
- Painted hollow metal back of house doors are in generally good condition. Some doors, particularly in the underground tunnel between Arrowhead and Kauffman Stadiums, appeared to be scuffed or scratched in various locations. Consider repainting such doors to avoid the spread of rust and corrosion.

- Painted hollow metal back of house doors are generally in good condition. Some doors, particularly in the tunnel between Arrowhead and Kauffman appeared to be scuffed or scratched in various locations. Consider repainting such doors to avoid the spread of rust and corrosion.

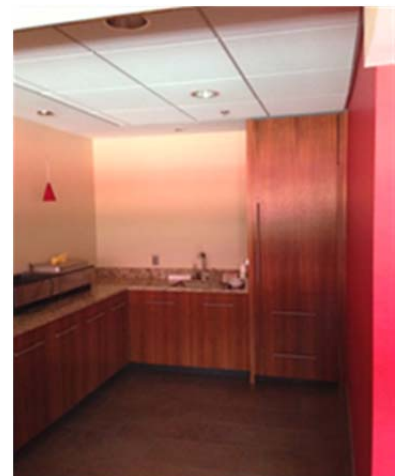
- All casework appears to be in excellent condition and no signs of scratching, chipping, or scuffing of the veneers were observed. Refer to Casework Images: [Exhibit C5.1](#) (right) for typical condition.

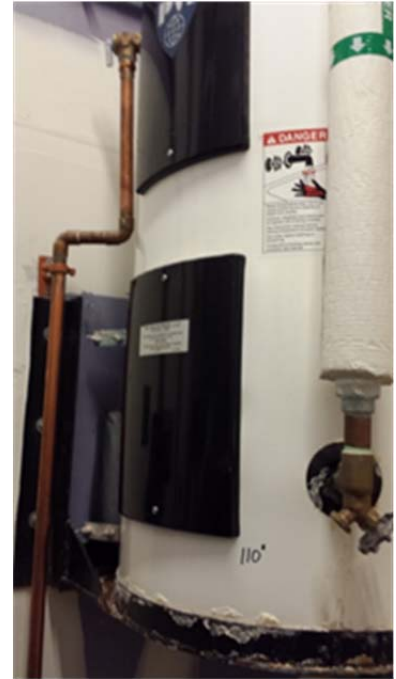
- Various water heaters throughout the facility appear to have corrosion at the base of the exterior shell. This is possibly due to the storage of chemicals in the same room with a lack of ventilation. Reference Plumbing Images: [Exhibit D1.1](#) (right). Piping insulated, labeled and flow direction identified. Water heater showing signs of corrosion at base.
- Plumbing piping appears to be properly labeled with direction of flow and valves are clearly tagged. Reference Plumbing Images: [Exhibit D1.2](#) (right).

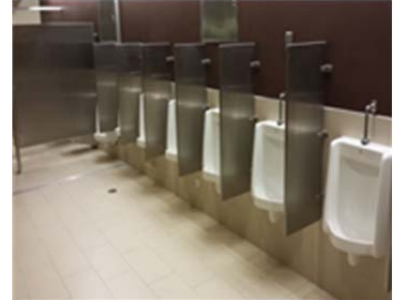
- Plumbing fixtures and associated flush valves, faucets, etc. appear to be in nearly new condition and very clean. Reference Plumbing Images: [Exhibit D1.3](#) (right).

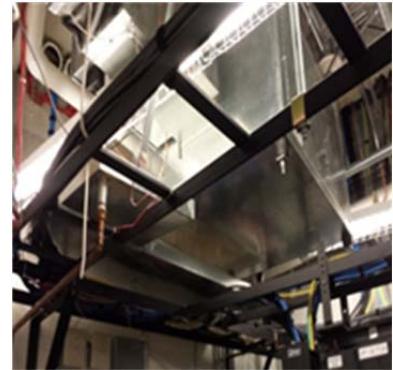
- Plumbing installed over electrical equipment/components has the required metal drip pan and associated drain line. Reference Plumbing Images: [Exhibit D1.4](#) (right).

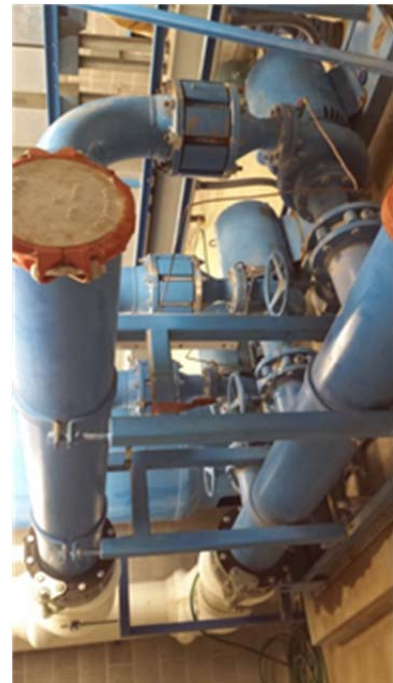
- Domestic water booster pump skid appear to be in good condition. Piping is insulated and tagged with direction of flow properly indicated. Reference Plumbing Images: [Exhibit D1.5](#) (right –rotated 90° for size and clarity).

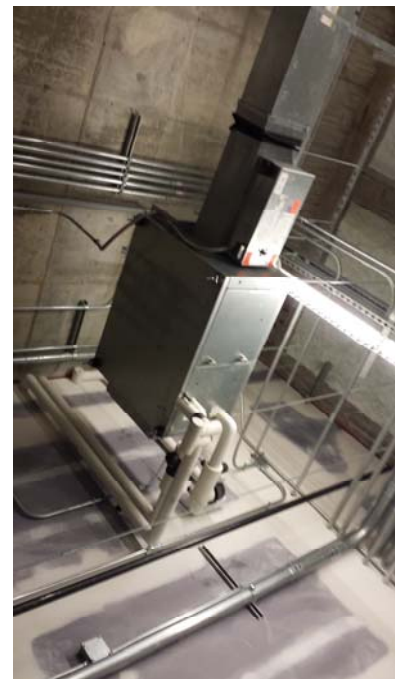
- Filters clean
    - Ductwork complete
    - Insulation complete
    - Electrical components in place
    - Controls components in place
    - Refer to HVAC Images: [Exhibit D2.3](#) (page 14)

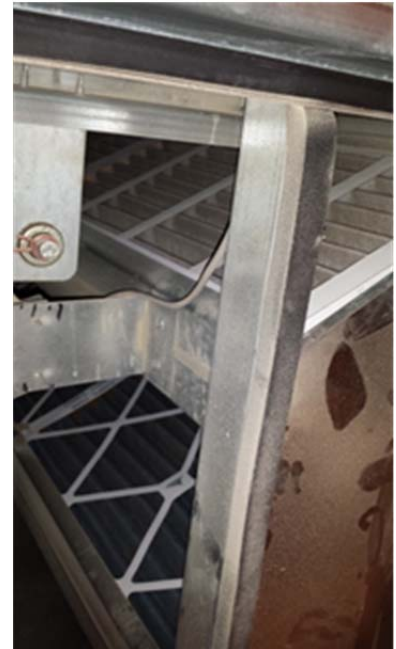
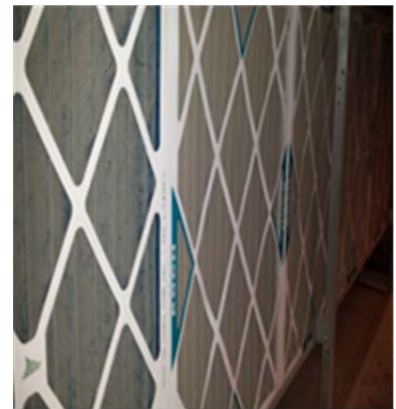
- Air Handling Units
  - Deficiencies
    - Filters – On more than one observation the filters appeared to be dirty and past due for replacement. Approximately half the equipment filters were dated with black Sharpie on filter casing at the time of replacement making it easy for maintenance staff to see when filters are out of date when periodic checks are performed. Reference HVAC Images: [Exhibit D2.4](#) (right). It is suggested to replace filters every 3 to 6 months depending on equipment use. Dirty filters and equipment casing were observed as shown in HVAC Images: [Exhibit D2.5](#) and [D2.6](#) (right).

- Mechanical/Plumbing
  - In general, all mechanical and plumbing systems have been well maintained and appear to be in excellent condition.
  - It is suggested to replace filters at air handling units every three to six months depending on equipment use. Dirty filters and equipment casing were observed in several locations.

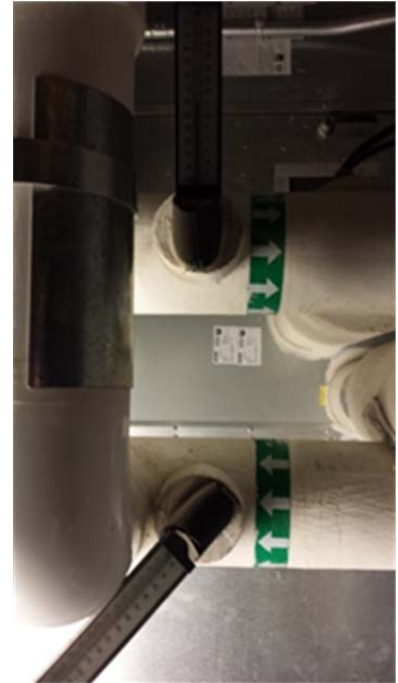
**HVAC Images:**[Exhibit D2.7](#)

- Piping system pressure and temperature clearly identified
- Reference HVAC Images: [Exhibit D2.7](#) (right – rotated 90° for size and clarity).
- Isolation, balancing and control valves installed and operable.

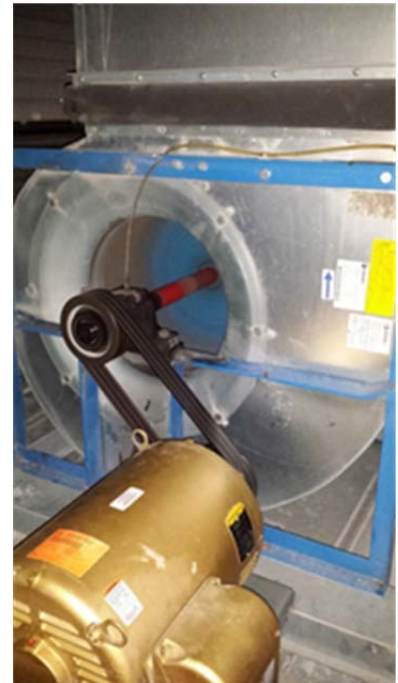
- Fans and motors properly aligned and lubricated.
- Belt tension and condition checked.
- Reference HVAC Images: [Exhibit D2.8](#) (right).
- Filters clean.

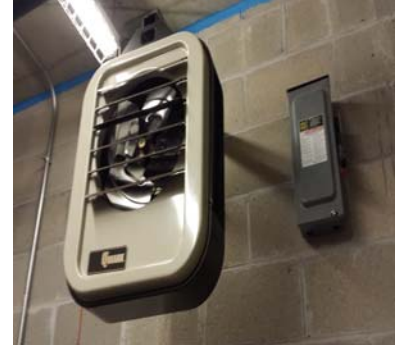
- Equipment tagged.
    - Check for excessive noise or vibrations from fan.
    - Refer to HVAC Images: Exhibit D2.9 (right).
- Exhaust Fans
  - Deficiencies

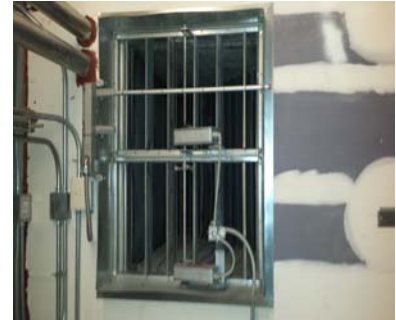
Exhibit D2.10

- travel.
- Check position of damper blades at full open and close positions.
- Check linkage and bearings for slack or wear.
- Refer to HVAC Images: [Exhibit D2.10](#) (page 17).
- Due to the ambient conditions present at the time of the site visit, (30 deg. F) various equipment was not operational and unable to be observed.
  - a) Chillers
    - Equipment tagged.
    - Check for excessive noise and vibration.
    - Check for excessive temperatures and pressures.
  - b) Roof Top Units – Direct Exchange (DX)
    - Equipment tagged.
    - Maintenance access acceptable for unit and components.
    - Fans and motors properly aligned and lubricated.
    - Belt tension and condition checked.
    - Filters clean.
    - Power disconnects installed and labeled. All safeties operable.

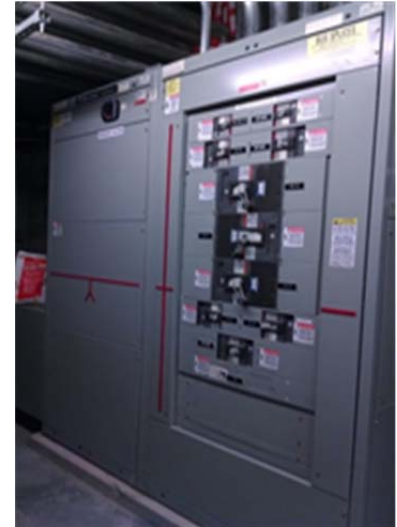
- The overall electrical system looks to be in excellent shape.
- Most electrical rooms are kept clear of debris and obstructions.
- All panel boards observed were well labeled and included type-written, laminated panel board schedule. All emergency panels were labeled with red placards, making it easy to identify quickly in an emergency situation, as shown under Electrical Images: [Exhibit D3.1](#) (page 18).

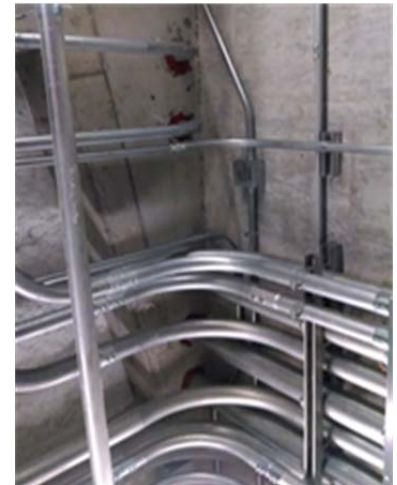
- Fire-barrier sealant looks to be in good condition and is located around wall and ceiling penetrations, as shown under Electrical Images: [Exhibit D3.2](#) (page 18 – rotated 90° for size and clarity).

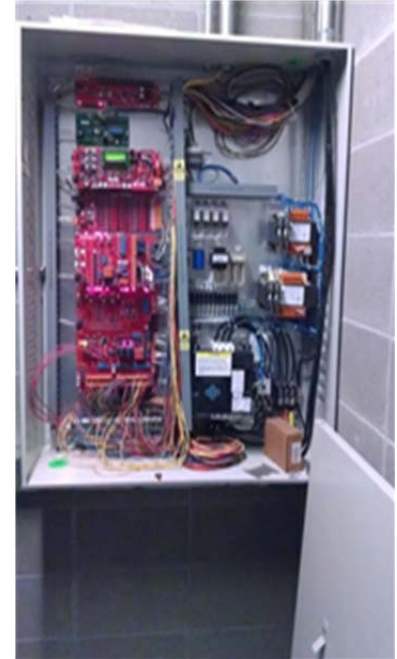
- All plug mold receptacles observed were in good condition.
- The control panel cover located in Elevator Machine Room 420D is not on the panel, and is instead lying next to the panel, as shown under Electrical Images: [Exhibit D3.3](#) (right). It is advised to secure this panel cover to protect wiring from dust, debris, and unauthorized wiring changes.

- Electrical
  - In general, all electrical elements appear to be in excellent condition.
  - Ensure that all electrical panel covers are installed properly and secured to protect wiring from dust, debris, and unauthorized wiring changes (typical).

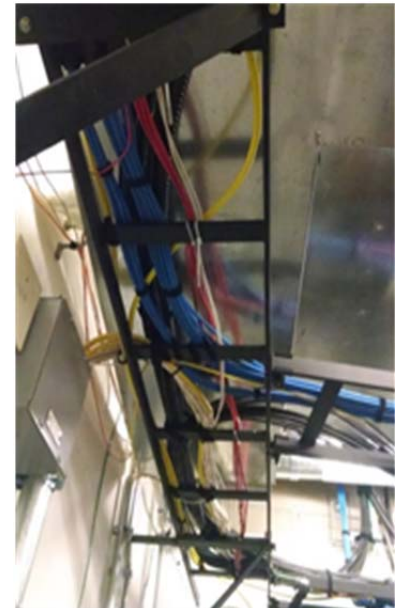
tray, as shown under Electrical Images: [Exhibit D3.4](#) (page 19).

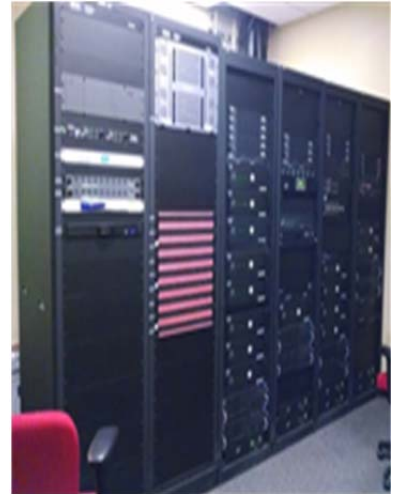
##### [Exhibit D3.5](#)

- Telecommunications racks observed are in good condition, and are labeled as needed, as shown under Electrical Images: [Exhibit D3.5](#) (right).

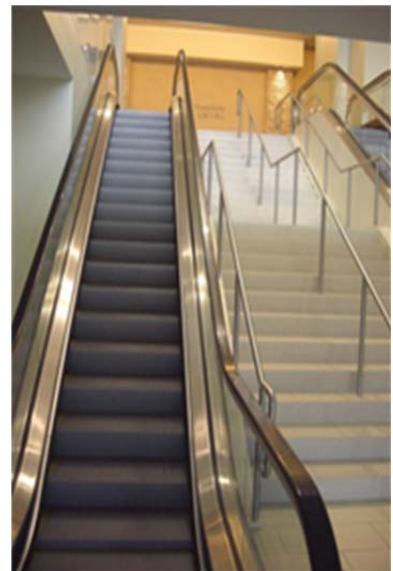
##### [Exhibit E2.1](#)

- Escalators appear to be in excellent condition with regard to cleanness. No significant scratching, scuffing, or other damage was observed. At the time of observation, none of the escalators were turned on due to energy conservation. Refer to Escalator Images: [Exhibit E2.1](#) (right).
