Arrowhead Stadium Assessment

JCSCA + Burns & McDonnell

This document contains information pertaining to the condition of Arrowhead Stadium as documented by the Jackson County Sports Complex Authority (JCSCA), including descriptions, conditions, and exhibits which have been reviewed by Burns & McDonnell and documented in this report.

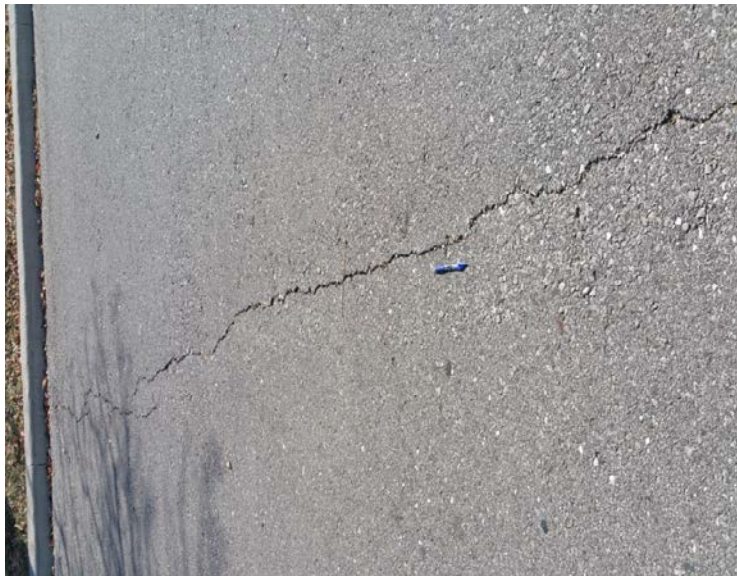
Figure C-1: Transverse Crack

Outside of the concourse of the stadium, a number of transverse cracks were observed in the surrounding asphalt circulation road. These cracks can also be found at locations where retractable bollards are located, as shown in Figures C-1 and C-2.

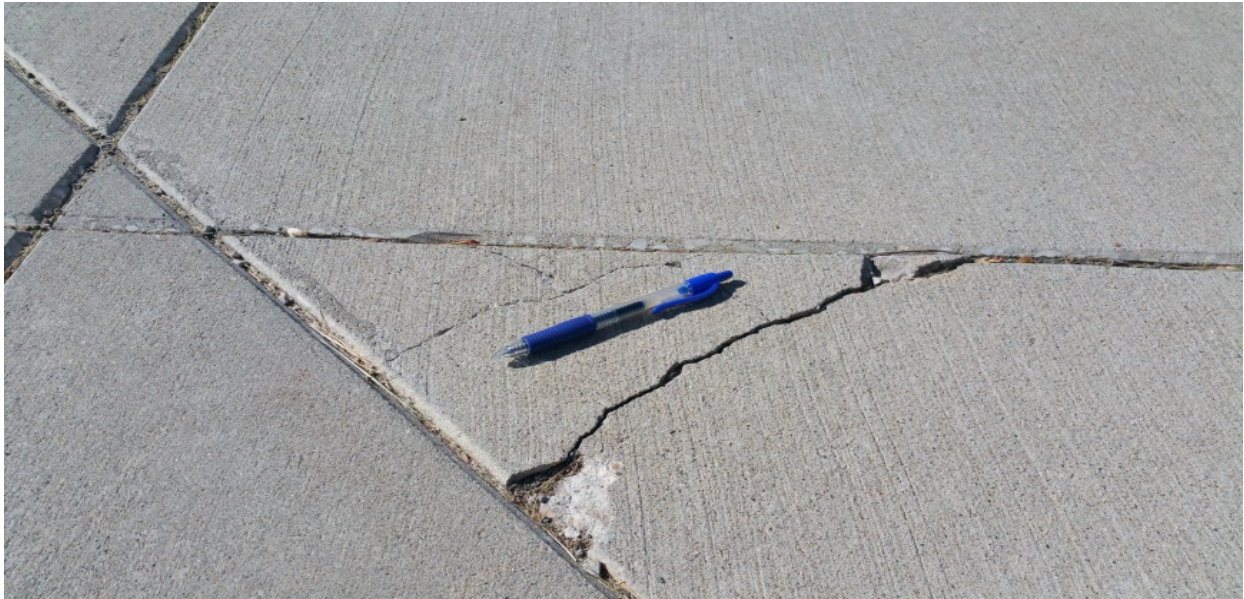
Figure C-3: Corner Spall Observed near Tower Gate

The most common deficiency observed throughout the exterior pavement was corner spalling. At several locations, low to moderate severity spalling was observed at panel corners, and was intermittently paired with cracking at the corners, as shown in Figures C-3 and C-4 respectively.

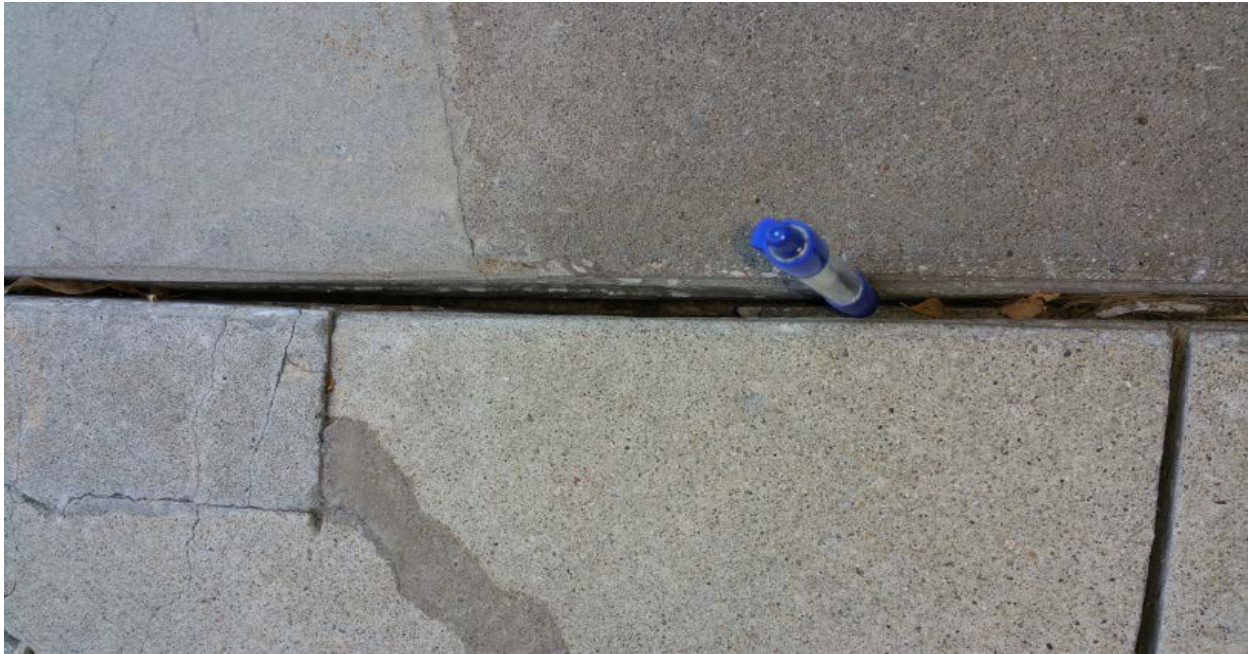
Figure C-5: Missing Sealant at the Isolation Joint near the Hy-Vee Gate

Many joints around the stadium are adequately sealed and in satisfactory condition, but some joints were missing sealant at the time of the assessment. In locations where sealant is missing or damaged, incompressible materials and organics could be found within the joint, as shown in Figure C-5.

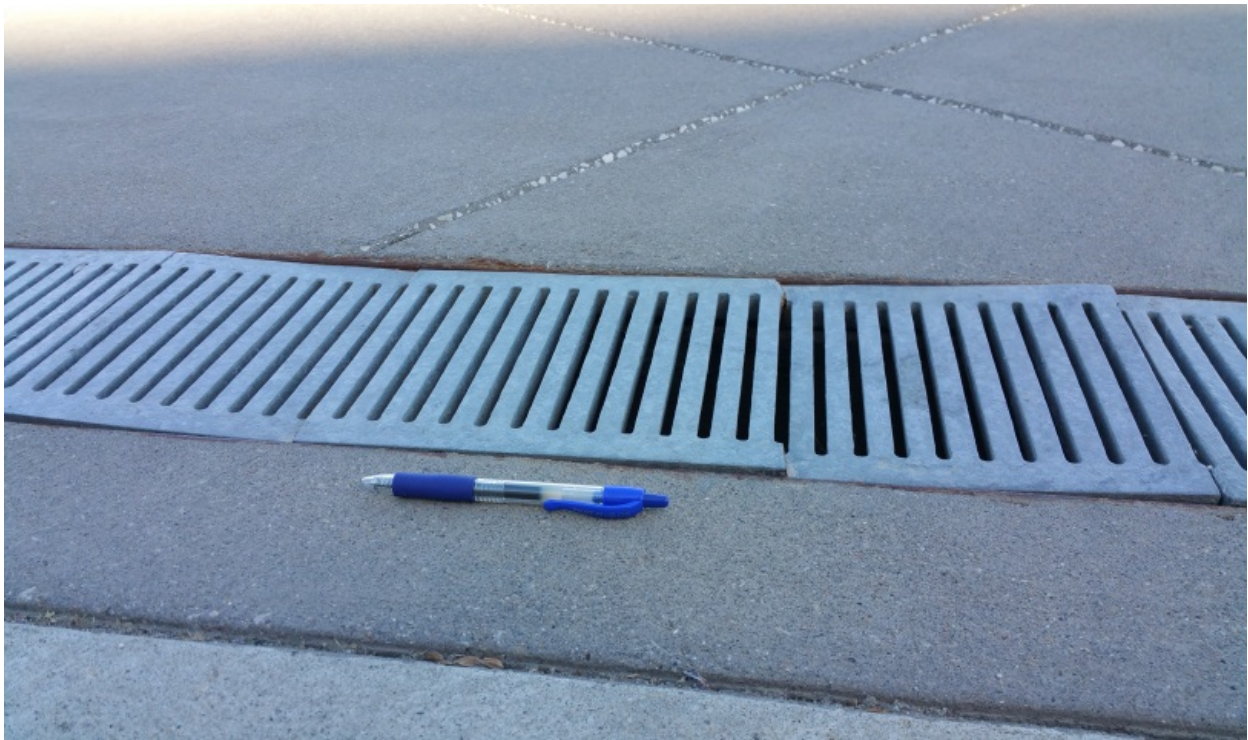
Figure C-6: Broken Trench Drain Grate Observed near Founders Plaza

Some of the trench drains observed were damaged, and not securely fastened to the ground. Specifically, trench drains on both sides of Founders Plaza were broken in several places and were free to move when stepped on, as shown in Figure C-6.

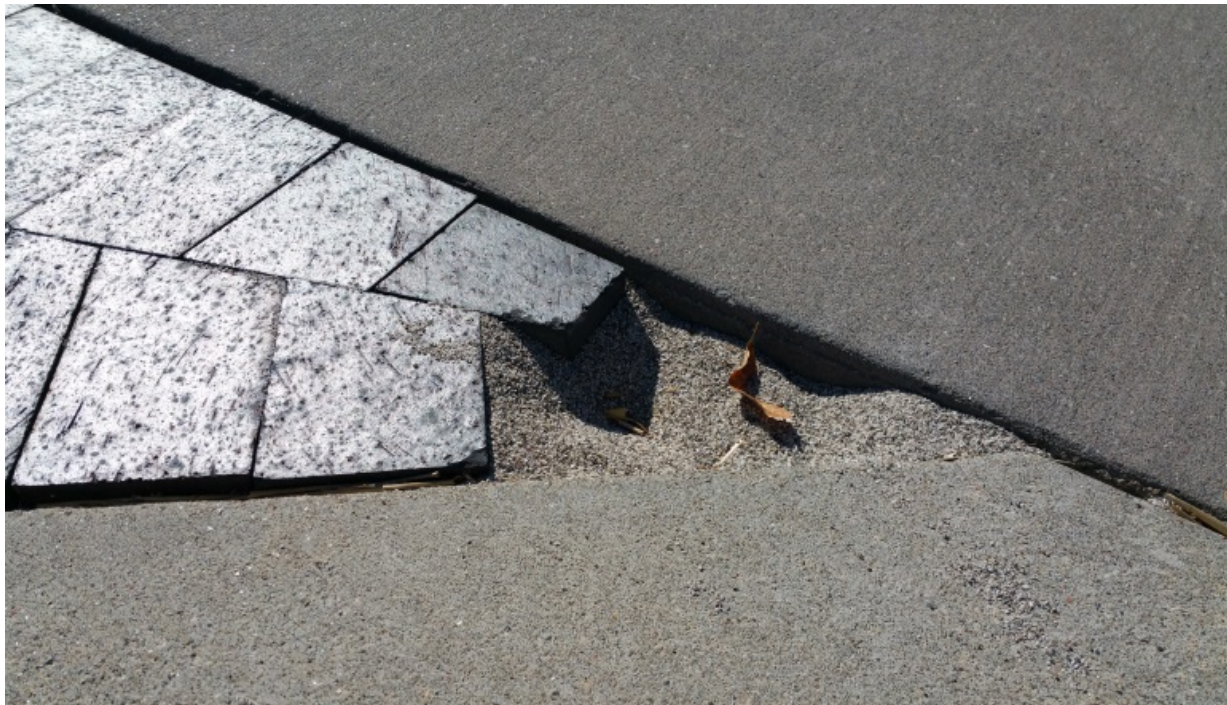
Figure C-7: Missing Paver in Main Pedestrian thoroughfare at Founder's Plaza

In several locations near the Founder's Plaza, pavers were missing and the subgrade beneath was exposed, as shown in Figure C-7. These locations create an inconsistency in surface elevation and present a potential trip hazard.

- Repair or replace panels or portions of panels showing more severe signs of deterioration. Damage severe enough in nature to present a trip hazard should be repaired to provide a consistent and even walking surface
- Replace any missing pavers to provide an even consistent walking surface for pedestrians. This would also be an improvement aesthetically. Refer to Figure C-7.

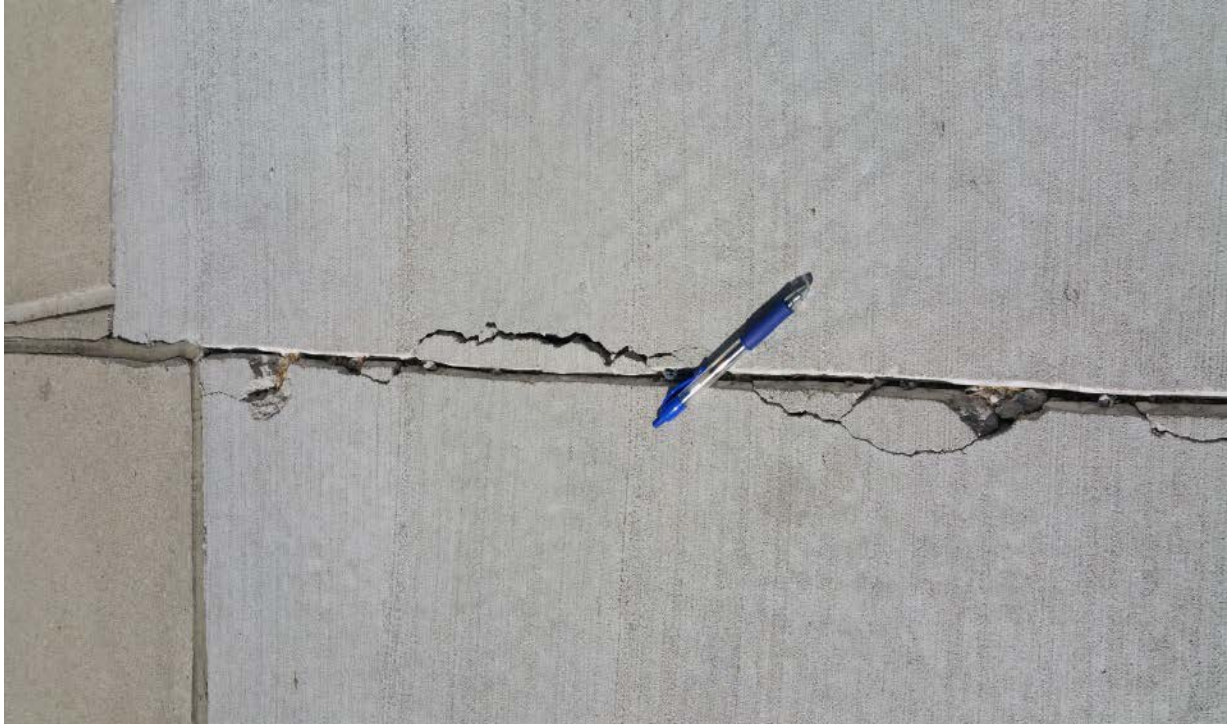
Figure C-8: Edge Spalling of Varying Severity was Observed

Within the concourse of the stadium, joint spalling and panel corner spalling was observed in several locations. This spalling ranged from low to moderate severity and was found in pavements of varying age. Some of the spalling was observed in panels that appeared to have been patched recently, as shown in Figure C-8.

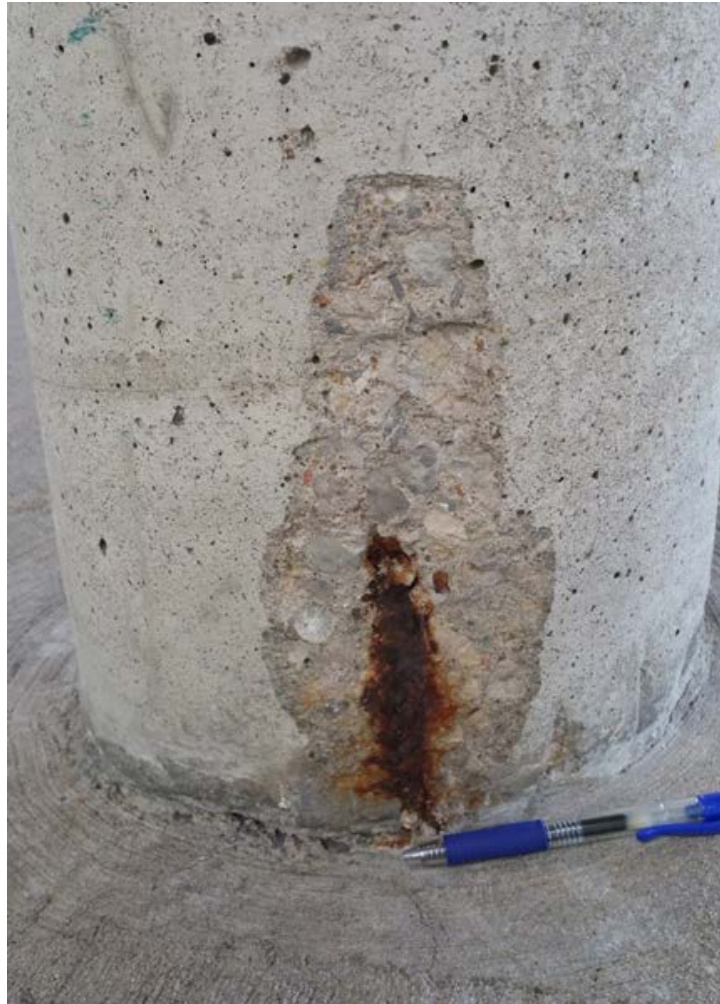
Figure C-9: Exposed Rebar within Column

A more severe case of spalling was observed at the base of a column near the Sprint gate, as shown in Figure C-9. In this case, spalling has exposed rebar within the column. Exposed rebar is susceptible to rust and corrosion which may ultimately lead to weaker reinforcing thereby affecting the structural integrity of the column.

- Monitor cracking in the surrounding asphalt roads and perform maintenance as necessary to prevent propagation of existing distresses.
- Perform routine maintenance to seal and repair minor cracking observed along walkways and concourses. Refer to Figure C-8.
- Remove incompressible material and organics from any joints missing sealant material, and replace the missing sealant and compressible material. Refer to Figure C-5.
- Monitor the various location of spalling for increased severity and repair more severe cases within panels and structural components. Refer to Figure C-9.

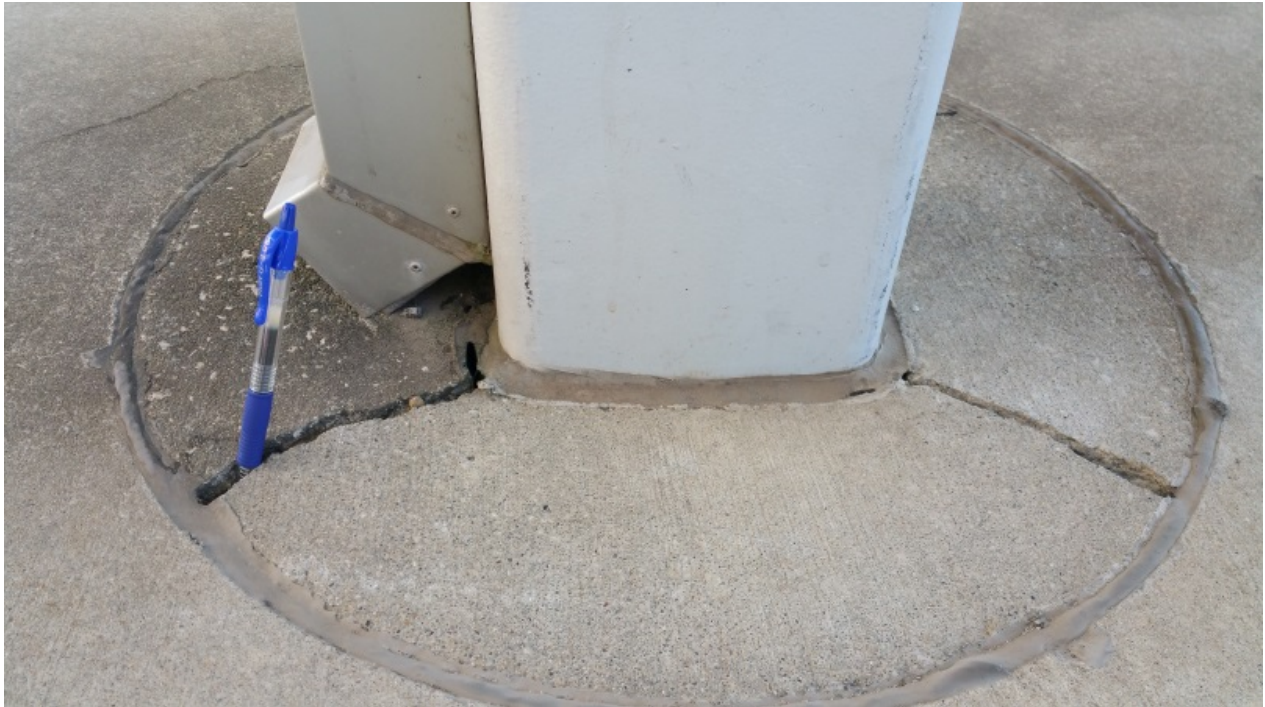
Figure C-10: Cracking at a Column Base near Gate D

Several columns just inside gate D have cracks in their structural bases that radiate out from the column, as shown in Figure C-10. It is estimated that these cracks are only in a concrete cap on top of the column foundation and do not have impact on the structure above. It is recommended to seal the cracks to prevent water from infiltrating and causing continued pavement damage through freeze-thaw iterations.

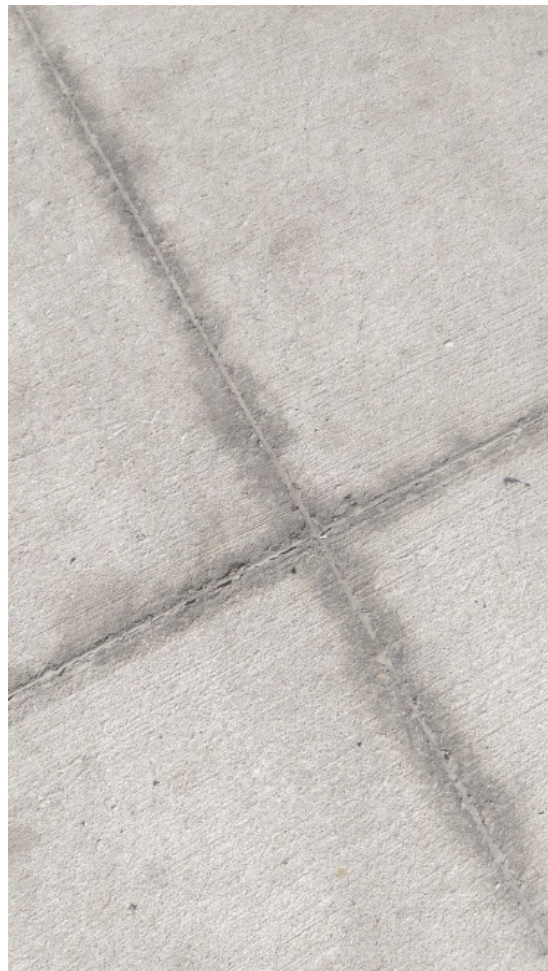
Figure S-1: Slab-On-Grade Control Joints

No significant settlement of the structure was observed. The slab-on-grade is primarily in satisfactory condition. No major cracks or spalling of the concrete were observed. Control joints and expansion joints are in satisfactory condition, as shown in Figure S-1.

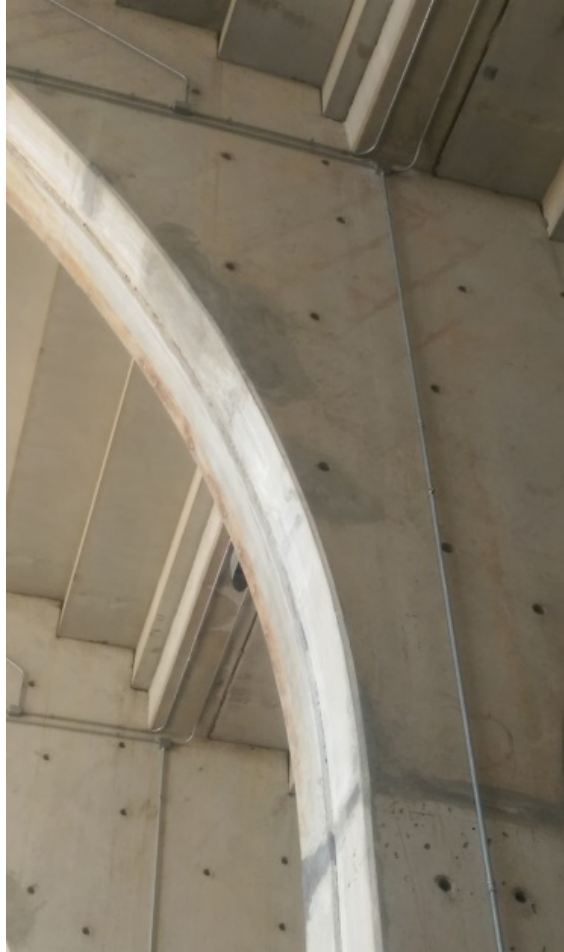
Figure S-3: Concrete Patchwork

The original reinforced concrete columns and walls are in satisfactory condition. No major cracks or spalling was observed. The vertical column and wall surfaces are flat and smooth. Concrete patchwork of the original structure is in satisfactory condition. The patchwork is flat and smooth, as shown in Figure S-3.

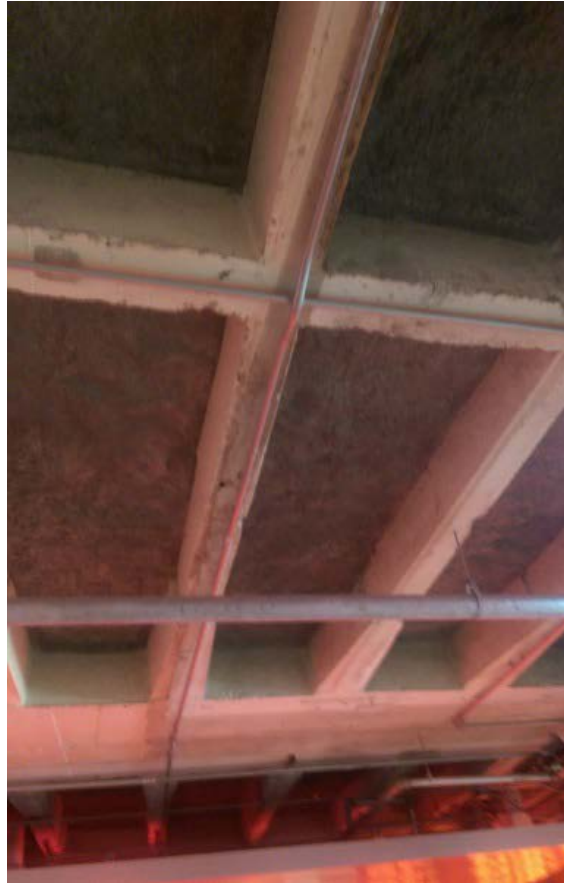
Figure S-4: Pan Joist Slab System Showing Minor Cracking

The original reinforced concrete pan joist slab systems are in satisfactory condition. No major cracks or spalling was observed. Minor cracking and spalling exist but are not detrimental to the structure, as shown in Figure S-4. The suspended slab surface is flat and smooth. The expansion joints between the original superstructure and the renovation superstructure are in satisfactory condition. No deterioration was observed.

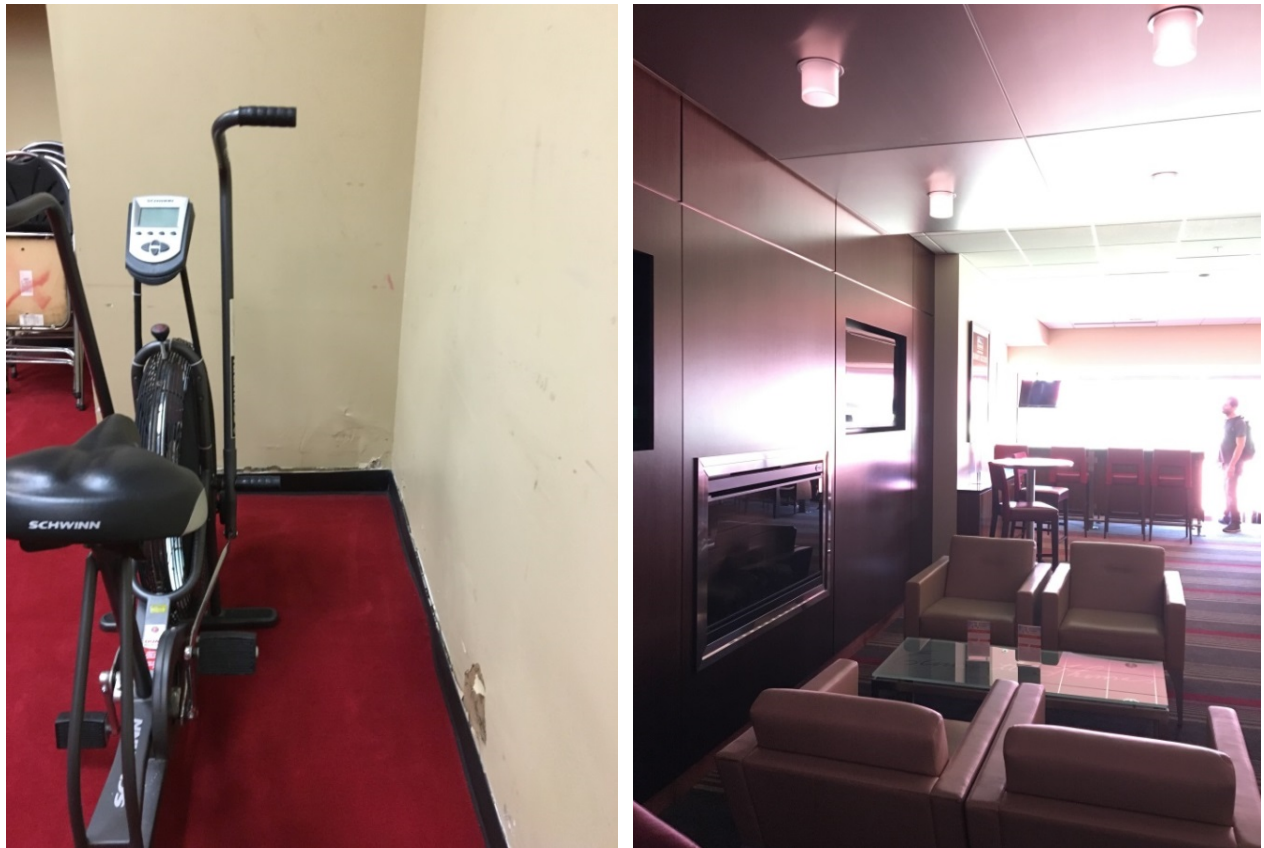
Figure AI-5: Flaking Paint at Coaches Room (left) and Wood Veneer Panel Wall (right)

Paint was observed flaking off of what appears to be a concrete wall at one of the coach's rooms in the Service Level, as shown in Figure AI-5 (left image). Wood veneer panel at interior walls appear to be in satisfactory condition, as shown in Figure AI-5(right image). No scratches, scuffs, or fading of any kind was observed.

Paint was observed flaking off of what appears to be a concrete wall at one of the visiting coach rooms in the Service Level, as shown in Figure AI-5 (left image).

- Consider removing flakes of paint around damaged area, prepping surface to receive new paint, and repainting area with the appropriate material in order to ensure proper adhesion to substrate material. Continual paint adhesion problems may be linked to improper paint type or potential moisture issues behind the wall surface.

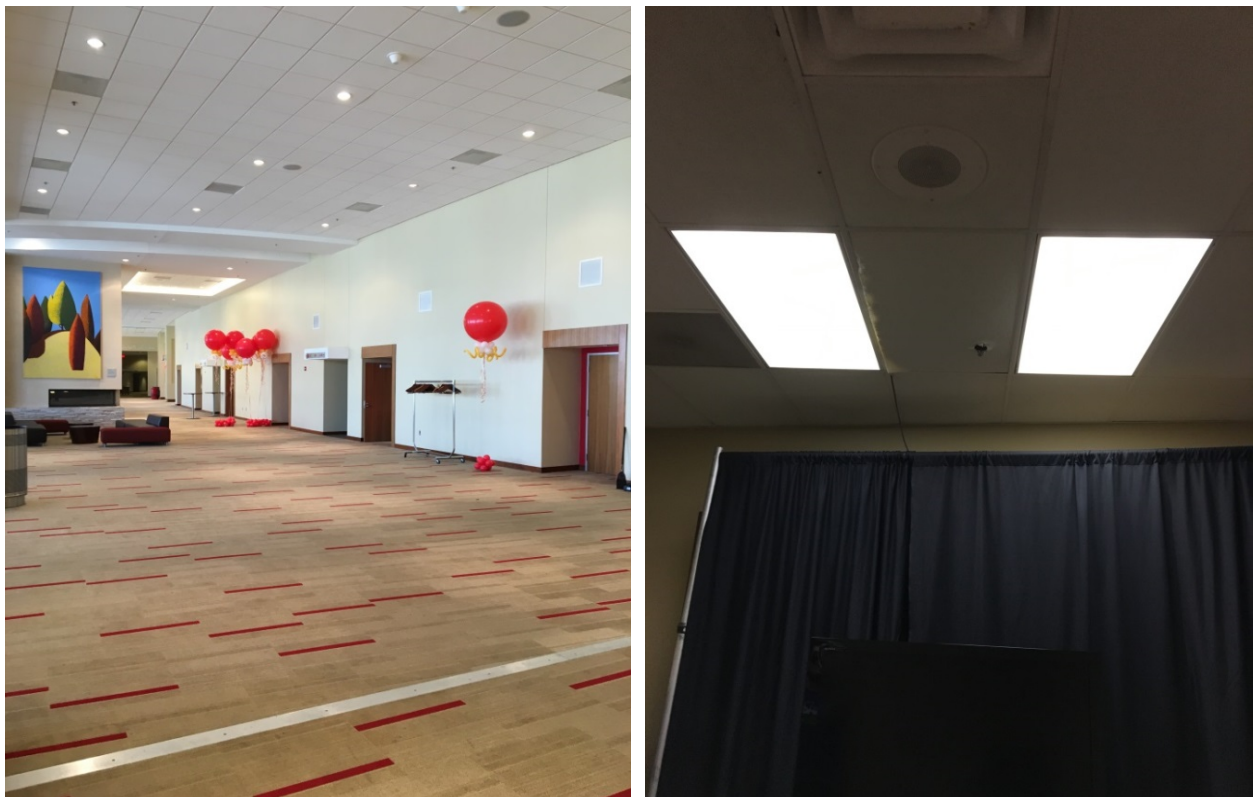
Figure AI-6: Acoustic Ceiling Tile at Event Space (left) and at Service Level Coach Room (right)

Acoustic ceiling tiles appear to be in satisfactory condition, generally. A typical condition at the Club Level lounge area is shown in Figure AI-6 (left image). Ceiling tile in these spaces do not show signs of stains or deterioration of any kind. However, at a few locations at the Service Level some ceiling tiles were observed to be damaged around the corners or were not properly set within the ceiling grid. One location where damaged ceilings tiles were observed was at the visiting coach room in the Service Level, as shown in Figure AI-6 (right image).

Acoustic ceiling tiles appear to be in satisfactory condition, generally. However, at a few locations at the Service Level some ceiling tiles were observed to be damaged around the corners or were not properly set within the ceiling grid. One location where damaged ceilings tiles were observed was at the visiting coach room in the Service Level, as shown in Figure AI-6 (right image).

- Consider replacing damaged ceiling tiles and properly cutting tiles around ceiling elements for a cleaner look. Also consider moving plenum cabling so that wiring may be routed along the surface of a wall in lieu of in the middle of a room.

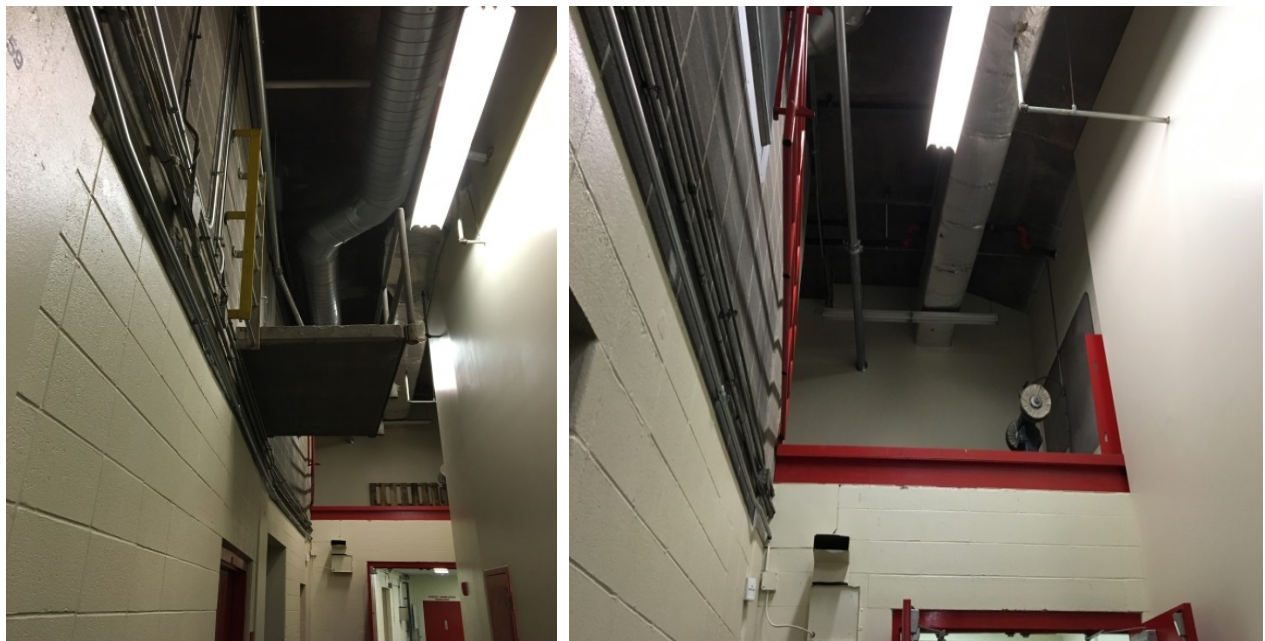
Figure AI-9: Balcony Areas without Proper Fall Protection

At the Service Level, two balcony areas were observed to have inadequate fall protection as shown in Figure AI-9. It is assumed that these areas are not accessible to the general public and that individuals accessing these spaces are aware of the hazard. It is also assumed that these areas are intended to allow forklift trucks to hoist and deliver items to the upper story of this space. However, failure to keep proper fall protection in place (guardrails) may present a major safety concern for individuals accessing these spaces. It is highly recommended that these balcony areas be adequately closed off with a guardrail when not required to be open for material delivery.

At the Service Level, two balcony areas were observed to have inadequate fall protection as shown in Figure AI-9. It is assumed that these areas are not accessible to the general public and that individuals accessing these spaces are aware of the hazard. It is also assumed that these areas are intended to allow forklift trucks to hoist and deliver items to the upper story of this space. However, failure to keep proper fall protection in place (guardrails) may present a major safety concern for individuals accessing these spaces.

- It is highly recommended that these balcony areas be adequately closed off with a guardrail when not required to be open for material delivery. It is also recommended that doors accessing these spaces be locked at all times and only accessible to individuals who are completely familiar with the potential hazards of these spaces. Unintentional passage through adjacent doors and onto unprotected balcony areas may cause serious injury or death should someone fall due to inadequate fall protection.

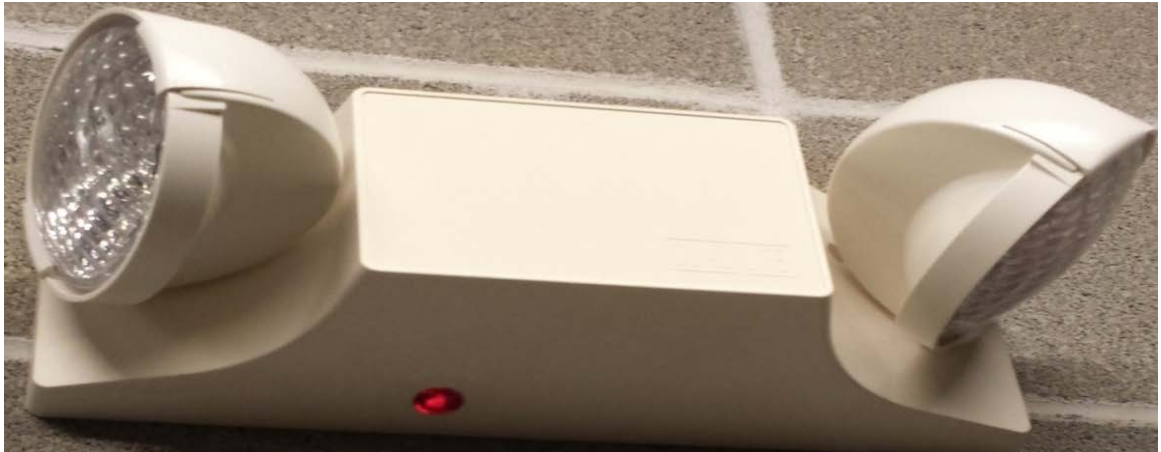
Figure E-2: Emergency Bug-Eyed Light Fixture

- 2) Bug-eye emergency lights, as shown in Figure E-2, were observed to be emitting a buzzing noise, which may indicate that the back-up batteries may be weak.

Bug-eyed emergency lights, as shown in Figure E-2, were observed to be emitting a buzzing noise, which may indicate that the back-up batteries may be weak.

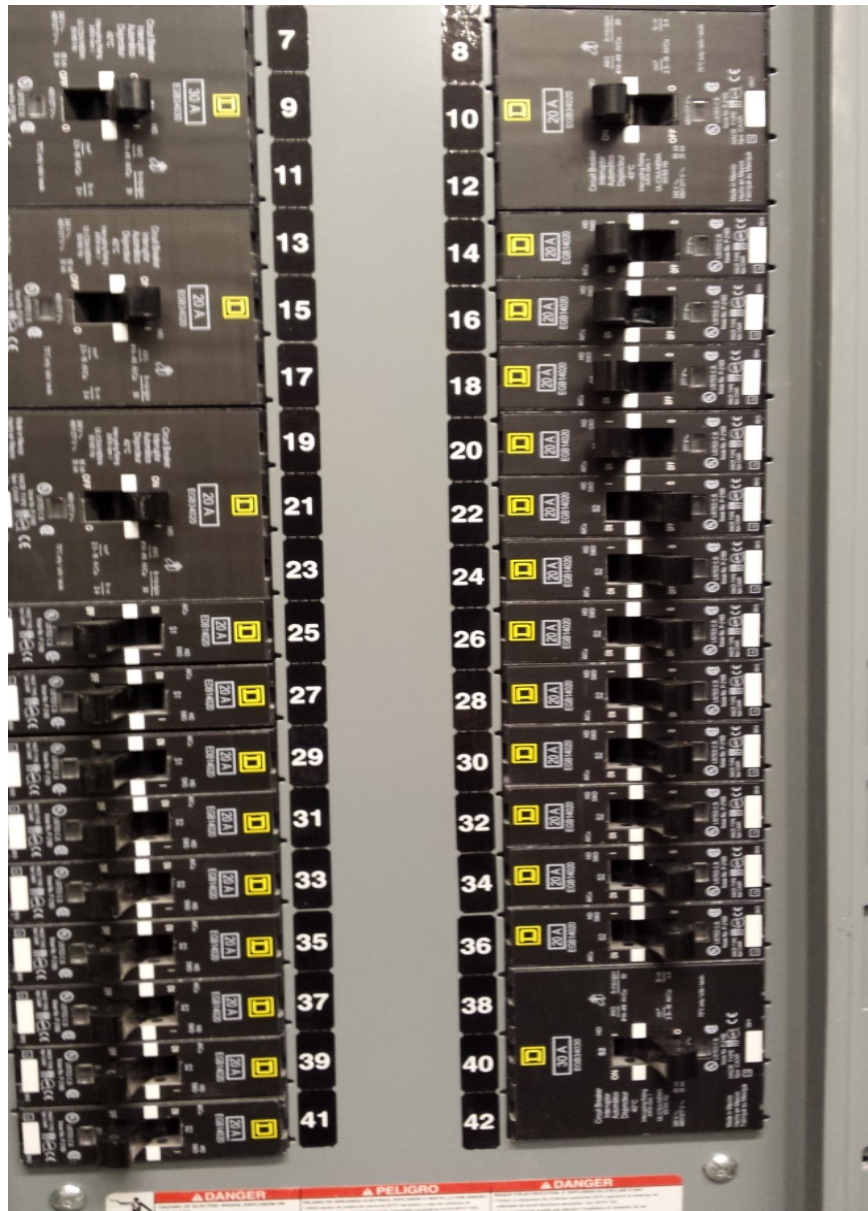
Figure E-4: Panelboard 3B3H4 Branch Circuit Breakers

- 1) Panelboard 3B3H4 directory does not indicate load for 3-pole breaker circuit 38, 40, 42. Refer to Figures E-3 and E-4 below.

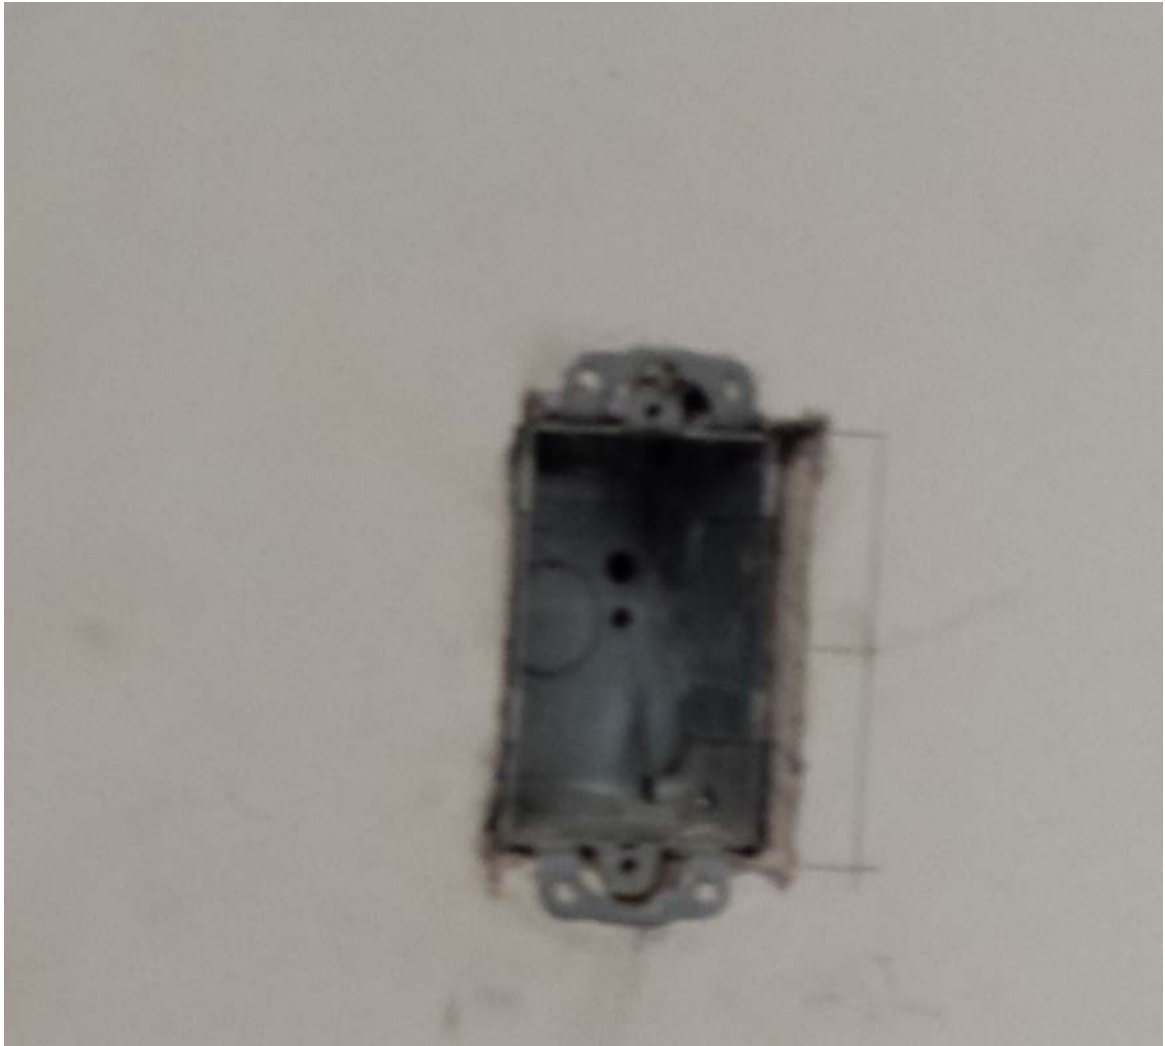
Figure E-5: Open Junction Box

- 2) Coverplate on open device box located on the interior of the main room entrance appears to be missing. Refer to Figure E-5 below.

Open junction boxes were observed in electrical room P253, which may pose a potential safety hazard.

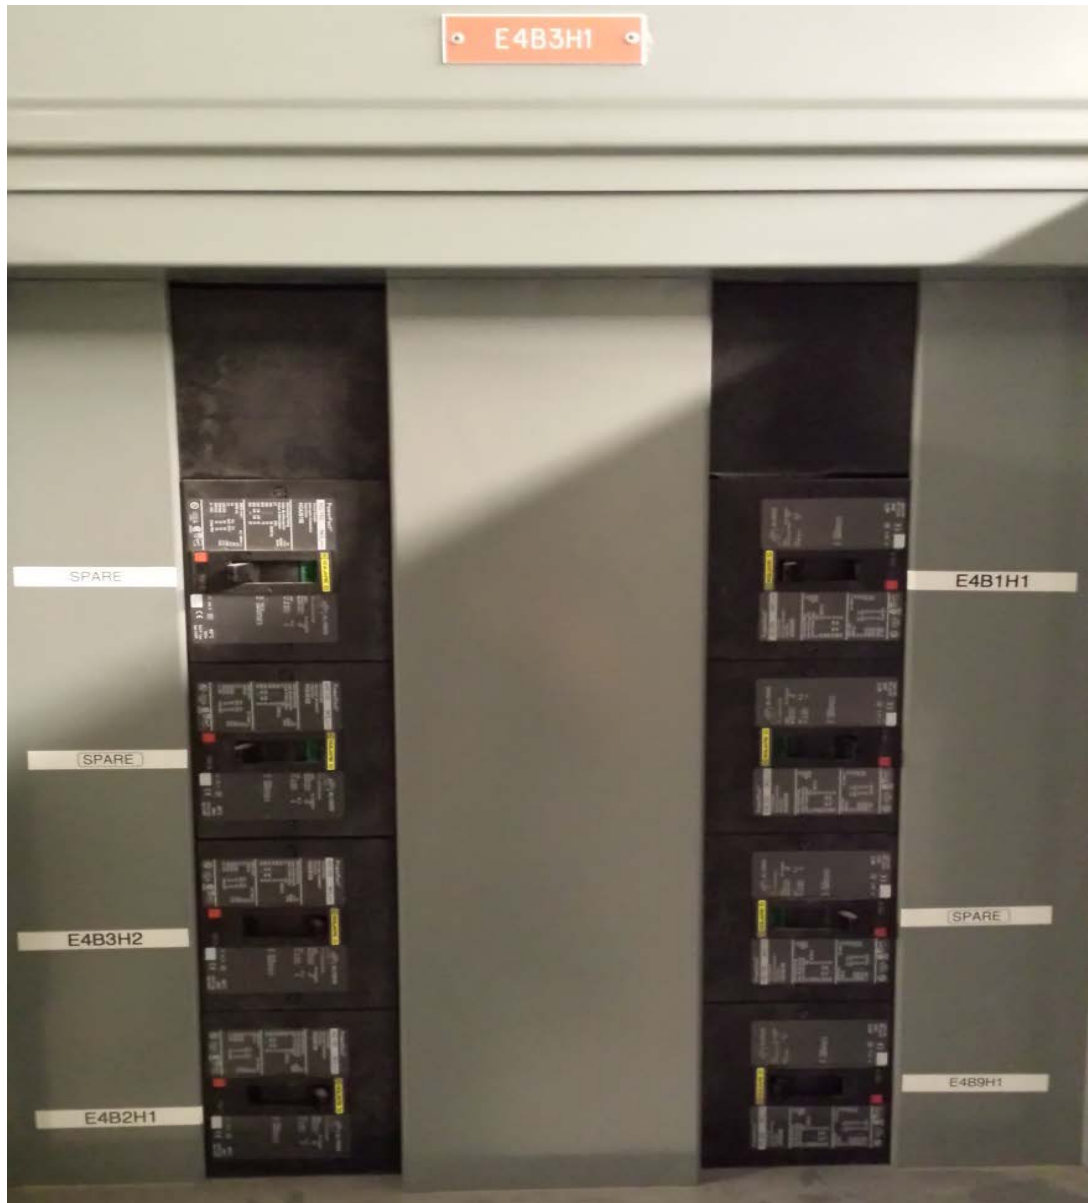
Figure E-6: Panelboard E4B3H1

- 1) Panelboard E4B3H1 3-pole circuit 8, 10, 12 is not labeled, as shown in Figure E-6.

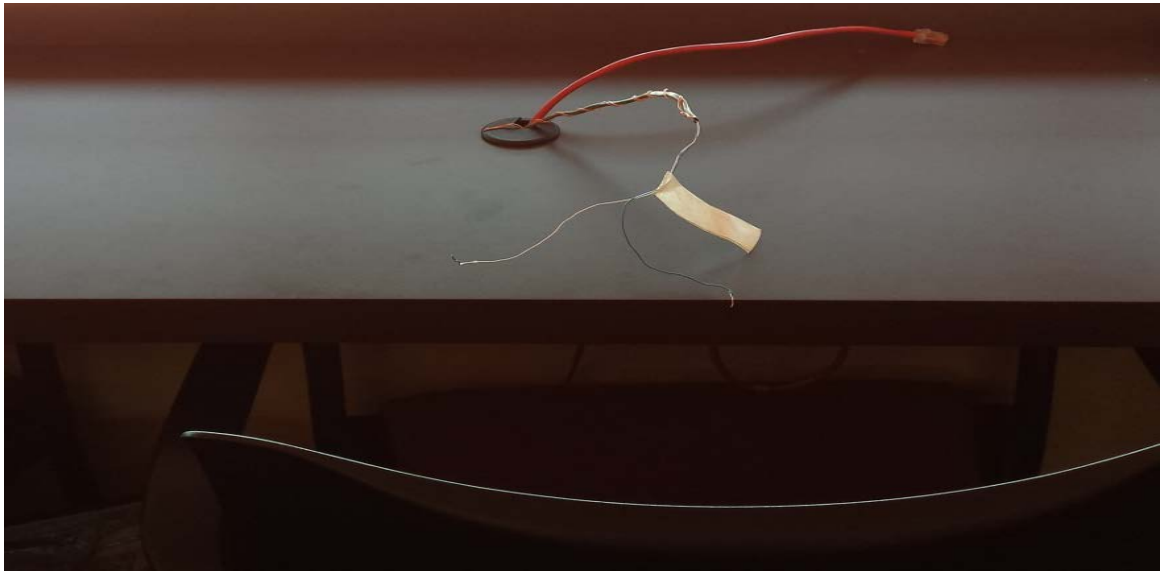
Figure E-7: Unterminated Twisted Pair Cable

- 2) The press level installation of the electrical and data connections at each work station are typically in satisfactory condition. However, at one work station a twisted pair cable was observed to be unterminated above the countertop. Refer to Figure E-7 as shown.

At the Press Level, one workstation was observed to have unterminated (exposed) low-voltage wiring sticking through the countertop, as shown in Figure E-7.
