Arrowhead Stadium Assessment

JCSCA + Burns & McDonnell

This document contains information pertaining to the condition of Arrowhead Stadium as documented by the Jackson County Sports Complex Authority (JCSCA), including descriptions, conditions, and exhibits which have been reviewed by Burns & McDonnell and documented in this report.

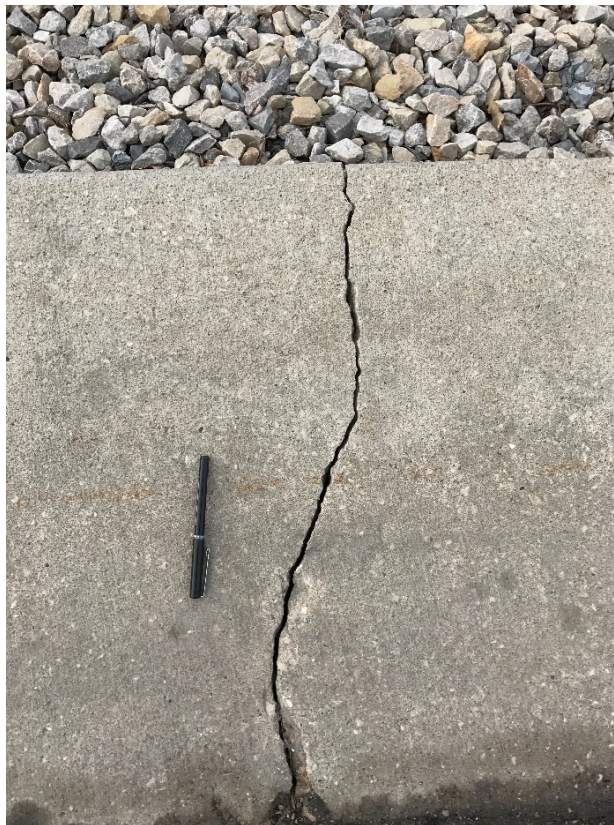
The most prominent defect observed during the walkthrough was the transverse cracking, spalling, & faulting of the pavement. Cracking can be observed in several spots along the curb that surrounds the stadium, as shown in [Figure C-1](#). Additionally, corner cracking of the pavement was observed in several areas throughout the stadium concourse, as shown in [Figures C-2 and C-3](#). [Figure C-2](#) shows corner cracking leading up to a trench drain located outside the Founder's Plaza. [Figure C-3](#) shows corner cracking located outside of gate D. Cracking was observed on several of post footings the perimeter gate. Cracking that leads into the footing could hold potential for displacement of the footing during freeze/thaw conditions. Damages to the fencing were also observed near the Hy-Vee gate. Both the cracking and fence damage are shown in [Figure C-4](#).

Figure C-1: Transverse Crack along Perimeter Curb.

- Cracking and spalling throughout the paved areas should be monitored closely or repaired to prevent further damage to the pavement and avoid pavement displacement during freeze-thaw conditions.
- Deteriorating or missing joint sealant on site will need to be repaired. Specifically on [Figure C-6](#), the damaged sealant shown is at the foot of a structural column and a fence post footing. Both of these footings could be subject to water damage.
- Several of the fence post footings show separation between the footing and the pavement, these post footings are also subject to water damage which can also lead to damage to the fence. Repairs to the fence surrounding the concourse should be made for aesthetic purposes. See [Figure C-4](#) for reference.

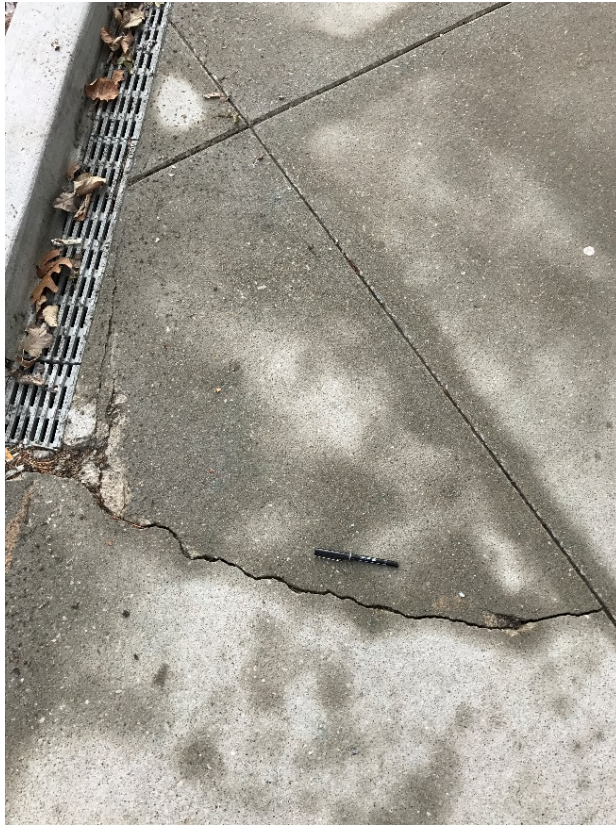
Figure C-2: Corner Cracking outside The Founder's Plaza.

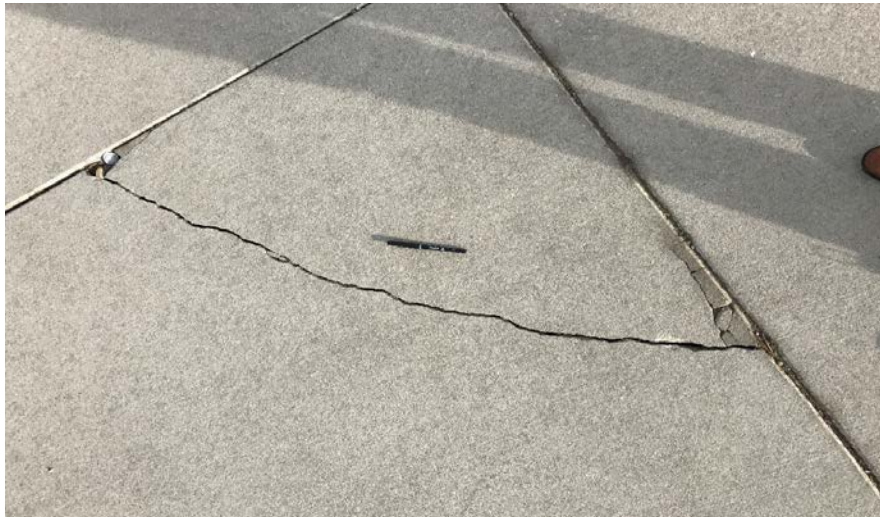
Figure C-3: Corner Cracking outside Gate D.

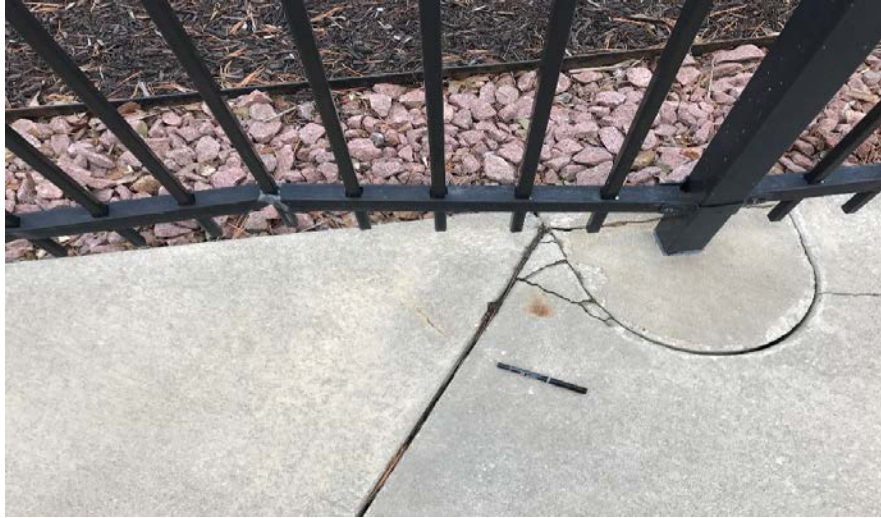
Figure C-4: Fence Damage and Cracking along Footing.

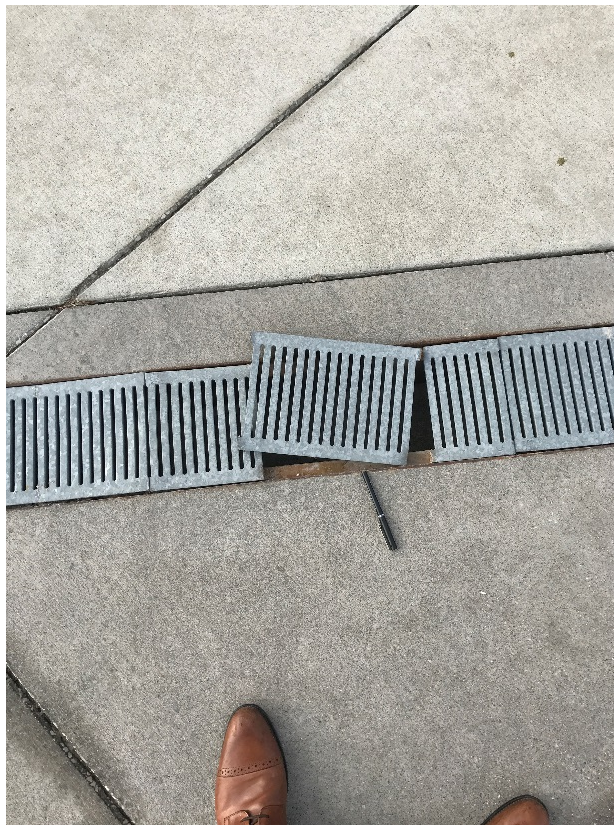
The trench drains outside of the Founder's Plaza were found to be damaged in several different places and were able to be removed or displaced when stepped on. [Figure C-5](#) show a broken piece of the drain displaced from the trench located outside the Founder's Plaza.

Figure C-5: Broken Trench Drain outside The Founder's Plaza.

- Repair or replace the trench drain outside the Founder's Plaza. The broken and displaced pieces of the drain can cause a tripping hazard for pedestrians entering the Stadium. Can also be used as a projectile. See [Figure C-5](#).
- Deterioration was observed on several of the detectable warnings leading into the building concourse. Damaged sealant was also seen between the detectable warning and the pavement which can be subject to displacement due to freeze-thaw conditions. Leaving these detectable warnings in an unsatisfactory can be hazardous to vision-impaired pedestrians and may also not be compliant with ADA regulation. See [Figure C-8](#).
- Any pavement faulting observed or warned of in this report will need to be addressed. Displaced pavement from freeze-thaw conditions can be a tripping hazard and is a threat to pedestrian safety.

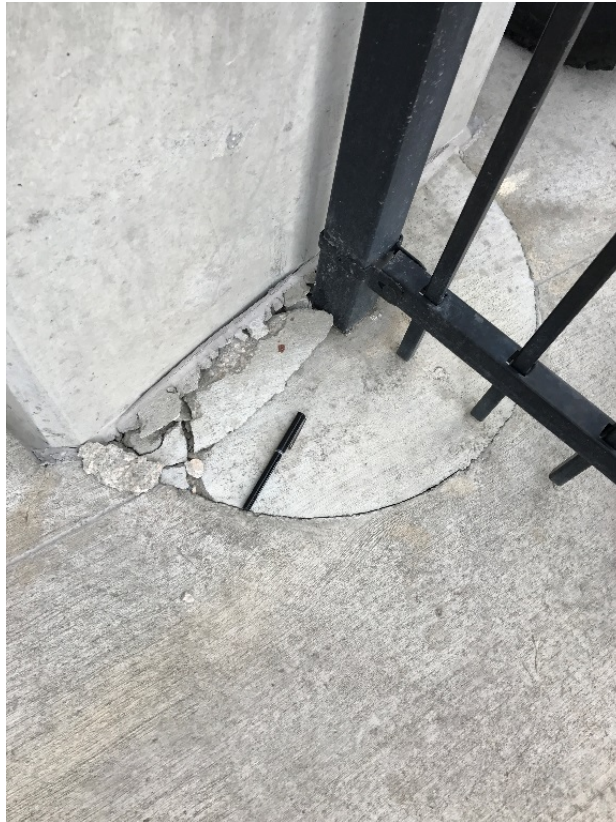
Damaged or deteriorating sealant was observed around the site, many cases it would also be accompanied by joint spalling. [Figure C-6](#) shows spalling occurring with a damaged joint sealant near gate D at the base of a structural column/gate post footing. Additionally, mild-moderate deterioration of joint sealant was observed throughout the site, as shown in [Figure C-7](#).

Figure C-6: Joint Spalling and Sealant Damage.

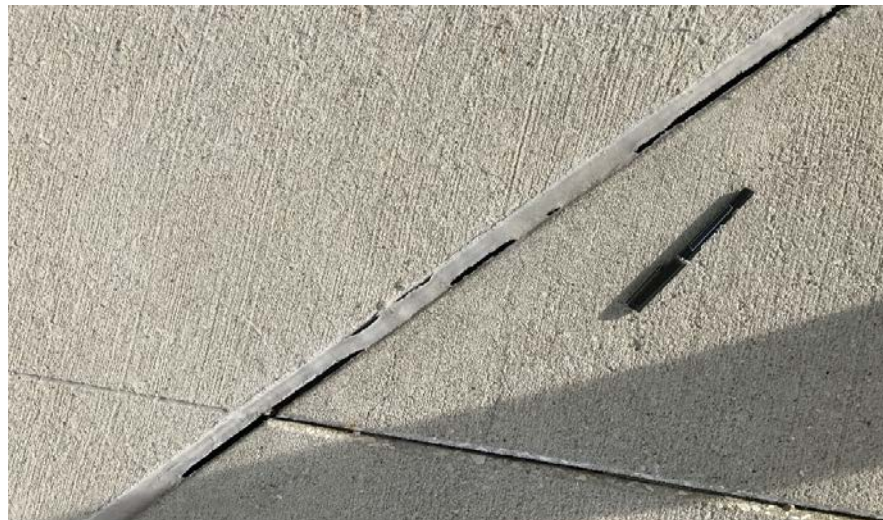
Figure C-7: Joint Sealant Deterioration.

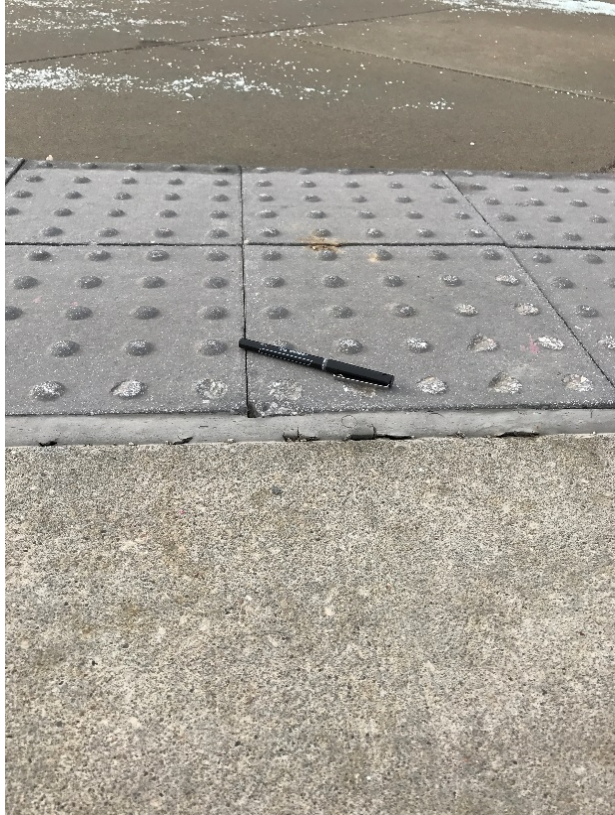
Concourse entryways that are located beyond the ticket gates (almost directly North, South, East, and West respectively) are subject to heavy foot traffic. As a result the detectable warnings at each corner of the concourse have deteriorated and may not be ADA compliant. One observed detectable warning also showed damaged sealant and a large gap between the warning and the pavement which can be subject to damage during freeze-thaw conditions. [Figure C-8](#) shows the detectable warning near the intersection of Chiefs Way and Red Coat Lane. Cracking in the bollard footing can also be seen just past the detectable warning near the Hy-Vee gate, which is shown on [Figure C-9](#).

Figure C-8: Detectable Warning Deterioration.

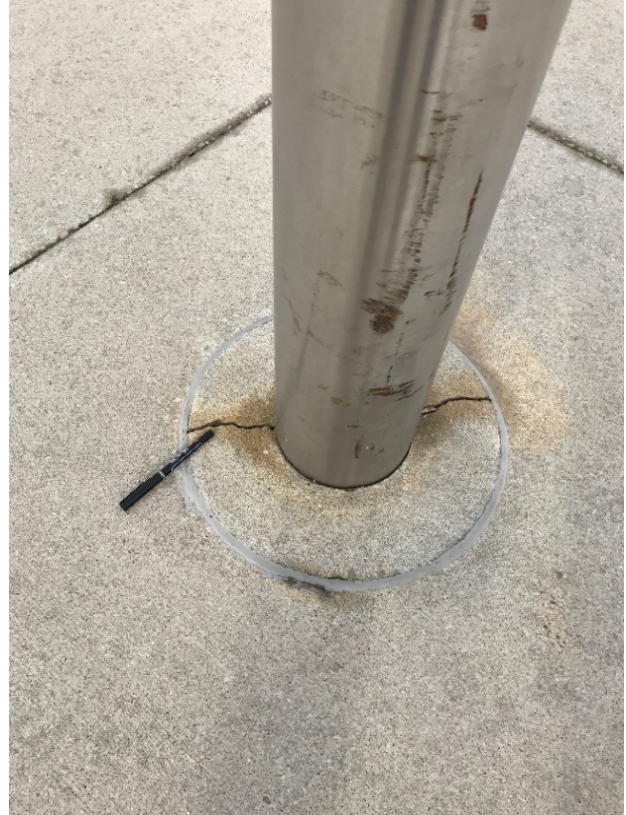
Figure C-9: Cracking in the Bollard Footing.

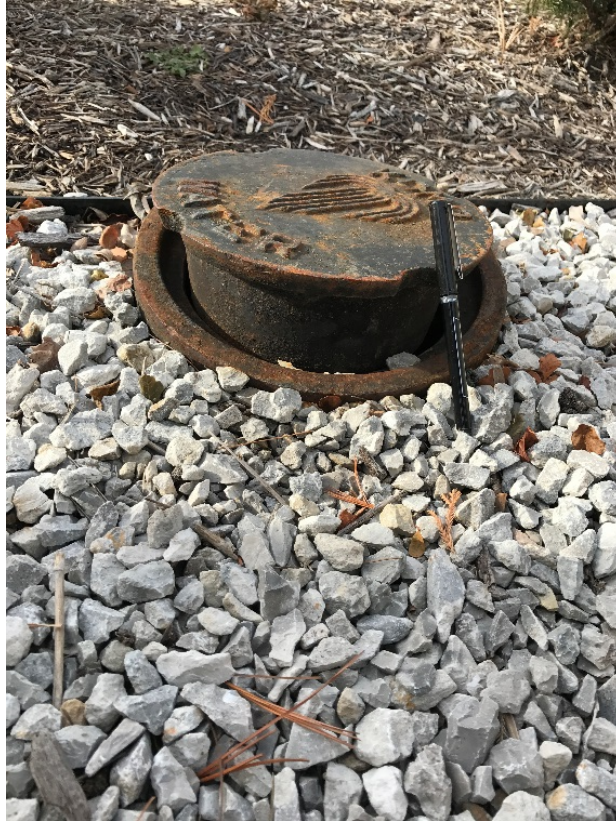
Water meters, storm drains, & man holes all seem to be in satisfactory condition. One water meter located outside the Tower Gate seemed to have been displaced causing the lip of the casing not to stay flush with the top of the meter, as shown in [Figure C-10](#). Further investigation may be needed to evaluate whether or not this needs to be corrected.

Figure C-10: Displaced Water Meter.

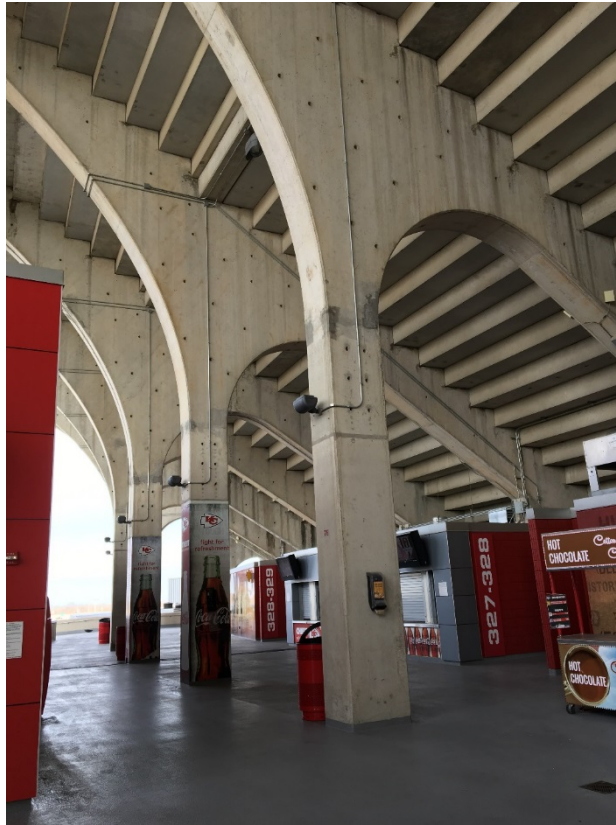
The original reinforced concrete columns and walls are in satisfactory condition. No major cracks or spalling was observed. The vertical column and wall surfaces are flat and smooth. Concrete patchwork of the original structure is in satisfactory condition. The patchwork is typically flat and smooth, as shown in [Figure S-3](#).

Figure S-3: Concrete Patchwork in Upper Concourse.

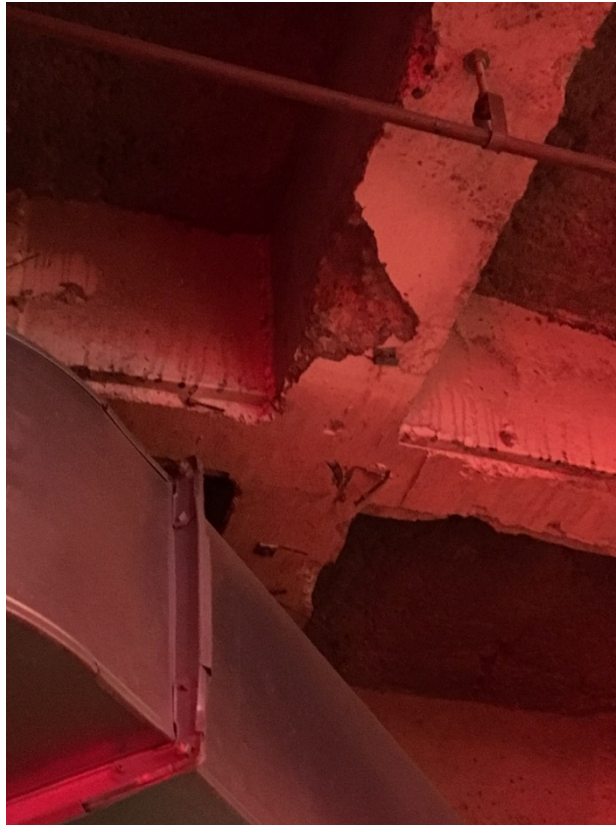
The original reinforced concrete pan joist slab systems are in satisfactory condition. No major cracks or spalling were observed. Minor cracking and spalling exist but are not detrimental to the structure and should be expected with a structure of this age. One location of moderate spalling was visible in Concourse Section 116 adjacent to the Hall of Honor, and should be patched to avoid deterioration of the surrounding concrete and reinforcing. This is shown in [Figure S-4](#) below.

Figure S-4: Concrete Joist Spalling at Concourse Section 116.

All observed structural elements are in satisfactory condition. One pan-joint location in Concourse Section 116, adjacent to the Hall of Honor, should be repaired with a cementitious patching material within the next year to avoid potential deterioration. Other concrete superstructure areas may require concrete patchwork within the next few years. Continue routine maintenance and inspection as required.

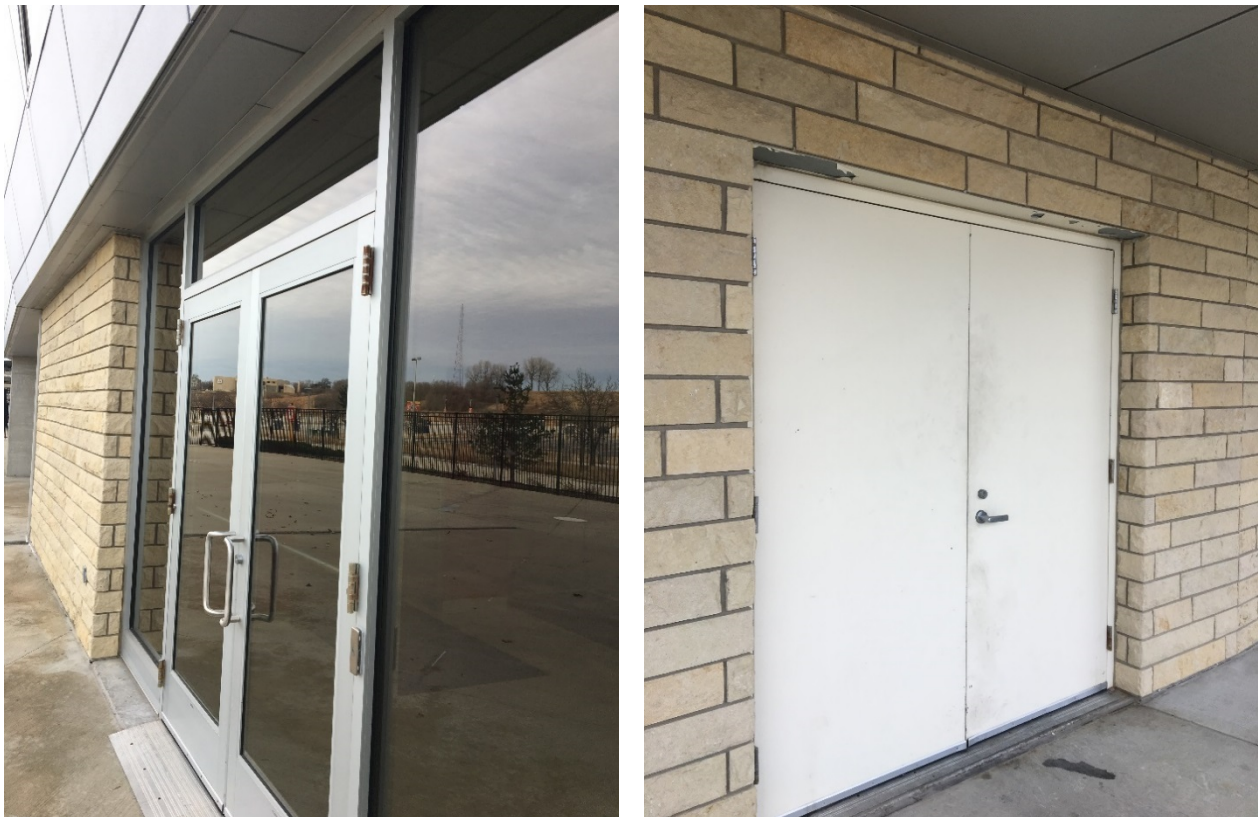
Exterior doors at the exterior plaza level were observed to have minor deficiencies. The hinges on the aluminum framed storefront doors near the team store were observed to have minor rust and corrosion accumulation. Refer to [Figure AF-3](#) (left image). To avoid rust stains or streaking on the aluminum frames, consider replacing hinges with an anti-corrosive material such as stainless steel.

Also, paint applied to steel angle lintels above nearly every Plaza Level hollow metal service door was observed to be peeling and flaking. Refer to [Figure AF-3](#) (right image). To avoid exposing the steel lintels to moisture and eventual rust development, consider scraping and repainting with an appropriate paint product which is specifically formulated for this material and exterior conditions.

Figure AF-3: Rusty Hinges at Aluminum Door (left) and Flaking Paint at Exterior Lintel (right).

Rust was observed on the hinges of the aluminum framed storefront doors near the team store, as shown in [Figure AF-3](#) (left image).

- To avoid rust stains or streaking on the aluminum frames, consider replacing hinges with an anti-corrosive material such as stainless steel.

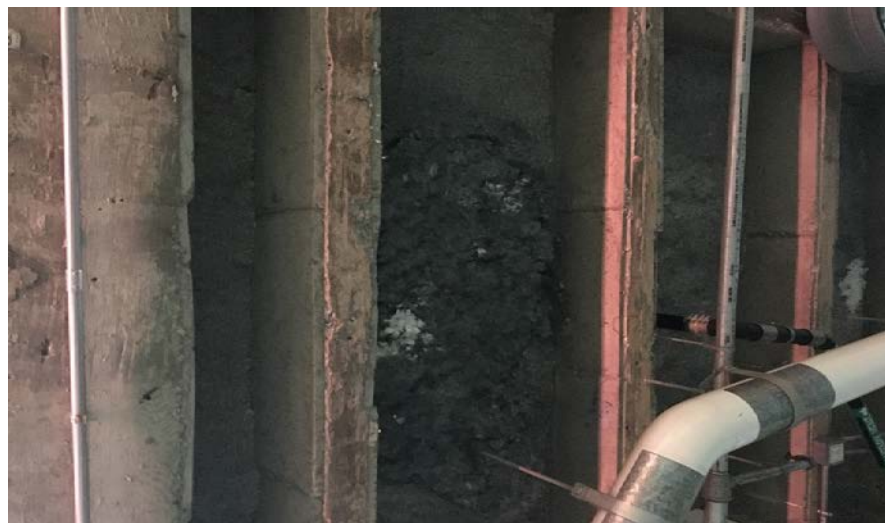
At the field level, between sections 112 and 113, insulation applied to the underside of the concrete deck was observed to be deteriorating. The condition of such insulation may significantly affect the material's resistance to resist heat flow (r-value), thus affecting the thermal comfort of the spaces above this area. Repair or replacement of this insulation and other similar areas is suggested within the near future. Refer to [Figure AME-1](#).

Figure AME-1: Failing Applied Insulation to underside of Concrete Deck.

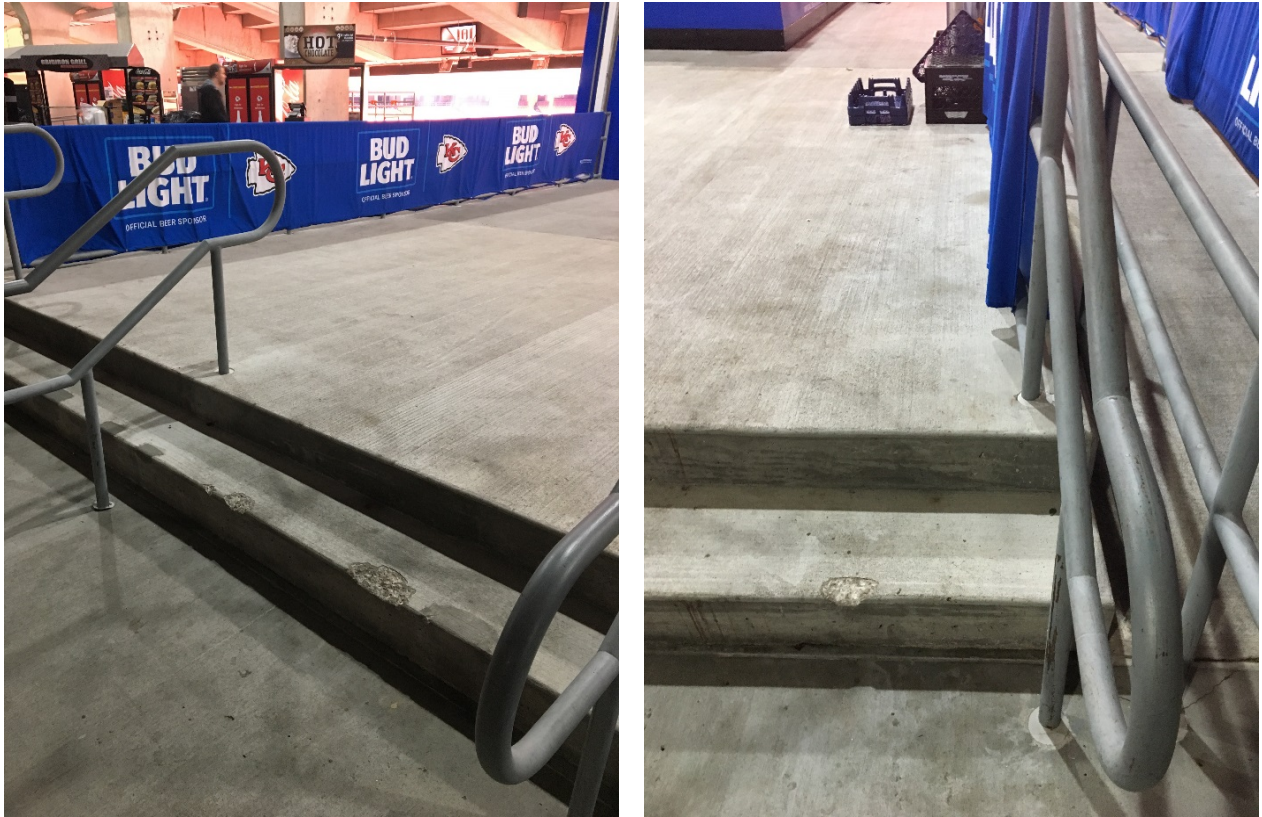
At the elevated Bud Light concessions area chipped concrete was observed at several concrete stairs, as shown in [Figures AME-2](#). Failure of the concrete material may pose a serious trip hazard and should be patched and repaired immediately.

Figures AME-2: Chipped Concrete at Bud Light Concession Stairs.

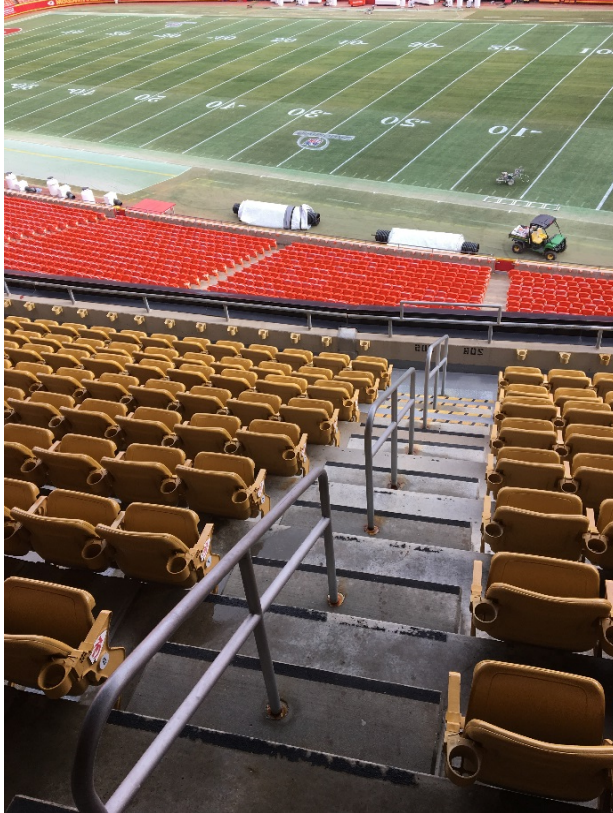
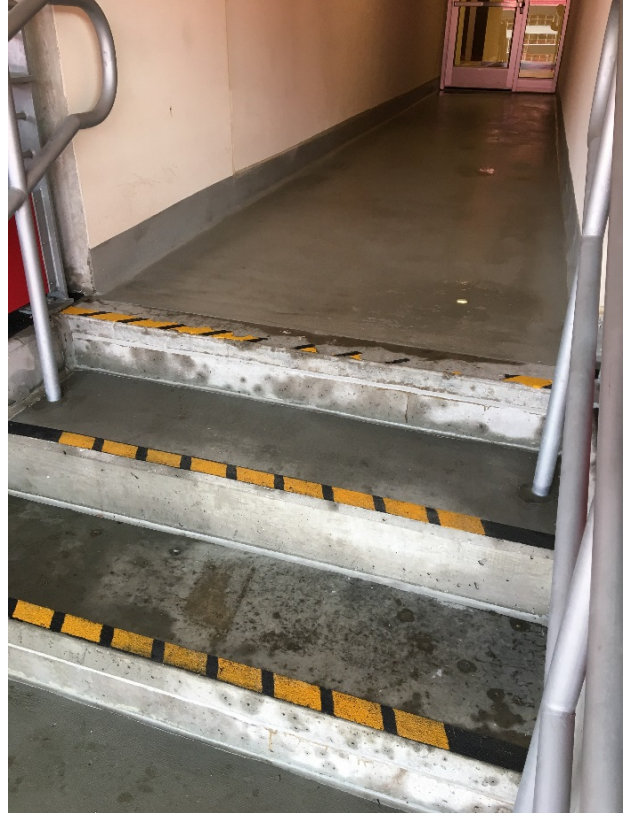
At several stairs within the club level seating bowl, the nosing applied slip resistant caution tape was observed to be significantly deteriorated or missing completely. Refer to [Figures AME-3](#). The absence of the slip resistant material poses a significant slip and fall hazard and should be repaired or replaced immediately.

Figures AME-3: Deteriorated Slip Resistant Caution Tape at Club Level Stairs.

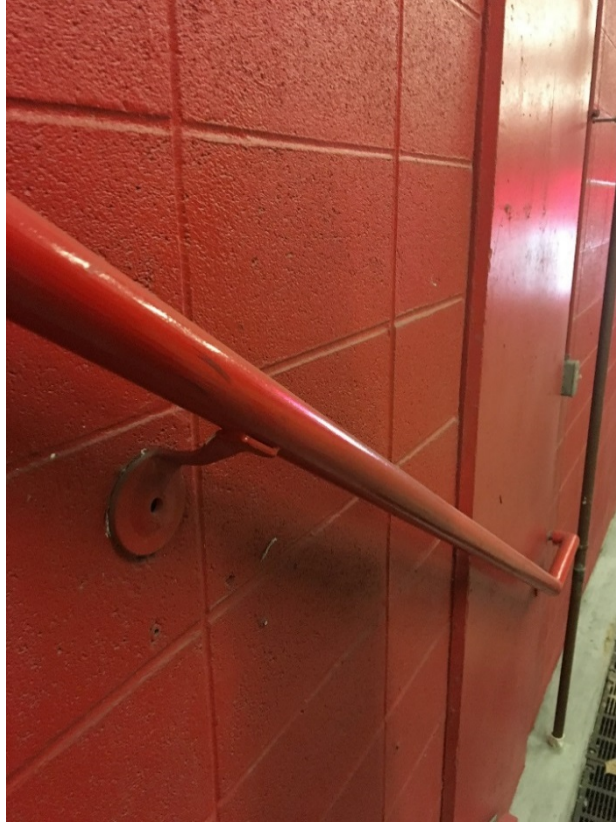
At the service level stair located in the field access tunnel, the handrail anchored to the concrete masonry unit wall was observed to be loose. An anchor bolt was missing from one of the handrail brackets, as indicated in [Figure AME-4](#). Install missing anchor to secure handrail to the wall and prevent potential future safety incidents.

Figure AME-4: Loose Handrail at Service Level Field Access Tunnel Stair.

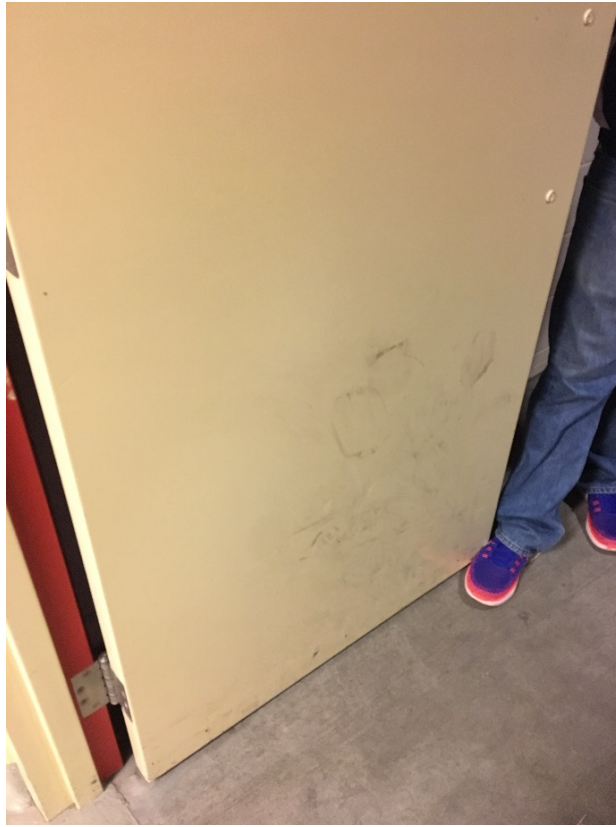
Door types and styles throughout Arrowhead Stadium include painted hollow metal doors and frames, flush wood doors, aluminum glazed doors, overhead coiling doors, and access doors. Generally speaking, all doors were observed to be in satisfactory condition. However, at the Field Level men's restroom, near the Bud Light concession, the hollow metal door paint was observed to be scuffed. Refer to [Figure AI-9](#). Continue routine painting as required to maintain the appearance of a world class NFL stadium.

Figure AI-9: Scuffed Hollow Metal Door at Field Level Men's Restroom.

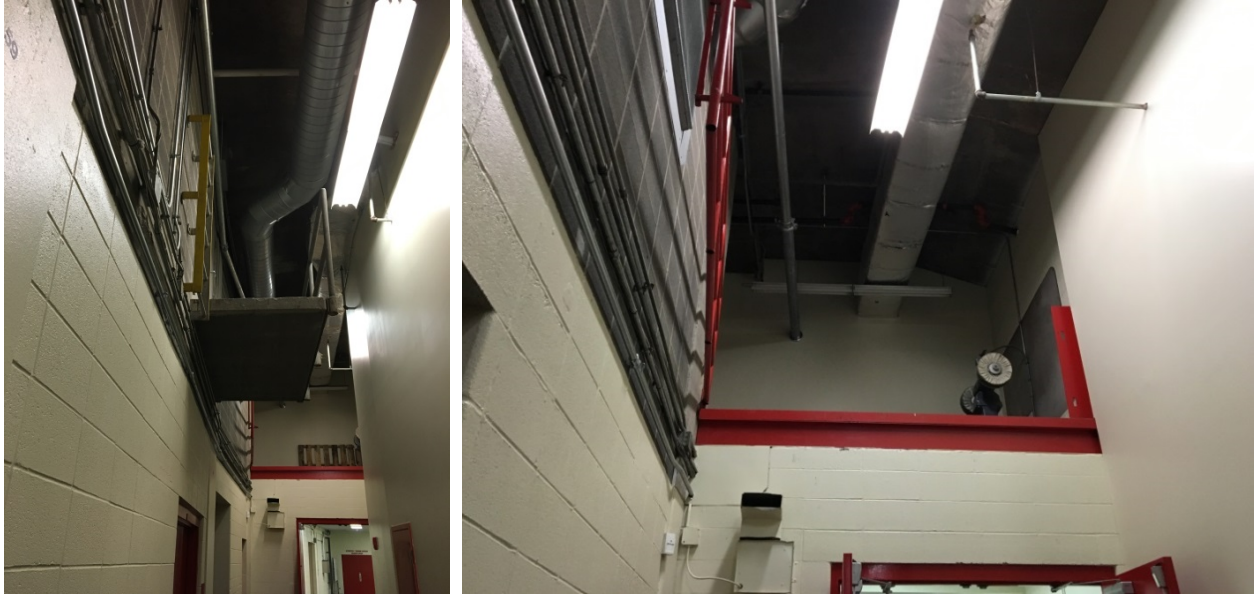
At the Service Level, two balcony areas were observed to have inadequate fall protection as shown in [Figures AI-10](#). It is assumed that these areas are not accessible to the general public and that individuals accessing these spaces are aware of the hazard. It is also assumed that these areas are intended to allow forklift trucks to hoist and deliver items to the upper story of this space. However, failure to keep proper fall protection in place (guardrails) may present a major safety concern for individuals accessing these spaces. It is highly recommended that these balcony areas be adequately closed off with a guardrail when not required to be open for material delivery.

Figures AI-10: Balcony Areas without Proper Fall Protection.

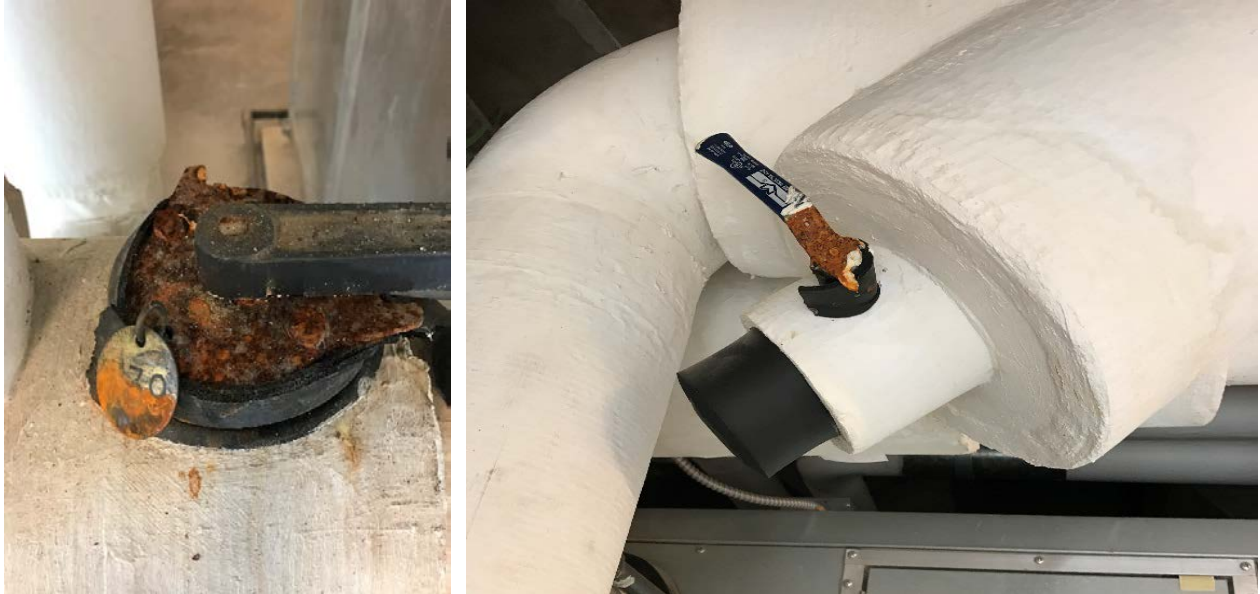
In general, all piping and insulation throughout the stadium appeared to be in satisfactory condition. In multiple locations, manual chilled water valves appeared to have rust and corrosion on the exterior face of the valve and on the valve handle. It is possible that this rust could continue into the valve itself, which should be verified. [Figures M-2](#) show an inline chilled water isolation valve (left) and a strainer drain valve (right) that appear to have rust and corrosion.

Figures M-2: Rust Present on Valve and Valve Handles.

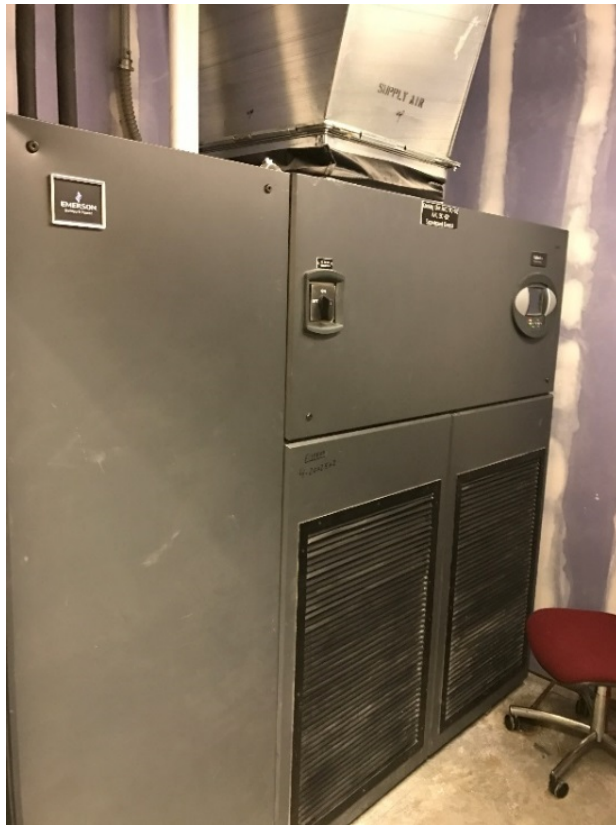
There appeared to be a squeaking noise coming from the interior of cooling unit A/C 9C-02 (scoreboard control), as shown in [Figure M-3](#). This is likely due to a loose or damaged belt.

Figure M-3: Scoreboard Control Air Handling Unit.

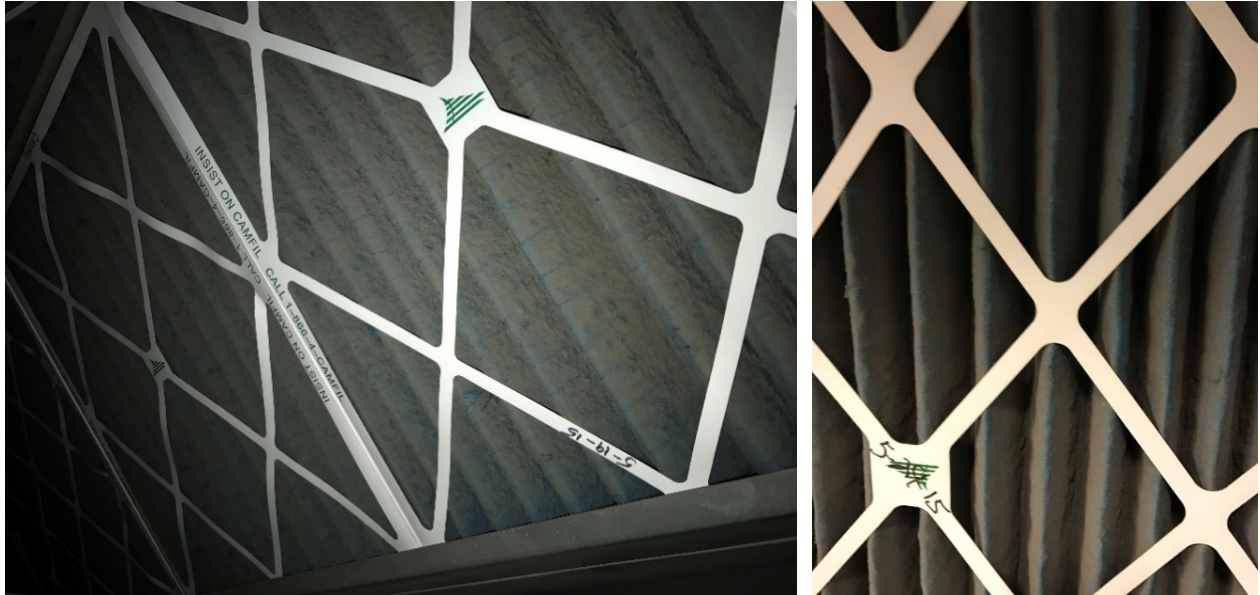
In general, air-conditioning unit filters appeared to be in satisfactory condition. Several units throughout the stadium had filters that have not been changed since May of 2015 and appear to be dirty. This can be seen in [Figures M-4](#).

Figures M-4: Dirty Air Handling Unit Filters.

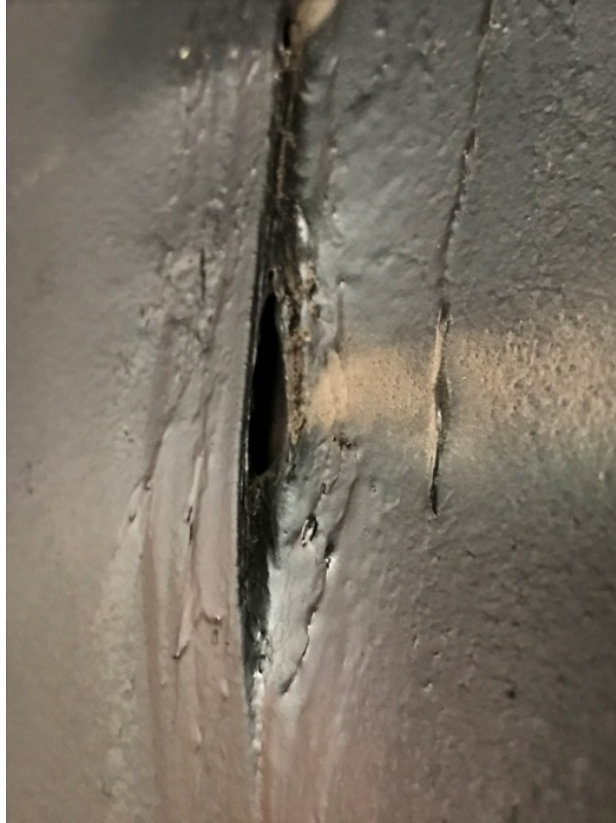
Air handling units serve conditioned spaces throughout the stadium. In some cases, the ductwork is located in the ceiling above. In other areas, such as the Founder's Club, the ductwork is exposed to the space. In the Founder's Club, it was observed that there were a few air leaks in the ductwork through small cracks and holes. A larger hole was observed as shown in [Figure M-5](#) below.

Figure M-5: Hole in Founder's Club Ductwork.

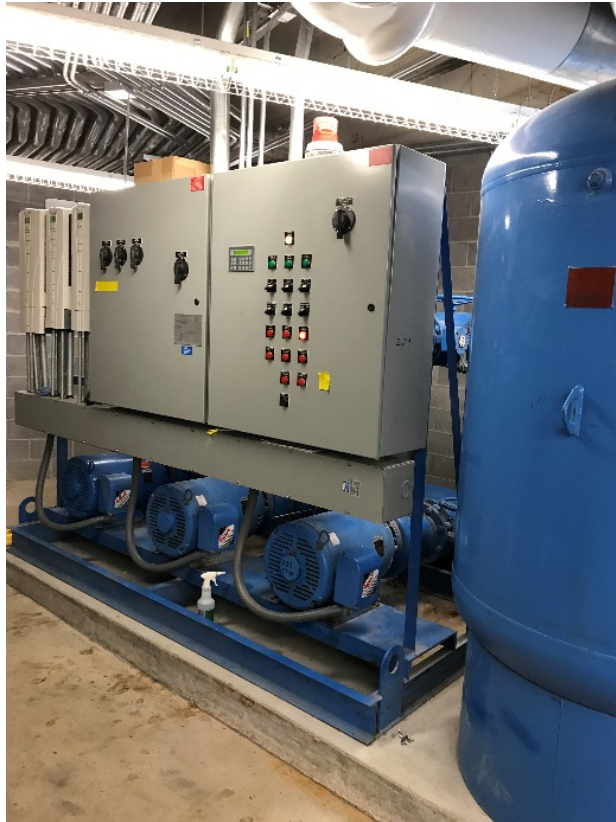
In the mechanical room that contains the domestic water booster pumps, it was observed that there was a “dry fault” for the Variable Frequency Drive (VFD) on Domestic Water Booster Pump 3, as shown in [Figure M-7](#). Pump 3 was sequenced to be the first operational pump. It was noted that staff was aware of this and was in the process of correcting this fault.

Figure M-7: Domestic Water Booster Pumps.

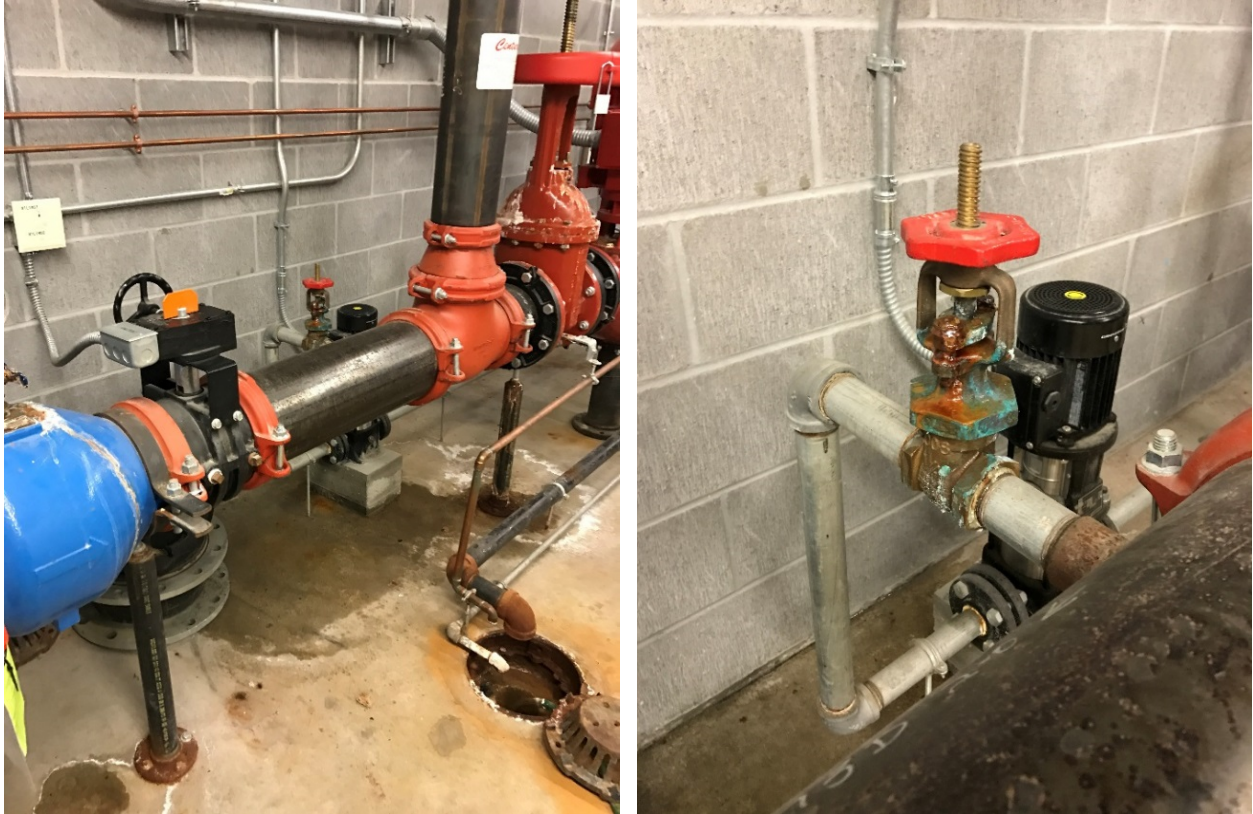
In this same mechanical room, fire protection pumping and piping exists. It was observed that the fire protection piping contained a leaky valve, as shown in [Figures M-8](#).

Figures M-8: Leak on Fire Piping Valve.

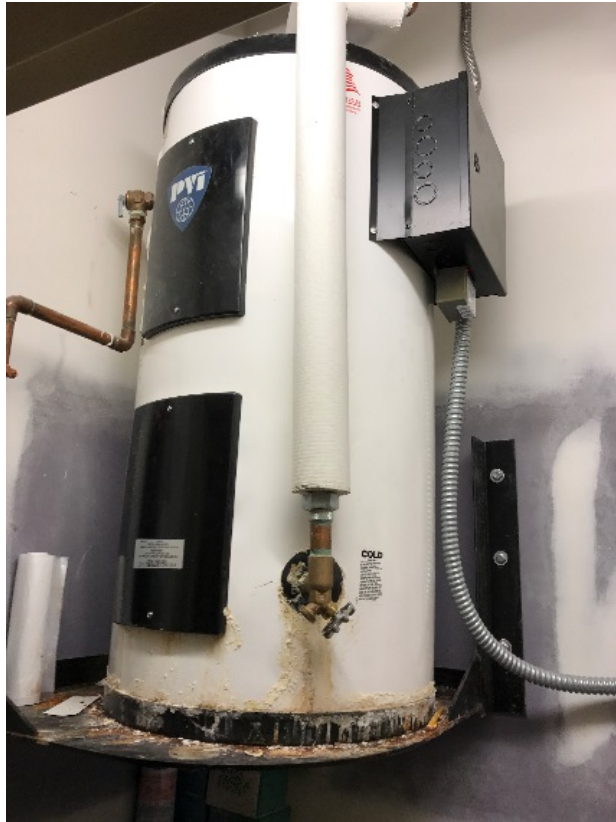
There is a large number of hot water heaters throughout the stadium in mechanical rooms and concession areas. These hot water heaters appeared to be in working condition. Various hot water heaters throughout the facility were observed to have calcium buildup on the exterior of the heater, as shown in [Figure M-9](#) below.

Figure M-9: Hot Water Heater.

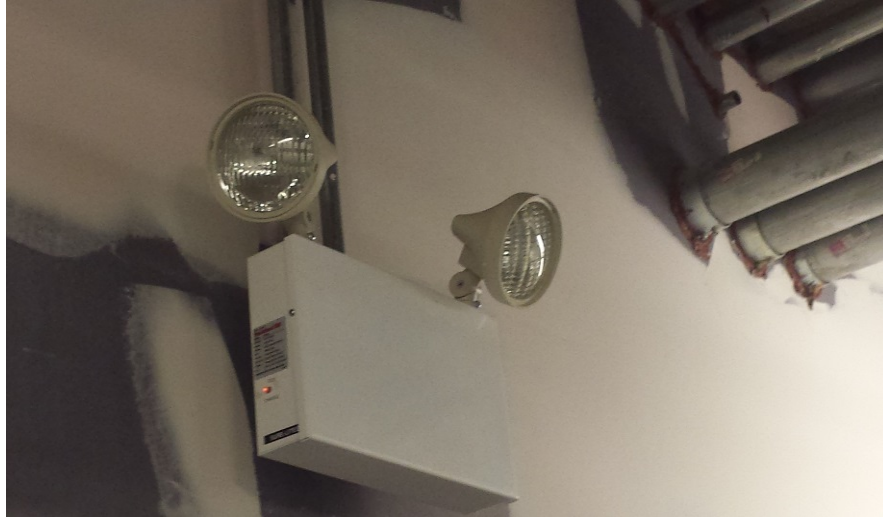
- The emergency bug-eyed battery units were evaluated in 2015 and observed to be non-operational. The assessment performed in 2017 observed the bug-eye emergency units be emitting a buzzing noise, which may indicate that the back-up batteries may be weak. The electrical rooms observed with bug-eyed emergency units are P252, P241, P240, P228 and P221. Refer to [Figure E-1](#).

Figure E-1: Emergency Bug-Eyed Light Fixture.

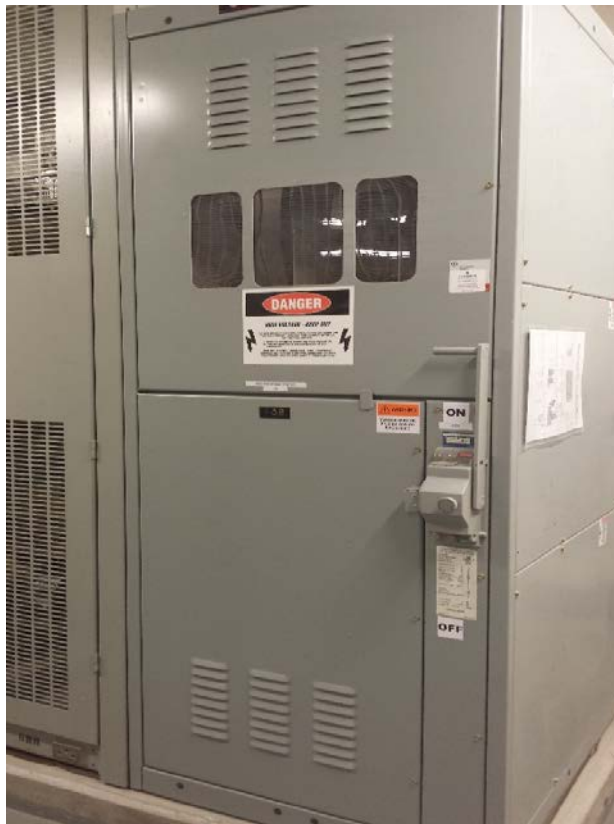
- 13.2KV switchgear, FB3, was observed to be operating and functioning in fair conditions, as shown in [Figure E-2](#).

Figure E-2: 13.2KV Switchgear FB3.
