# Arrowhead Stadium Assessment

## JCSCA + Burns & McDonnell

This document contains information pertaining to the condition of Arrowhead Stadium as documented by the Jackson County Sports Complex Authority (JCSCA), including descriptions, conditions, and exhibits which have been reviewed by Burns & McDonnell and documented in this report.

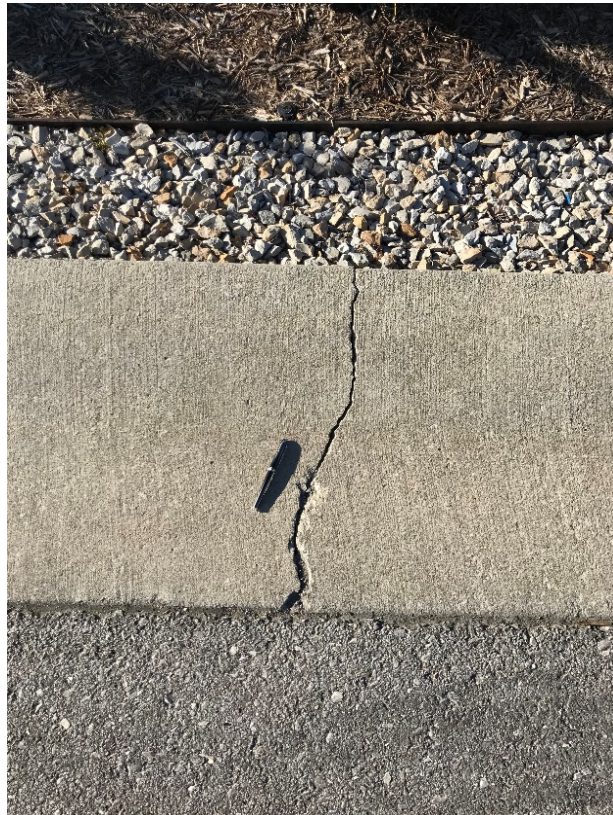
The most common defect observed on site is the transverse cracking, spalling, & faulting of the concourse pavement. Transverse cracking was observed on the exterior curb around the stadium concourse in several locations, [Figure C-1](#) shows an example of curb cracking observed on site. Cracking along the pavement corners was also commonly seen around the stadium, [Figure C-2](#) shows an example of pavement corner cracking. Repairs were seen to be made to longitudinal (transverse) cracking on site, which is an acceptable solution to any of the site issues previously mentioned. [Figure C-3](#) shows an example of proper cracking repair utilizing joint sealant.

**Figure C-1: Cracking Along Exterior Curb**  
**Location:** East of the Founder's Plaza Gate, North of the Helix Walkway

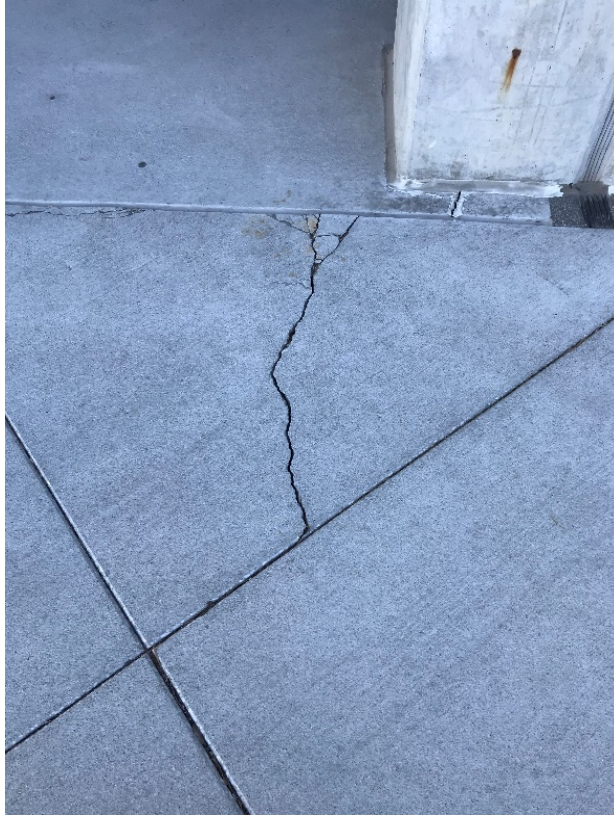
**Location:** Near Column Adjacent to the Founder's Plaza Gate

**Figure C-2: Corner Cracking**

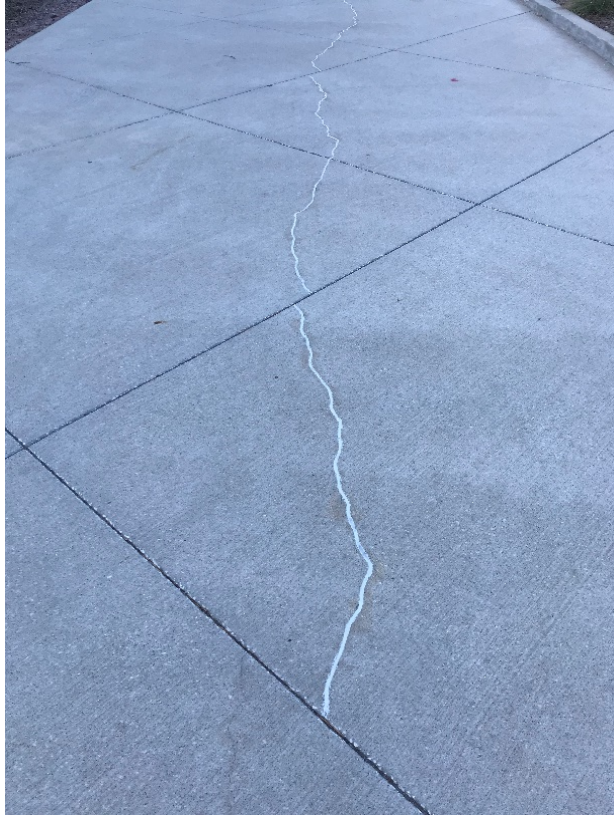
**Figure C-3: Repaired Transverse Cracking**

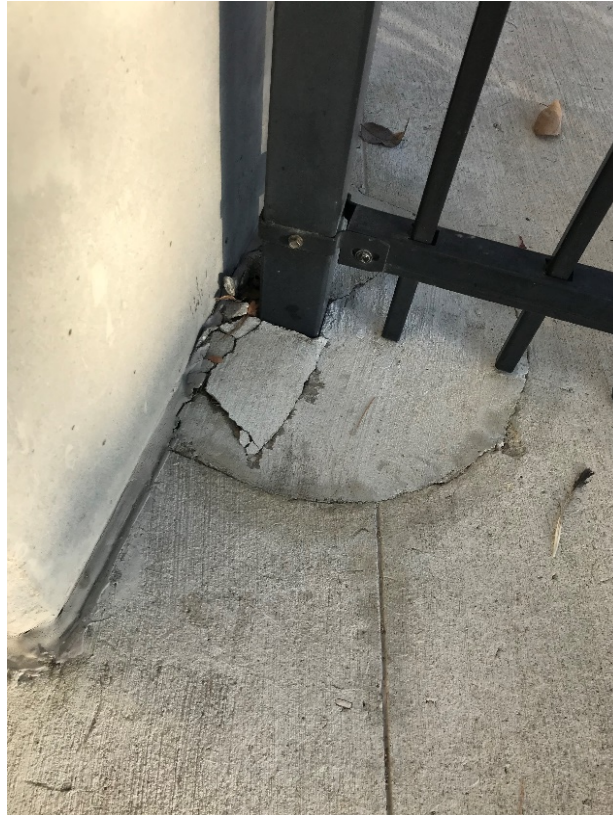
Damaged footings were observed around the stadium concourse in various locations. Footings with damaged sealant or cracking should be addressed to avoid further damage to the footing and fence due to freeze/thaw conditions. [Figure C-4](#) shows an example of a damaged fence footing observed on site. Damaged sealant was also observed around the stadium in the paved walkways, which was often accompanied by joint spalling. [Figure C-5](#) shows an example of joint sealant deterioration that has occurred within the concourse.

**Figure C-4: Cracking at Fence Footing**  
**Location:** Directly West of the Sprint Gate Entrance

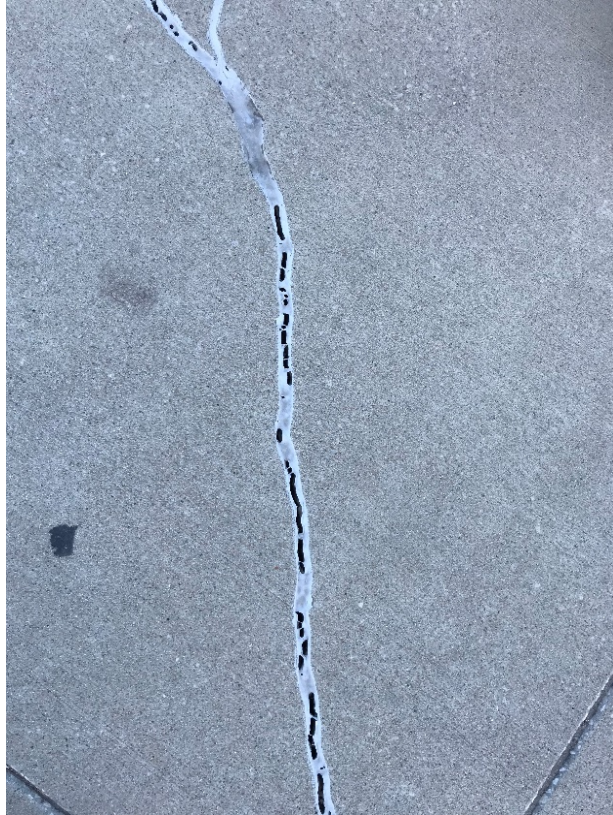
**Figure C-5: Joint Sealant Deterioration**  
**Location:** Directly West of Hy-Vee Gate

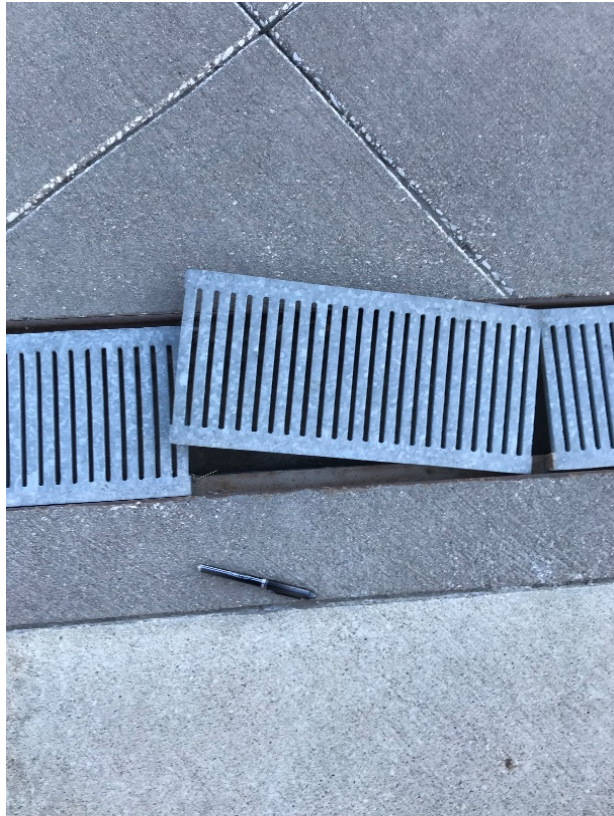
**Location:** Directly Outside of the Founder's Plaza Gate

The trench drains were utilized on site, primarily outside of the Founder's Plaza. The grate on the trench drains were found to be damaged/broken into several pieces and could be removed from the trench or displaced when stepped on. [Figure C-6](#) shows a displaced piece of trench drain found directly outside of the Founder's Plaza Gate.

**Figure C-6: Broken Trench Drain**

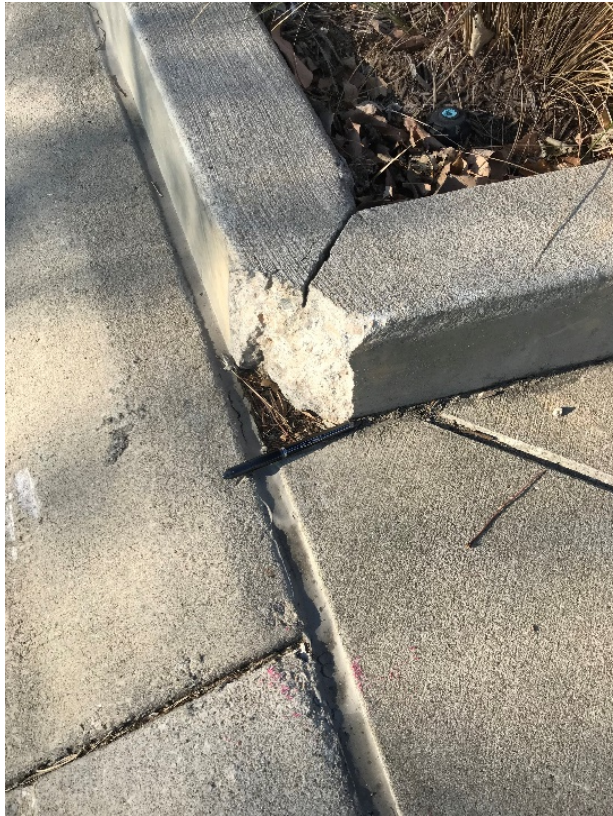
Damaged concrete curbing utilized for landscape beds was observed around the concourse, [Figure C-7](#) shows damaged curb found inside the stadium grounds.

**Figure C-7: Damaged Curb**  
**Location: South of Gate D**

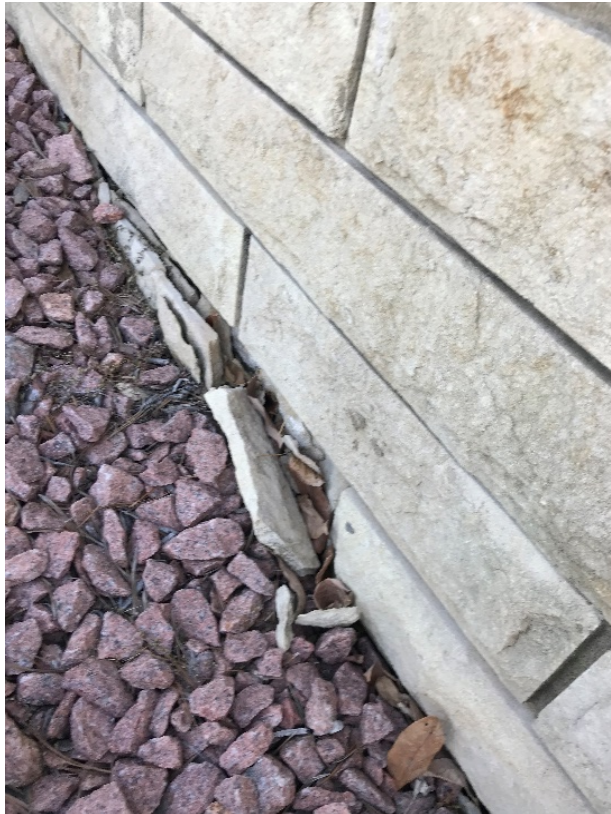
**Location:** West of the Tower Gate, Adjacent to the Stairs

**Figure C-8: Damaged Decorative Wall**

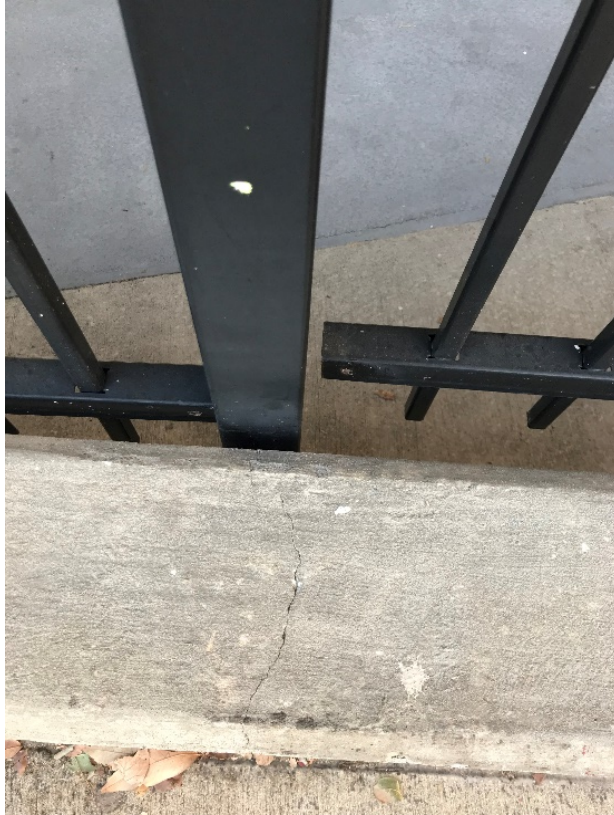
**Location:** Adjacent to Gate D, Along the Helix Walkway

**Figure C-9: Damaged Fencing**

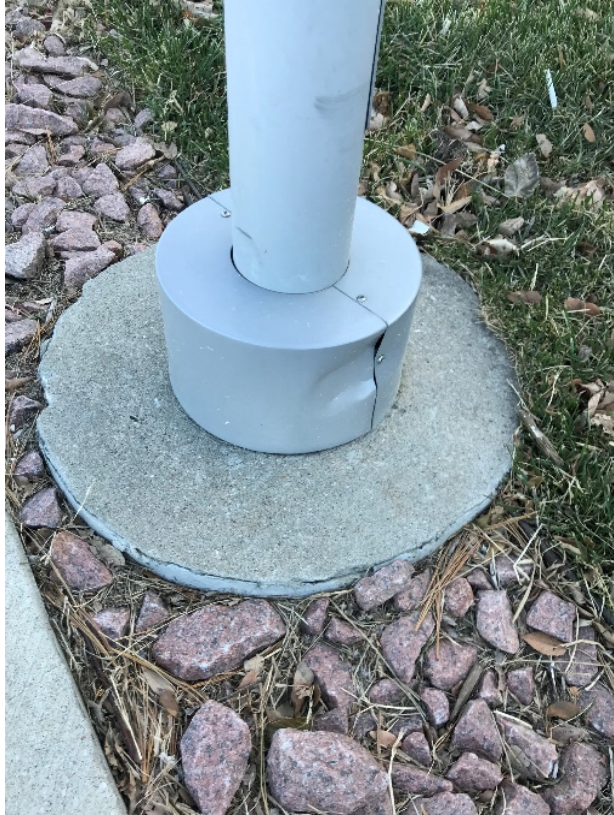
Other site amenities that were evaluated in the stadium concourse included fencing, decorative walling, hand railings, and light poles. Most of which was observed to be in acceptable condition. Damaged or deteriorating decorative walling was identified on site, [Figure C-8](#) shows damaged decorative stone. Damaged fencing was found within the stadium concourse, [Figure C-9](#) shows the displaced fence. Light poles around the stadium concourse were mostly intact and functional, but there were a few damaged pole bases amongst them. [Figure C-10](#) shows one of the damaged pole bases.

**Figure C-10: Damaged Light Pole Base**  
**Location:** North of Gate G, Along Exterior Paved Walkway

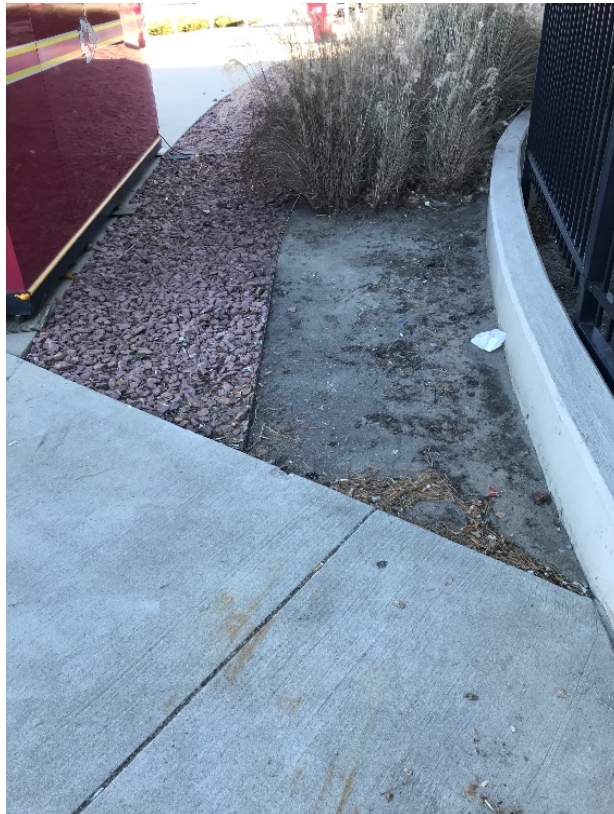
Some barren landscape areas have been observed on site, these areas contain little to no plantings, grasses, rock or mulch. [Figure L-1](#) depicts an example of a barren landscape bed found within the concourse.

**Figure L-1: Barren Landscape Bed**  
**Location:** Adjacent to North Helix Walkway

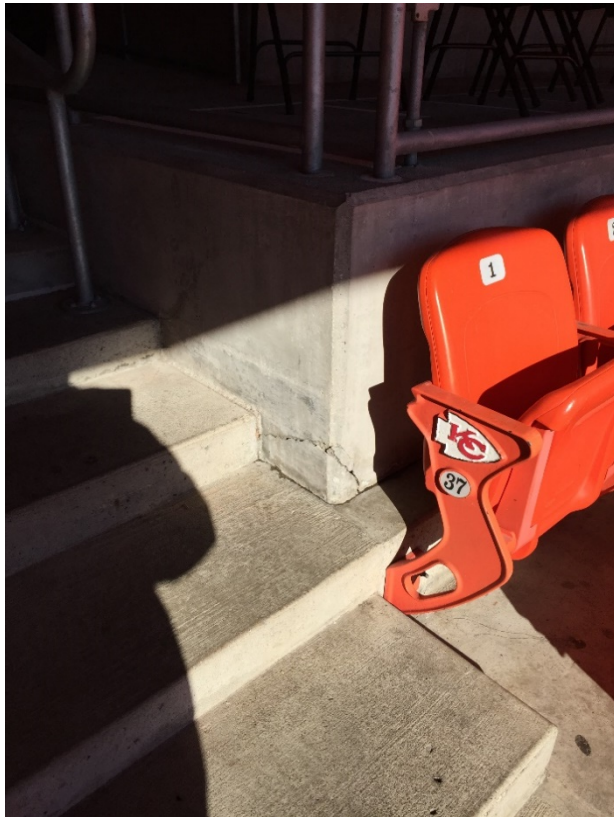
No significant settlement of the structure was observed. The slab-on-grade is primarily in satisfactory condition. No major cracks or spalling of the concrete were observed, however minor spalling was encountered in a few spots as shown in [Figure S-1](#) & [Figure S-2](#). Control joints and expansion joints are in satisfactory condition.

**Figure S-1: Concrete Spalling In Lower Bowl**  
**Location:** Between Sections 128 & 129

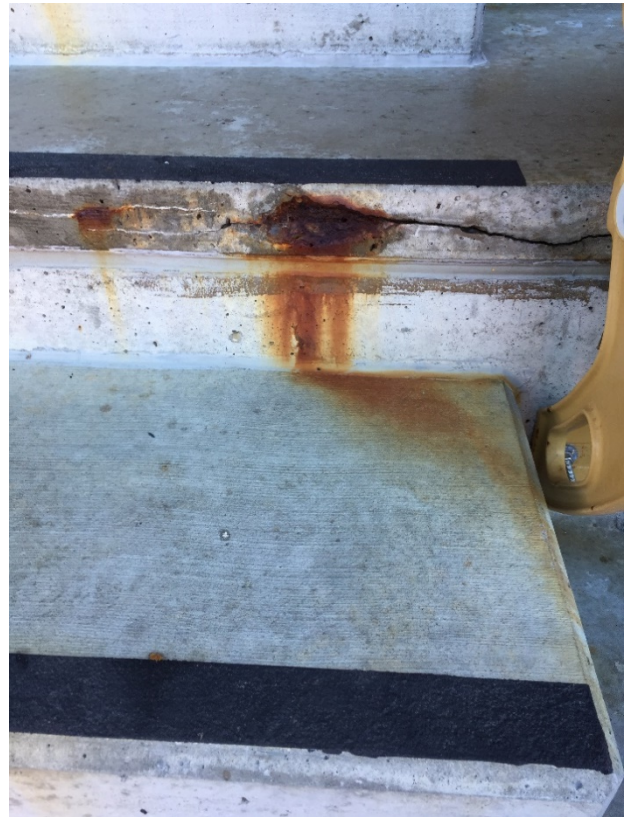
**Figure S-2: Concrete Spalling**  
**Location:** Between Sections 218 & 219

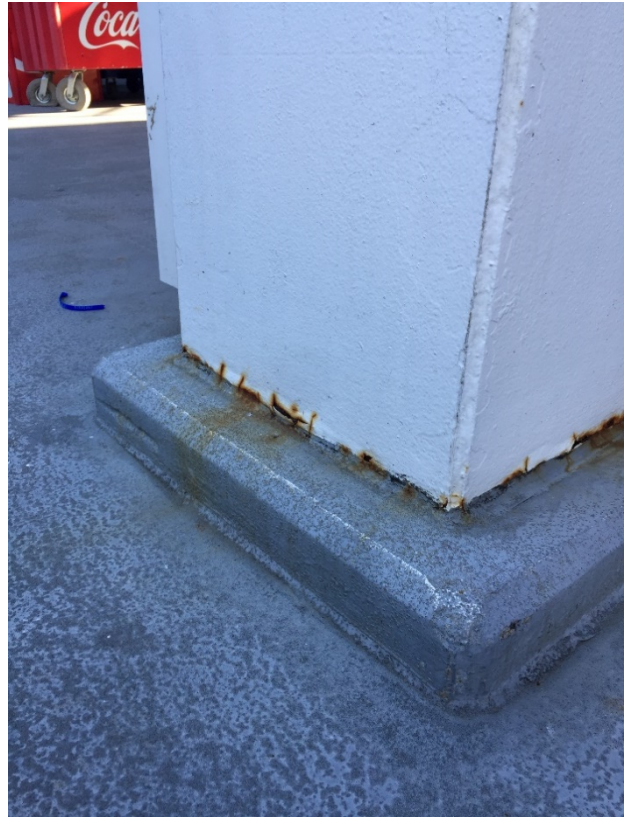
**Figure S-4: Rust & Corrosion of Speaker HSS Column**  
**Location:** HSS Column in Concourse 05.83.03

The steel wide flange columns and beams are in satisfactory condition. Rust and corrosion was observed at the base of the scoreboard and speaker HSS columns as shown in [Figure S-4](#). Scoreboard column base and mid-span connections are in satisfactory condition. Beam connections are in satisfactory condition. The steel decks are in satisfactory condition. No corrosion or significant deflection was observed.

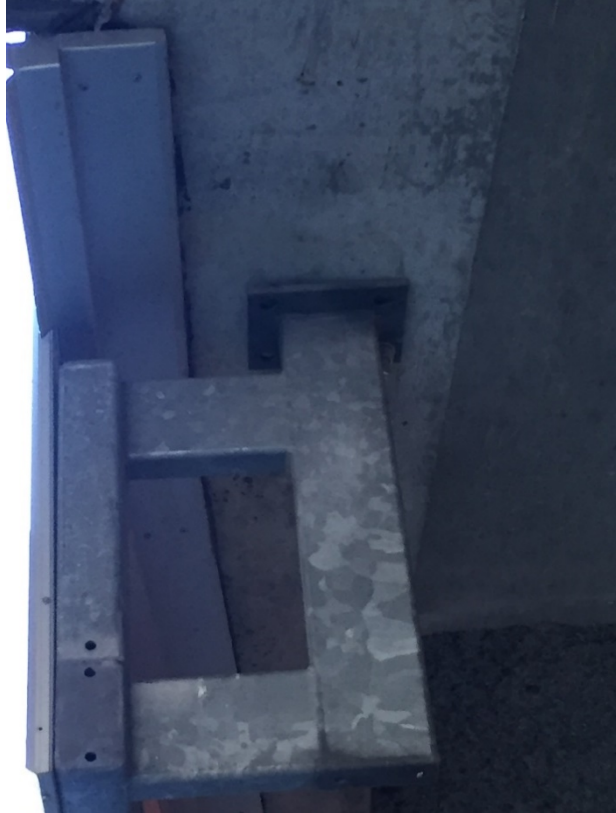
The graphic fiber mesh system was observed throughout the stadium. In multiple locations, it was observed that (2) anchor bolts were missing between the connection of the steel structure and the concrete structure. In one location, it was observed that (3) anchor bolts were missing as shown in [Figure S-5](#).

**Figure S-5:** Graphic Fiber Mesh Structural Steel Missing (3) Anchor Bolts  
**Location:** Concourse 02.01.03

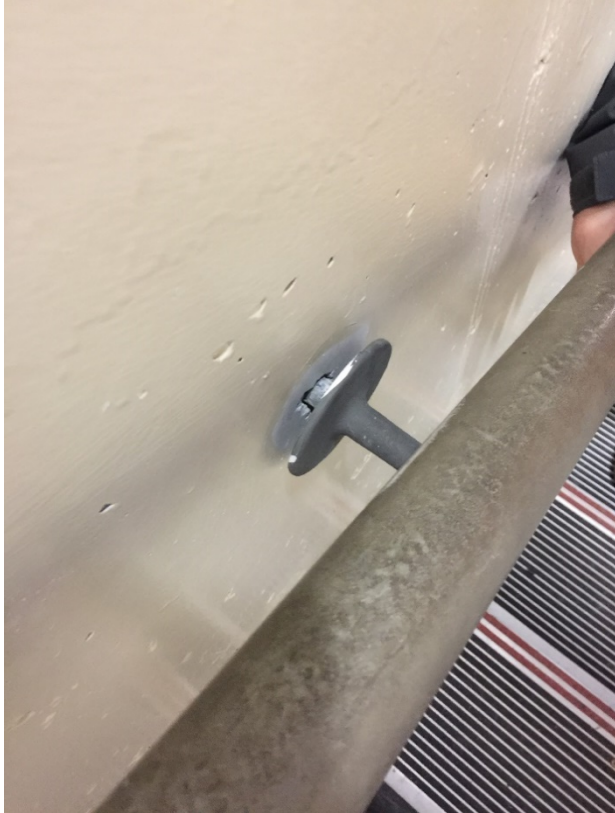
The handrails were observed at various locations throughout the stadium. Loose anchors are present in multiple locations as shown as shown in [Figure S-6](#) and [Figure S-7](#). The grout at the base of the handrails were missing in multiple locations which leads to rusting of the base of the handrail. Refer to [Figure S-8](#).

**Figure S-6:** Loose Handrail Support  
**Location:** Player Tunnel 01.69.01

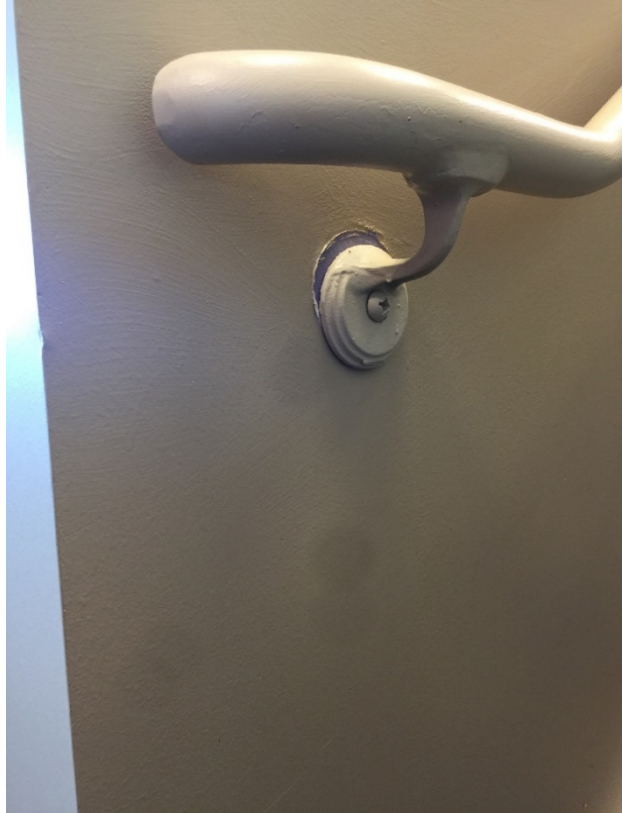
**Figure S-7:** Loose Handrail Support  
**Location:** Press Level Room 09.75.01

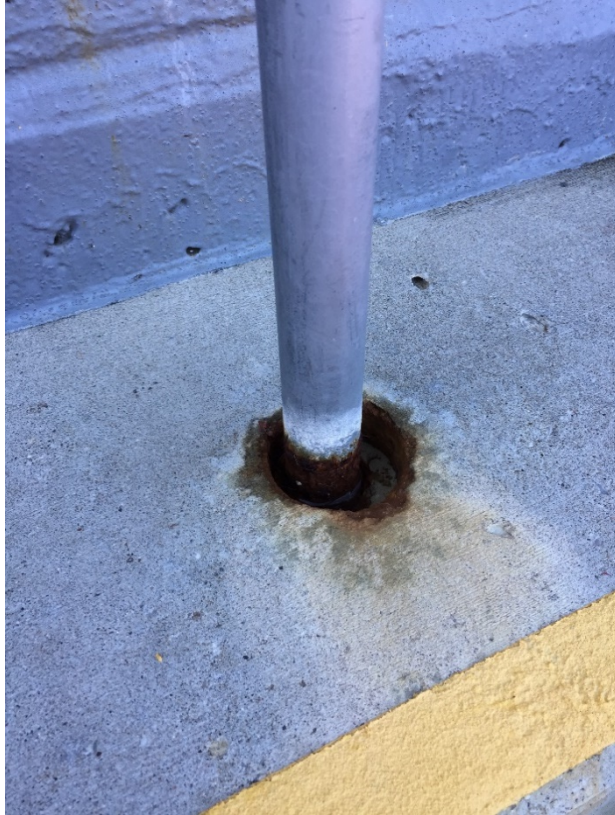
**Figure S-8: Missing Grout & Rust at Base Handrail**  
**Location:** Between Sections 218 & 219

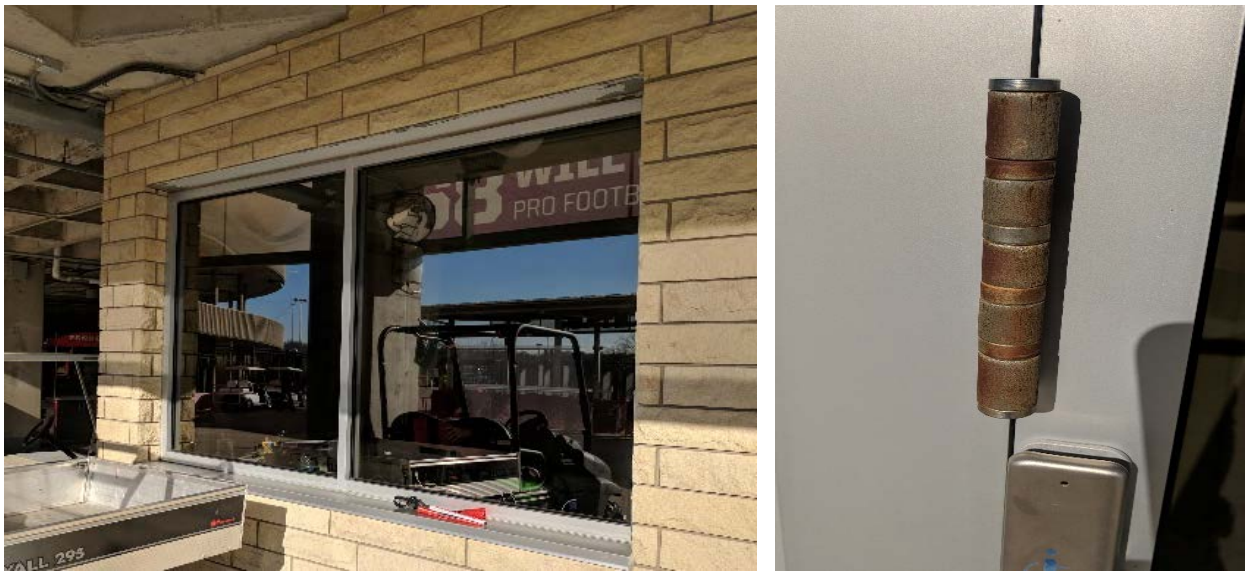
Exterior doors at the exterior plaza level were observed to have minor deficiencies. As noted in the 2016 assessment, the hinges on the aluminum framed storefront doors near the team store were observed to have minor rust and corrosion accumulation. Refer to [Figure AF-3](#) (right image). To avoid rust stains or streaking on the aluminum frames, consider replacing hinges with an anti-corrosive material such as stainless steel.

Paint applied to steel angle lintels above Plaza Level hollow metal service doors appear to have been repainted. However, the steel lintel above the windows at the Security & Fire Command room appears to be chipping and flaking, refer to [Figure AF-3](#) (left image). To avoid exposing the steel lintels to moisture and eventual rust development, consider scraping and re-painting with an appropriate paint product which is specifically formulated for this material and exterior conditions.

**Figure AF-3:** Flaking Paint at Exterior Lintel (left) and Rusted Hinges at Aluminum Door (right)  
**Location:** Plaza Level 3 – 03.54.02A Security & Fire Command

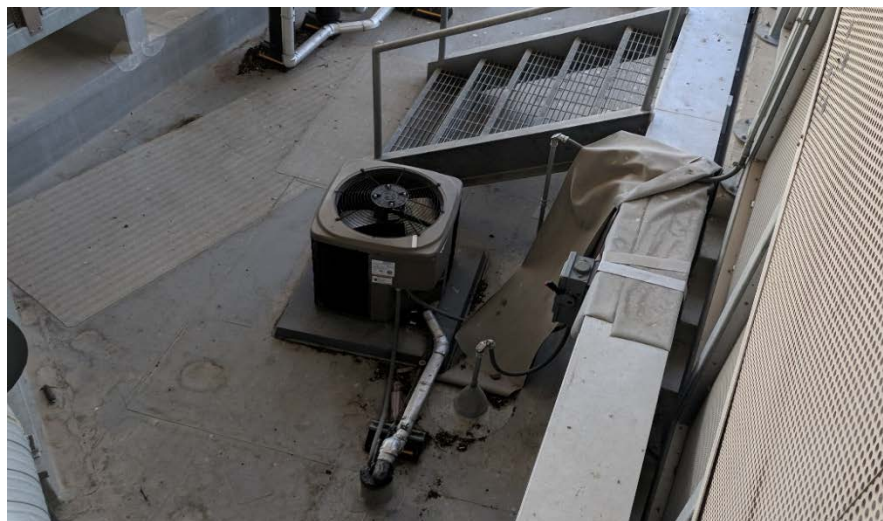
Roofing membranes were observed to be in satisfactory condition. No rips, tears, or other failures were observed. All observed copings, flashings, and sealants appear to be in satisfactory condition, as shown in [Figure AR-1](#). However, debris was observed near the stair to the roof, as shown in [Figure AR-2](#).

**Figure AR-2:** Debris Over Roof Membrane & Coping  
**Location:** Upper Concourse Level 6 – 06.76.02 Cooking Concession & Restroom Building

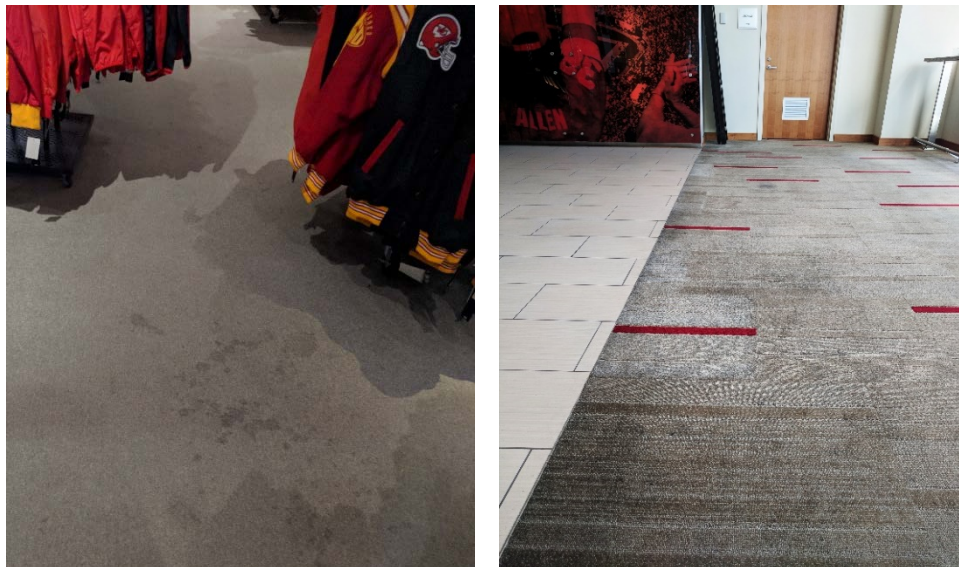
**Figure AI-3: Carpet Flooring Stains & Discoloration**  
**Location:** Plaza Level 3 - 03.20.01 Team Store (left) & Club Level 4 – 04.64.02 Club Lounge (right)

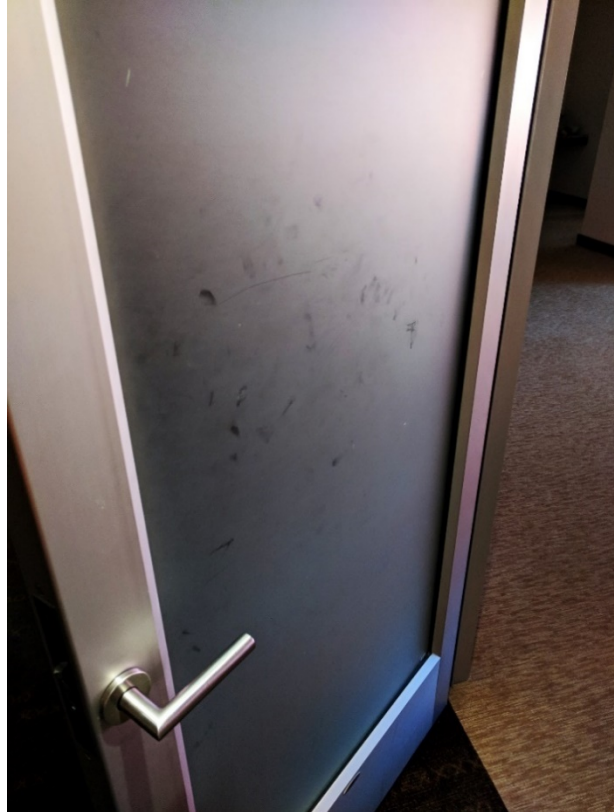
Door types and styles throughout Arrowhead Stadium include painted hollow metal doors and frames, flush wood doors, aluminum glazed doors, overhead coiling doors, and access doors. Generally speaking, all doors were observed to be in satisfactory condition. However, at the Plaza level suites, near the broadcast booth, the glazing at each suite entry door was observed to be scuffed. Refer to [Figure AI-10](#). Continue routine painting and cleaning as required to maintain the appearance of a world class NFL stadium.

**Figure AI-10:** Scuffed Hollow Metal Full Lite Doors at Plaza Level Suites  
**Location:** Plaza Level 3 – 03.66.03 Suite Lounge

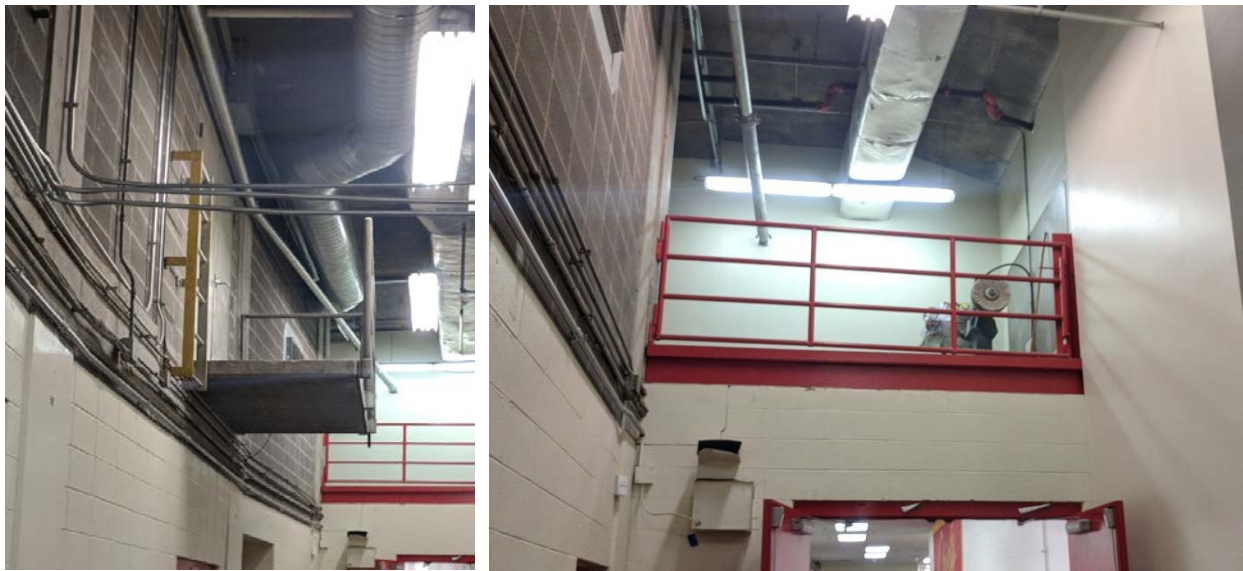
At the Service Level, two balcony areas were observed to have inadequate fall protection in the 2016 assessment. Upon review, proper fall protection was observed on the balcony over the double door, as shown in [Figure AI-11](#) (right). However, the balcony shown in [Figure AI-11](#) (left) does not maintain proper guard rail around all three sides. It is assumed that this area is not accessible to the general public and that individuals accessing this space are aware of the hazard. It is also assumed that this area is intended for maintenance. However, failure to keep proper fall protection in place (guardrails) may present a major safety concern for individuals accessing this space. It is highly recommended that these balcony areas be adequately closed off with a guardrail when not required to be open.

**Figure AI-11: Balcony Areas Without Proper Fall Protection**  
**Location:** Service Level 1 – 01.61.04 Corridor

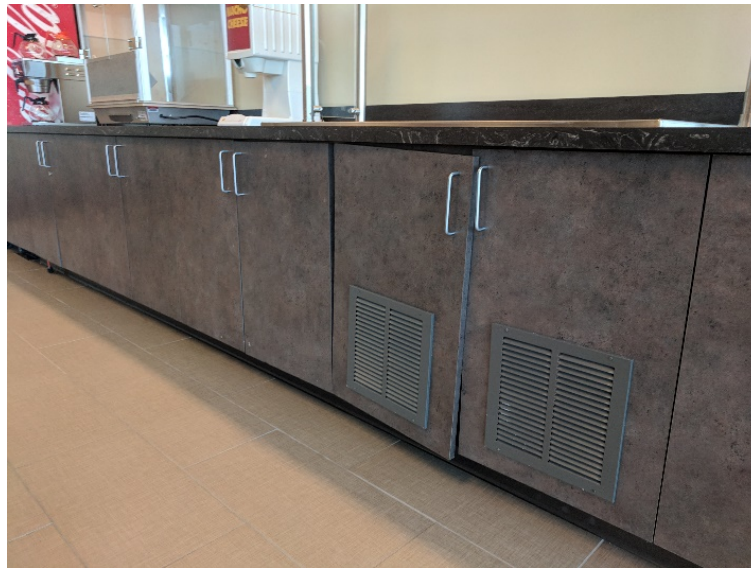
On the Press level, one of the cabinet doors at the Bar was observed to not close fully and no longer hung properly, as shown in [Figure AMI-2](#).

**Figure AMI-2: Cabinet Door Hung**  
**Location: Press Level 08 – 08.72.01 Bar**

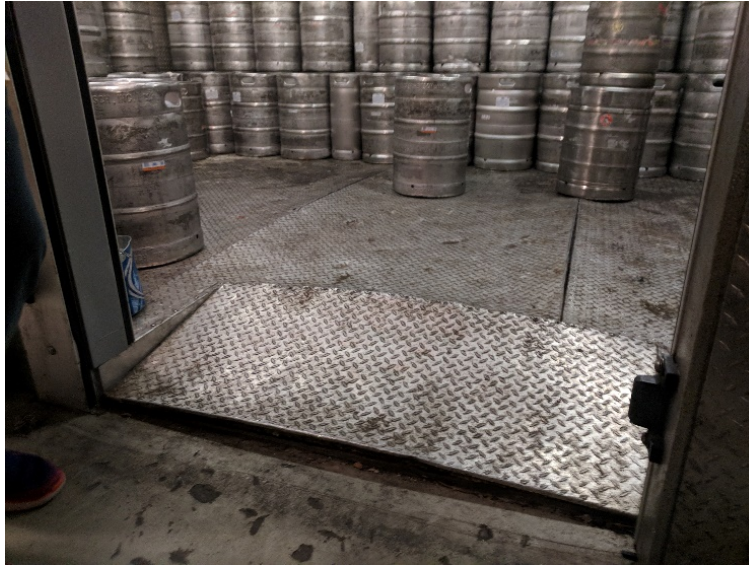
Observed service areas appeared to be generally in satisfactory condition. However, it was observed at the Club Beer Pump room that IMP floors and ramp have been warped, most likely due to the weight on top of them. The significant warping of the entry ramp has created a high lip and a potential tripping hazard to workers, as shown in [Figure AMI-3](#).

**Figure AMI-3: Pump Room Ramp**  
**Location:** Plaza Level 3 – 03.29.03 Club Beer Pump Room

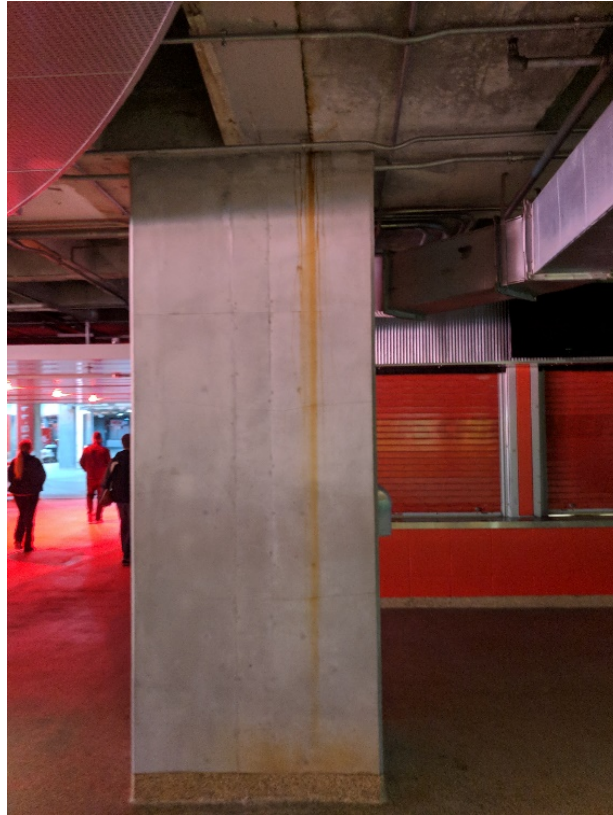
Upon observation of concourses, finishes generally appear to be in satisfactory condition. However, a large rust stain was observed from a seam between placements in the exposed concrete ceiling above. This most likely is a result of moisture penetrating from above and coming into contact with the reinforcement inside the structure and streaking down the face of the column, as shown in [Figure AMI-4](#). This may result in future structural implications.

**Figure AMI-4:** Rust Stain on Column

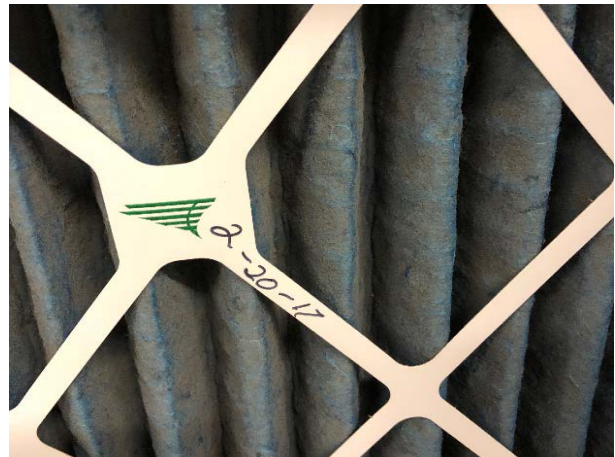
The 2016 assessment identified dirty or old filters as an action item. Upon review, most of the filters observed had been changed recently and appeared to be in good condition, as shown in [Figure M-1](#). One observed unit had filters dated from February 2017, as shown in [Figure M-2](#), these should be replaced along with any others of similar age.

**Figure M-2:** Dirty filter  
**Location:** Main Elec. 03.42.02

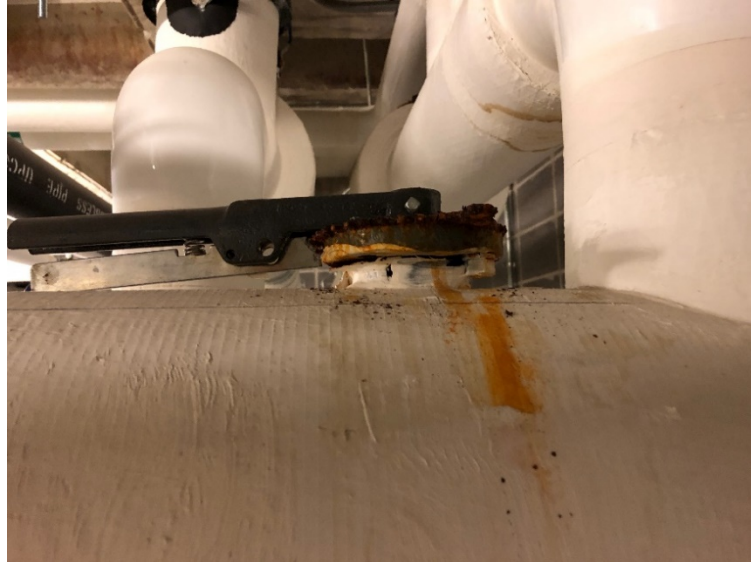
**Figure M-3:** Corroded Valve  
**Location:** Mech. 01M.64.01

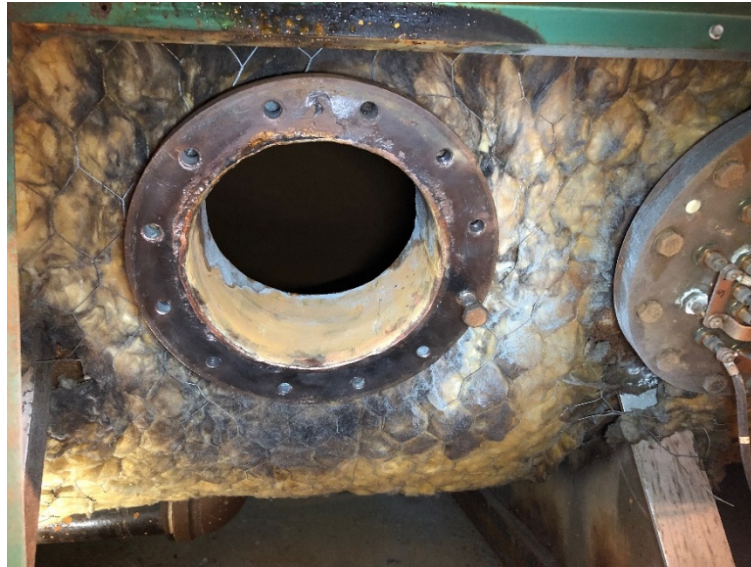
**Figure M-4: Water Heater Flange Under Repair**  
**Location:** Mech. 01M.64.01

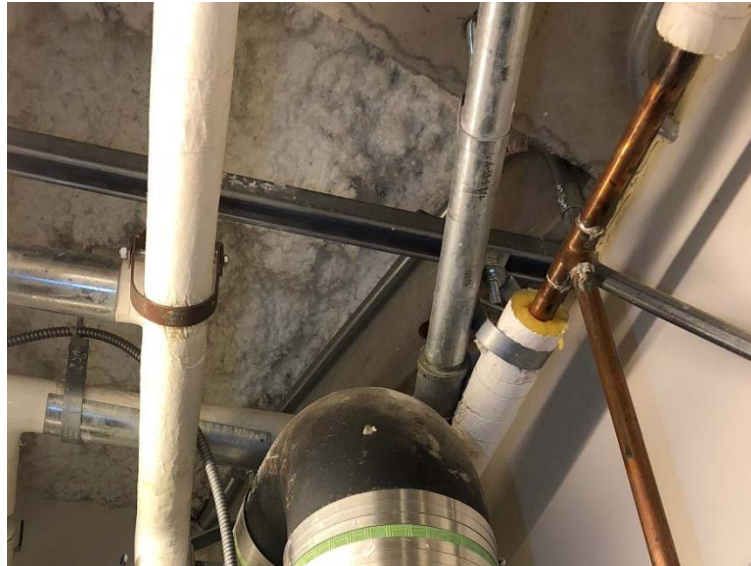
**Figure M-5: Pipe Shields Missing**

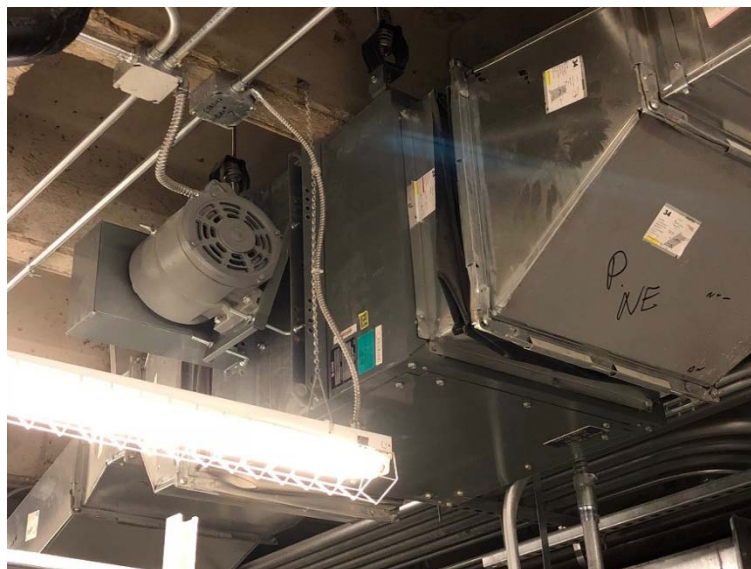
An exhaust fan, shown in [Figure M-6](#), in Mechanical Room 03.31.01 was vibrating loudly while operating. The fan should be inspected and repaired to prevent damage to the fan.

**Figure M-6: Exhaust Fan**

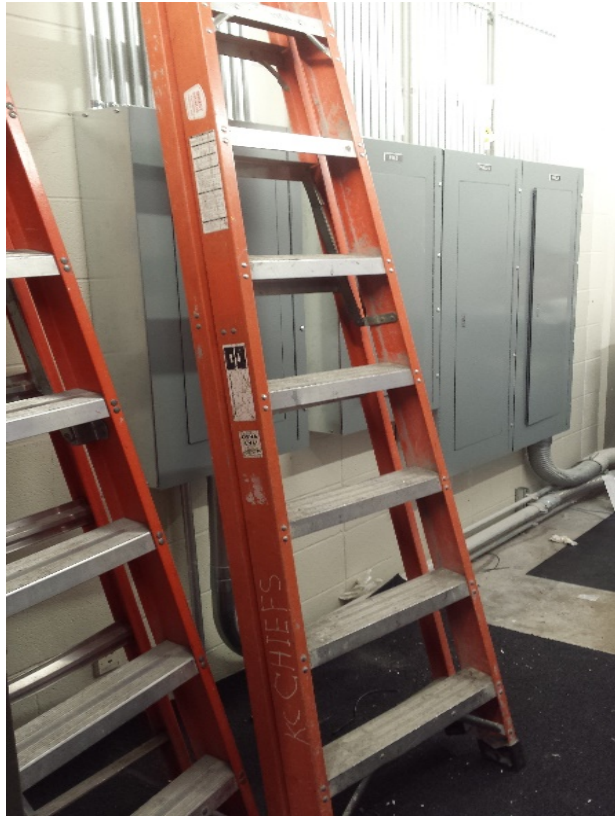
**Figure E-3: Obstructed Panelboard**  
**Location:** Room Elec. 01.68.08

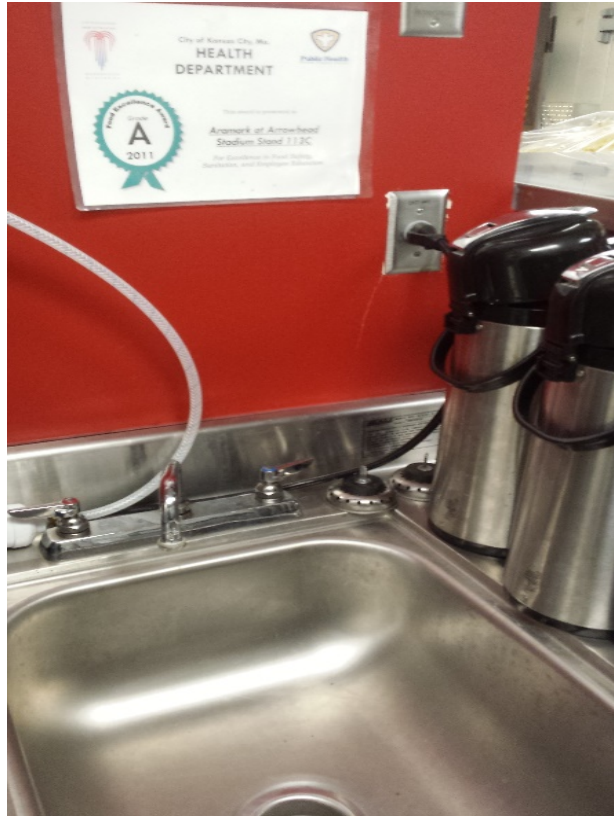
**Figure E-4:** Non-GFCI Single Receptacle  
**Location:** Room Concession 02.51.02

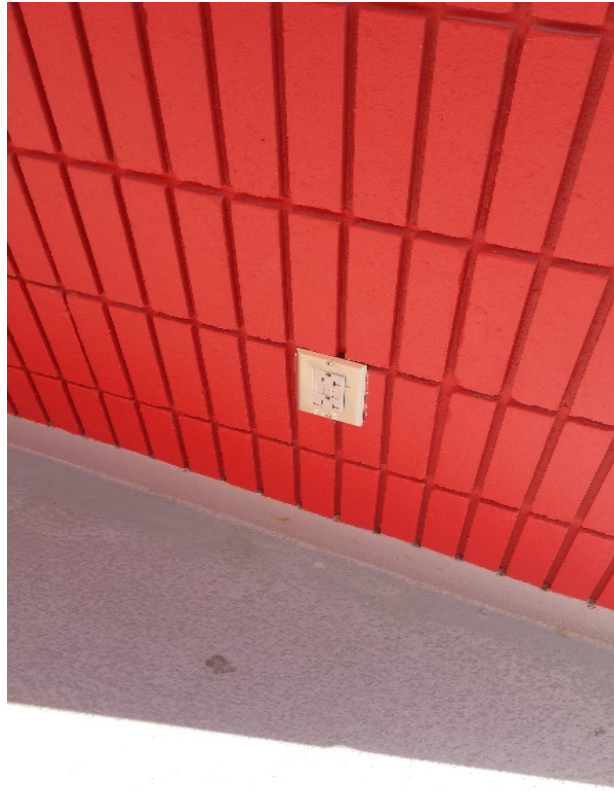
**Figure E-5:** GFCI Receptacle Without Cover-plate  
**Location:** Concourse 05.55.03, Between Grid Columns 50 & 51
