Arrowhead Stadium Assessment

JCSCA + Burns & McDonnell

This document contains information pertaining to the condition of Arrowhead Stadium as documented by the Jackson County Sports Complex Authority (JCSCA), including descriptions, conditions, and exhibits which have been reviewed by Burns & McDonnell and documented in this report.

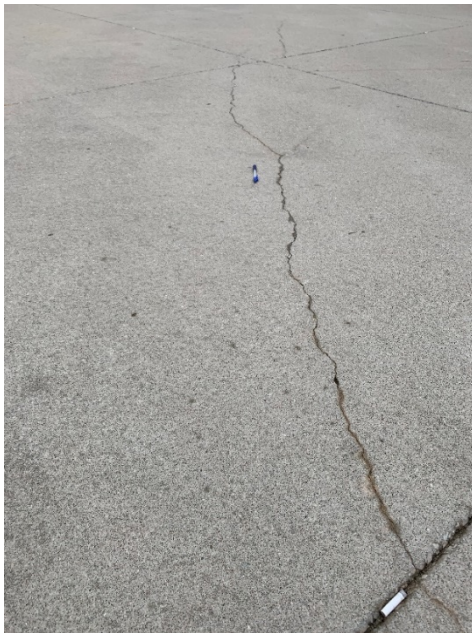
The most common site defect observed on site was pavement cracking. Fatigue cracking, transverse cracking, spalling, and faulting of the pavement. [Figure C-1](#) shows an example of transverse cracking found on site. [Figure C-2](#) shows an example of corner cracking of the pavement that was observed in several areas throughout the stadium concourse. [Figure C-3](#) shows cracking observed on several footings along the stadium fencing. Cracking that exceeds 1/4" should be further inspected and considered for replacement as it is primed to be subject to displacement due to freeze-thaw condition.

Figure C-1: Transverse Cracking
Location: Outside of Gate A
(Founder's Plaza)

- Pavement cracking throughout the stadium concourse should be monitored closely or repaired. Cracks exceeding $\frac{1}{4}$ " in width should be replaced or sealed to avoid pavement damage during freeze-thaw conditions. Significant displaced of pavement can create a tripping hazard for pedestrians and are aesthetically unpleasant. Refer to [Figure C-1](#) to area outside of Gate A (Founder's Club); Refer to [Figure C-2](#) to see area adjacent to Gate H, Inside Security Fencing; and Refer to [Figure C-3](#) to see area adjacent to Gate D, Inside Security Fencing.

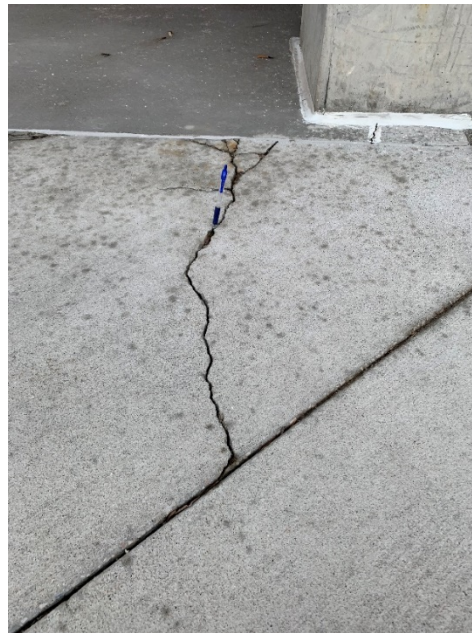
Figure C-2: Corner Cracking
Location: Adjacent to Gate H,
Inside Security Fencing

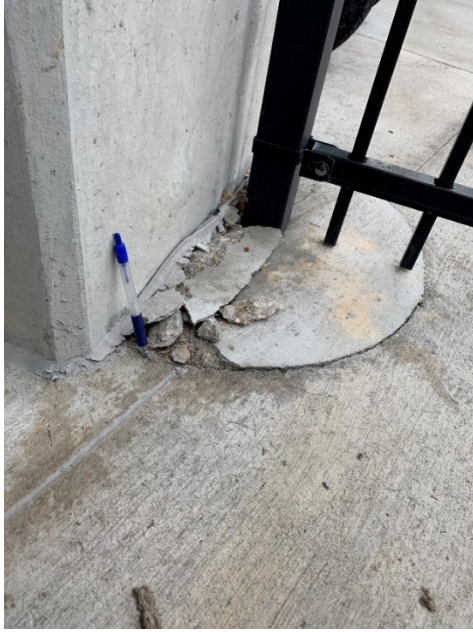
Other observed damages to the pavement included deteriorated joint sealant and damaged curb in several places within the concourse. [Figures C-3, C-4 and C-5](#) show examples of joint sealant becoming completely detached from the pavement, leaving a considerable space for water entry. [Figure C-6](#) shows an example of the damaged curbing.

Figure C-3: Cracking on Fencing Footing and Deteriorated Sealant
Location: Adjacent to Gate D, Inside Security Fencing

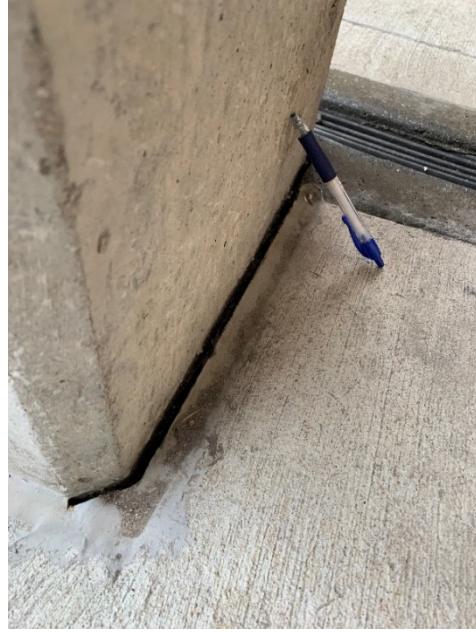
Figure C-4: Detached Sealant
Location: Adjacent to Gate H, Inside Security Fencing

- Joint sealant that is deteriorated or damaged will need to be repaired. Deficient joint sealant can allow water to flow into paved walkways or footings and displace the pavement during freeze-thaw conditions. For examples, refer to [Figure C-3](#) to see area adjacent to Gate D, Inside Security Fencing; Refer to [Figure C-4](#) to see area adjacent to Gate H, Inside Security Fencing; and Refer to [Figure C-5](#) to see area southwest of Gate E (Tower Gate), Outside Security Fencing.

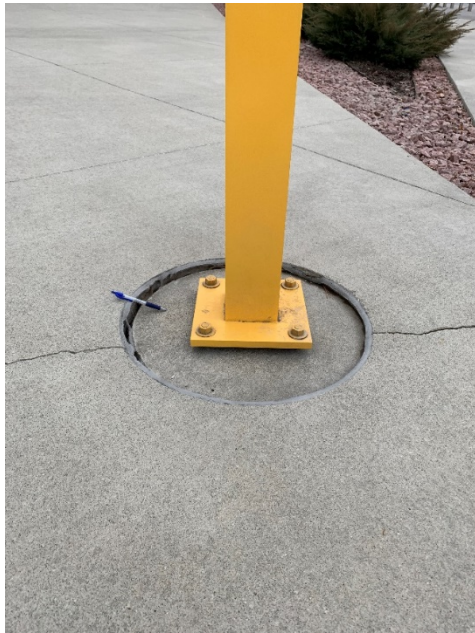
Figure C-5: Detached Sealant and Displaced Sign Footing
Location: Southwest of Gate E (Tower Gate), Outside Security Fencing

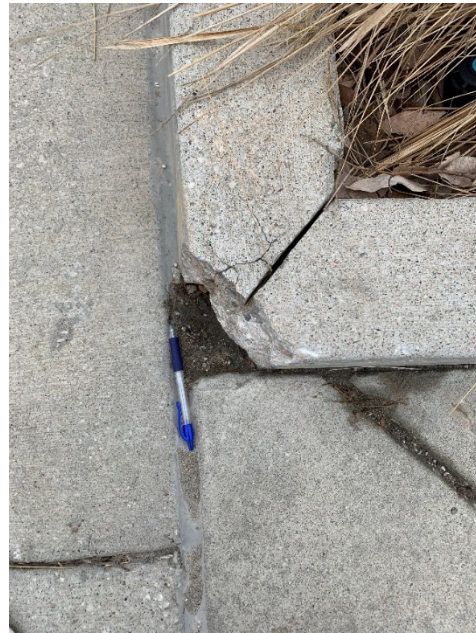
Figure C-6: Curb Damage
Location: Southeast Corner of The Concourse, Outside Security Fencing

- Broken or damaged site appurtenances. To see damaged site amenities, refer to [Figure C-6](#), southeast corner of the Concourse, Outside Security Fencing; refer to [Figure C-7](#), area adjacent to Gate D, Inside Security Fencing; refer to [Figure C-8](#), area outside Electrical Room P251; and refer to [Figure C-10](#), north of Gate A (Founder's Plaza). Each area doesn't pose as a hazard for stadium visitors but will improve the stadium's overall aesthetic quality.

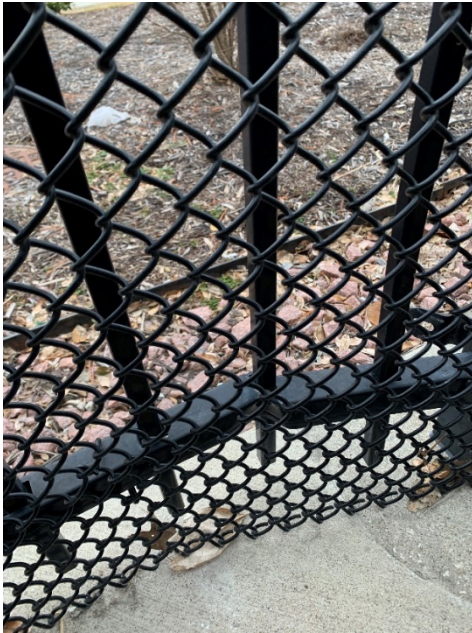
Figure C-7: Fence Damage
Location: Adjacent to Gate D,
Inside Security Fencing

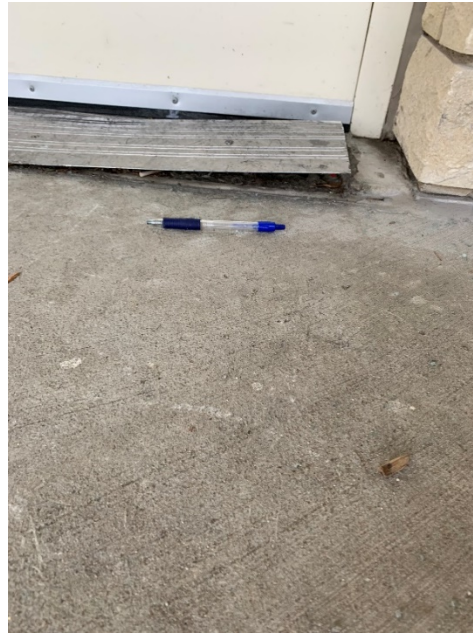
Figure C-8: Doorway Threshold Damage
Location: Outside Electrical Room P251

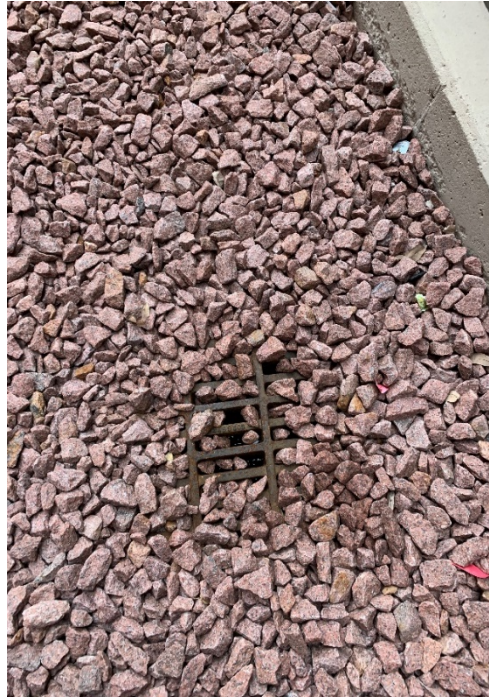
Figure C-9: Area Drain Covered
Location: Adjacent to The Southwest Helix Ramp

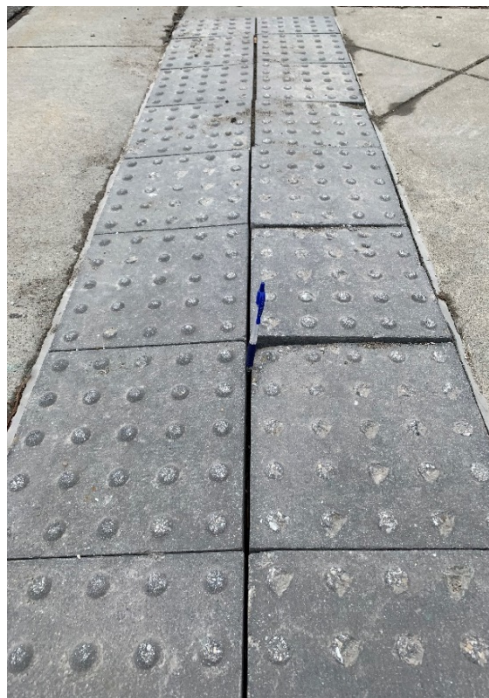
Figure C-10: Detectable Warning Displacement and Deterioration
Location: North of Gate A (Founder's Plaza)

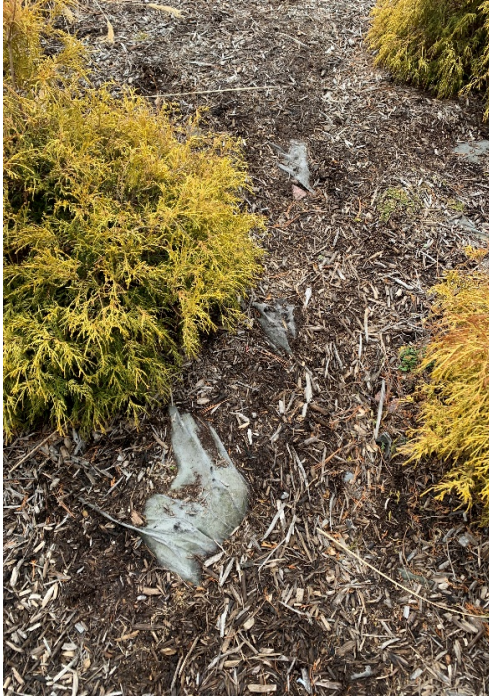
Figure L-1: Deteriorated Landscape Bedding
Location: North of Gate A (Founder's Plaza)

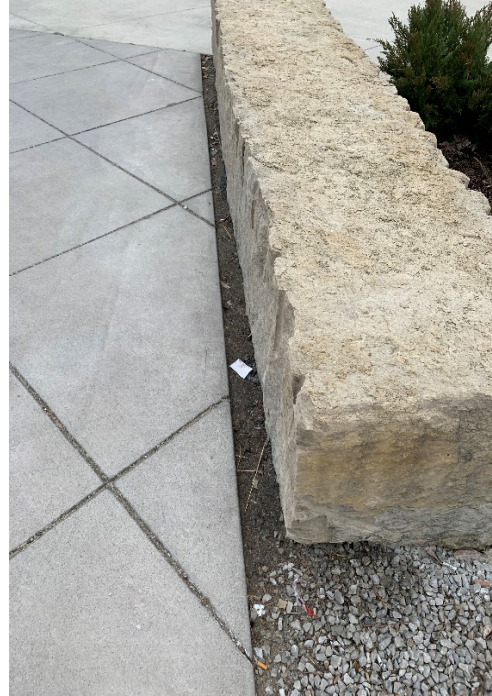
Various species of native planting and grass can be found between walkways and within planting beds surrounding the stadium. Landscaping around the stadium improves aesthetic appeal of the facility and provides visual breaks within the otherwise largely paved surface. Overall, the landscaping features were observed to be in acceptable condition, with only a few landscaping features containing defects. [Figure L-1](#) shows deterioration of the mulch bed exposing the tarping underneath. [Figure L-2](#) displays a barren area of the decorative rock bed.

Figure L-2: Deteriorated Rock Bed
Location: South of Gate E (Tower Gate)

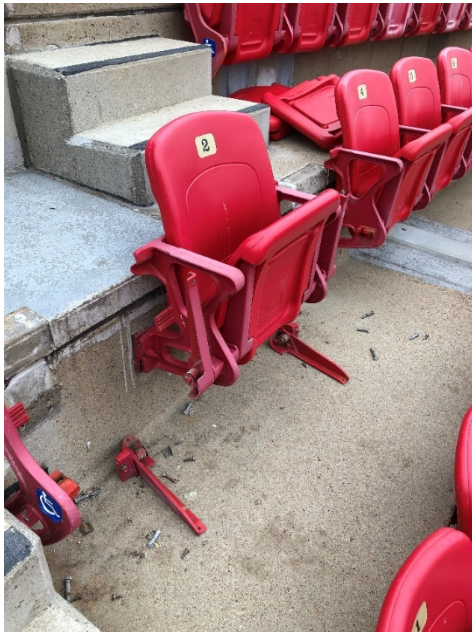
Figure S-1: Upper Bowl Seat Removal
Location: Entire Upper Bowl

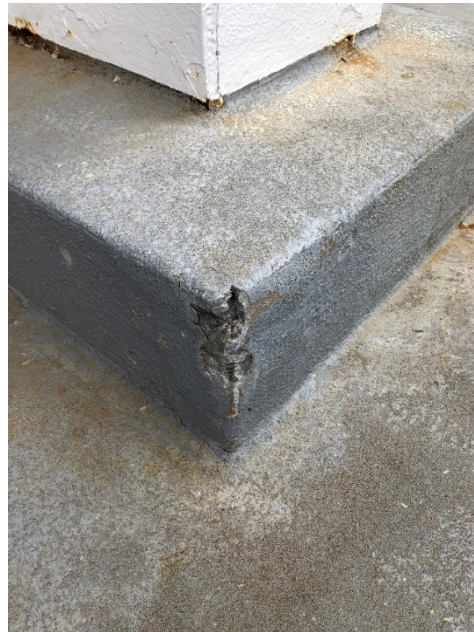
Figure S-2: Concrete Spalling
Location: Upper Concourse Multiple Locations

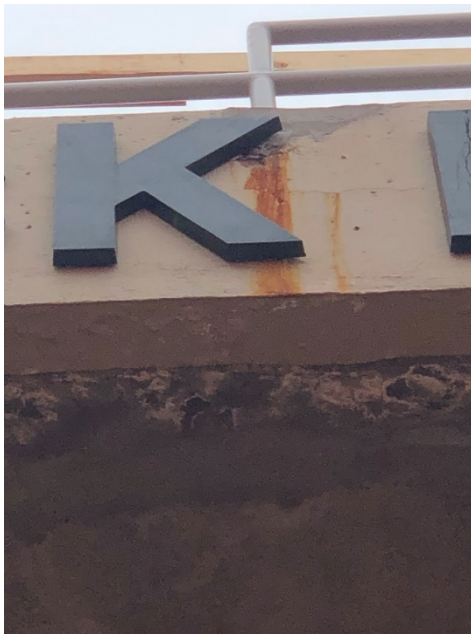
The Plaza, Club, Lower-Upper Concourse and Upper Concourse levels consist primarily of reinforced concrete pan and joist slab system. Concrete spalling was present at the rim of the upper bowl as shown by [Figure S-3](#). The Horizon and Press level consists of light weight composite deck supported by steel wide flange beams. The roof levels primarily consist of steel roof deck supported by steel wide flange beams. Other roof systems consist of cold form metal joists with steel roof deck. The lateral resisting system consists of reinforced concrete load bearing shear walls. The scoreboard and advertising boards consists of built-up hollow steel shapes.

Figure S-3: Corrosion from Concrete Spalling
Location: Rim of Upper Bowl

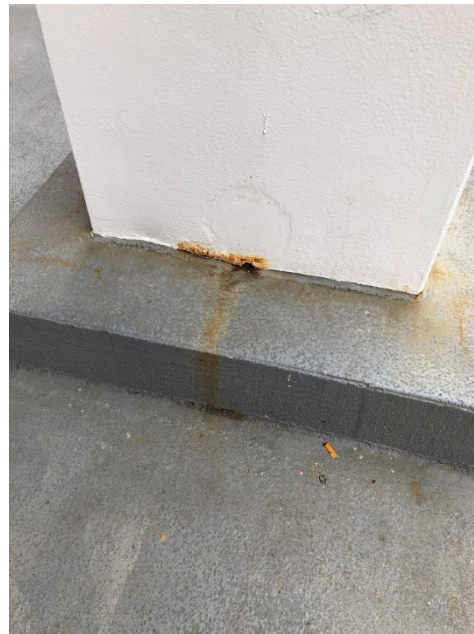
The steel wide flange columns and beams are in satisfactory condition. Rust and corrosion was observed at the base of the scoreboard and speaker HSS columns as shown in [Figure S-4](#). Scoreboard column base and mid-span connections are in satisfactory condition. Beam connections are in satisfactory condition. The steel decks are in satisfactory condition. No corrosion or significant deflection was observed.

Figure S-4: Rust & Corrosion of Speaker Column
Location: Adjacent to Room 05.41.01

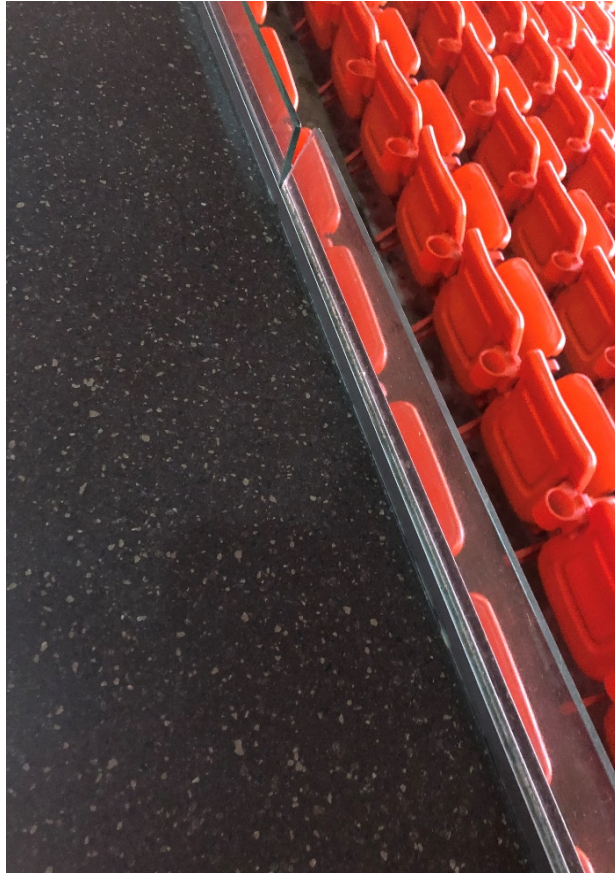
At various locations throughout the stadium, the glass drink-stop located in multiple suites, shown in [Figure S-5](#), was loose. If not maintained, this could pose potential hazards to the occupants below.

Figure S-5: Loose Glass Drink Stop
Location: Field Suite 119A

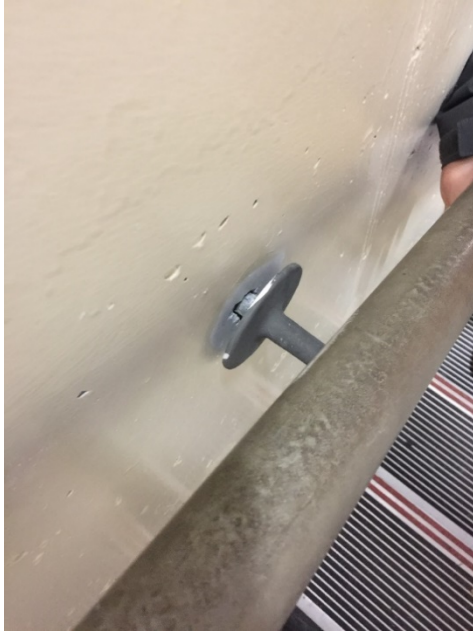
The handrails were observed at various locations throughout the stadium. Loose anchors are present in a few locations as shown as shown in [Figure S-6](#). The grout at the base of the handrails was missing in multiple locations which leads to rusting of the base of the handrail. Refer to [Figure S-7](#).

Figure S-6: Loose Handrail Support
Location: Player Tunnel 01.69.01

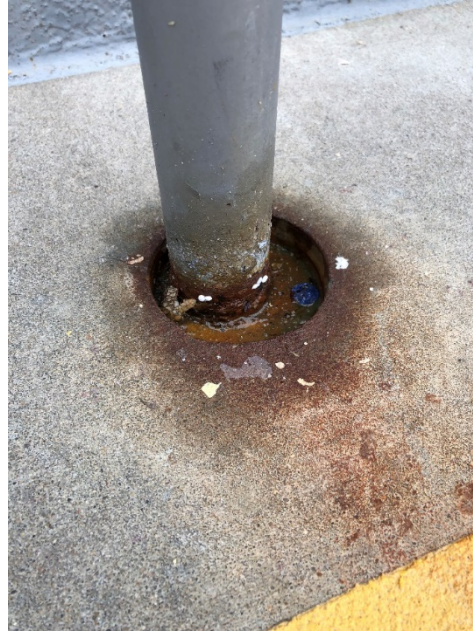
**Figure S-7: Missing Grout and Rust
at Base Handrail**
Location: Multiple locations

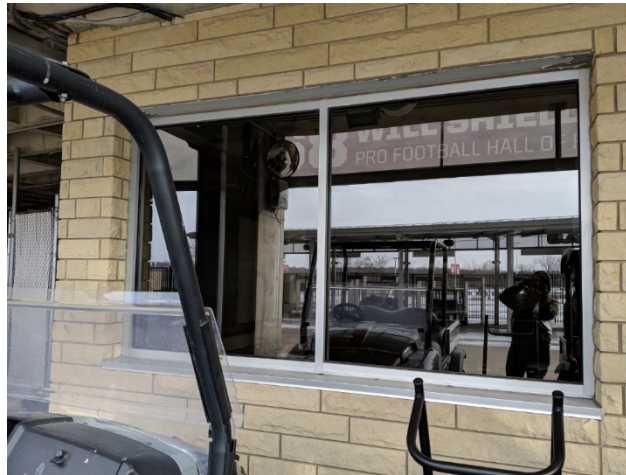
Paint applied to steel angle lintels above Plaza Level hollow metal service doors appear to have been repainted. As noted in the 2017 report, the steel lintel above the windows at the Security & Fire Command room 03.54.02A appeared to be chipping and flaking once more, refer to [Figure AF-3](#). To avoid exposing the steel lintels to moisture and eventual rust development, consider scraping and re-painting with an appropriate paint product which is specifically formulated for this material and exterior conditions.

Figure AF-3: Flaking Paint at Exterior Lintel
Location: Plaza Level 3 – 03.54.02A Security & Fire Command

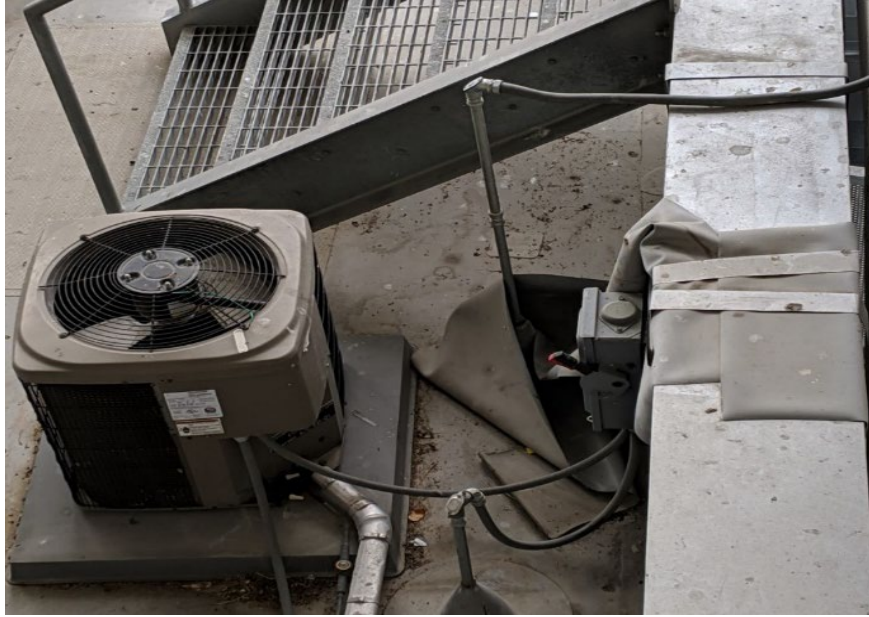
Roofing membranes were observed to be in satisfactory condition. No rips, tears, or other failures were observed. All observed copings, flashings, and sealants appear to be in satisfactory condition, as shown in [Figure AR-1](#). However, portions of the roofing membrane improperly placed were observed near the stair to the roof, as shown in [Figure AR-2](#).

Figure AR-2: Debris over Roof Membrane & Coping
Location: Upper Concourse Level 6 – 06.76.02 Cooking Concession & Restroom

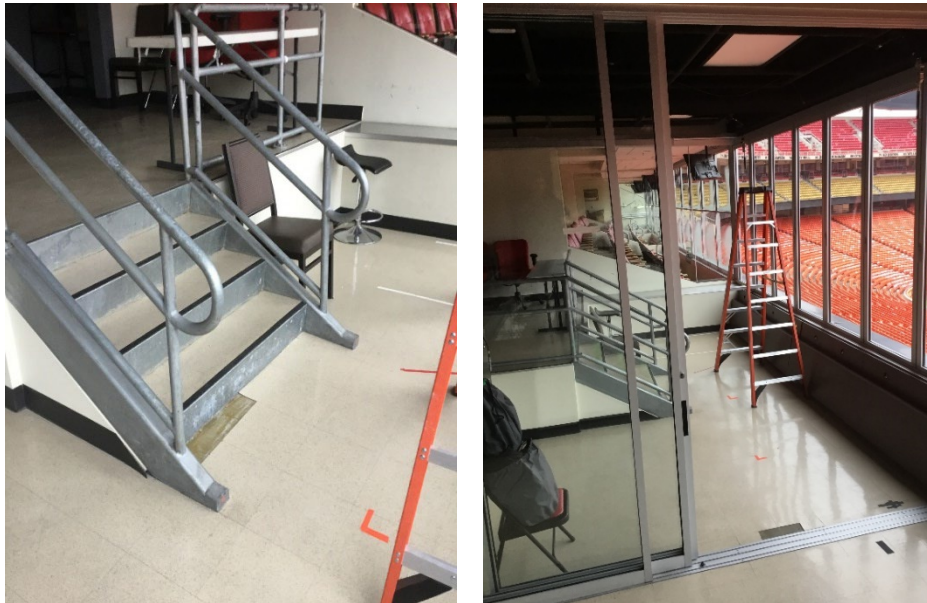
Location: Plaza Level 3 - 03.70.02 Cameras and 03.68.03 National Broadcast

Figure AI-3: VCT Floor Tiles Missing

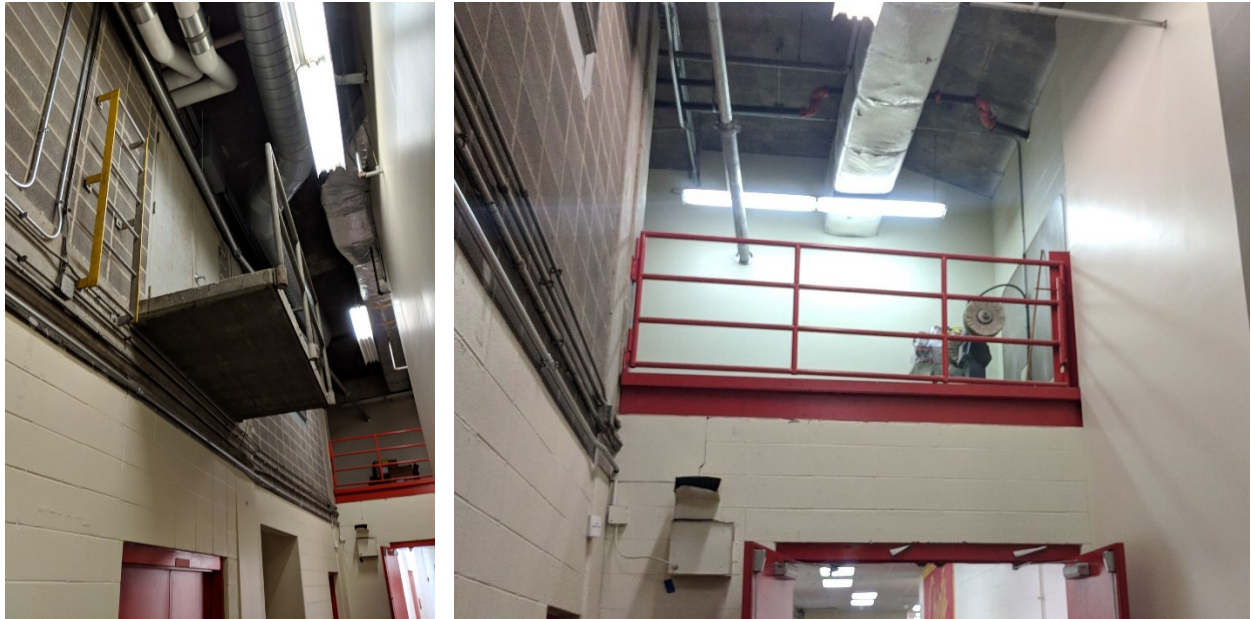
protection in the 2017 assessment. Upon review, proper fall protection was observed on the balcony over the double door, as shown in **Figure AI-11** (right). However, the balcony shown in **Figure AI-11** (left) does not maintain proper guard rail around all three sides. It is assumed that this area is not accessible to the general public and that individuals accessing this space are aware of the hazard. It is also assumed that this area is intended for maintenance. However, failure to keep proper fall protection in place (guardrails) may present a major safety concern for individuals accessing this space. It is highly recommended that these balcony areas be adequately closed off with a guardrail when not required to be open.

Figure AI-11: Balcony Area without Proper Fall Protection
Location: Service Level 1 – 01.61.04 Corridor

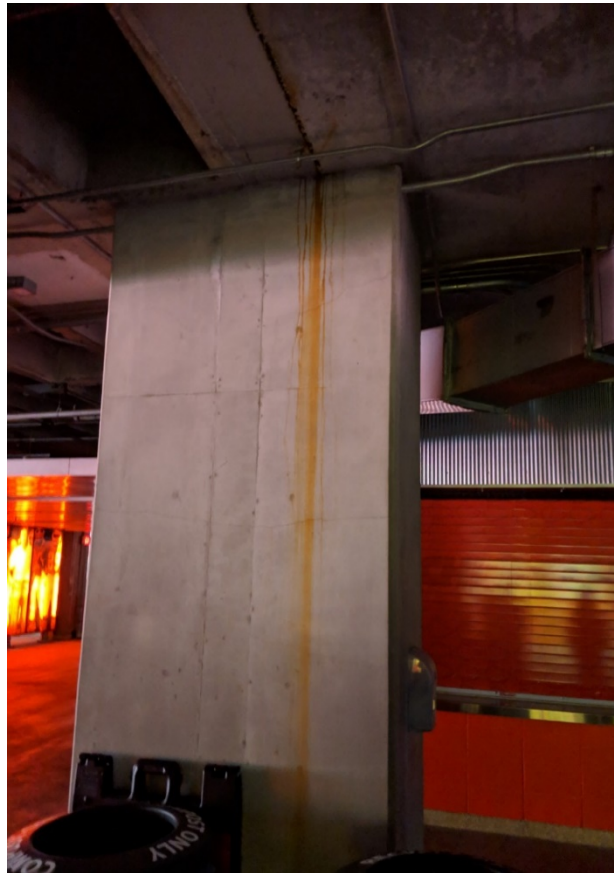
Upon observation of concourses, finishes generally appear to be in satisfactory condition. In the 2017 assessment, a large rust stain was observed from a seam between placements in the exposed concrete ceiling above at Field Level 2 outside Cooking Concession 02.61.02. Refer to **Figure AMI-3**. This most likely is a result of moisture penetrating from above and contacting the reinforcement inside the structure and streaking down the face of the column. This may result in future structural implications. The condition was existing upon further observation and remains an issue.

Figure AMI-3: Rust Stain on Column
Location: Field Level 2 – 02.70.05 Concourse
Outside of Cooking Concession 02.61.02

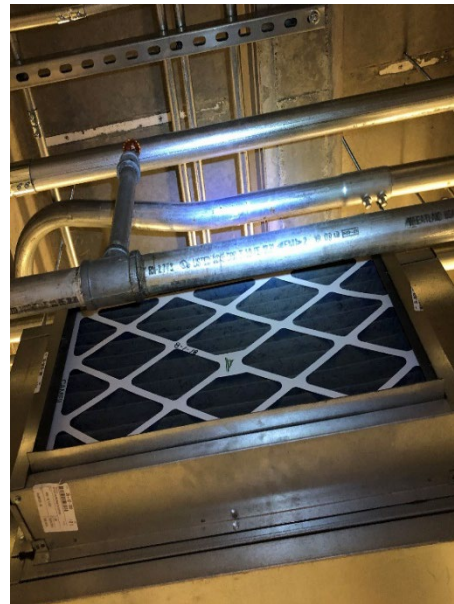
The 2017 assessment noted that some filters were observed to be in need of replacement due to visible dirt and indicated age. During this year's assessment, similar conditions were present. While some filters appeared clean, as shown in [Figure M-1](#), others were dated up to 6 months old and clearly in need of replacement, as shown in [Figure M-2](#).

Figure M-2: Dirty Filter
Location: Elec. 03.50.02

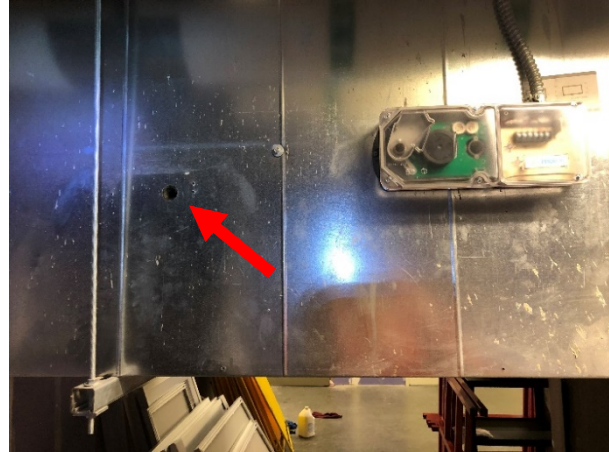
While in Mech. 05.17.01, some noise was observed from the chilled water pipes serving the air handling unit. The noise sounded like there could be air in the chilled water lines. It is recommended that the system be purged of all air and all air vents, automatic and manual, be checked for proper operation. Air in the piping can cause damage to equipment, corrosion, and loss of performance, so addressing this issue is a priority. In the same room, a duct smoke detector was observed to be sealed poorly to the surrounding duct, as shown in [Figure M-3](#), and a hole from a previous piece of equipment in the duct was not sealed at all, as shown in [Figure M-4](#).

Figure M-4: Hole in Duct
Location: Mech. 05.17.01

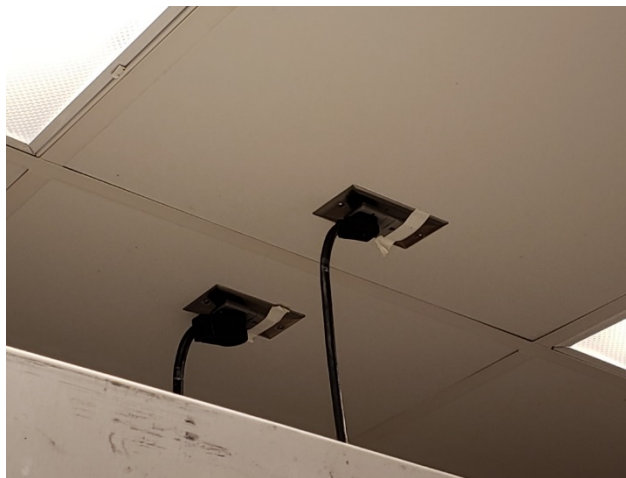
The GFCI receptacles in the ceiling of Concessions 06.28.02, as shown in [Figure E-6](#), (U303B) are taped off.

Figure E-6: Ceiling Receptacles
Location: Concession 06.28.02

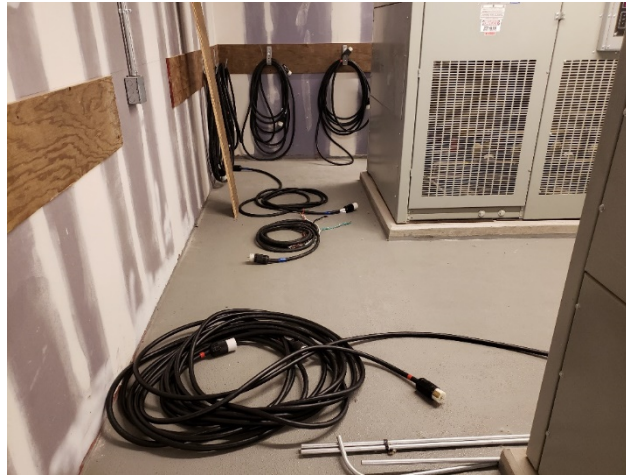
Electrical room 03.42.02, as shown in [Figure E-7](#), (P 252) had extension cords on the floor. Floor located power cords pose as a trip hazard.

Figure E-7: Cords on the Floor
Location: 03.42.02
