# Arrowhead Stadium Assessment | 2015

## JCSCA + Burns & McDonnell

This document contains information pertaining to the condition of Arrowhead Stadium as documented by the Jackson County Sports Complex Authority (JCSCA), including descriptions, conditions, and exhibits which have been written and verified by Burns & McDonnell.

2 / 1 / 2015

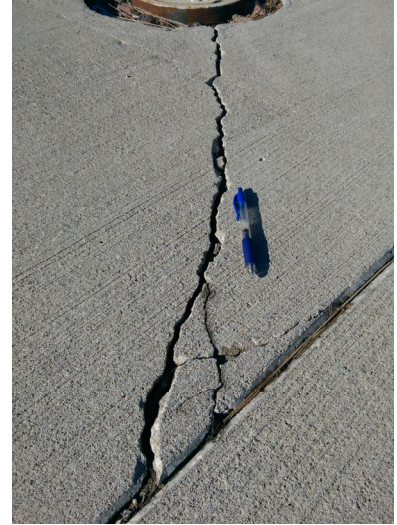
- Concourse Concrete Walkways
  - Mild cracking and more severe edge/corner spalling was found in a few locations outside of the entrances to the stadium. Refer to Flatwork Image: [Exhibit A1.1](#) (right).
  - Several joints within the perimeter fence have separated due to moderate spalling and some of the joints are missing sealant.
- Exterior Concrete Walkways.
  - Concrete pavement between Red Coat Drive and the stadium shows moderate signs of deterioration. Refer to Flatwork Image: [Exhibit A1.2](#) and [A1.3](#) (right).
  - Occasional, mild cracking is present in concrete panels near Red Coat Drive.
  - Concrete on the northwest side of the stadium shows mild, but more continuous signs of wear and cracking.
  - Settling of foundation for a signpost was observed near the west corner of the complex. Refer to Flatwork Image: [Exhibit A1.4](#) (right).

- Perform routine maintenance to seal and repair minor cracking observed along walkways and concourses. Refer to Exhibits A1.1, A1.2 and A1.3 (page 4).
- Monitor more severe signs of pavement deterioration after maintenance is performed to confirm deterioration does not continue to advance. Refer to Exhibits A1.2 and A1.3 (page 4).

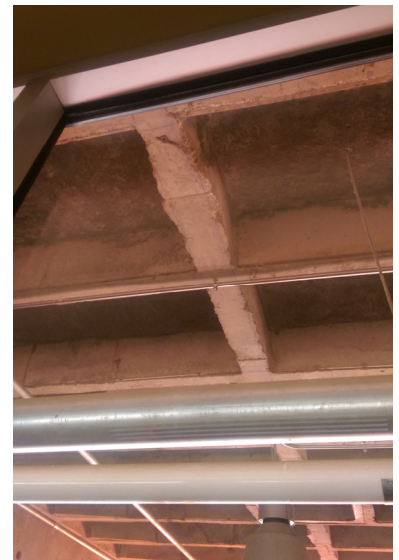
- The original superstructure is primarily reinforced concrete columns and walls with reinforced concrete pan joist slab system. See the following bullet points for a description of the additions constructed during the major renovations stage. Refer to Superstructure Images: [Exhibit B2.1](#) (page 5) and [B2.2](#) (right).

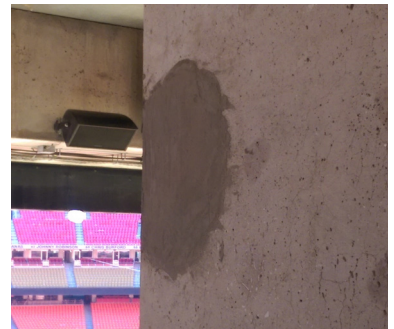
- Concrete patchwork of the original structure is in excellent condition. The patchwork is flat and smooth. Refer to Superstructure Images: [Exhibit B2.3](#) (page 6).

- All observed structural elements are in satisfactory condition. Concrete patchwork may be required within the next few years for the original concrete superstructure. Continue routine maintenance as required.

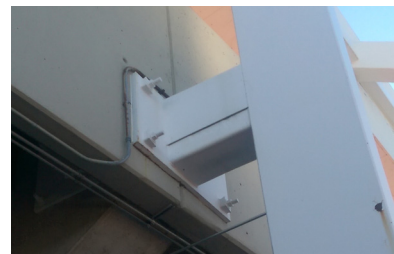
- The steel wide flange columns are in excellent condition. No corrosion was observed. Scoreboard column base and mid-span connections are in satisfactory condition. Refer to Superstructure Images: [Exhibit B2.4](#) (page 6).

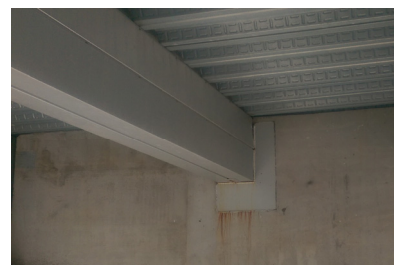
- The steel wide flange beams are in satisfactory condition. No corrosion or significant deflection was observed. Beam connections are in satisfactory condition. Refer to Superstructure Images: [Exhibit B2.5](#) (page 6).

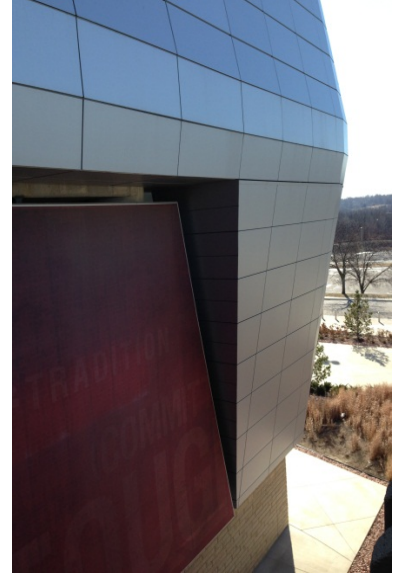
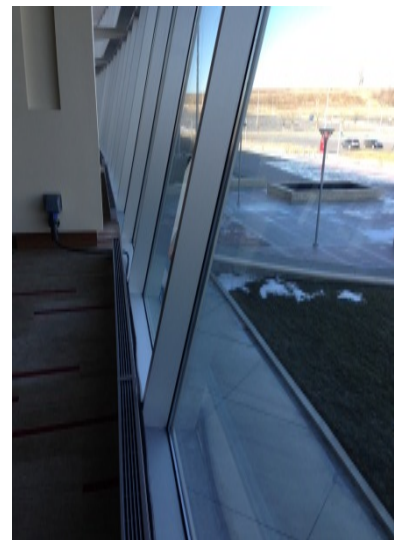
- All observed façades, in general, are in satisfactory condition.
- Metal panel and graphic mesh systems were observed to be in satisfactory condition. No signs of oil canning, staining, or degradation were observed.
- Stone cladding systems were observed to be in satisfactory condition. No signs of chipping or staining of the stone or grout was observed.
- All observed glass storefronts are in satisfactory condition. Aluminum frame and mullions were observed to be free of staining, fading, or degradation of any kind. Seals and flashing around observed storefronts are in satisfactory condition.
- Refer to Façade Images: Exhibits B3.1 through Exhibit B3.3 (page 7) for typical façade conditions.

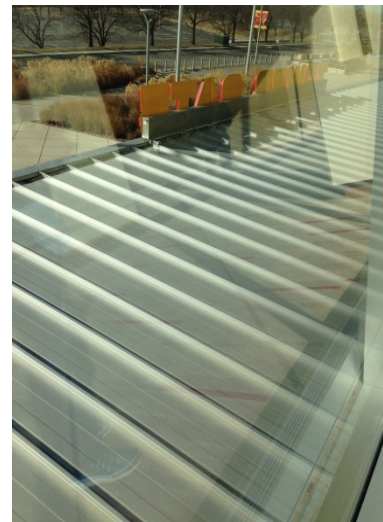
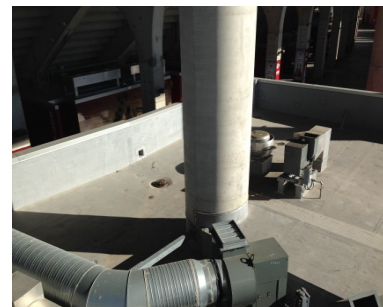
- Observed metal roofing is in satisfactory condition. No signs of rust, staining, or other failures were observed.
- Refer to Roofing Images: [Exhibit B4.1](#) and [B4.2](#) (page 8) for typical roofing condition.

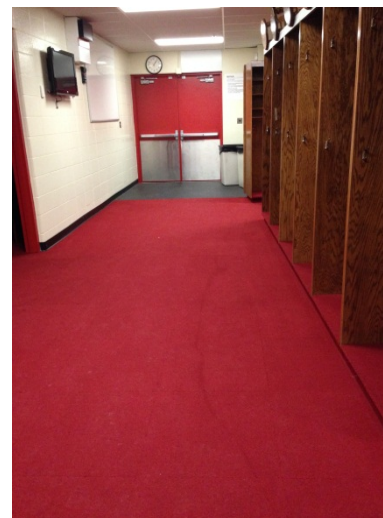
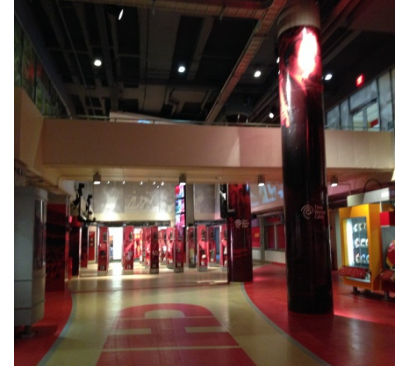
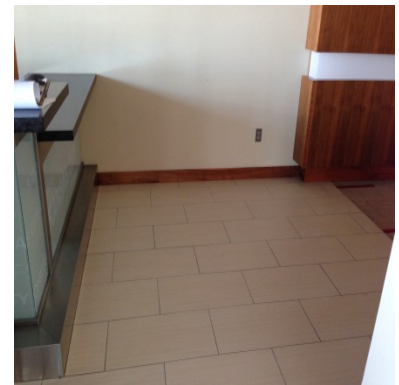
- Flooring surfaces are generally in satisfactory condition.
- Carpet, in general, is in satisfactory condition. Carpet deficiencies found in the 2014 stadium assessments were repaired as recommended. Refer to Flooring Images: [Exhibit C1.1](#) (page 8).
- Epoxy floors were observed to be satisfactory. No visible signs of wear and tear were observed. Refer to Flooring Images: [Exhibit C1.2](#) (right) for typical conditions at epoxy flooring.
- Observed sealed or painted flooring is in satisfactory condition. No visible signs of chipping or flaking were observed.
- Porcelain tile floors were observed to be in satisfactory condition. Refer to Flooring Images: [Exhibit C1.3](#) (right) for typical conditions.

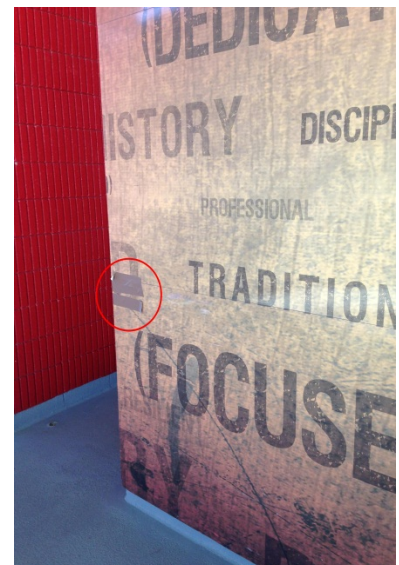
- Observed painted and exposed block walls are in satisfactory condition with no visible chipping, flaking, or cracking of the applied paint system.
- Applied graphic walls, in general, were observed to be in satisfactory condition. However, at the upper concourse a graphic panel was observed to be damaged. Refer to Interior Wall Images: [Exhibit C2.1](#) (page 9) for typical condition.

- Applied graphic walls, in general, were observed to be in satisfactory condition. However, at the upper concourse a graphic panel was observed to be damaged. Consider repairing or replacing panel in the near future to maintain the appearance of a First Class NFL Football stadium. Refer to Exhibit C2.1 (page 9).

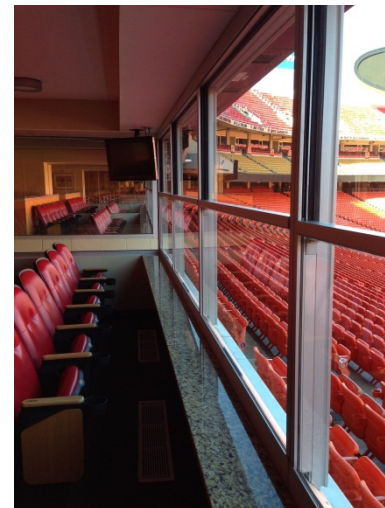
- Glazed storefront systems were observed to be in satisfactory condition. No signs of staining, fading, or degradation were observed. Seals and flashing around storefronts are in satisfactory condition. Refer to Interior Wall Images: [Exhibit C2.2](#) (right) for typical condition.

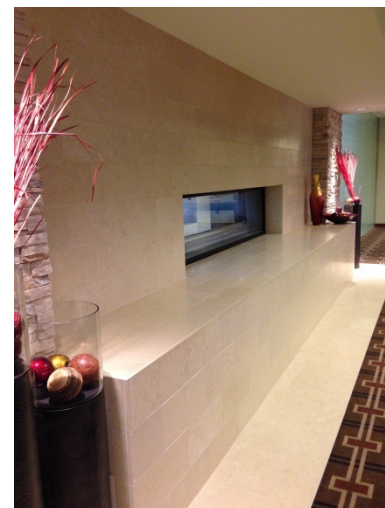
- Porcelain tile, typically, was observed to be in satisfactory condition. No signs of chipping or cracking were observed and mortar joints do not show signs of dirt or grime. Refer to Interior Wall Images: [Exhibit C2.3](#) (right) for typical condition.

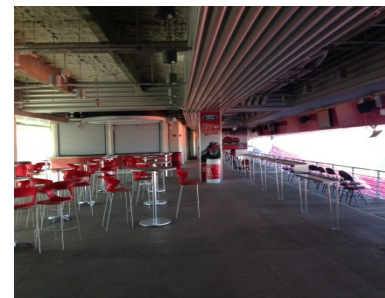
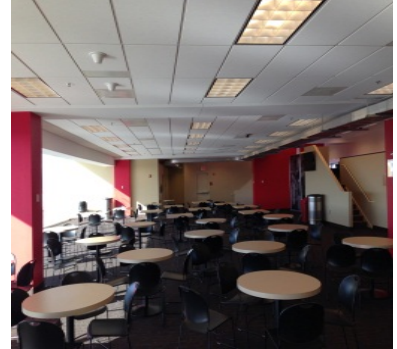
- Exposed and painted ceilings were observed to be in satisfactory condition. Refer to Ceiling Images: [Exhibit C3.1](#) (page 10) for typical condition.
- Observed gypsum board ceilings are in satisfactory condition, in general. No punctures, holes, or scratches were observed.
- Acoustic ceiling tile was observed to be in satisfactory condition, in general. Refer to Ceiling Images: [Exhibit C3.2](#) (right) for typical condition.

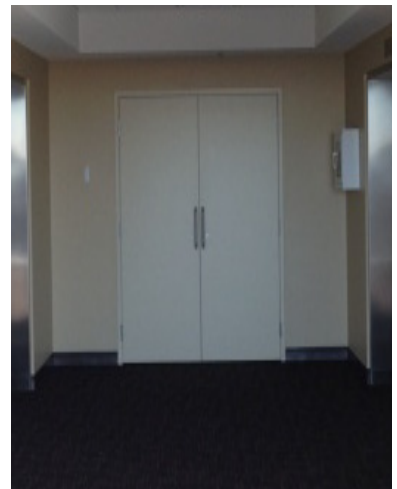
- Doors observed, in general, are in satisfactory condition. Refer to Door Images: [Exhibit C4.1](#) (right) for typical condition.
- Flush wood doors are generally in satisfactory condition. However, the paint was observed chipping and flaking around the hollow metal frame of the pantry door in the club lounge/banquet space. Refer to Door Images: [Exhibit C4.2](#) (right).

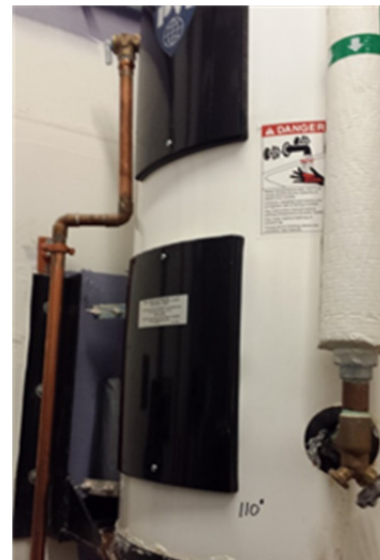
- Various water heaters throughout the facility were observed to have corrosion at the base of the exterior shell. This is possibly due to the storage of chemicals in the same room with a lack of ventilation. Reference Plumbing Images: [Exhibit D1.1](#) (right). This comment was previously reported during the 2014 Arrowhead assessment report.

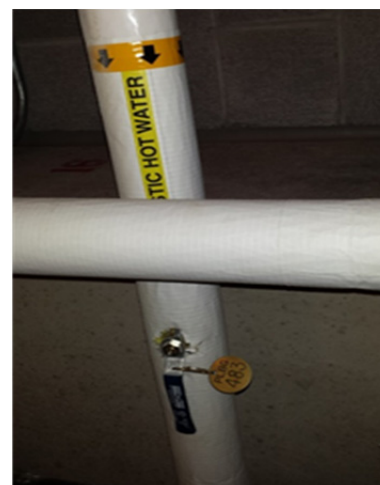
- Plumbing piping is properly labeled with direction of flow and valves are clearly tagged. Labels were shown to be tight and secure. Reference Plumbing Images: [Exhibit D1.2](#) (right).

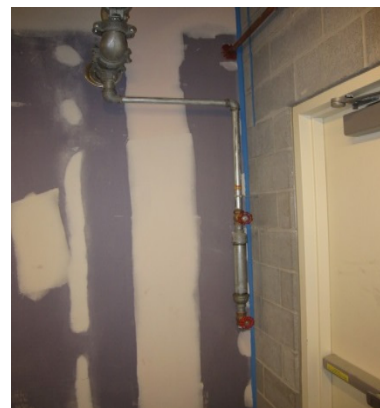
- Fire protection drain lines should also be labeled and tagged for maintenance and service. There were observed in most electrical room locations. Reference Plumbing Images: [Exhibit D1.3](#) (right).

- It is suggested to replace filters at air handling units every three to six months depending on equipment use. Refer to Exhibit D2.3 (page 15).
- Maintenance must be performed to avoid significant water collection and electrical malfunction. Refer to Exhibit D2.2 (page 14).
- It is recommended to label fire protection piping drains within electrical rooms for maintenance and service. Refer to Exhibit D1.3 (page 12).

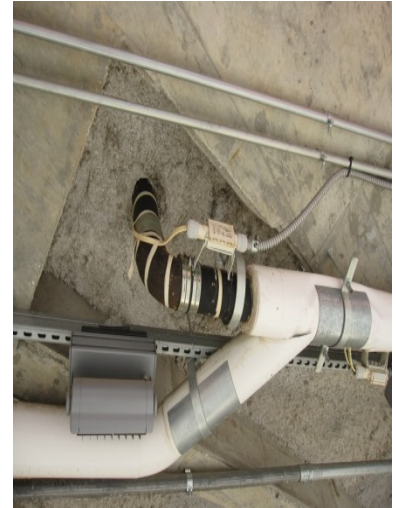
- Exposed piping is equipped with electric heat trace tape. It was noted that some areas of this exposed piping had section that lacked adequate insulation. These areas should be addressed. Reference Plumbing Images: [Exhibit D1.4](#) (page 13).

- In general, all mechanical and plumbing systems have been well maintained and were observed to be in satisfactory condition.
- It was noted that some areas of this exposed piping had section that lacked adequate/missing insulation. These areas should be addressed. Refer to

Exhibit D1.4 (page 13).

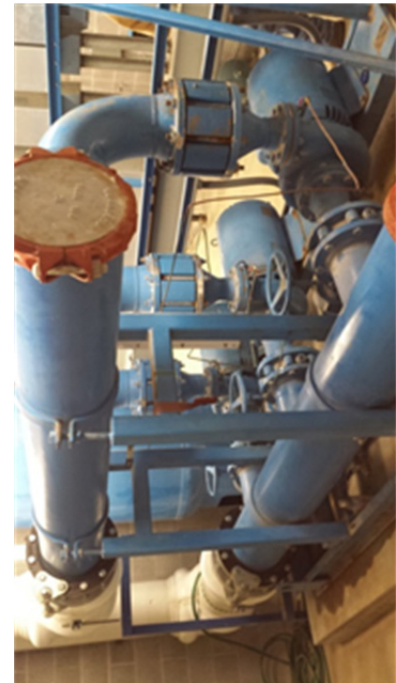
- Access doors to shutoff valves in public restrooms should remain locked during operating hours in an effort to avoid vandalism to concealed piping, valves, etc.
- Natural gas piping serving kitchens has the required emergency shut off valve which is accessible and clearly labeled.
- Water pressure, temperatures and drainage to plumbing fixtures exposed to the outside elements could not be observed due to ambient temperature (20° F) at time of site visit. All exposed restrooms were winterized at the time of site observation.
- Domestic water booster pump skid was observed to be in good condition. Piping is insulated and tagged with direction of flow properly indicated. Reference Plumbing Images: [Exhibit D1.5](#) (right -rotated 90° for size and clarity).

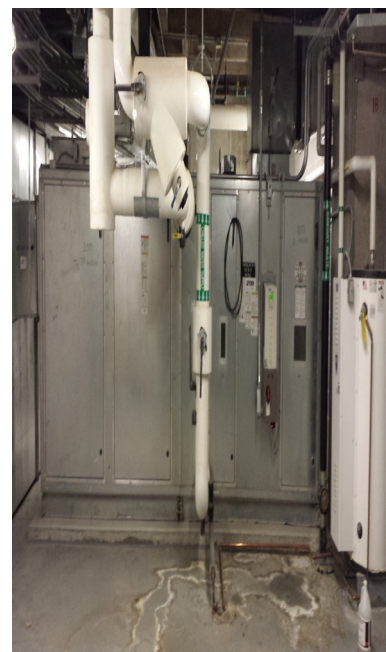
- Air Handling Units
  - Deficiencies
    - Condensate leaking onto floor. Reference HVAC Images: [Exhibit D2.2](#) (right). This was observed on the mezzanine level. Equipment filters were dated with black Sharpie on filter casing at the time of replacement making it easy for maintenance staff to see when filters are out of date when periodic checks are performed. Reference HVAC Images: [Exhibit D2.3](#) (page 15).

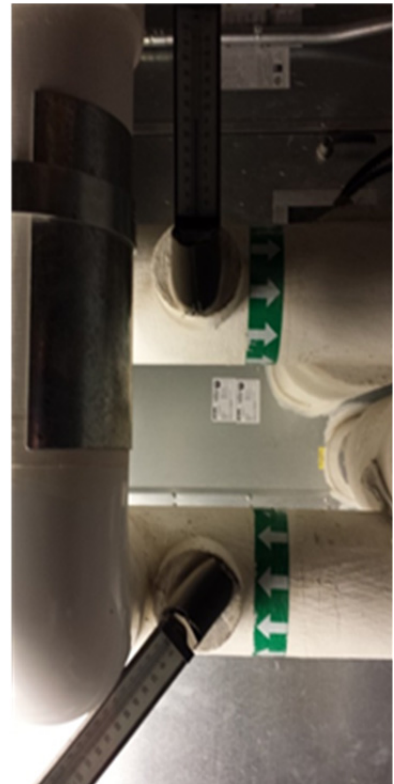
- Piping system pressure and temperature clearly identified  
Reference HVAC Images: [Exhibit D2.4](#) (right – rotated 90° for size and clarity).
- Isolation, balancing and control valves installed and are operable.

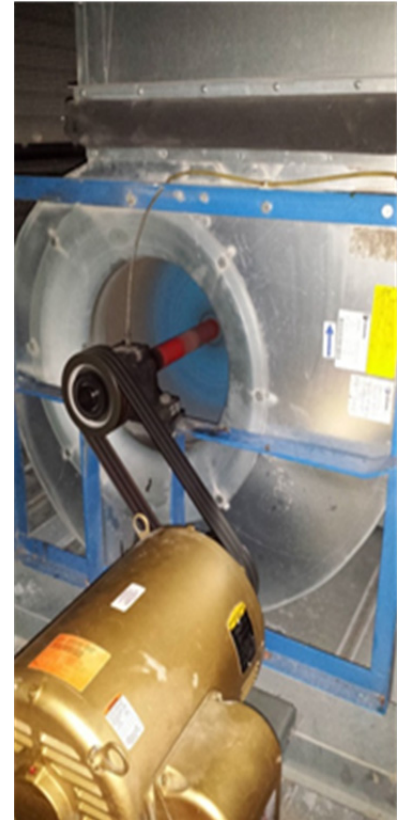
- Fans and motors were observed to be properly aligned and lubricated.
- Belt tension and condition were visually inspected for cracks or breaks. Reference HVAC Images: [Exhibit D2.5](#) (page 16).

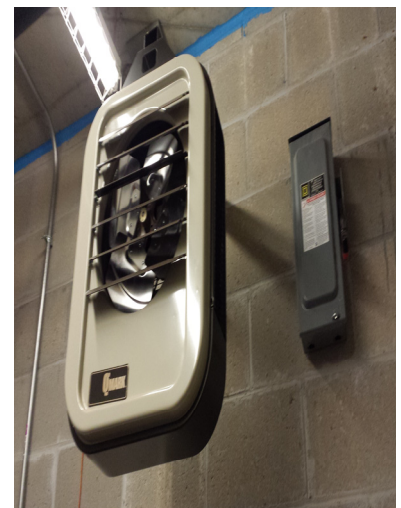
- Refer to HVAC Images: [Exhibit D2.6](#) (right).
- Exhaust Fans
  - Deficiencies
    - None observed.
  - System Maintenance Checks Observed by Engineer

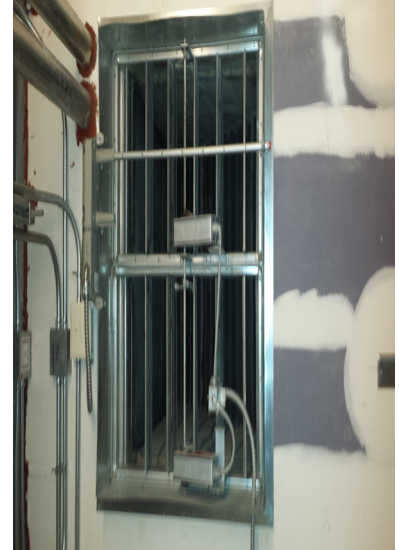
- Motorized Dampers
  - Deficiencies
    - None observed.
  - System Maintenance Checks Observed by Engineer
    - Check damper action is smooth over full travel.

- Check position of damper blades at full open and close positions.
    - Check linkage and bearings for slack or wear.
    - Refer to HVAC Images: Exhibit D2.7 (right).

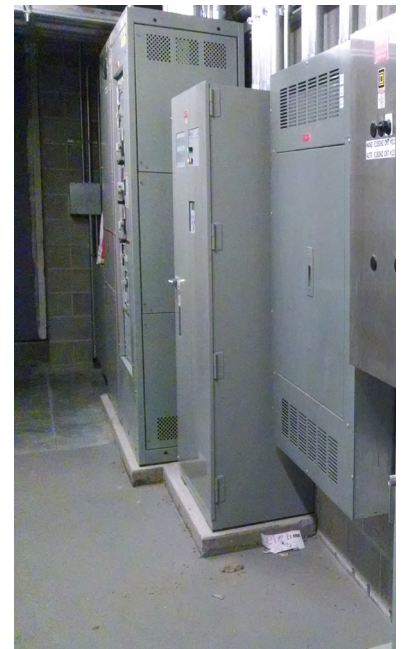
- The overall electrical system was observed to be in satisfactory condition.
- Most electrical rooms have been kept clear of debris. Panelboard clearances have been maintained as required by the 2014 National Electrical Codes, article 110.26
- All panel boards observed were labeled and included type-written, laminated panel board schedule or labeled branch circuit breakers. All emergency panels were labeled with red placards, identifying it as emergency panelboard, as shown under Electrical Images: [Exhibit D3.1](#) (right).
- The installation of telecommunications

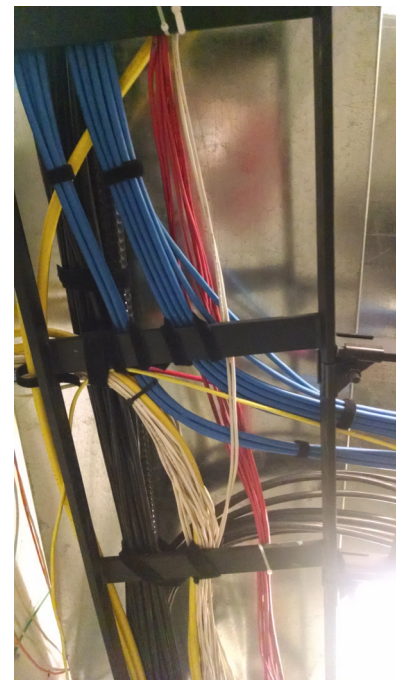
equipment and cabling are in a neat and workman like manner, as shown in Electrical Images: [Exhibit D3.2](#) (page 18).

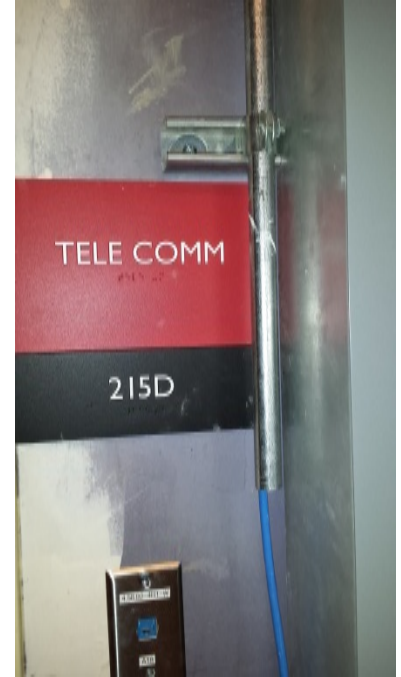
- The conduit installation outside of telecomm room 215D was observed to not be installed with a bushing on the end, as shown in Electrical Images: [Exhibit D3.3](#) (right).
- Black ground conductor was terminate on ground bus bar in Electrical closet 04-31.05.

- In general, all electrical elements were observed to be in satisfactory condition.
  - Ensure that all conduits used for routing of low-voltages are provided bushings on the end of conduits to protect from damage to cabling. Refer to Exhibit D3.3 (page 19).
  - Ensure that all grounding conductors are green jacketed or wrapped in green tape to readily identify as grounding conductors.
-
