Kauffman Stadium Assessment

JCSCA + Burns & McDonnell

This document contains information pertaining to the condition of Kauffman Stadium as documented by the Jackson County Sports Complex Authority (JCSCA), including descriptions, conditions, and exhibits which have been reviewed by Burns & McDonnell and documented in this report.

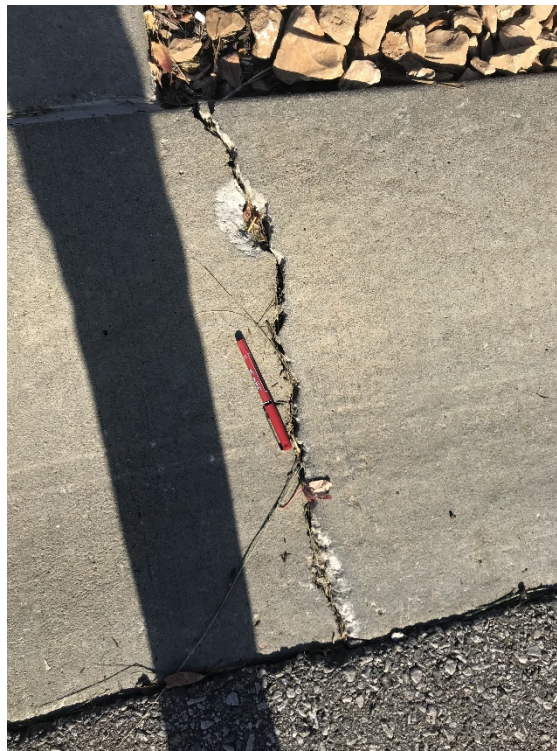
Figure C-1: Cracking Along Exterior Curb
Location: Near Gate D

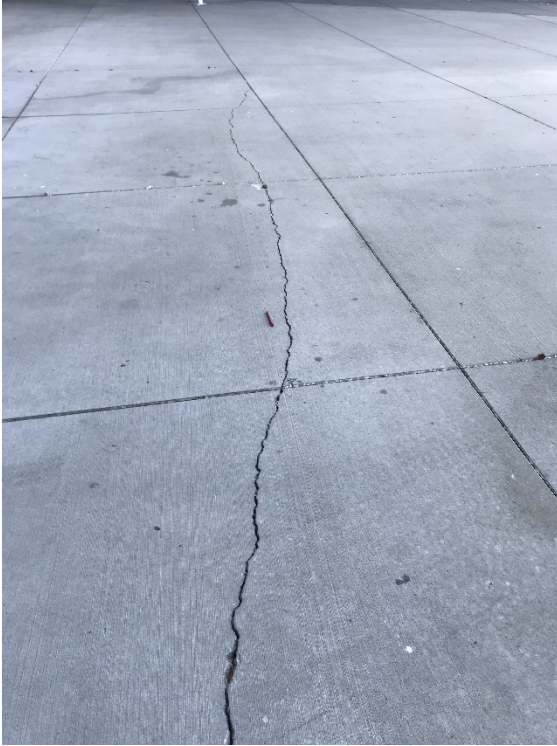
Figure C-2: Transverse Cracking
Location: Near Gate A

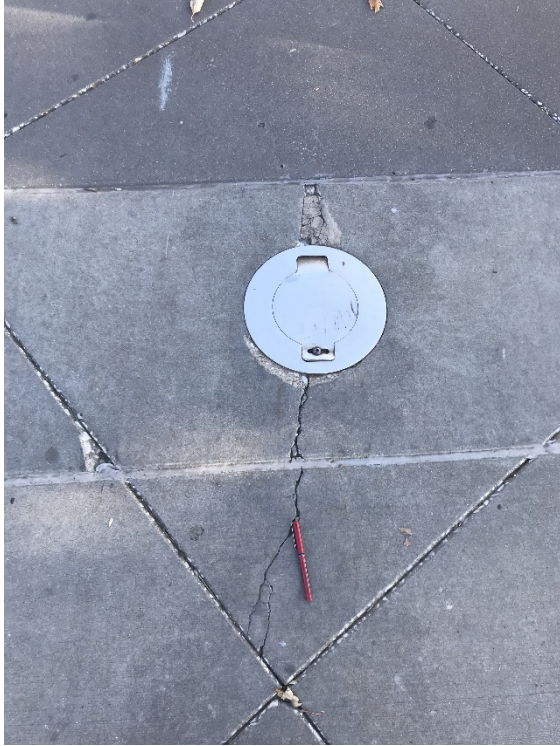
**Figure C-3: Transverse Cracking Leading
Up to Removable Bollard**
Location: Near Gate D

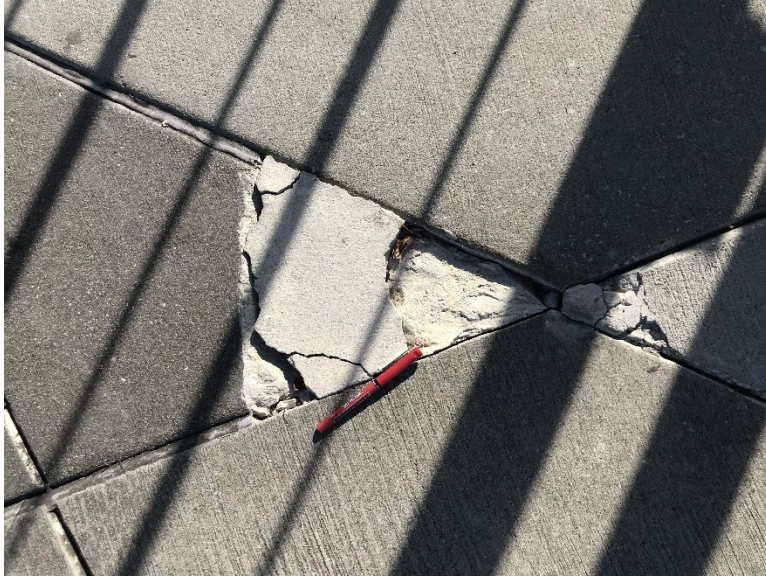
Figure C-4: Corner Cracking Observed
Location: Near Playground Area

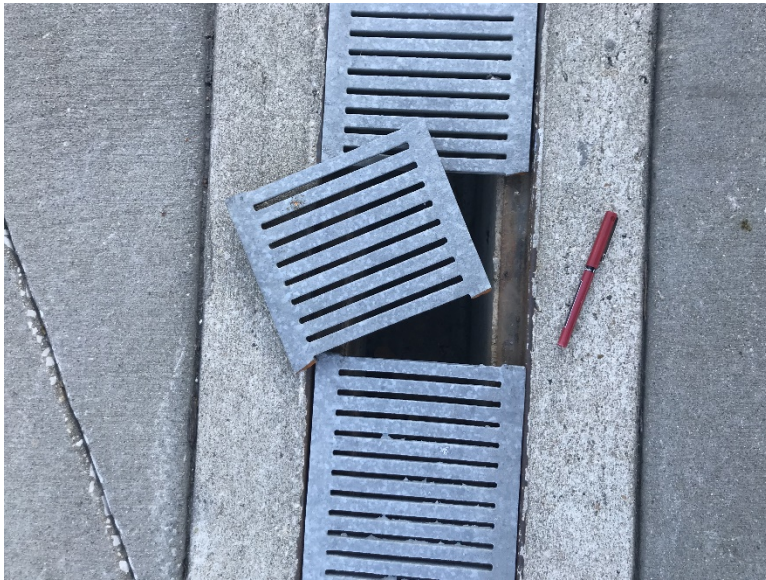
Trench drains are located in several locations around the stadium concourse. Many of the trench drains were found to be broken into pieces, making them susceptible to displace from the channel grooves. **Figure C-5** shows a broken section of trench drain that has been displaced from the channel.

Figure C-5: Damaged Trench Drain
Location: Near the Children's Baseball Field

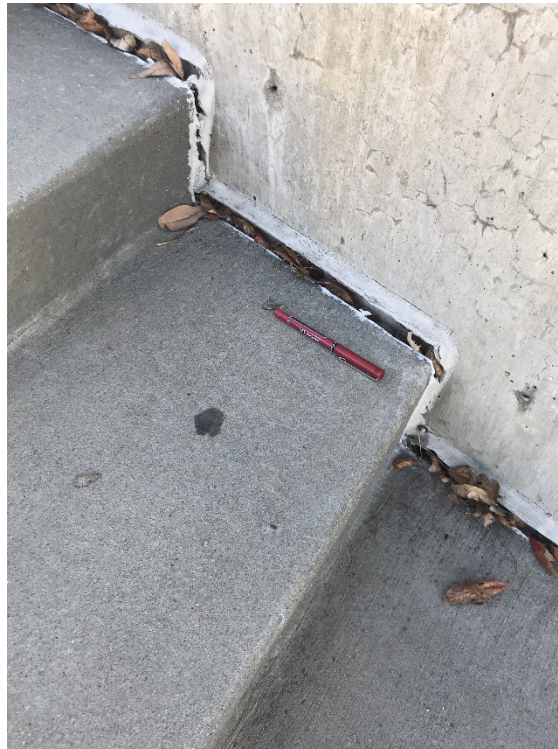
Damaged or deteriorating joint sealant was another common occurrence within the site flatwork, in some cases it would be accompanied by joint spalling. **Figure C-6** show separation of the sealant from the stairs and adjacent wall. **Figure C-7** show deterioration of the sealant.

Figure C-6: Joint Sealant Separation
Location: Near Gate E

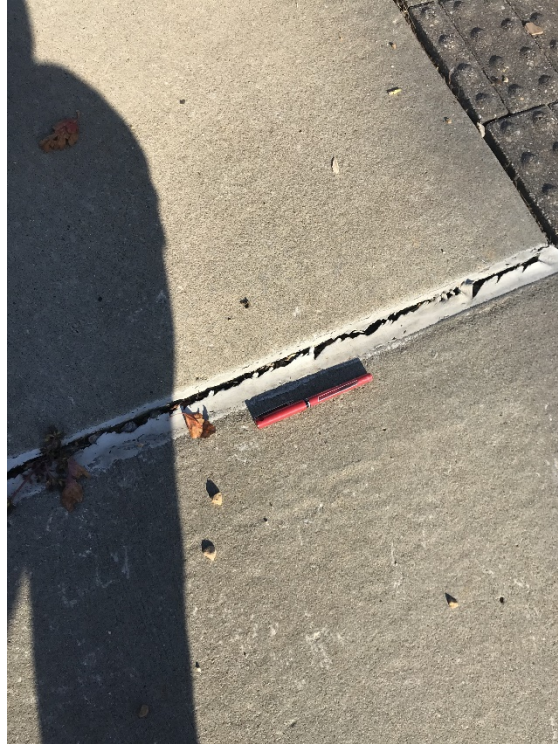
Figure C-7: Joint Sealant Deterioration
Location: Near Gate E

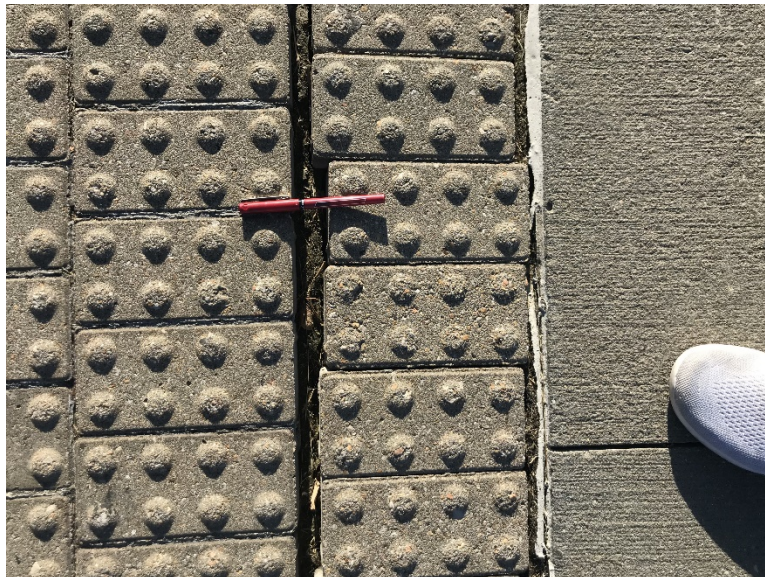
Pavers are commonly used around the site for decorative purposes and double in use as a detectable warning. Some of the pavers on site were observed to be loosened making them easy to displace when stepped on. **Figure C-8** shows the separated pavers located in front of Gate C.

Figure C-8: Loosened Pavers
Location: Near Gate C

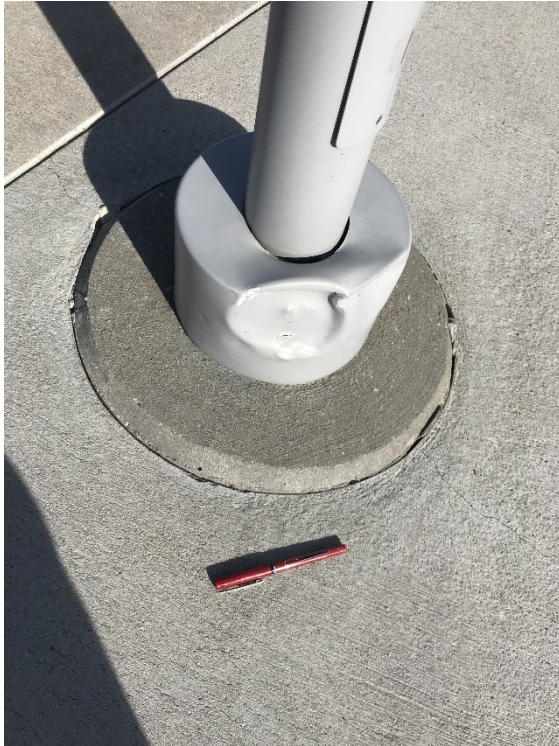
Other site amenities were observed to be damaged during the visit, although they do not create any risk to pedestrians it is recommended that they be addressed for aesthetic appeal. **Figure C-9** shows damage to a light pole and **Figure C-10** shows damaged tile near a set of stairs in the concourse.

Figure C-9: Damaged Light Pole
Location: Near Gate E

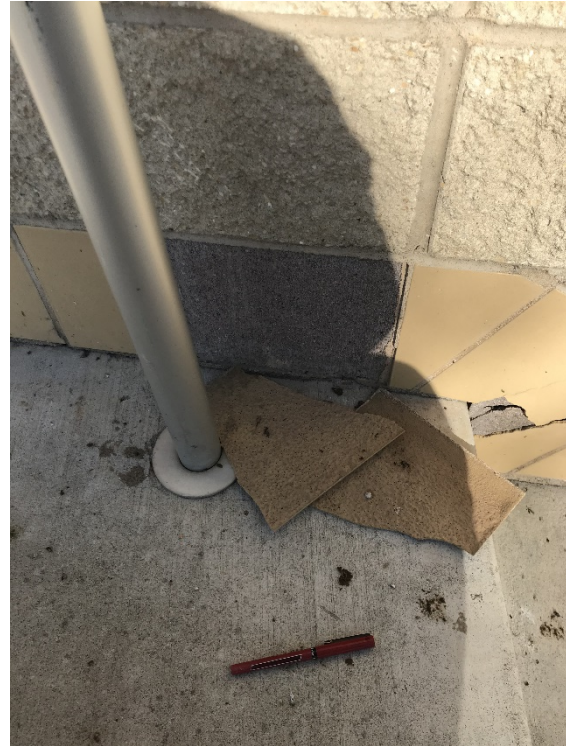
Figure C-10: Broken Tile Along Stairs
Location: Near Gate D

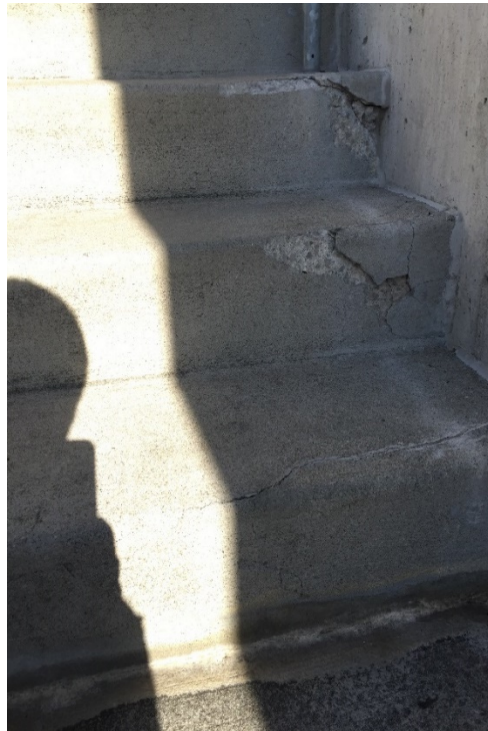
No significant settlement of the structure was observed. The slab-on-grade is primarily in satisfactory condition. No major cracks or spalling of the concrete slab-on-grade was observed. A few control joints and expansion joints need repair or replacement as shown in **Figure S-1**. Concrete was observed to be spalling around various steps and handrail posts as shown in **Figures S-2, S-3** and **S-4**.

Figure S-2: Concrete Spalling on Stairs
Location: Top of stairs in section 206

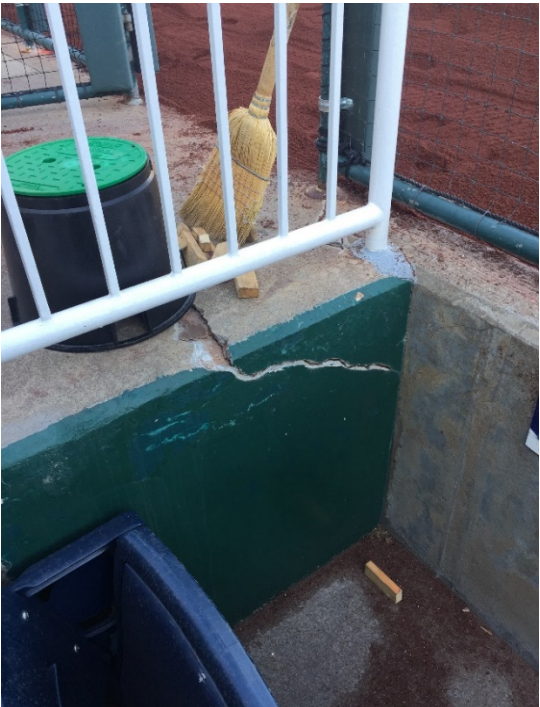
Figure S-3: Concrete Spalling
Location: Home Dugout Suite 1.09.02

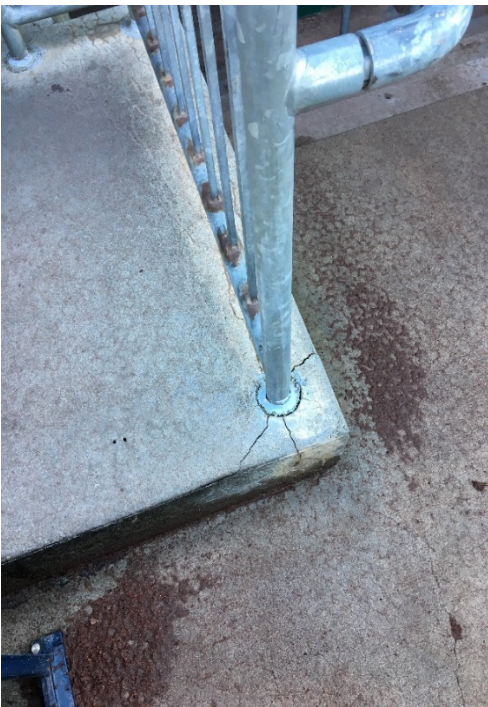
Figure S-4: Concrete Spalling
Location: Home Dugout Suite 1.09.02

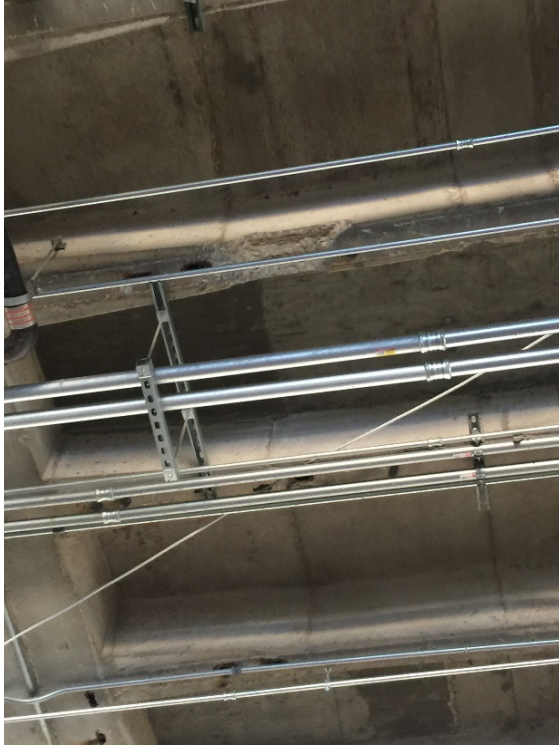
The original reinforced concrete pan joist slab systems are currently in satisfactory condition. No major cracks or widespread spalling was observed. However, minor cracking and some spalling exists which has exposed the reinforcement in the concourse at the top of section 234, as shown in [Figure S-5](#) (left). Minor cracking and spalling was also observed while standing in the concourse at the top of section 312, shown in [Figure S-6](#) (right).

Figure S-5: Exposed Reinforcement
Location: Concourse 03.10.01

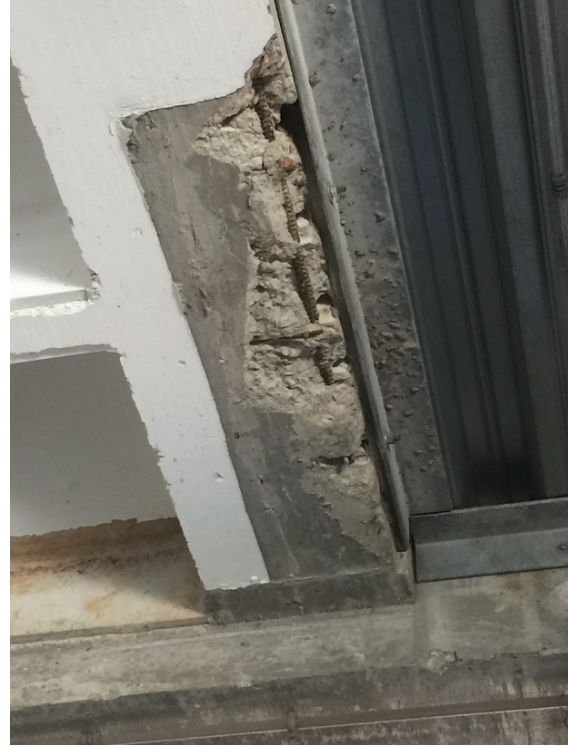
Figure S-6: Exposed Reinforcement
Location: Adjacent to Signature Suite 05.17.01

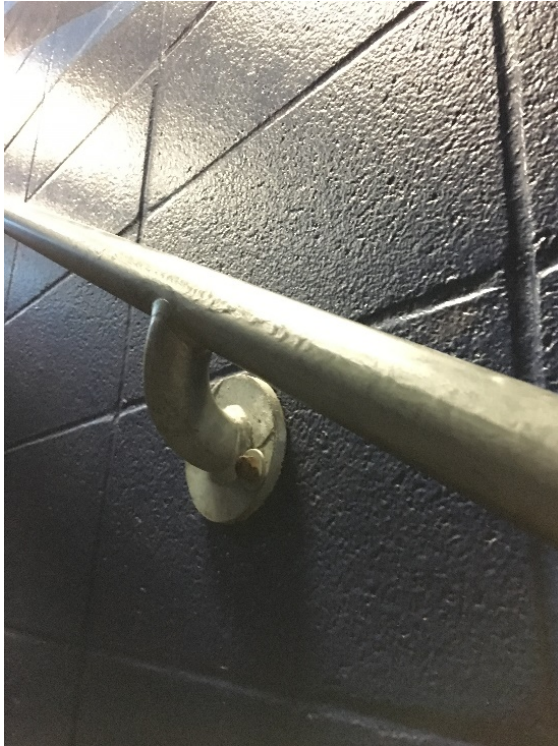
Handrails and handrail anchorage was inspected in various locations throughout the stadium. At (2) locations inspected, it was observed that anchorage was either loose (**Figure S-7**) or the base plate and anchorage was missing (**Figure S-8**). Additionally, various washers and anchors associated with the handrails surrounding the Hall of Fame Suite have developed rust.

Figure S-7: Loose Handrail Anchors
Location: Stair 16 Room S16.01

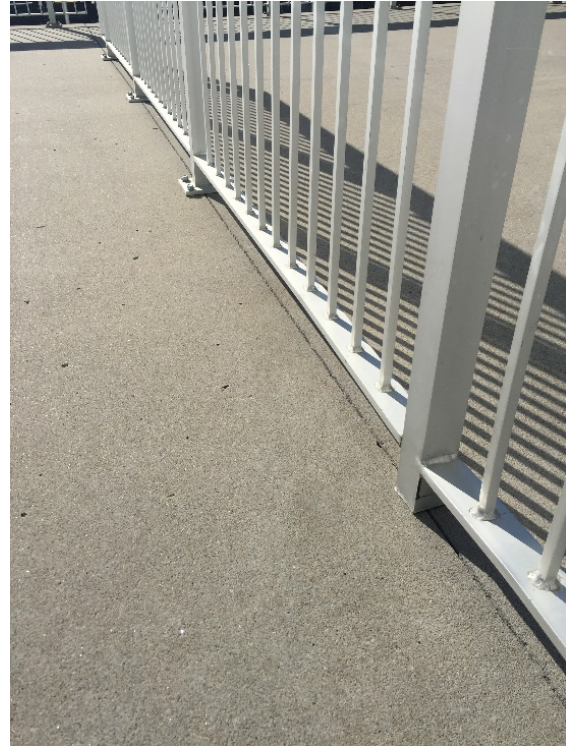
Figure S-8: Missing Base Plate & Anchorage
Location: Outside Hall of Fame Suite
Meeting Room 02.51.01

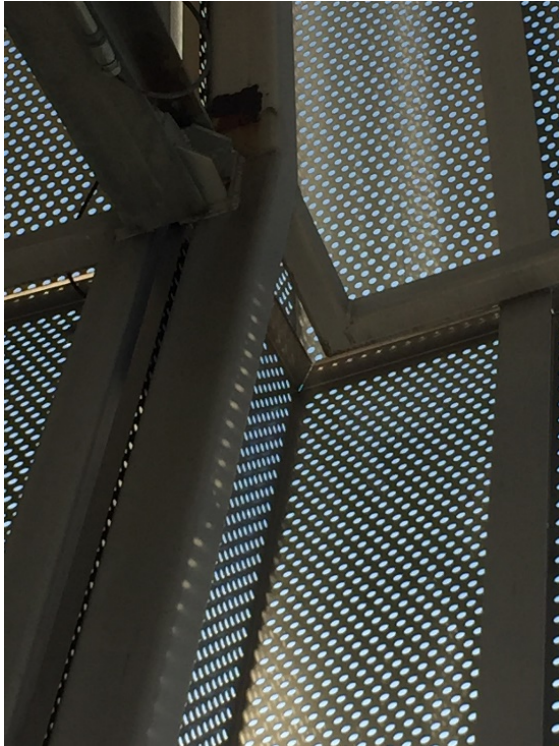
Exterior ungalvanized steel was present at several locations throughout the stadium. This was mostly likely due to paint peeling or chipping off. **Figure S-9** shows paint missing on the external perforated metal panel system. **Figure S-10** shows paint missing on the outfield steel light tower columns.

Figure S-9: Exposed Ungalvanized Steel
Location: Adjacent to Escalator ES01.03

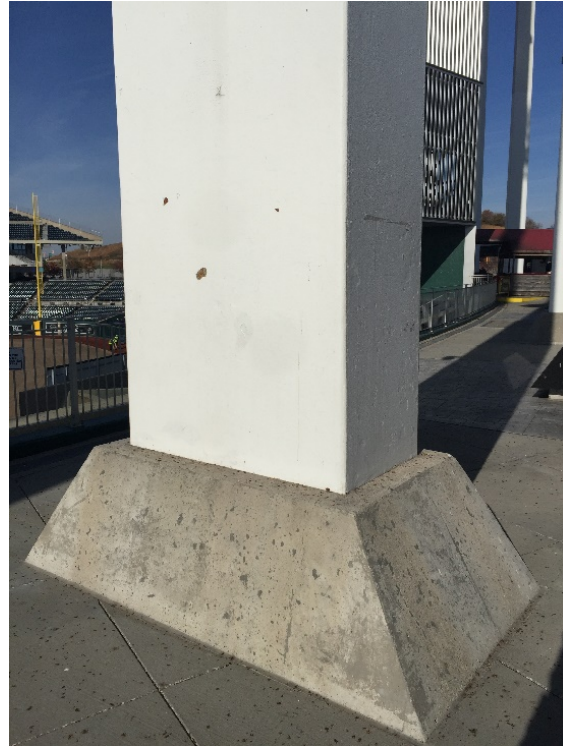
Figure S-10: Paint Chipping
Location: Outside Steel Light Towers

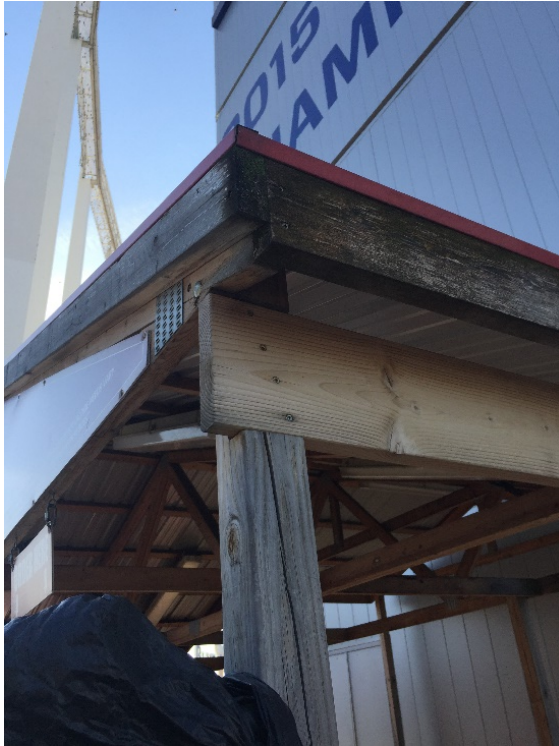
Temporary structures around the stadium were also inspected. The wood Leinenkugel stand beyond the scoreboard in the outfield has sustained wood degradation in a few spots (**Figure S-11**). The hot dog stand in the concourse beyond section 208 has developed rust in places (**Figure S-12**).

Figure S-11: Leinenkugel Outfield Structure
Location: Behind Outfield Scoreboard

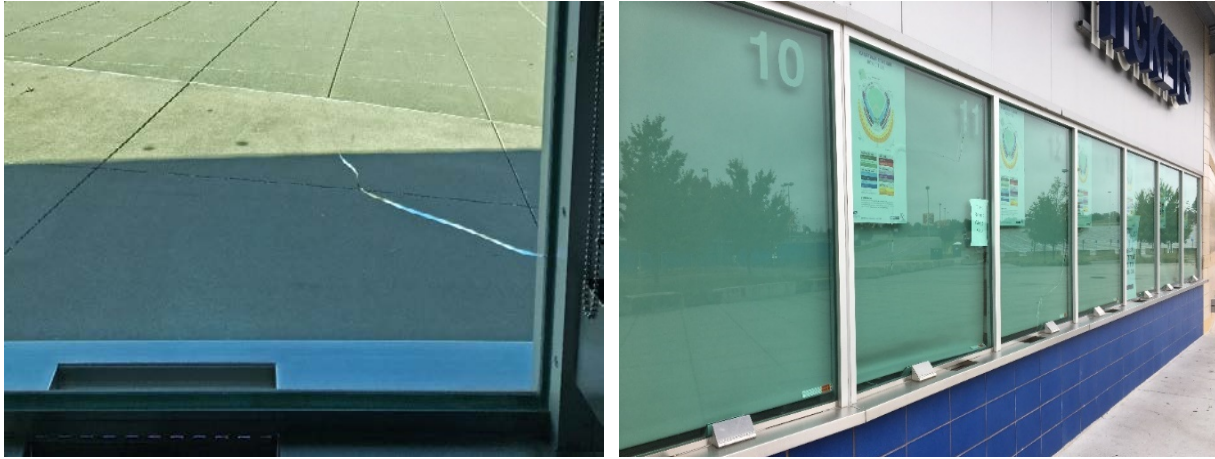
Glazing, in general, appears to be free of damage or defects. However, glass at ticketing window 5 was observed to be cracking as shown in **Figures AF-4** and windows 11 and 12 were observed to be scratched. These images were taken at ticketing structure 03.17.01. We note that the cracked glass at window 5 was observed to be cracked during the 2015 assessment while windows 11 and 12 have since been damaged as well.

Figure AF-4: Cracked Glass at Ticketing Building
Location: Plaza Level 3 - 03.17.01 Ticketing Building

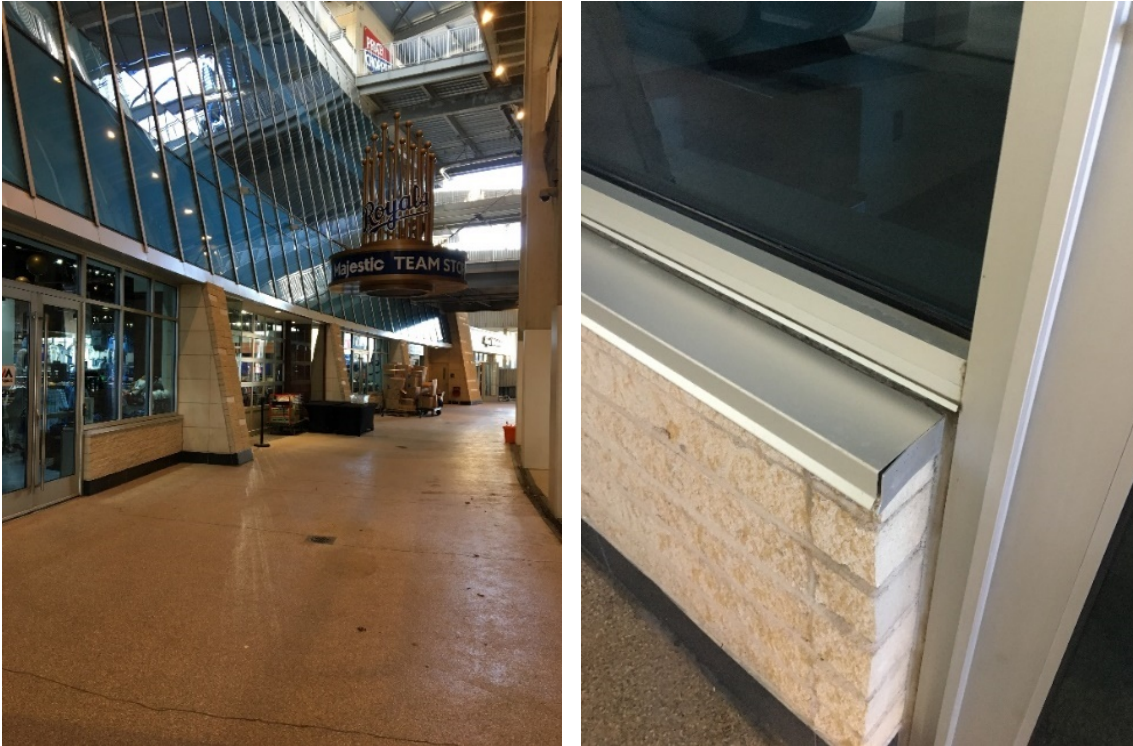
Additionally, internal storefront systems appear to be in satisfactory conditions, as shown in **Figures AF-5**. Aluminum frame and mullions were observed to be free of staining, fading, or degradation of any kind. Seals and flashing around storefront appear to be in satisfactory condition. However, storefront flashing outside room 03.23.02 was observed to be bent outwards exposing an opening in the system. This may pose potential risks of snagging clothing or getting cut by exposed edge to guests.

Figure AF-5: Interior Storefront (left) and Storefront Flashing (right)
Location: Plaza Level 3 – 03.26.02 (left) and 03.23.02 (right)

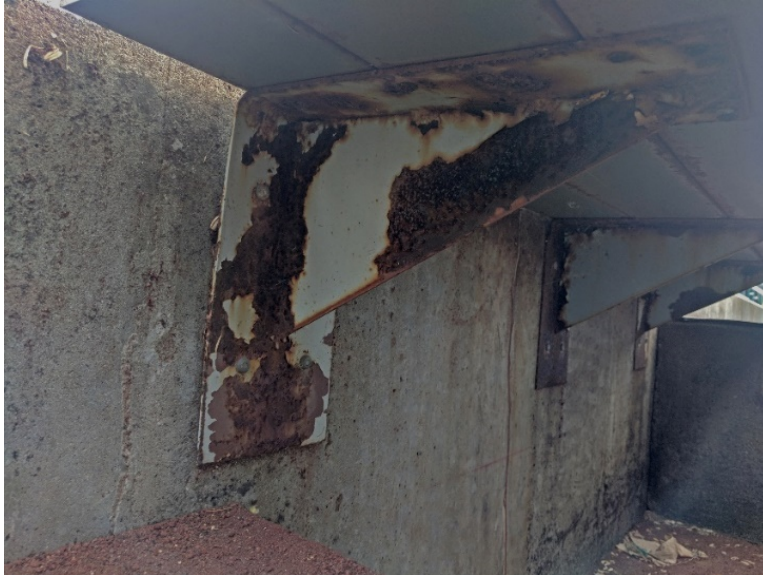
At the home dugout, the platform structure paint was observed to be chipping off and exposing the raw steel as shown in **Figure AME-1**. The steel shows surface rust, which if not properly treated will eventually compromise the structural integrity of the supports. This may be a safety issue if not properly maintained, due to multiple players or coaches standing on this structure. We note that the surface rust was observed in the 2016 assessment.

Figure AME-1: Surface Rust on Platform Support Brackets
Location: Clubhouse Level 1 - Royal's Dugout

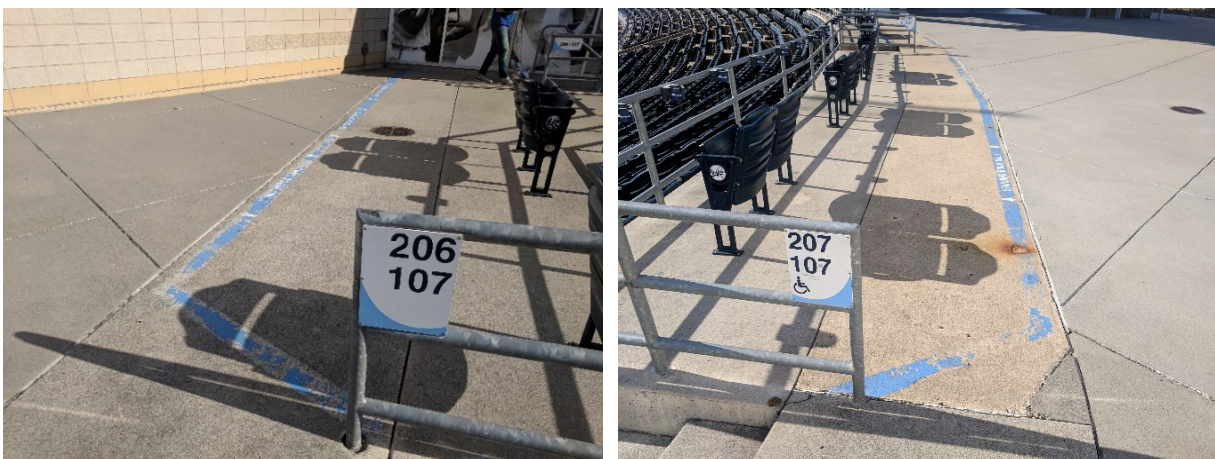
At standing room only areas along outfield concourse, it was observed that the designation paint has begun to wear away, as shown in [Figures ME-3](#).

Figure AME-3: Standing Room Only Paint

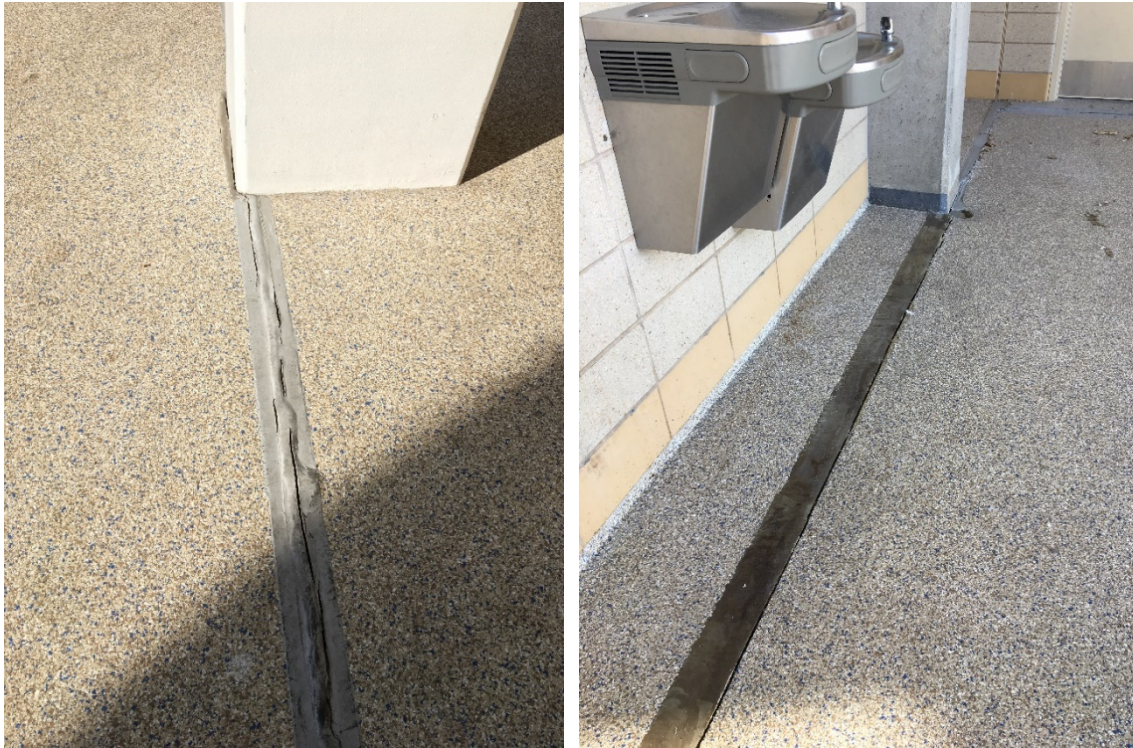
In most locations joint sealant observed appears to be in satisfactory condition. However, at various locations throughout the stadium, sealant was observed to be cracked or separating, as shown in **Figure AME-4**, in the South-West Plaza Concourse near 03.14.01. This condition may create a potential moisture problem in various service spaces under the stadium. Refer to the “Civil” Section of this report for additional locations throughout the stadium.

Figure AME-4: Joint Sealant

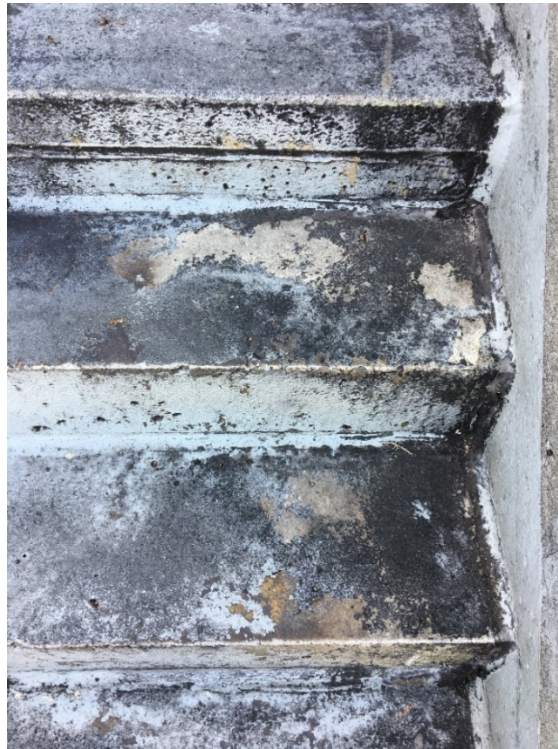
It was observed that the non-slip texture is beginning to wear away from typical use in various locations in the Upper Seating Bowl 07.18.23, as shown in **Figure AME-5**, This could become a slip and fall hazard to patrons.

Figure AME-5: Non-Slip Coating

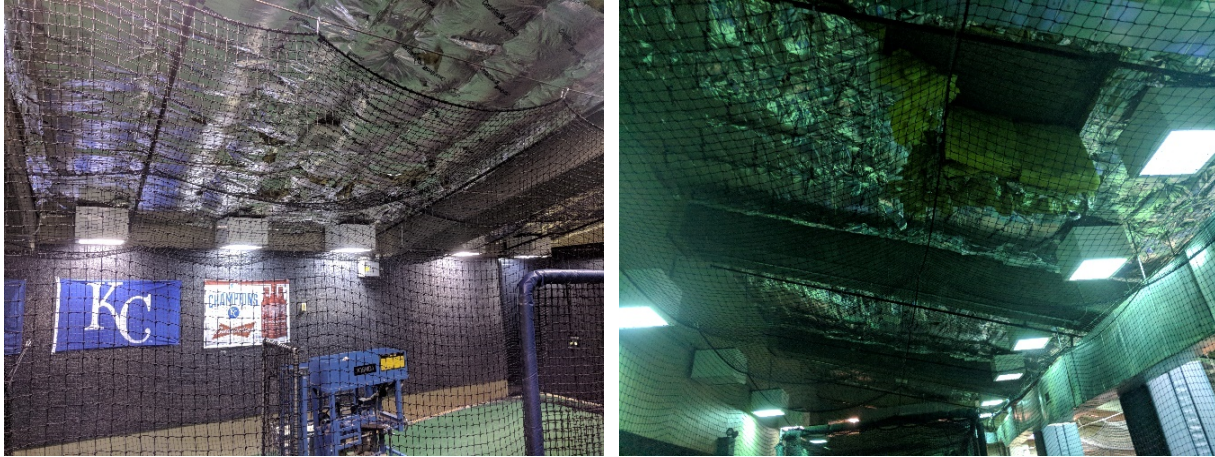
Exposed ceilings typically appear to be in satisfactory condition. It had been observed in the 2016 assessment that several foil faced batt insulation sections in the Clubhouse Batting Tunnels 01.13.01 were hanging down due to suspected impact from baseballs or a potential gap in the expansion joint above. From observation underneath, the issue appears to have been resolved, with the exception of one significant area of insulation hanging down, as shown in **Figure AI-8** (right), suspected to be due to maintenance.

Figure AI-8: Foil Faced Batt Insulation
Location: Clubhouse Level 1 – Batting Tunnels 01.13.01

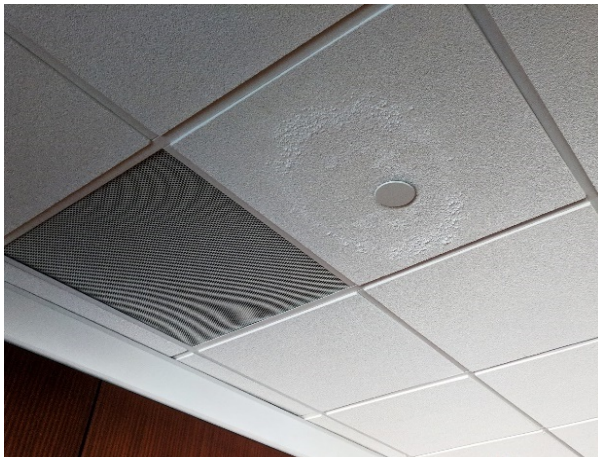
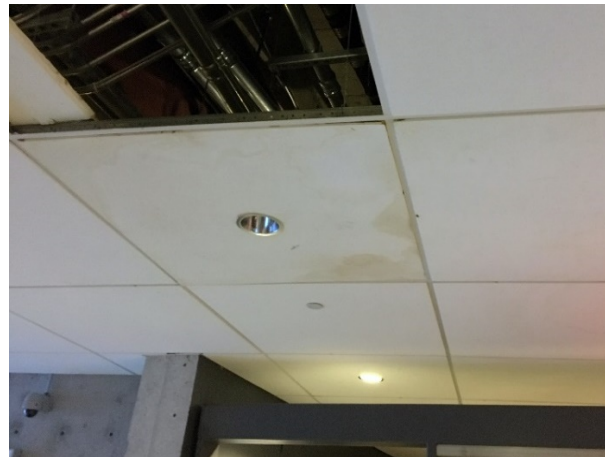
Acoustical ceiling tile is the primary material used for interior spaces. The typical condition of the acoustical ceiling tile appears to be in satisfactory condition. Refer to [Figure AI-10](#) for typical condition at observed interior ACT ceilings. However, locations in the Triple Crown Suites 05.24.01 and Dugout Concourse 02.11.02 were observed to have been stained, as shown in [Figure AI-11](#).

Figure AI-11: Stained Acoustic Ceiling Tile
Location (left): Loge Level 5 – Triple Crown Suites 05.24.01
Location (right): Service Level 2 - 02.11.02 Dugout Concourse

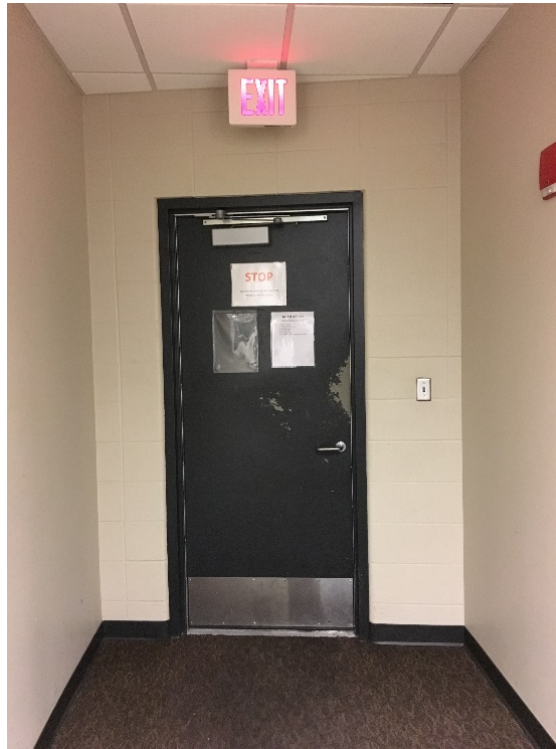
Generally, painted hollow metal doors were observed to be in satisfactory condition. However, at the entrance to the Police Open Office 02.26.07, it was observed that significant amounts of paint have begun to wear away **Figure AI-13**.

Figure AI-13: Hollow Metal Door
Location: Service Level 2 - 02.26.07 Police Open Office

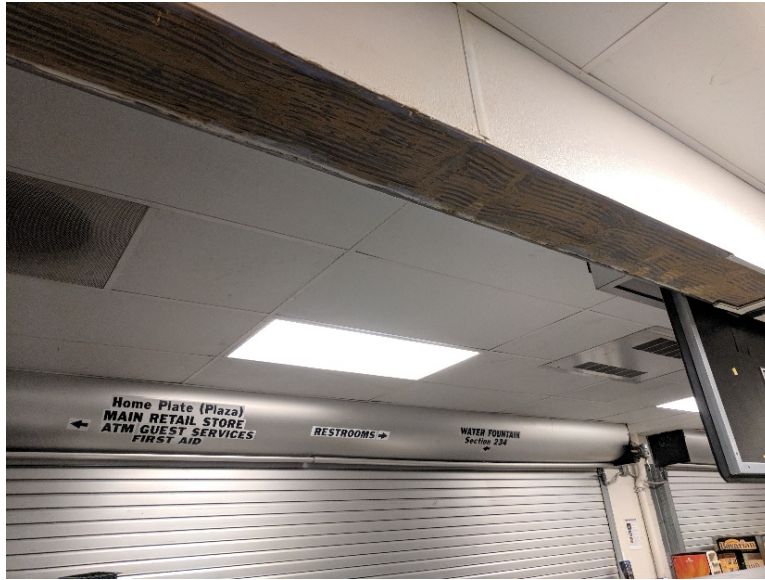
Upon observation of concessions stand 03.14.01 it was observed that fiberglass reinforced plastic at the head of the opening has fallen off as shown in [Figure AMI-1](#). Exposure of construction adhesive materials in a concessions environment may not comply with retail / health standards.

Figure AMI-1: Missing Header Cap

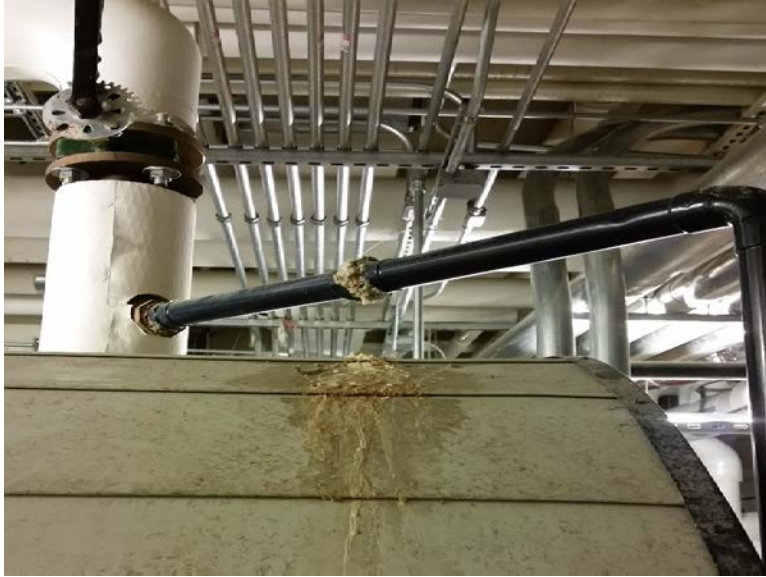
Also in the boiler room, a union on the domestic water heater #1 is leaking and leaving lime scale discharge on the top of the water heater, as shown in [Figure M-1](#). Above the water heaters, a duct mounted fan appears to be missing the protective guard at the motor pulley, as shown in [Figure M-2](#).

Figure M-1: Leaking Union on Domestic Water Heater #1
Location: Service Level – 02.26.03 Boiler Room

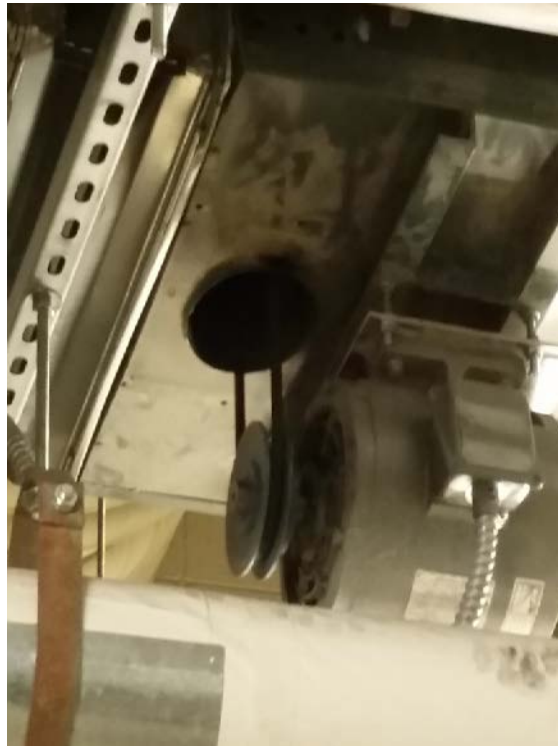
Figure M-2: Missing Motor Guard
Location: Service Level – 02.26.03 Boiler Room

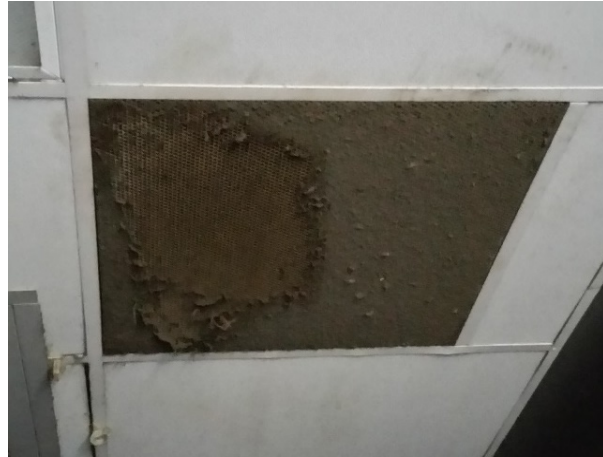
Figure M-5: Dirty Grilles in Concessions Areas
Location: Plaza Level – 03.50.01 Concession

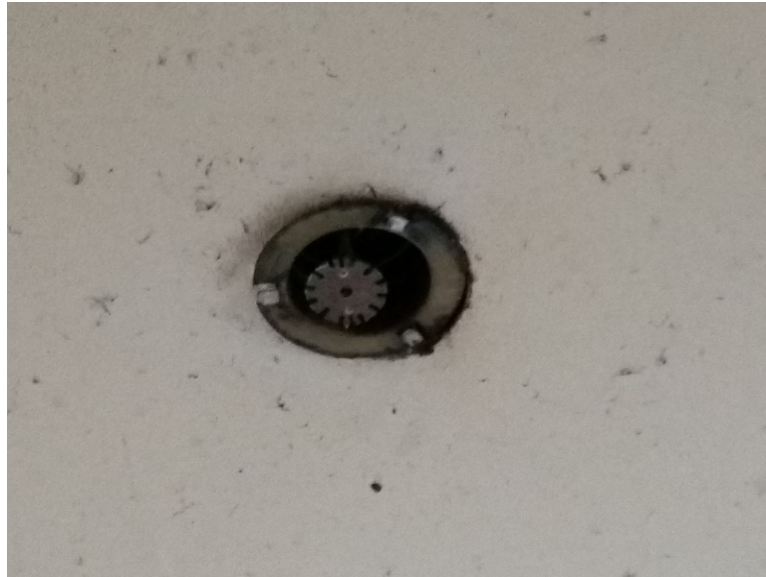
Figure M-6: Sprinkler Missing Cover Plate
Location: Plaza Level – 03.14.01 Special Cooking

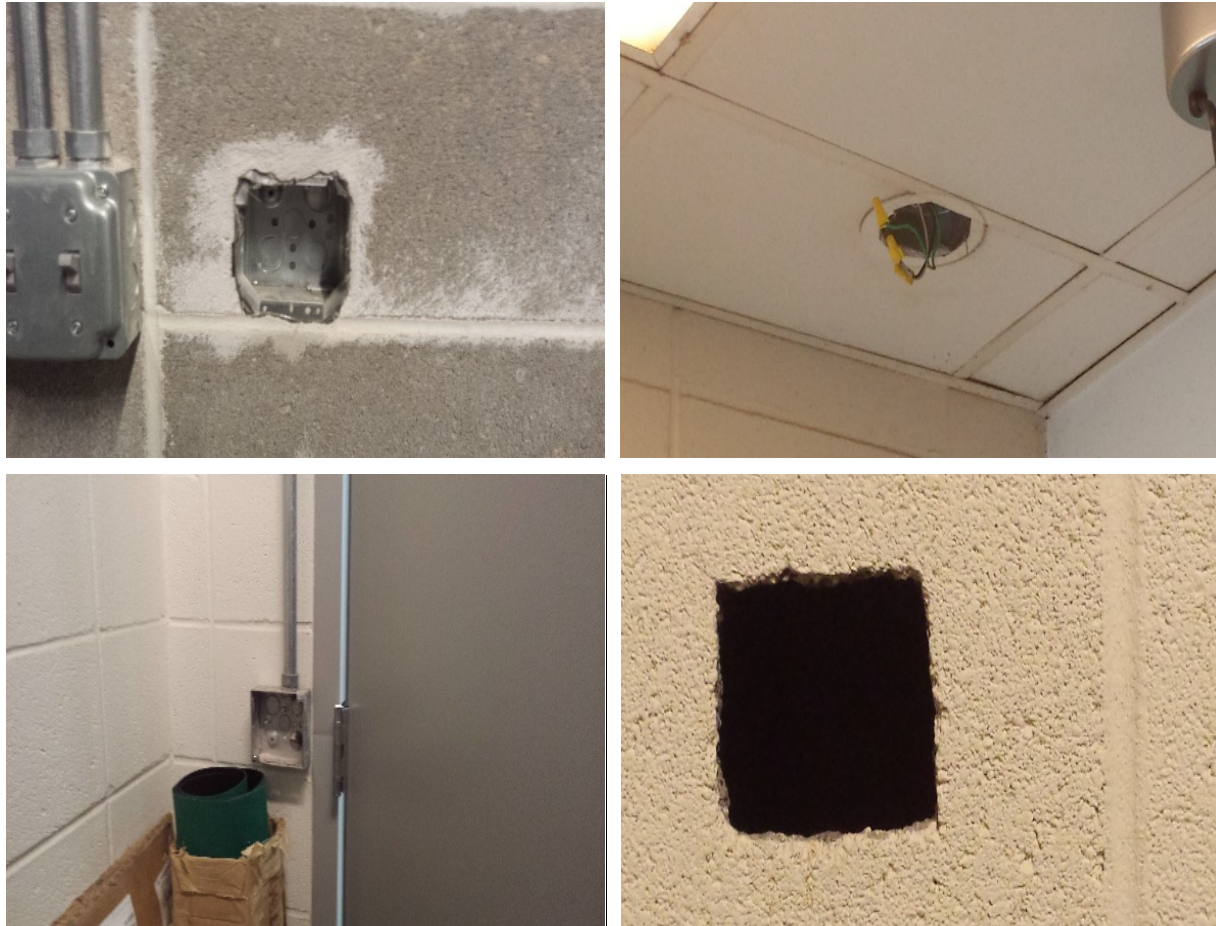
Junction boxes were found without cover-plates in the following rooms. Refer to **Figure E-1**:

Figure E-1: Junction Boxes without Cover Plates

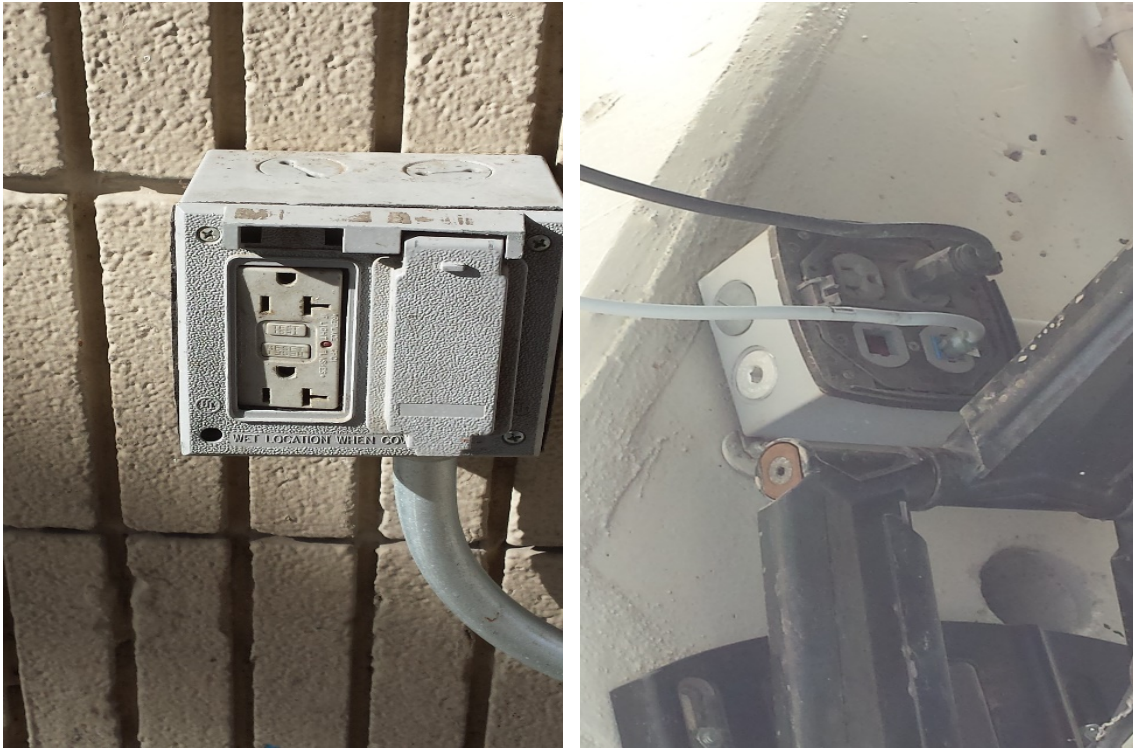
Figure E-2: Receptacle w/o Cover Plate (left), Non-GFI receptacle and w/o WIU cover (right)
Location: Concourses 07.39.01 and 07.24.04, Bridges 07.19.01 and 07.29.01

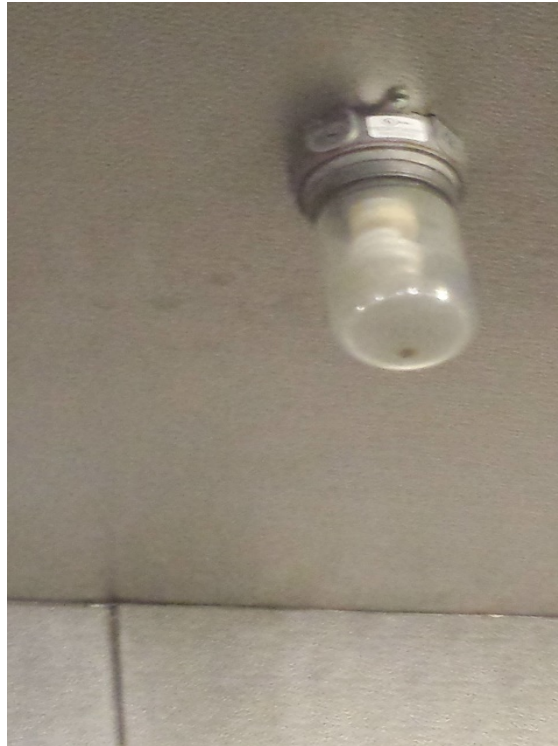
Figure E-3: Inoperable Cooler Light Fixture
Location: Service Level – Beer 02.18.02

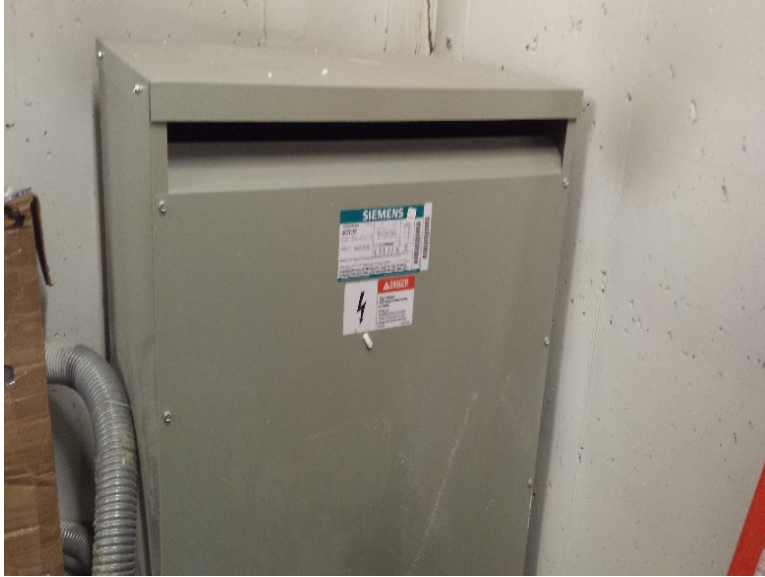
Figure E-4: Electrical Equipment Not Labeled

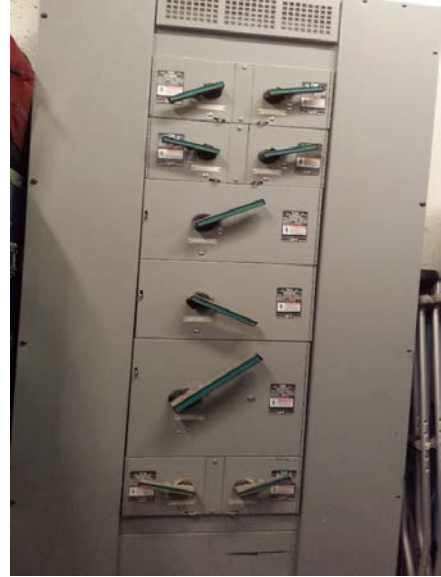
Figure E-5: Fused Switches Not labeled

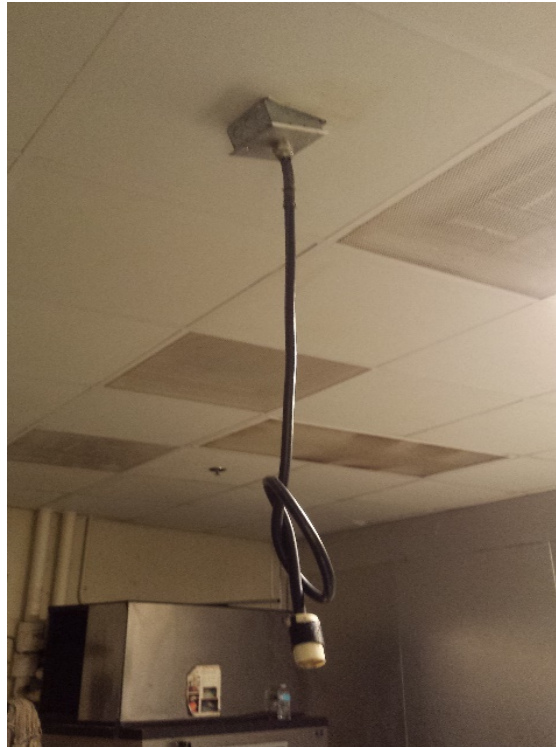
Figure E-6: Unsupported Pendant Receptacle
and Dirty Light Fixture Lenses
