Kauffman Stadium Assessment

JCSCA + Burns & McDonnell

This document contains information pertaining to the condition of Kauffman Stadium as documented by the Jackson County Sports Complex Authority (JCSCA), including descriptions, conditions, and exhibits which have been reviewed by Burns & McDonnell and documented in this report.

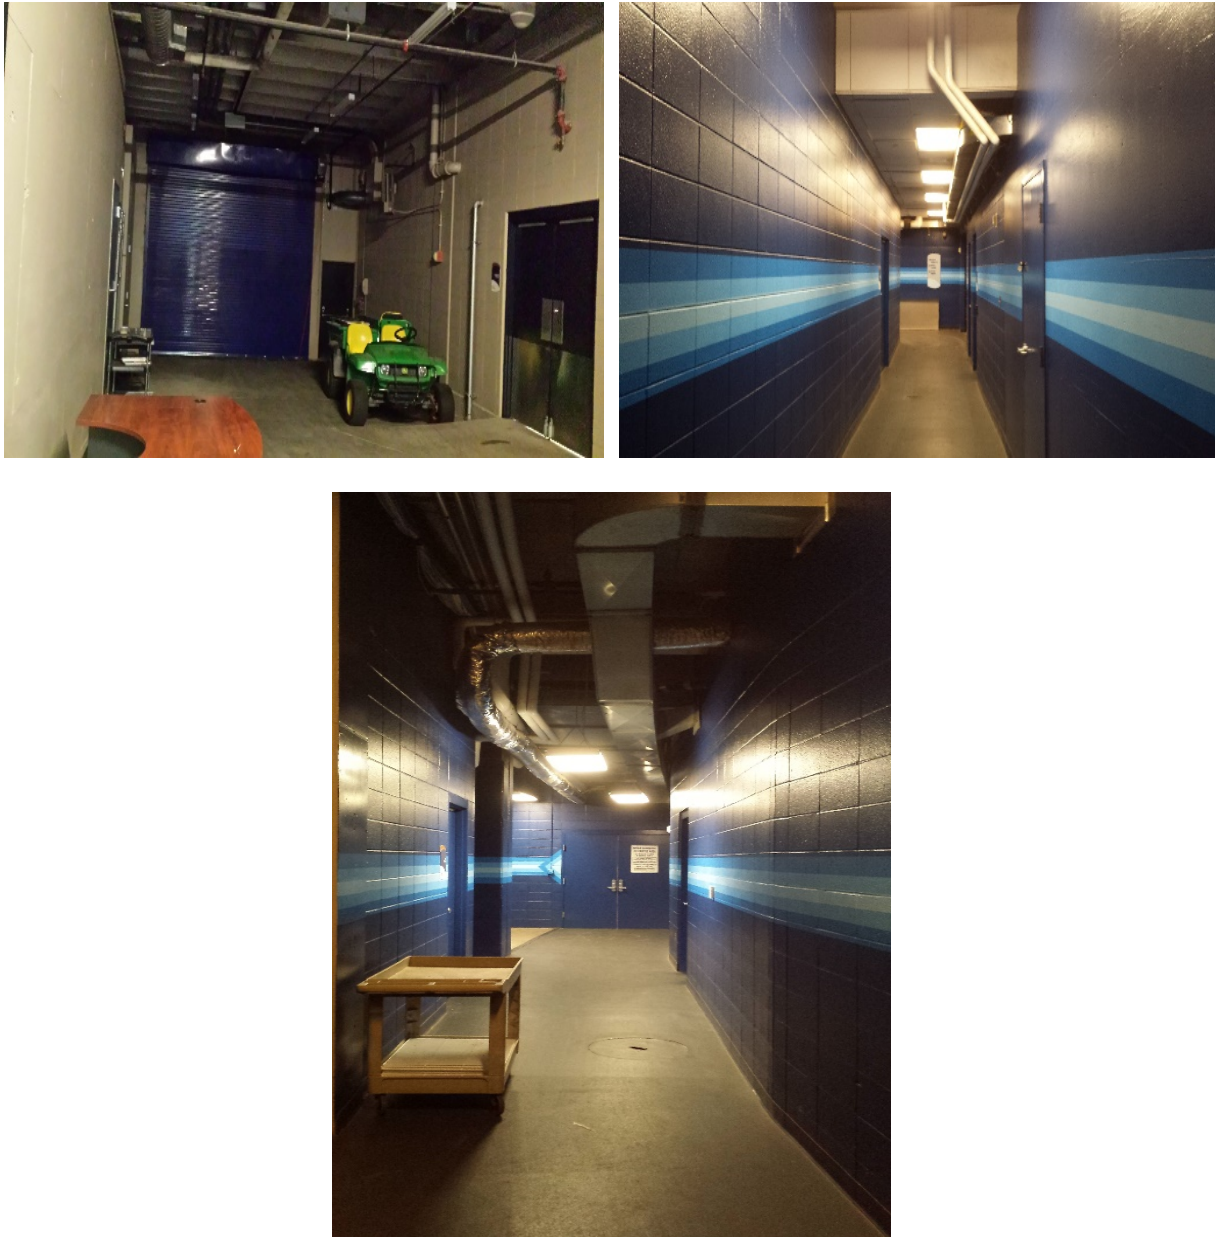
Figure E-7: Corridors with No Exit Signs
Locations: South Corridor 01.16.02 (top left)
North Corridor 01.16.02 (top right)
Corridor 01.17.08 (bottom middle)

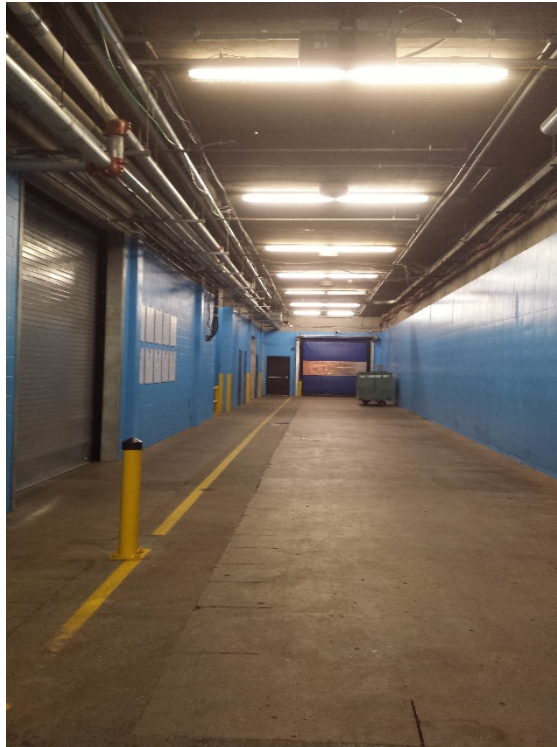
Figure E-8: Royals Service Tunnel with No
Emergency Egress Lights or Exit Signs
Location: Royals Service Tunnel
