Kauffman Stadium Assessment | 2014

JCSCA + Burns & McDonnell

This document contains information pertaining to the condition of Kauffman Stadium as documented by the Jackson County Sports Complex Authority, including descriptions, conditions, and exhibits which have been verified by Burns & McDonnell.

2 / 14 / 2014

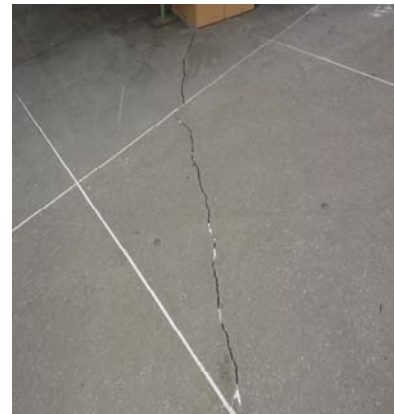
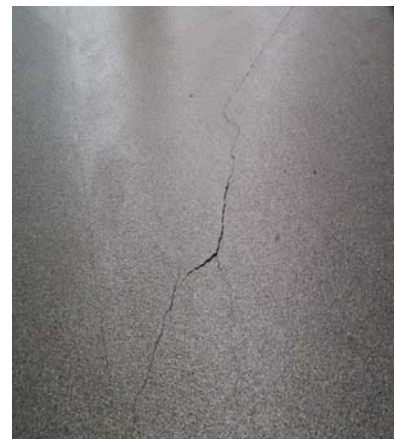
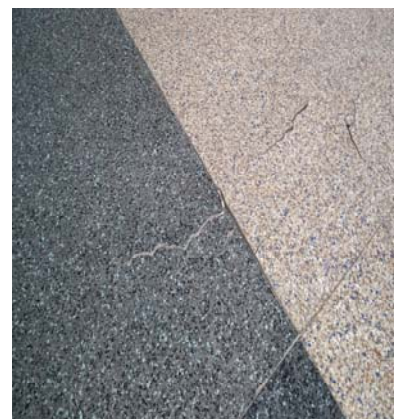
- Retaining Walls and Stairs
 - No significant deterioration was observed with exception of minor hair line cracking at some locations.
- Concrete Walkways
 - Minor cracking was observed throughout the facility on walkways and concourses. Routine maintenance with sealant should be performed in the near future. Refer to Flatwork Images: [Exhibit A1.1](#) (right).
 - Excessive cracking was found near the east entry gate at the edge of the polished surface with the concourse and exterior walkway. Refer to Flatwork Images: [Exhibit A1.2](#) and [A1.3](#) (right). This area should be repaired prior to the beginning of the 2014 season.

- Site
 - Perform routine maintenance to seal and repair minor cracking observed along walkways and concourses.
 - Excessive cracking was observed near the east entry gate at the edge of the polished surface of the concourse and exterior walkway. Consider repairing this area prior to the 2014 season to avoid additional damage.

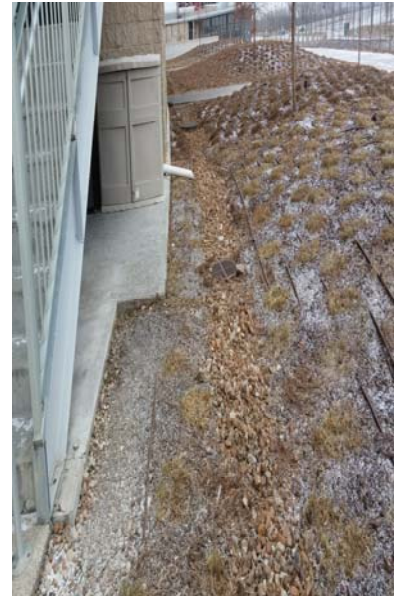
- All landscaping observed was in a dormant stage at the time of observation, but appears to be well maintained and in good condition. Refer to Landscape Images: [Exhibit A2.1](#) (right).

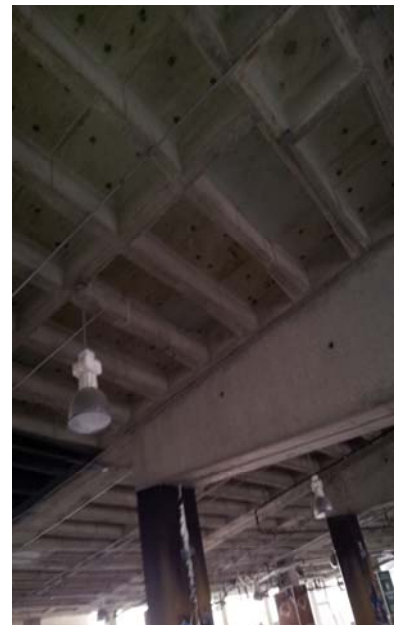
- The original reinforced concrete pan joist slab systems are in good condition. No major cracks or spalling was observed. Small cracking and spalling exist but are of no concern. The suspended slab surface is flat and smooth. Refer to Superstructure Images: [Exhibit B2.1](#) (page 5).

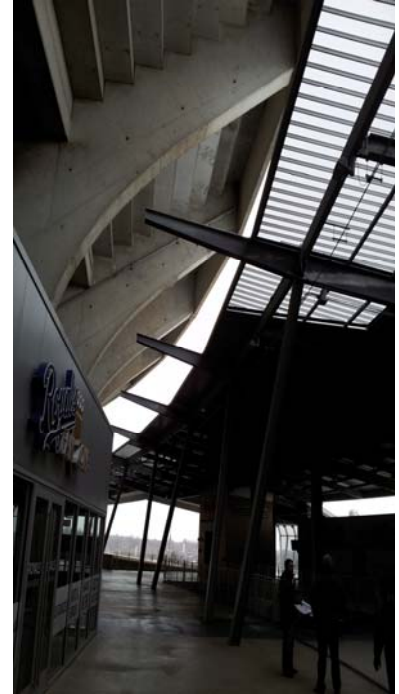
Exhibit B2.2

- The steel wide flange columns are in excellent condition. No corrosion was observed. Column base plate connections are in excellent condition. Refer to Superstructure Images: [Exhibit B2.2](#) (page 6).

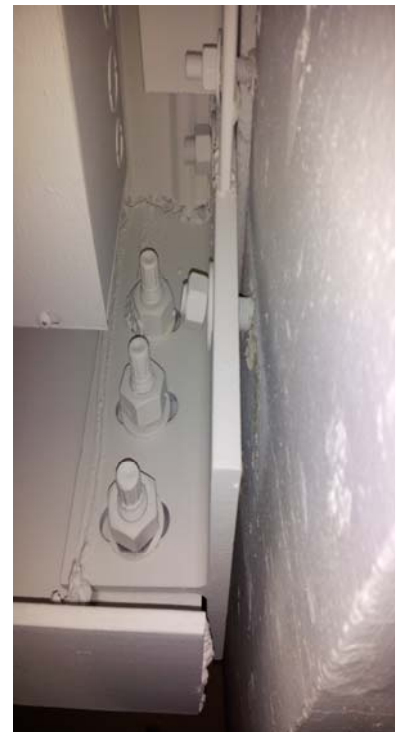
Exhibit B2.3

- The steel wide flange beams are in excellent condition. No corrosion or significant deflection was observed. Beam connections are primarily in excellent condition. Concrete anchors of the beam connection pulling out of concrete were observed in the ceiling of the corridor at the Press Level, as shown under Superstructure Images: [Exhibit B2.3](#) (page 6).

- Structural
 - The majority of all structural elements appear to be in excellent condition. Continue routine maintenance as required.
 - Concrete anchors at the ceiling of the Broadcast Press Level corridor (near the bar) were observed to be pulling out of the concrete. Analysis by a qualified structural engineer is recommended prior to the 2014 season to verify that no structural failures have occurred and to ensure that the structural system is performing as designed.

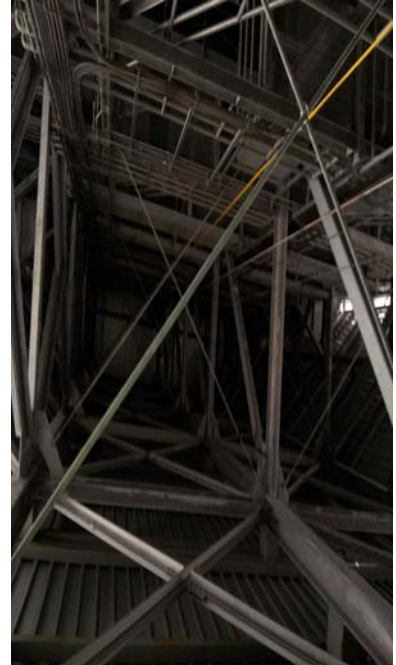
Superstructure Images:[Exhibit B2.4](#)

- The steel decks are in excellent condition. No corrosion or significant deflection was observed.
- The structural steel of the scoreboard is in excellent condition. No corrosion or significant deflection was observed. Beam, column and bracing connections are in excellent condition. Refer to Superstructure

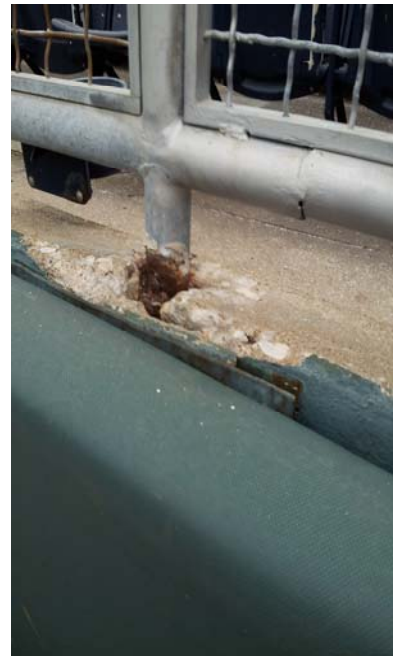
- Guard rails are primarily in good condition. However, corrosion and concrete spalling were observed in some locations, as shown under Superstructure Images: [Exhibit B2.5](#) (page 7).

- Guard rails are generally in good condition. However, corrosion and concrete spalling was observed in some locations. Consider reinforcing guard rail and patching concrete surrounding railing base to avoid additional damage and/or guard rail failure.

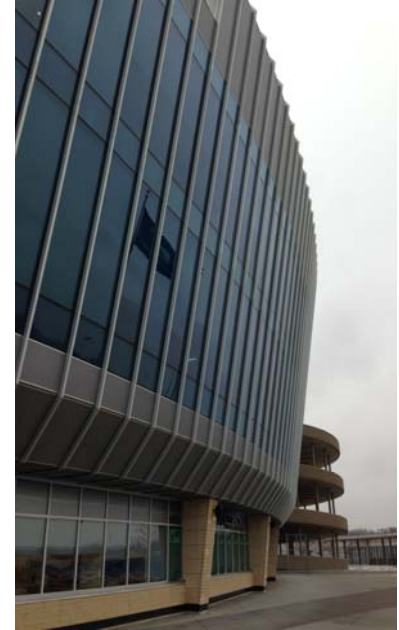
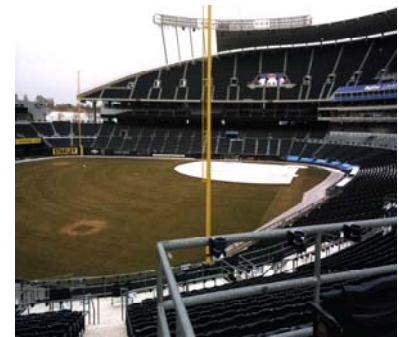
- All façades, in general, appear to be in excellent condition.
- Metal panel and graphic mesh systems appear to be in excellent condition and do not show signs of oil canning, staining, or degradation of any kind.
- Stone cladding systems appear to be in excellent condition and do not show signs of chipping or staining. Grout joints appear to be in good condition.
- Glass storefronts appear to be in excellent condition and do not show signs of staining, fading, or degradation of any kind. Seals around storefront appear to be in good condition.
- Refer to Façade Images: [Exhibit B3.1](#) and [B3.2](#) (right) for typical façade conditions.

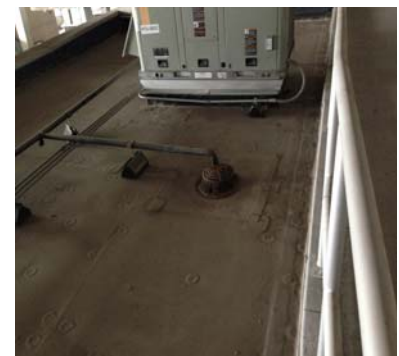
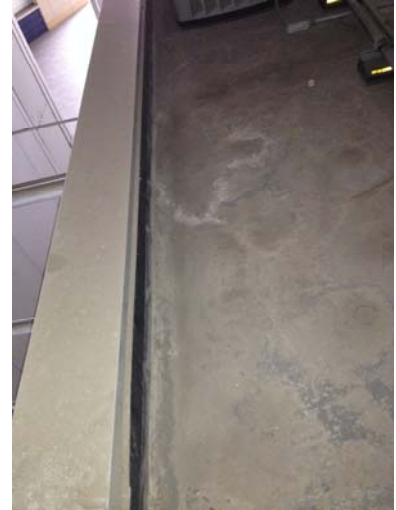
- Roofing membranes appear to be in good condition and do not show signs of rips, tears, or other failures.
- All observed copings, flashings, etc. appear to be in excellent condition.
- Metal roofing appears to be in good condition and does not show any signs of rust or staining.
- Refer to Roofing Images: [Exhibit B4.1](#) (page 8) and [B4.2](#) (right) for typical roofing condition.

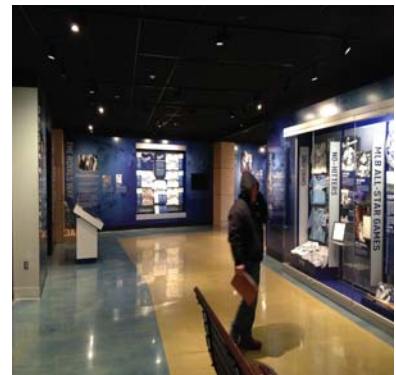
- Flooring surfaces are generally in excellent condition.
- Epoxy floors are showing excellent resistance

to wear and tear. Refer to Flooring Images: [Exhibit C1.1](#) (page 9) for typical conditions at acrylic/epoxy flooring.

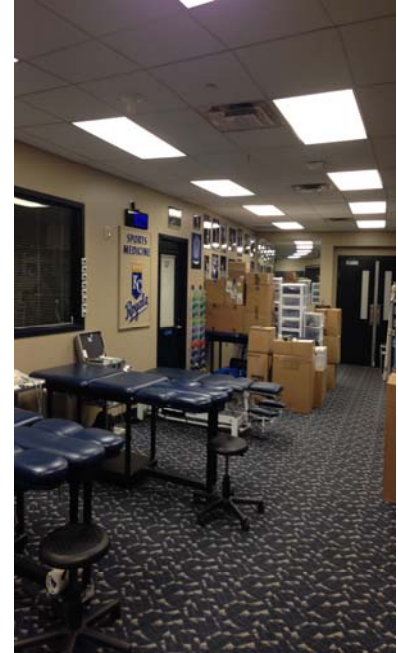
- Sealed or painted flooring appears to be in good condition with no visible chipping or flaking of finish.
- Ceramic tile floors appear to be in excellent condition, generally. Tile base boards were observed delaminating from the walls in a dugout level suite. Refer to Flooring Images: [Exhibit C1.2](#) (page 9). Consider replacing tile and grout in the near future to avoid further damage to adjacent floor/base tiles.
- Carpet, in general, is in excellent condition and does not show signs of rips, tears, or discoloration. Refer to Flooring Images: [Exhibit C1.3](#) (right) for typical condition.

- Site
 - Refer to immediate recommendations on page 22.
 - Structural
 - Refer to immediate recommendations on page 22.
 - Architectural
 - Ceramic tile floors appear to be in generally excellent condition. However, tile base boards were observed to be delaminating from the walls in a few dugout level suites. Consider replacing tile and grout in the near future to avoid further damage to adjacent floor/base tiles.

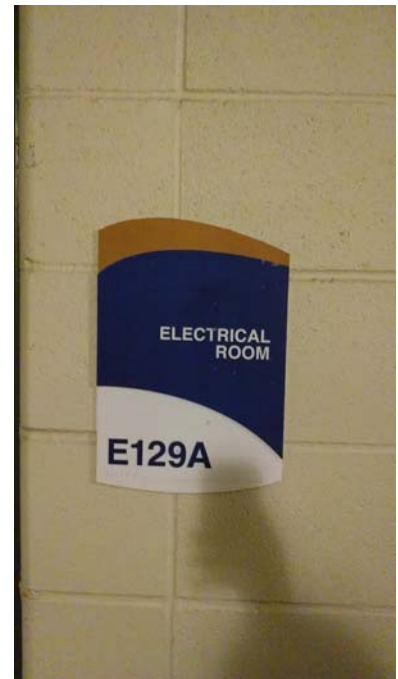
- Painted and exposed block walls appear to be in excellent condition with no visible chipping, flaking, or cracking of the applied paint system. Refer to Wall Images: [Exhibit C2.1](#) (right) for typical condition.
- Painted gypsum board walls appear to be in excellent condition and do not show signs of punctures or holes in the gypsum board material. Minimal scuffing was observed in various locations back of house spaces due to normal wear and tear. Refer to Wall Images:

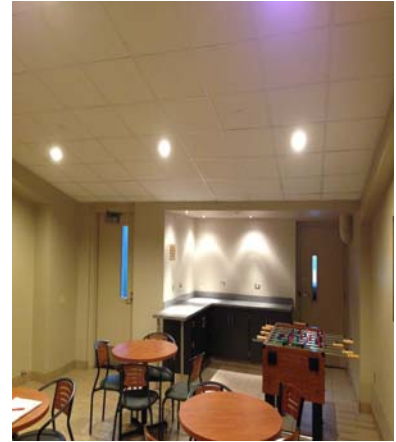
Exhibit C2.2 (right) for typical condition.

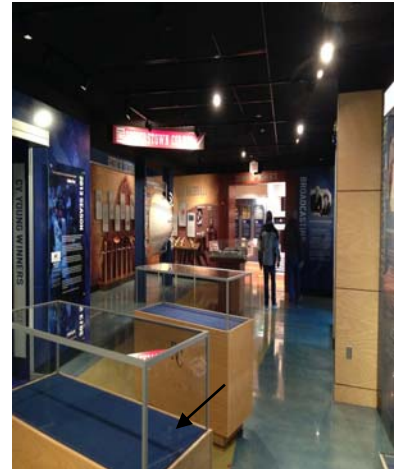
Exhibit C2.3

- Glazed storefront systems appear to be in excellent condition and do not show signs of staining, fading, or degradation of any kind. Seals around storefronts appear to be in good condition.
- Wood veneer located in the hall of fame area is in excellent condition and does not show signs of deterioration of any kind. Refer to Wall Images: **Exhibit C2.3** (right) for typical condition.

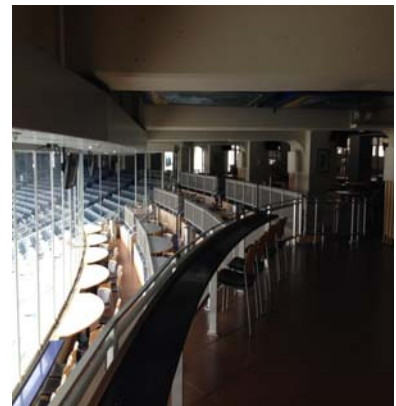
Exhibit C3.1

- Exposed and painted ceilings appear to be in good condition. Refer to Ceiling Images: **Exhibit C3.1** (right) for typical condition.
- Gypsum board ceilings appear to be in excellent condition, in general. However, at the Stadium Club Dining room excessive leaking through the roof has caused damage to the paint/drywall adjacent to the curtain wall system. Refer to Ceiling Images: **Exhibit C3.2** (page 12). Repair of drywall and paint is necessary in the near future. Consider acquiring analysis and solution by a roofing consultant to prevent future water damage.
- Acoustic ceiling tile appears to be in good condition, in general. Several back of house spaces, including kitchens and pantry areas, contained warped, drooping, or stained ceiling tiles. Refer to Ceiling Images: **Exhibit C3.3**

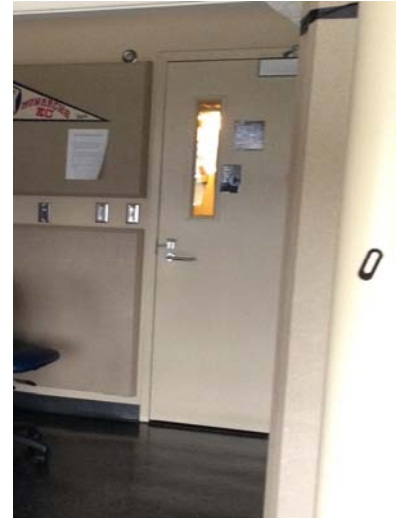
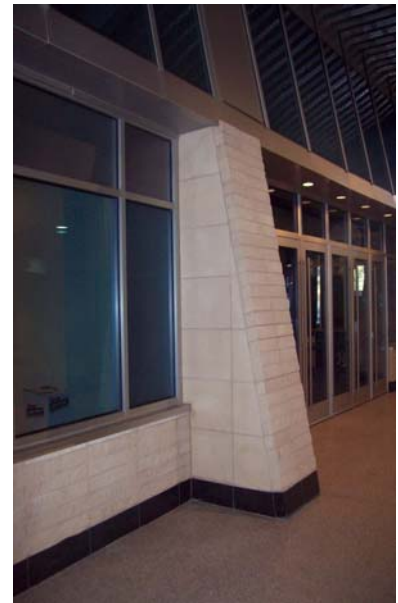
- All doors, in general, are in excellent condition.
- Painted hollow metal back of house doors are in generally good condition. Some doors, particularly in the underground tunnel between Arrowhead and The K, appeared to be scuffed or scratched in various locations. Consider repainting such doors to avoid the spread of rust and corrosion.
- Refer to Door Images: [Exhibit C4.1](#) and [C4.2](#) (page 13) for typical conditions.

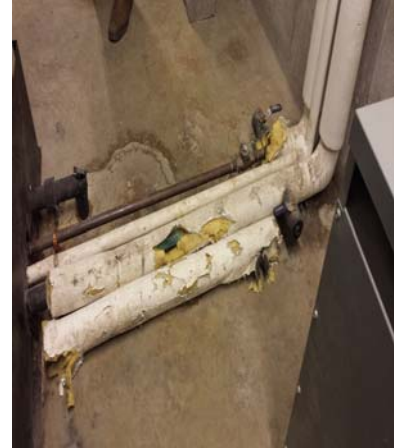
- Plumbing piping insulation in various areas of the facility are degrading and in need of repair. Reference Plumbing Images: [Exhibit D1.1](#) (page 14).

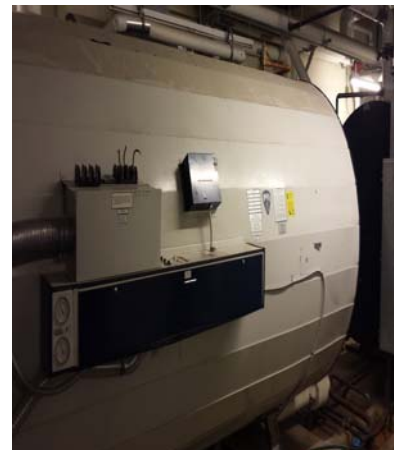
- Facility central PVI water heating boilers appear to be in good condition. Reference Plumbing Images: [Exhibit D1.3](#) (page 14).
- Plumbing fixtures and associated flush valves, faucets, etc. appear to be in good working order.

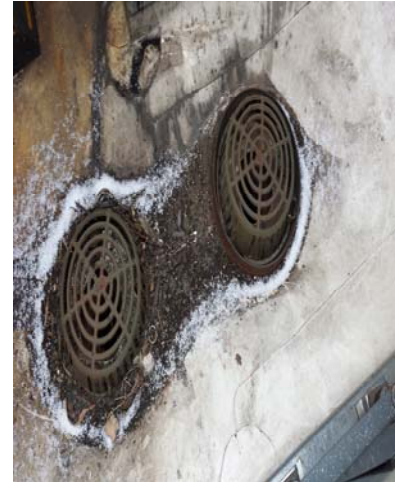
Exhibit D1.6

- Fountain system could not be observed due to ambient temperature (30 deg. F) at time of site visit. All exposed restrooms were winterized at the time of site observation.
- Domestic water booster pump skid appear to be in good condition. Piping is insulated and tagged with direction of flow properly indicated. Loge and View Levels maintain pressure at 100 psi and lower levels are set at 80 psi via pressure reducing valves. Reference Plumbing Images: [Exhibit D1.5](#) (page 15).
- Roof drainage system was observed to be generally clean and unobstructed. Reference Plumbing Images: [Exhibit D1.6](#) (page 16).

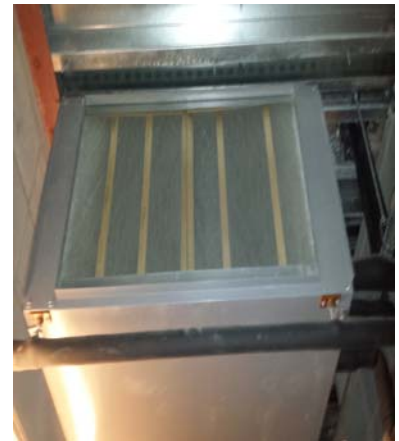
Exhibit D2.1

- ❖ Filters – On more than one observation the filters appeared to be dirty and past due for replacement. It is suggested to replace filters every 3 to 6 months depending on equipment use. Reference Mechanical Images: [Exhibit D2.1](#) (page 16).

- In general, all mechanical and plumbing systems have been well maintained and appear to be in excellent condition.
 - It is suggested to replace filters at air handling units every 3 to 6 months depending on equipment use.

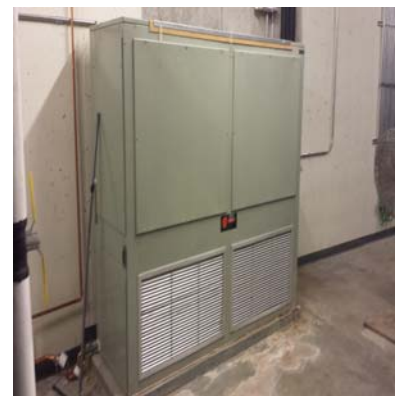
Exhibit D2.2

- ❖ Condensate leaking through casing onto floor. Note the water stain on the floor. Reference Mechanical Images: [Exhibit D2.2](#) (page 16).
- System Maintenance Checks Observed by Engineer

- The Computer Room Air Conditioning Unit (computer room) was observed to have condensate leaking through casing onto floor. Maintenance must be performed to avoid significant water collection and electrical malfunction.
- Electrical
 - In general, all electrical elements appear to be in excellent condition.
 - Ensure that all electrical panels are kept clear of debris and obstructions. Several rooms, mostly in food service areas, have racks or other obstructions in front of panel boards and exit doors, making it a code violation.
 - A junction box, located in Mechanical Room 2 MB300B, did not have a cover over the box. It also appears to have quite a few splices in the box. A professional engineer should verify if the junction box is of adequate size for the number of terminations and the cover should be secured on the junction box.

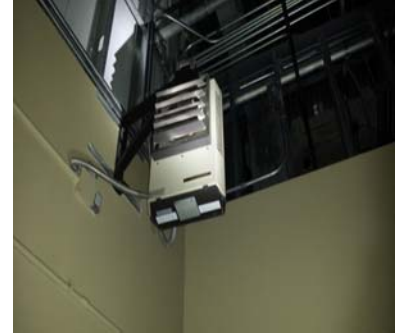
HVAC Images:[Exhibit D2.3](#)

- System Maintenance Checks Observed by Engineer
 - ❖ Equipment tagged.
 - ❖ Check for excessive noise or vibrations from fan.
 - ❖ Reference HVAC Images: [Exhibit D2.3](#) (right).

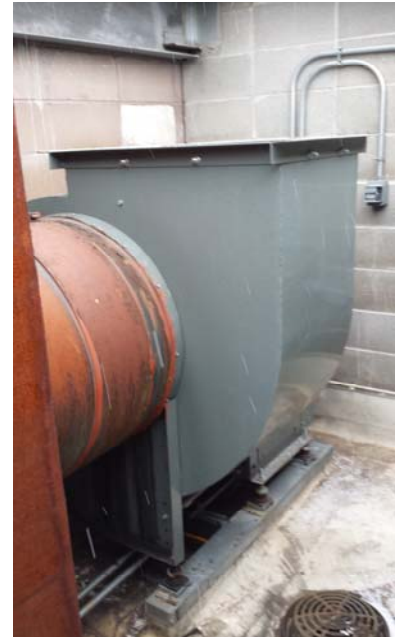
- ❖ Equipment tagged.
- ❖ Check bearings for noise.
- ❖ Reference HVAC Images: [Exhibit D2.4](#) (page 17).

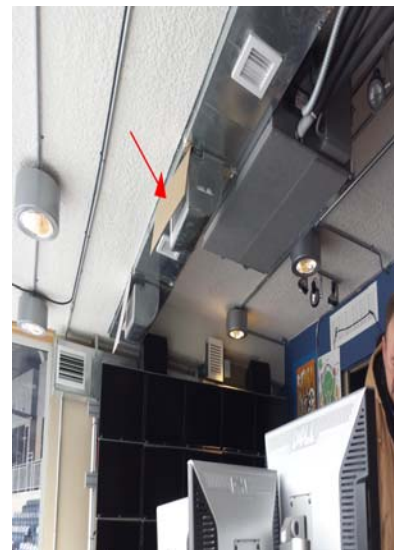
- ❖ Fans and motors properly aligned and lubricated.
 - ❖ Belt tension and condition checked.
 - ❖ Filters clean.
 - ❖ Power disconnects installed and labeled. All safeties operable.
 - ❖ Reference HVAC Images: [Exhibit D2.5](#) (page 17) for observed condition.
- General Comments – Heating Ventilation and Air Conditioning (HVAC)
 - Grease exhaust systems in the concessions area were noted to be in need of cleaning. Exhaust grilles should be scrubbed or replace in several areas. Reference HVAC Images: [Exhibit D2.6](#) (page 18).
 - Supply air diffusers were obstructed with cardboard in the press box suggesting occupants are uncomfortable with the volume of air supplied to the space. Suggest rebalancing the supply air system. Reference HVAC Images: [Exhibit D2.7](#) (page 18).

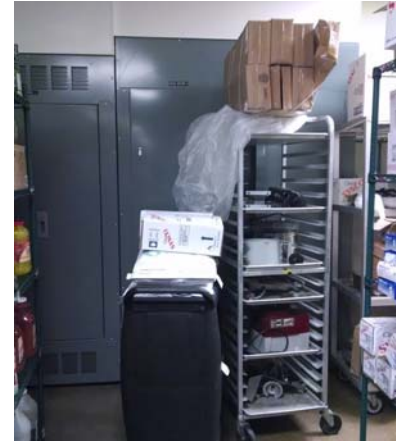
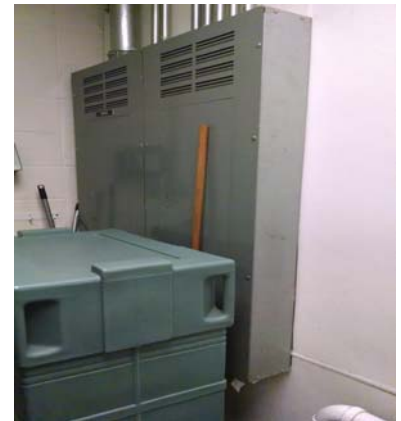
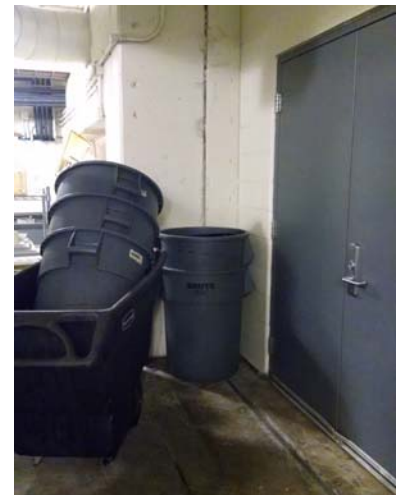
- The overall electrical system looks to be in excellent shape.
- Most electrical rooms are kept clear of debris and obstructions. Several rooms, mostly in food service areas, have racks or other obstructions in front of panel boards and exit doors, making it a code violation. Some of these violations are shown under Electrical Images: [Exhibit D3.1 through D3.3](#) (page 19).

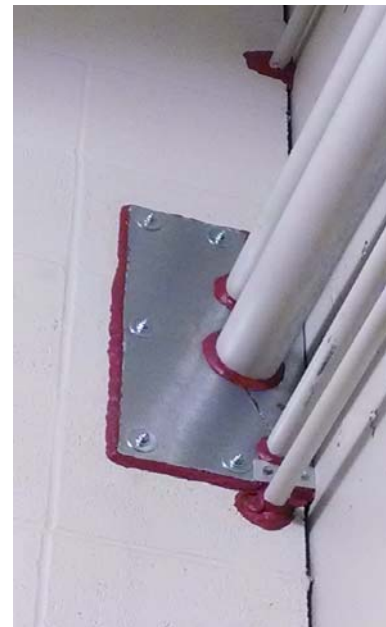
- Fire-barrier sealant looks to be in good condition and is located around wall and ceiling penetrations, as shown under Electrical Images: [Exhibit D3.4](#) (right).

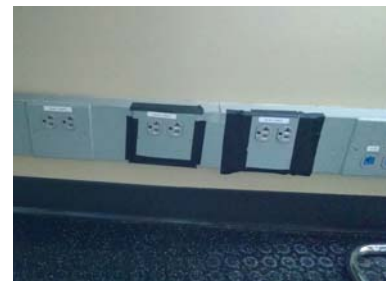
- Most plug mold receptacles observed were in good condition. A couple of receptacles were secured with black electricians tape to the plug mold, as shown under Electrical Images: [Exhibit D3.5](#) (right).

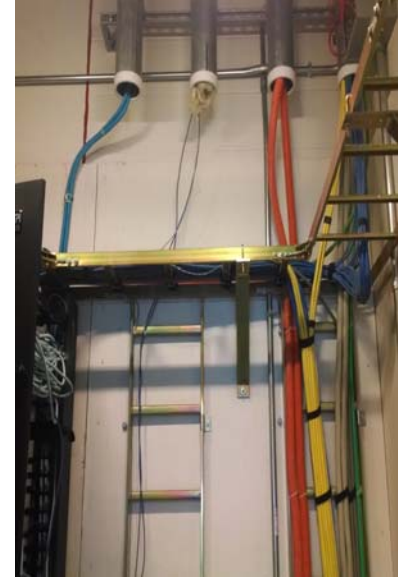
and all cabling is secured to cable tray, as shown under Electrical Images: [Exhibit D3.7](#) (right).

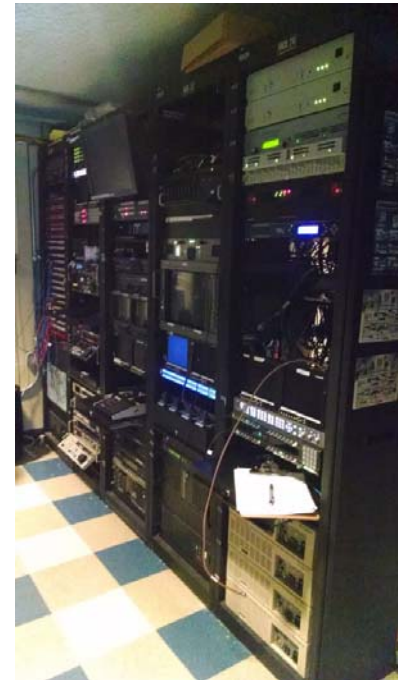
- Telecommunications racks observed are in good condition, and both the rack equipment and cables are labeled as needed, as shown under Electrical Images: [Exhibit D3.8](#) (right).
