Kauffman Stadium Assessment | 2015

JCSCA + Burns & McDonnell

This document contains information pertaining to the condition of Kauffman Stadium as documented by the Jackson County Sports Complex Authority (JCSCA), including descriptions, conditions, and exhibits which have been verified by Burns & McDonnell.

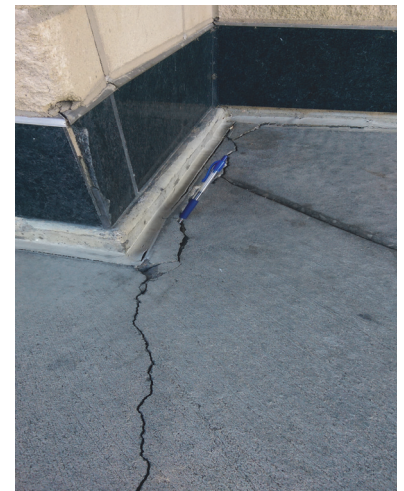
- Several locations near the structure facade around the Royal Way entrance show signs of distress. Moderate pavement deterioration and occasionally missing joint sealant can both be observed in this area. Refer to Flatwork Image: [Exhibit A1.2](#) and [A1.3](#) (right).

- Perform routine maintenance to seal and repair minor cracking observed along walkways and concourses. Refer to [Exhibit A1.1](#) (page 4).
- Replace any missing, damaged, or otherwise unsatisfactory joint sealant and/or backer rod required for concrete joints. Refer to [Exhibit A1.2](#) (page 4).
- Monitor faulting slabs in walkways for progression of the faulting. If faulting becomes more severe, repair or replacement of concrete may be necessary to protect pedestrian safety and provide a full ADA compliant route. Refer to [Exhibit A1.3](#) (page 4).
- Secure the trench drain as necessary to prevent it from being accidentally or intentionally dislodged by pedestrians or small vehicle traffic. Refer to [Exhibit A1.4](#) (page 4).

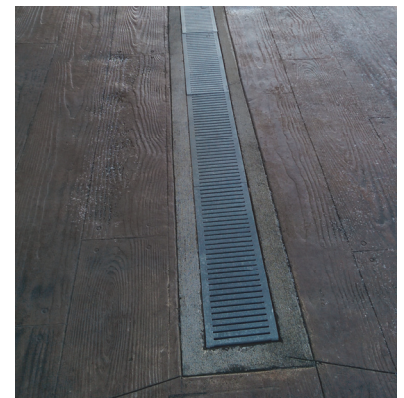
- A trench drain was observed in the upper section beyond the right field fence. The drain grate is not properly secured and presents a potential safety concern. Refer to Flatwork Image: [Exhibit A1.4](#) (page 4)

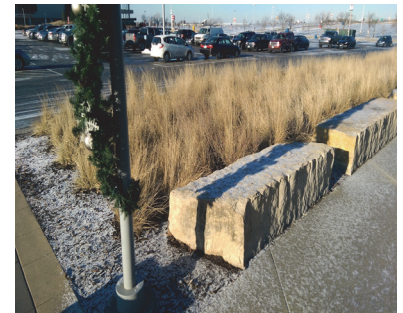
- All landscaping observed was in a dormant stage at the time of observation, but is well maintained and in satisfactory condition. Refer to Landscape Images: [Exhibit A2.1](#) (right).

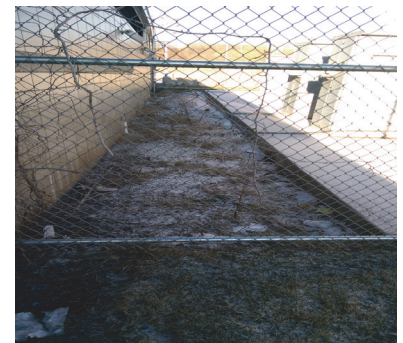
- The narrow grass area next to the electrical equipment pad just northeast of the stadium will not drain properly. Minor earthwork may be required to provide positive drainage. Refer to Landscape Images: [Exhibit A2.2](#) (right).

- Consider regrading the narrow grass area next to the electrical equipment pad northeast of the stadium to provide positive drainage away from both the adjacent structure and the concrete equipment pad. Refer to [Exhibit A2.2](#) (page 5).
- Repair and reset the damaged storm water inlet structure. Refer to [Exhibit A2.3](#) (page 5).
- Backfill under and around the utility pad with appropriate backfill material as necessary. Refer to [Exhibit A2.4](#) (page 5).

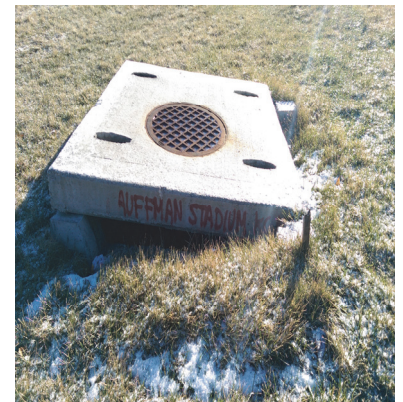
- The storm water inlet structure to the south of this electrical equipment pad is damaged and dislodged from its intended position. Repair of this structure may be required to provide sufficient flow capacity. Refer to Landscape Images: [Exhibit A2.3](#) (right).

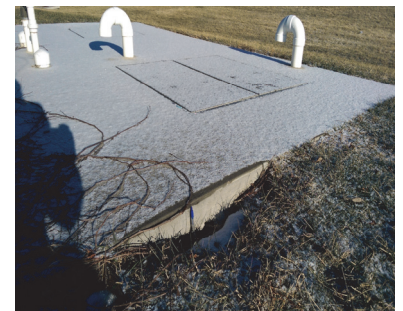
- Sediment scouring was observed at the utility pad to the south of this storm structure. Proper backfill may be required to improve the structural integrity of the slab. Refer to Landscape Images: [Exhibit A2.4](#) (right).

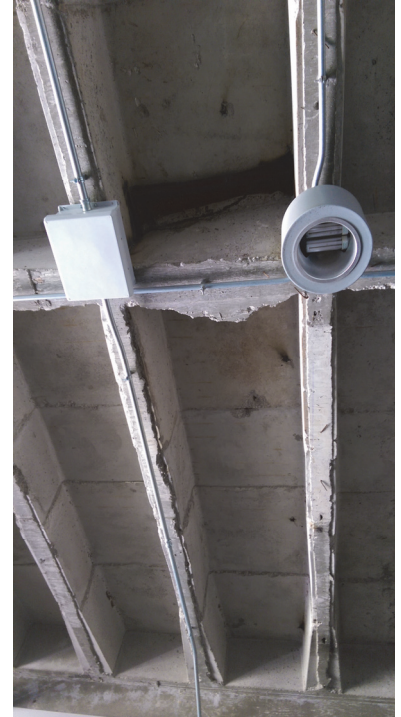
Superstructure Images:**Exhibit B2.1**

- The original reinforced concrete columns and walls are in satisfactory condition. No major cracks or spalling was observed. The vertical column and wall surfaces are flat and smooth.
- Concrete patchwork of the original structure is in satisfactory condition. The patchwork is flat and smooth.
- The expansion joints at the original superstructure to the renovation superstructure are in satisfactory condition. No deterioration was observed.
- The original reinforced concrete pan joist slab systems are in satisfactory condition. No major cracks or spalling was observed. Minor cracking and spalling exist but are of no concern. The suspended slab surface is flat

and smooth. Refer to Superstructure Images: [Exhibit B2.1](#) (page 6).

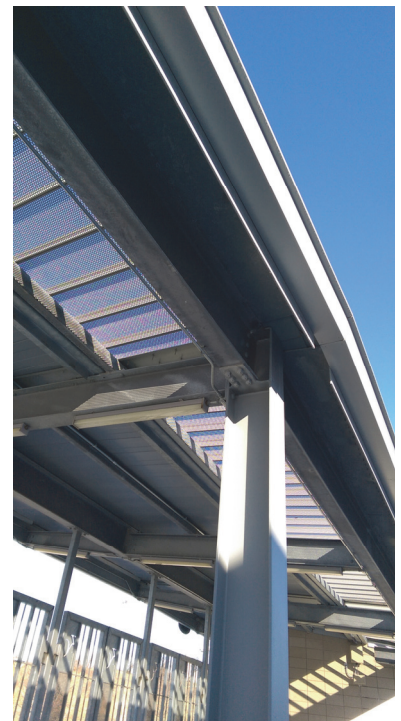
**Exhibit B2.2**

- The steel wide flange columns are in satisfactory condition. No corrosion was observed. Column base plate connections are in satisfactory condition. Refer to Superstructure Images: [Exhibit B2.2](#) (page 6). Minor cracking of the concrete at the base of the foul pole was observed. Refer to Superstructure Images: [Exhibit B2.3](#) (page 7).

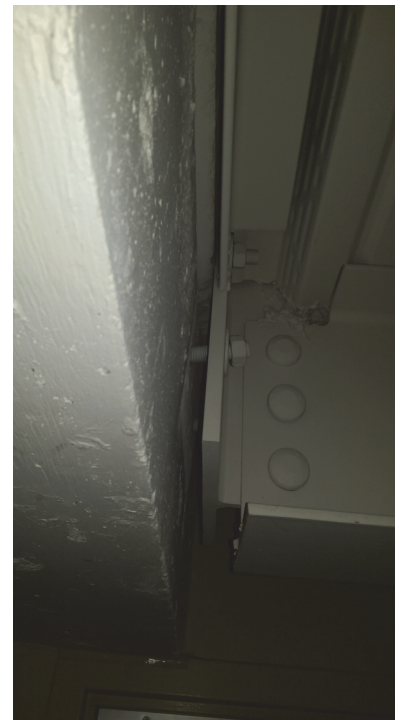
**Exhibit B2.4**

- The steel wide flange beams are in satisfactory condition. No corrosion or significant deflection was observed. Beam connections are primarily in satisfactory condition. Concrete anchors of the steel beam connection pulling out of concrete were observed in the ceiling of the corridor at the Press Level, as shown under Superstructure Images: [Exhibit B2.4](#) (page 7).

- The following comments pertain to elements that may pose potential safety concerns and should be addressed as soon as possible.
 - Concrete anchors at the ceiling of the Broadcast Press Level corridor were observed to be pulling out of the concrete. Analysis by a qualified structural engineer is recommended prior to the 2015 season to verify that no structural failures have occurred and to ensure that the structural system is performing as designed. Refer to [Exhibit B2.4](#) (page 7).
 - Guard rails are generally in satisfactory condition. However, corrosion and concrete spalling were observed just outside of the Dugout Suite B. Consider reinforcing guard rail and patching concrete surrounding railing base to avoid additional damage and/or guard rail failure. Refer to [Exhibit B2.5](#) (page 8).

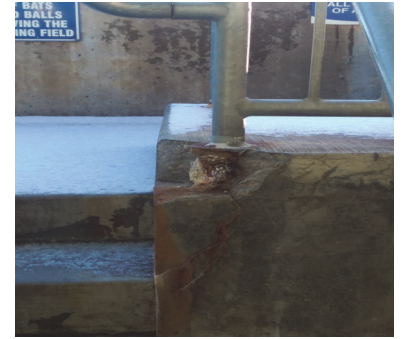
Exhibit B2.5

- Guard rails are primarily in satisfactory condition. However, corrosion and concrete spalling were observed in some locations, as shown under Superstructure Images: [Exhibit B2.5](#) (right).

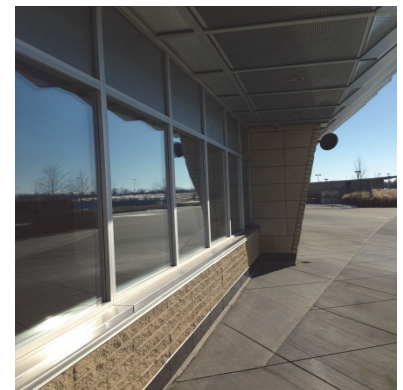
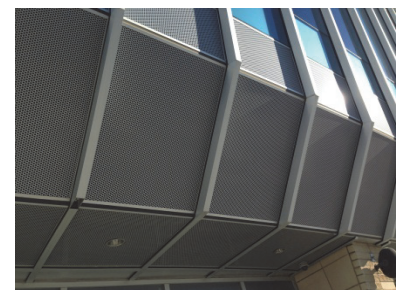
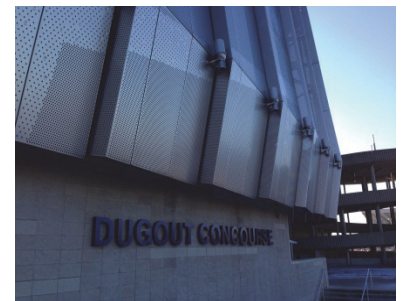
- All observed façades, in general, are in satisfactory condition.
- Metal panel and graphic mesh systems were observed to be in satisfactory condition. No oil canning, staining, or degradation of any kind was observed.
- Stone cladding systems were observed to be in satisfactory condition. No chipping or staining of the stone or grout was observed.
- All observed glass storefronts are in satisfactory condition. Aluminum frame and mullions were observed to be free of staining, fading, or degradation of any kind. Seals and flashing around observed storefronts are in satisfactory condition.
- Refer to Façade Images: [Exhibit B3.1](#), [B3.2](#), and [B3.3](#) (page 8) for typical façade conditions.

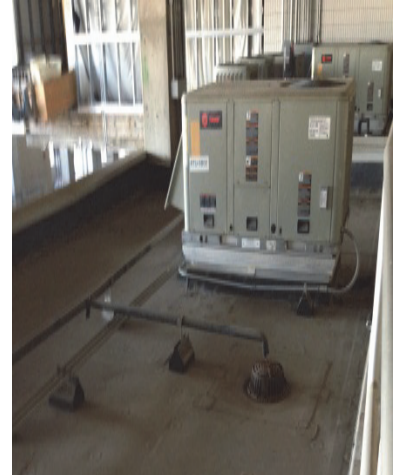
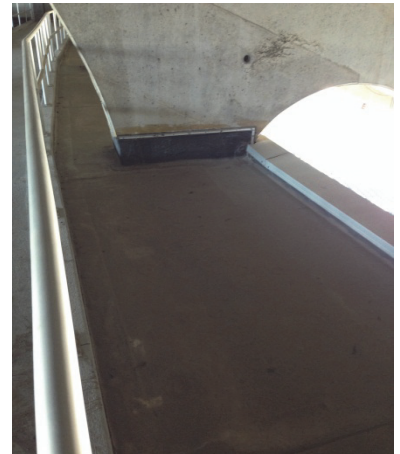
- Roofing membranes were observed to be in satisfactory condition. No rips, tears, or defects were observed.
- All observed copings, flashings, and curbs are in satisfactory condition.
- Observed metal roofing is in satisfactory condition. No rust, staining, or defects were observed.
- Refer to Roofing Images: [Exhibit B4.1](#) and [B4.2](#) (page 9) for typical roofing condition.

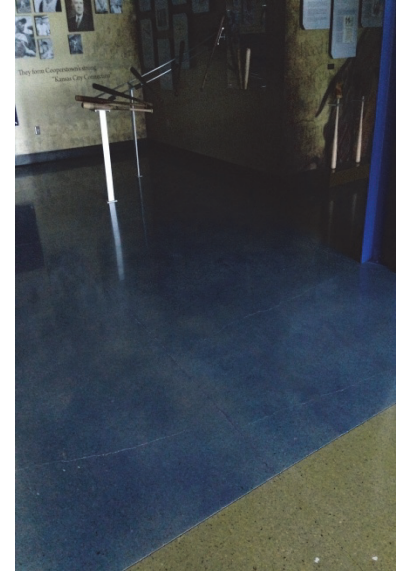
- Flooring surfaces are generally in satisfactory condition. Some minor defects were observed as described below.
- Epoxy floor finishes were observed to be in satisfactory condition, typically. Minor cracking was observed at the view level finish adjacent to the women's restroom. Refer to Flooring Images: [Exhibit C1.1](#) (page 9).
- Observed sealed/stained flooring is in satisfactory condition, typically. Minor cracking was observed at the kid's academy as shown in [Exhibit C1.2](#) (right).
- Porcelain tile floors were observed to be in

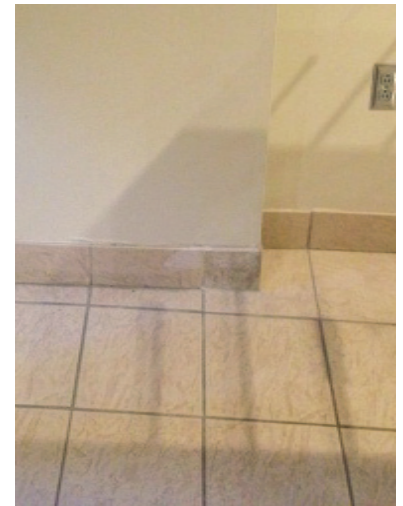
satisfactory condition, typically. Tile base board deficiencies found in the 2014 stadium assessments have been repaired as recommended. Refer to Flooring Images: [Exhibit C1.3](#) (page 10).

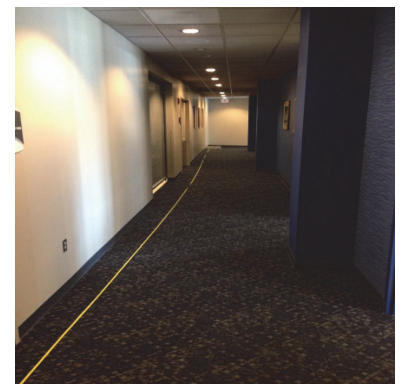
- Carpet, in general, is in satisfactory condition. No signs of rips, tears, or discoloration were observed. Refer to Flooring Images: [Exhibit C1.4](#) (page 10) for typical condition.

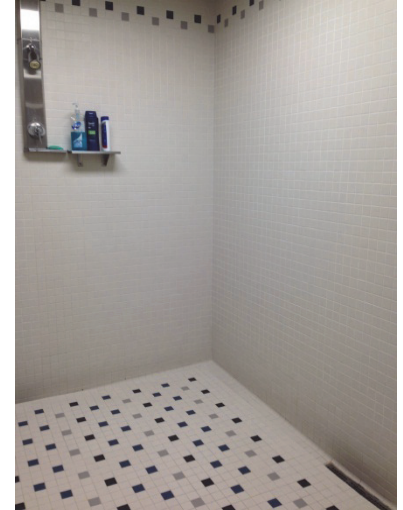
- Ceramic tile walls were observed to be in satisfactory condition. No visible chipping, flaking, or cracking of the tile or grout was observed. Refer to Wall Images: [Exhibit C2.1](#) (right) for typical condition.
- Observed painted gypsum board walls are in satisfactory condition. No punctures, holes, or scratches were observed. Refer to Wall Images: [Exhibit C2.2](#) (right) for typical condition.
- Observed glazed storefront systems are in satisfactory condition. No signs of staining, fading, or degradation were observed.
- Wood paneling, typically, is in satisfactory condition. No signs of scratching, fading, or deterioration were observed. Refer to Wall Images: [Exhibit C2.3](#) (right) for typical condition.

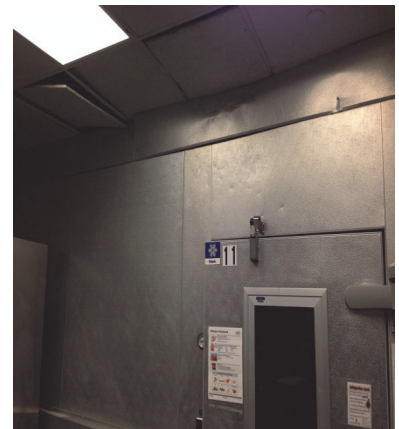
- Exposed and painted ceilings were observed to be in satisfactory condition.
- Observed gypsum board ceilings are in satisfactory condition, in general. However, at the Stadium Club Dining room excessive leaking through the roof has caused damage to the drywall/paint adjacent to the curtain wall system. Refer to Ceiling Images: [Exhibit C3.1](#) (right). Repair of drywall/paint is necessary in the near future. Consider acquiring analysis and solution by a roofing consultant to prevent future water damage.
- Observed acoustic ceiling tiles are in satisfactory condition, in general. Several back of house spaces, including kitchens and pantry areas, contained warped, drooping, or stained ceiling tiles. Refer to Ceiling Images: [Exhibit C3.2](#) (right) as an example. Consider replacing ceiling tile at such locations in the near future.

- Gypsum board ceilings were observed to be in satisfactory condition, in general. However, at the Stadium Club Dining room excessive leaking through the roof has caused damage to the paint/drywall adjacent to the curtain wall system. Consider acquiring analysis and solution by a roofing consultant to resolve moisture infiltration. Repair of drywall and paint is necessary when the moisture problem has been resolved. Refer to [Exhibit C3.1](#) (page 12).
- Observed acoustic ceiling tile is in good condition, in general. Several back of house spaces, including kitchens and pantry areas, contained warped, drooping, or stained ceiling tiles. Consider replacing ceiling tile at such locations in the near future. Refer to [Exhibit C3.2](#) (page 12).

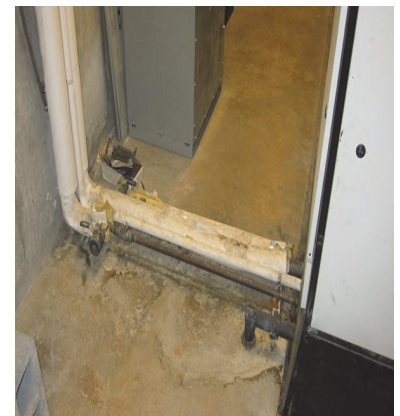
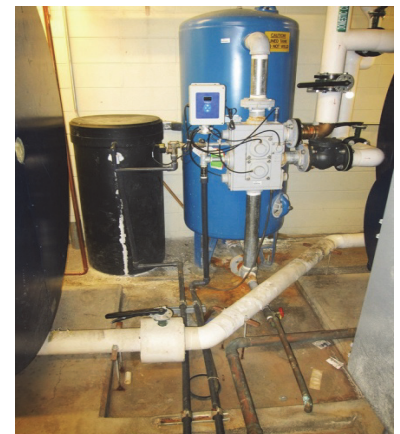
- Plumbing piping insulation in various areas of the facility are degrading and in need of repair. Reference Plumbing Images: [Exhibit D1.1](#), [D1.2](#) (right), and [D1.3](#) (Page 14).
- Plumbing piping is properly labeled with direction of flow and valves are clearly tagged.
- Several pipe hanging supports were missing their protective insulation shields. Over time, this will result in insulation damage. Reference Plumbing Images: [Exhibit D1.4](#) (page 14).
- Facility central PVI water heating boilers were observed to be in good condition. Reference Plumbing Images: [Exhibit D1.5](#) (page 14).
- Plumbing fixtures and associated flush valves,

- In general, all mechanical and plumbing systems have been well maintained and were observed to be in satisfactory condition.
- All VAV box control panels must be checked for exposed components.
- Plumbing piping insulation in various areas of the facility are degrading and in need of repair. Refer to [Exhibits D1.1 and D1.2](#) (page 13) and [D1.3](#) (page 14).
- Several pipe hanger insulation shields were observed to be missing. These shields will need to be replaced to prevent insulation damage. Refer to [Exhibit D1.4](#) (page 14).

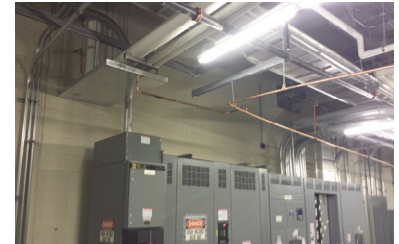
- Plumbing installed over electrical equipment/components has the required metal drip pan and associated drain line. Reference Plumbing Images: [Exhibit D1.6](#) (page 15).
- Access doors to shutoff valves in public restrooms should remain locked during operating hours in an effort to avoid vandalism to concealed piping, valves, etc.
- Water pressure, temperatures and drainage to plumbing fixtures exposed to the outside elements could not be observed due to ambient temperature (20 deg. F) at time of site visit. All exposed restrooms were winterized at the time of site observation.
- Domestic water booster pump skid is in good condition. Piping is insulated and tagged with direction of flow properly indicated. Roof drainage system was observed to be generally clean and unobstructed.

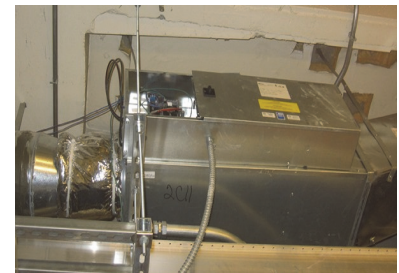
- Variable Air Volume (VAV) Terminal Units
 - Deficiencies
 - ❖ Control panels – On more than one observation, the control panel to the VAV box was open and exposed. Reference HVAC Images: [Exhibit D2.1](#) (page 15).
 - System Maintenance Checks Observed by

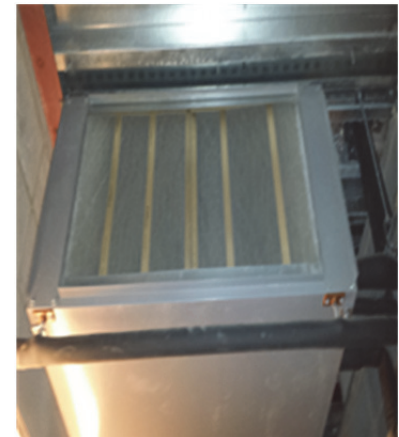
- Fan Powered Terminal Units
 - Deficiencies
 - ❖ Filters – On more than one observation the filters were dirty and past due for replacement. It is suggested to replace filters every 3 to 6 months depending on equipment use. Reference HVAC Images: [Exhibit D2.2](#) (right).

- It is suggested to replace filters at air handling units every 3 to 6 months depending on equipment use. Dirty filters and equipment casing were observed in several locations. Refer to [Exhibit D2.2](#) (page 15).
- The Computer Room Air Conditioning Unit (computer room) was observed to have condensate leaking through casing onto floor. Maintenance must be performed to avoid significant water collection around the unit. Refer to [Exhibit D2.3](#) (page 15).

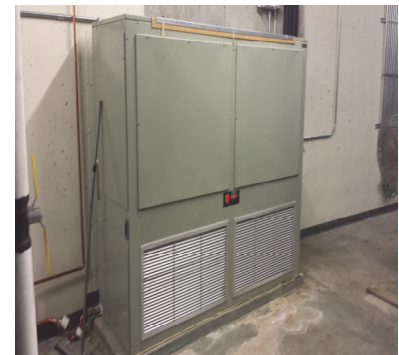
- Deficiencies
 - ❖ Condensate leaking through casing onto floor. This comment was previously reported during the 2014 Arrowhead assessment report. Reference Mechanical Images: [Exhibit D2.3](#) (page 15).

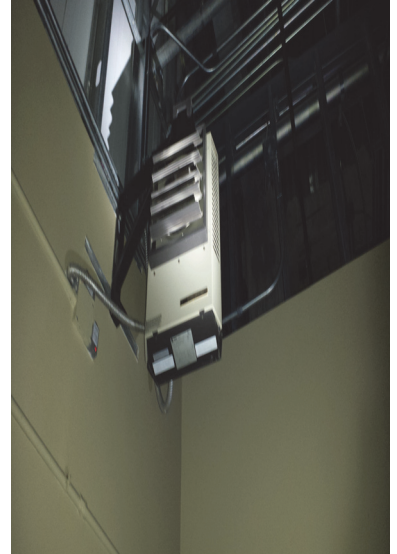
HVAC Images:[Exhibit D2.4](#)

- Electric Unit Heaters
 - Deficiencies
 - ❖ None observed.
 - System Maintenance Checks Observed by Engineer
 - ❖ Equipment tagged.
 - ❖ Listened for excessive noise or vibrations from fan.
 - ❖ Reference HVAC Images: Exhibit D2.4 (page 16).

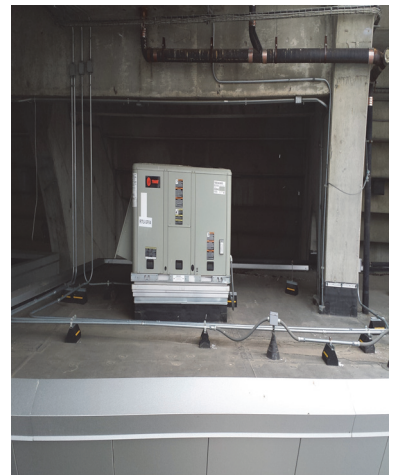
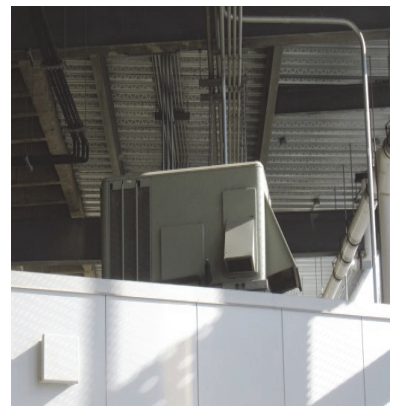
- ❖ Belt tension and condition were visually inspected for cracks or breaks.
- ❖ Filters clean.
- ❖ Power disconnects installed and labeled.
- ❖ Reference HVAC Images: [Exhibit D2.5](#) and [D2.6](#) (page 16) for observed condition.

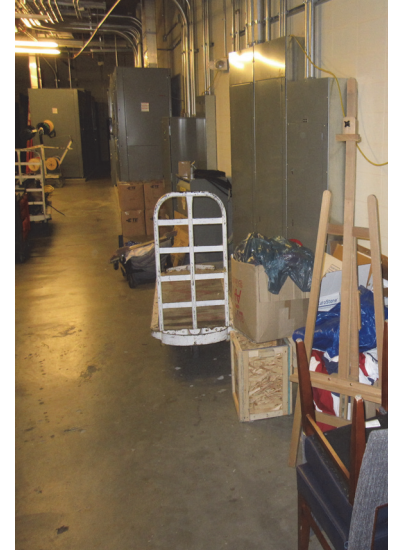
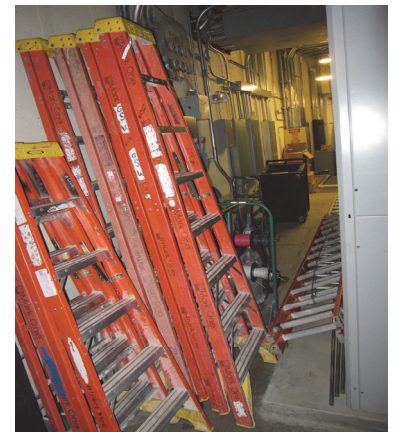
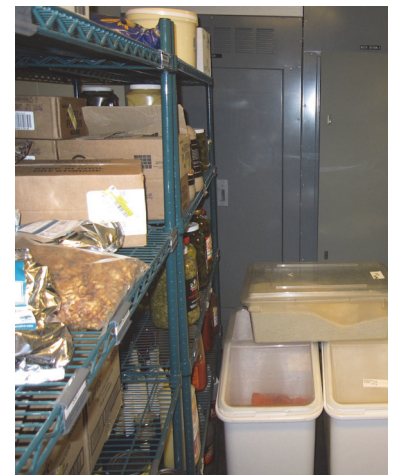
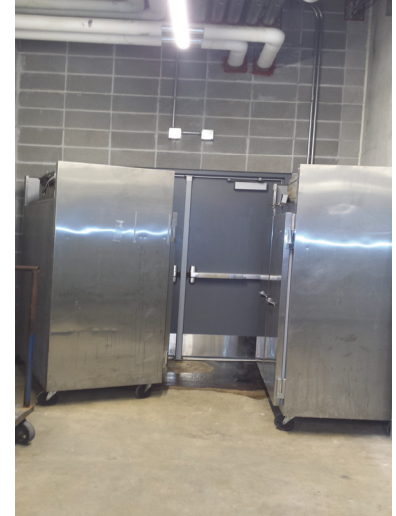
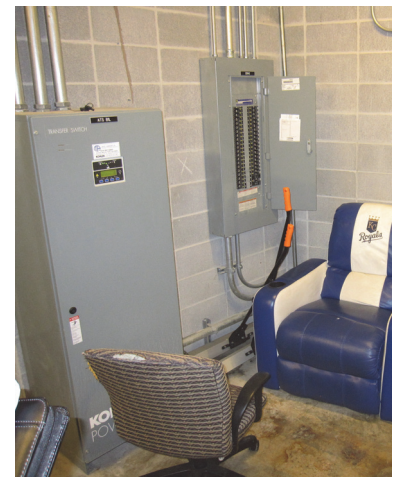
- The overall electrical system was observed to be in satisfactory condition.
- Switchgears and panelboards in observed electrical closets were blocked by stadium furniture, equipment and other obstructions.
- Racks or other obstructions in front entrance and exit doors which does not comply with the 2014 National Electrical Codes, article 110.26.

See Electrical Images: Exhibits D3.1 through D3.3 (page 17), D3.4 and D3.5 (page 18).

- In general, all electrical elements were observed to be in satisfactory condition.
- Ensure that all electrical panels are kept clear of debris and obstructions. Several rooms, mostly in food service areas, have racks or other obstructions in front of panel boards and exit doors, violating the 2014 National Electrical Code requirements for maintaining clearances in front of panelboards as stated in article 110.26. Refer to [Exhibits D3.1 through D3.5](#) (pages 17 and 18).
- Ensure that all panelboards are labeled identifying panelboard name. Refer to [Exhibit D3.6](#) (page 18).
- Ensure that coverplates are provided on wiring devices, conduit boxes and fittings. Refer to [Exhibit D3.9](#) (page 19).
- Ensure that panelboard schedules are tailored to the panelboard name, numbering and load description. Refer to [Exhibit D3.8](#) (page 19).

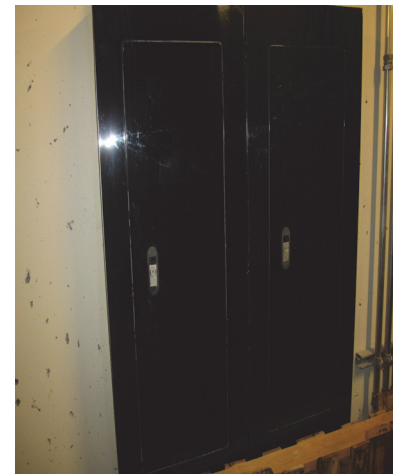
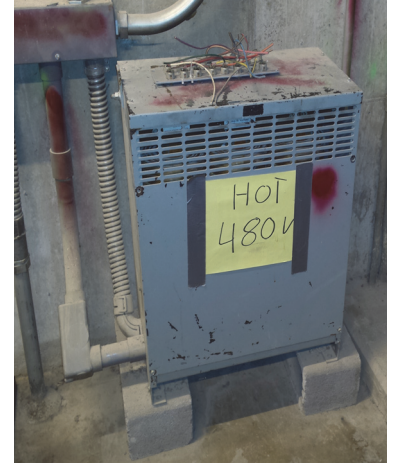
- Most panel boards and transformers observed were labeled and included type-written, laminated panel board schedule with the exception of a panelboard in the electrical room E125A. Panelboard doesn't have a nameplate identifying the panelboard name. A transformer in the Kitchen and Commissary electrical closet E129B does not have a label identifying the name of the transformer. A two-section panelboard B3AH2B in electrical room T-125B was observed to have conflicting panelboard schedules. Panelboards were labeled the same name with no reference to the panelboard section number. Branch circuits numbering on the schedule did not match numbering in panelboard. See Electrical Images: Exhibits D3.6 (page 18), D3.7 and D3.8 (right).

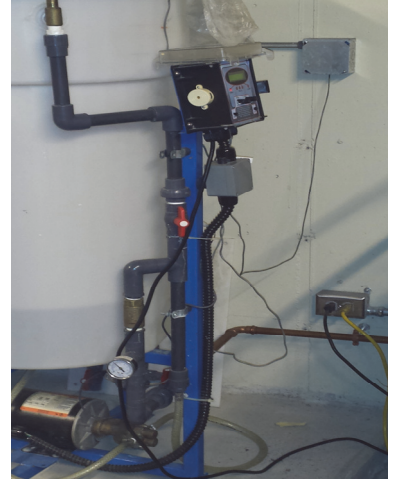
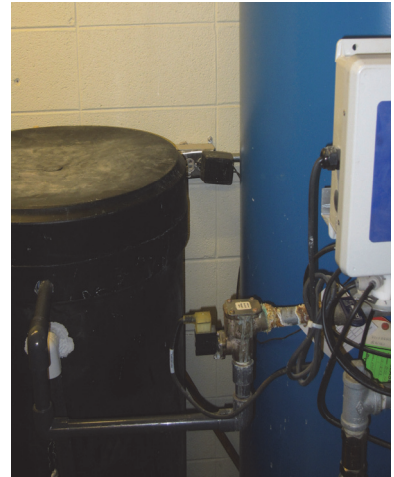
- Conduit and fittings were observed in Water room 126D to not be installed with bushings on the end of the conduit and coverplate on the LB fitting.
- Boiler room M127 was observed to have non-GFCI duplex receptacles located within 6ft of water-held equipment. See Electrical Images: Exhibits D3.10 and D3.11 (page 20).

- Replace existing duplex receptacles in Boiler room M127 with GFCI duplex receptacles in locations within 6ft of equipment containing liquids as required by 2014 national Electrical Code, article 210.8(B)(6). Refer to Exhibits D3.10 and D3.11 (page 20).
- Terminate grounding electrode conductors on grounding bus bar as in accordance with 2014 National Electrical Code, article 250.64 (C). Refer to Exhibit 3.12 (page 20).
- It is recommended to replace damage strobe light in corridor 02.20.02 so as to resume intent of functionality within corridor.
