# Kauffman Stadium Assessment

## JCSCA + Burns & McDonnell

This document contains information pertaining to the condition of Kauffman Stadium as documented by the Jackson County Sports Complex Authority (JCSCA), including descriptions, conditions, and exhibits which have been reviewed by Burns & McDonnell and documented in this report.

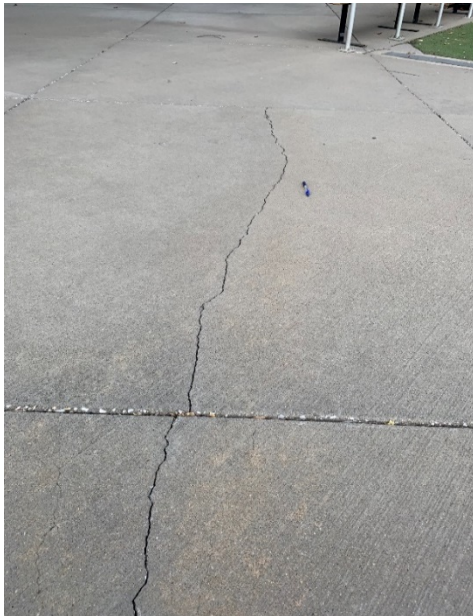
Pavement cracking was the most prominent site defect observed. Transverse, fatigue, and corner cracking was found in several areas throughout the concourse. [Figure C-1](#) displays a typical example of transverse cracking found on site. [Figure C-2](#) shows an example of fatigue cracking from stadium use. [Figure C-3](#) shows an example of corner cracking approximately  $\frac{1}{4}$ " wide. Pavement cracking that exceeds  $\frac{1}{4}$ " should be further inspected and considered for replacement as it leaves room for water to infiltrate the pavement slab causing displacement due to freeze-thaw conditions. [Figure C-4](#) is another example of fatigue cracking, this time being located near a footing.

**Figure C-1: Transverse Cracking**  
**Location:** Adjacent To Batting Cages

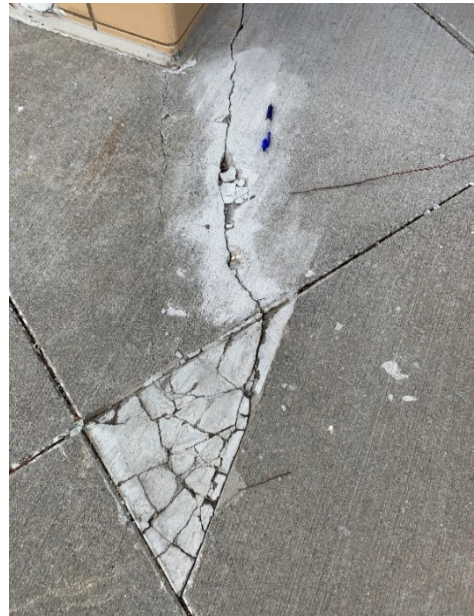
**Figure C-2: Fatigue Cracking**  
**Location:** Adjacent To Putting Golf Course

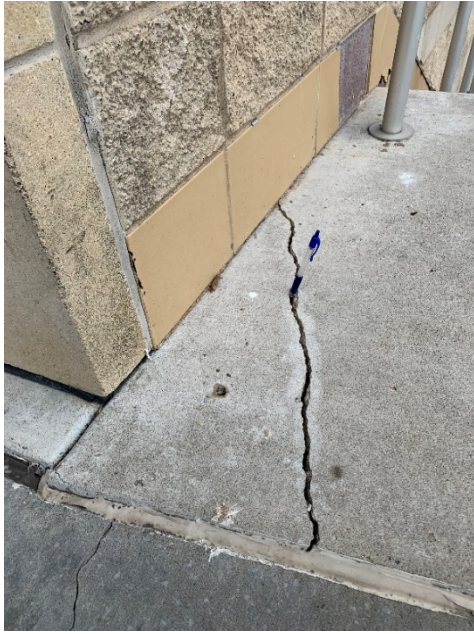
**Figure C-3: Corner Cracking**  
**Location:** Stairway Located Northeast of East Helix Ramp

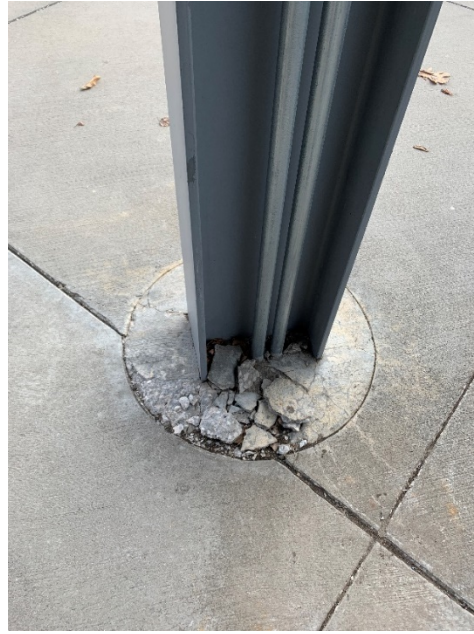
**Figure C-4: Footing Cracking**  
**Location:** Adjacent To Batting Cages

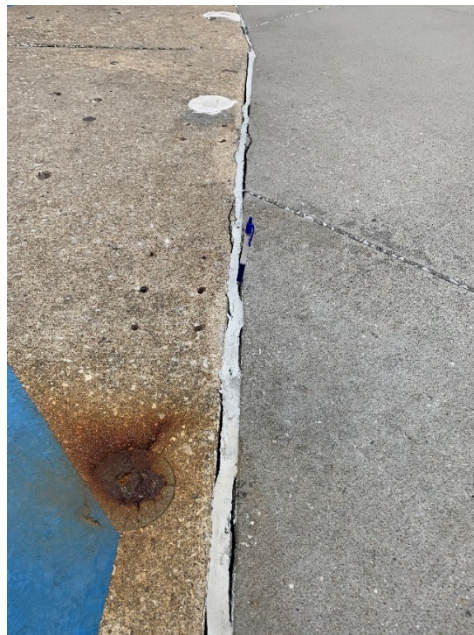
Dilapidated joint sealants were also commonly observed around site. Sealant deterioration provides the opportunity for water to penetrate the pavement which also can cause displacement due to freeze thaw conditions. [Figure C-5](#) shows an example of sealant degradation found on site, leaving the sealant detached from sections of pavement. Damaged curbing and seating wall were another defect typically encountered on site, [Figure C-6](#) shows an example of a broken section of seat wall.

**Figure C-5: Detached And Deteriorated Sealant**  
**Location:** Adjacent To Standing Area Near Section 248

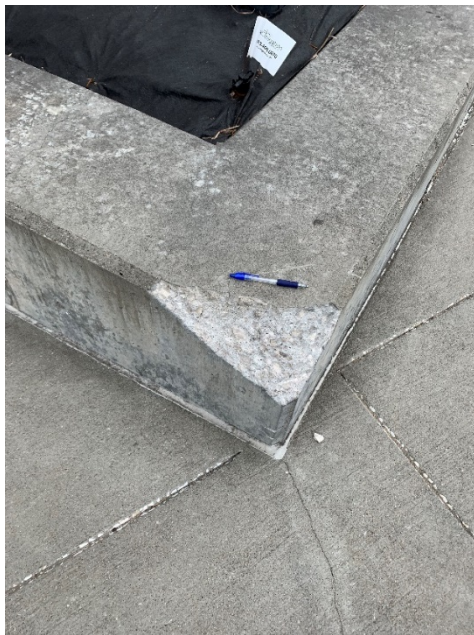
**Figure C-6: Curb Damage**  
**Location:** Adjacent to East Helix Ramp

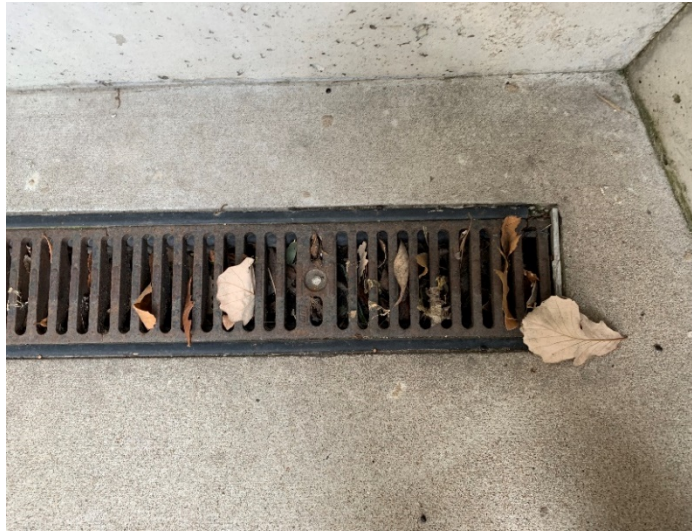
Other site appurtenances on site were evaluated, this included fencing, decorative walls, hand railings, light poles, and drainage structures. Minor site defects were observed and most of which was deemed to be in acceptable condition. [Figure C-7](#) shows a trench drain found on site filled with leaves random debris.

**Figure C-7:** Trench Drain Filled With Debris  
**Location:** Bottom Of Stairway Located Northeast of East Helix Ramp

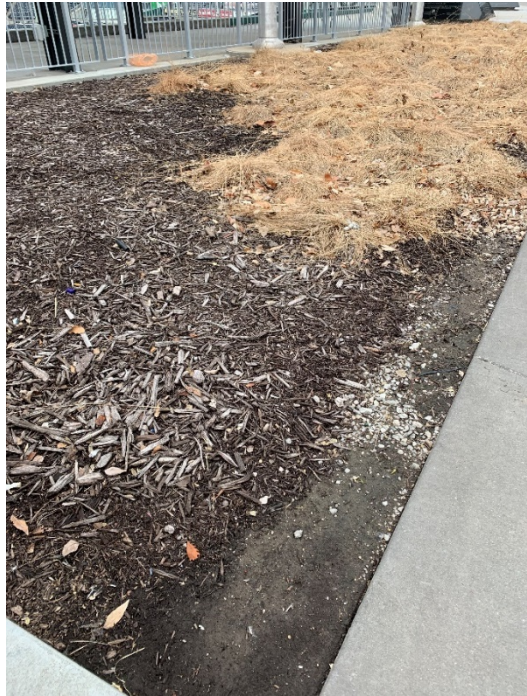
Various species of native planting and grass can be found between walkways and within planting beds surrounding the stadium. Landscaping around the stadium improves aesthetic appeal of the facility and provides visual breaks within the otherwise largely paved surface. Overall, the landscaping features were observed to be in acceptable condition, with only a few landscaping features containing defects. [Figure L-1](#) shows deterioration of the mulch bed and decorative rock.

**Figure L-1:** Deteriorated Landscape Bedding  
**Location:** Adjacent To Rivals Tables

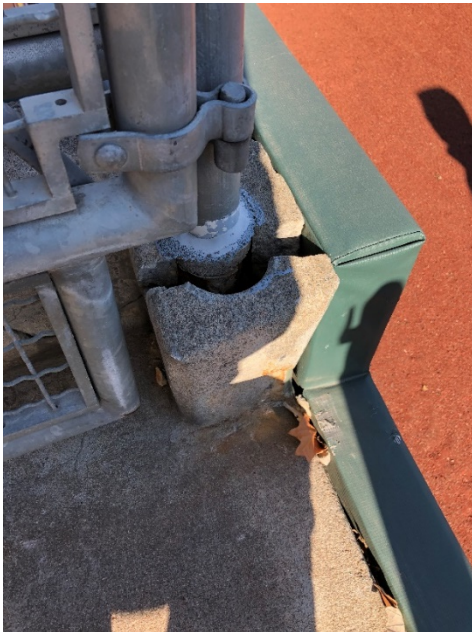
No significant settlement of the structure was observed. The slab-on-grade is primarily in satisfactory condition. No major cracks or spalling of the concrete slab-on-grade was observed. The slab-on-grade at the Hall of Fame entrance was consistently cracked. This is most likely due to the lack of control joints in the slab-on-grade. See [Figure S-6](#). A few control joints and expansion joints need repair or replacement. Concrete was observed to be spalling and rusting around various steps and handrail posts as shown in [Figures S-1](#) and [S-2](#).

**Figure S-1: Concrete Spalling**  
**Location:** Bottom of Section 115

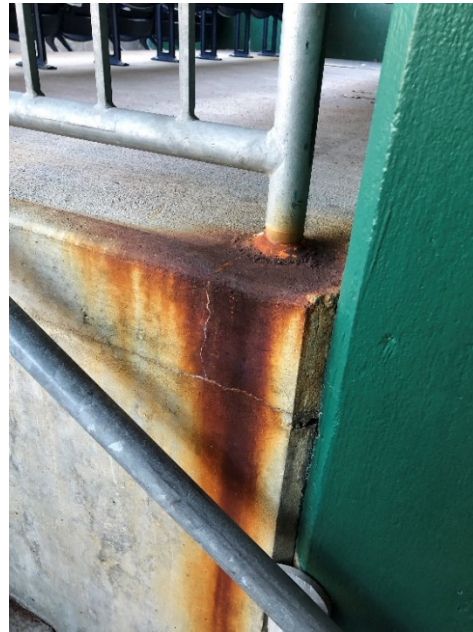
**Figure S-2: Handrail Rusting**  
**Location:** Home Dugout Suite 01.09.02

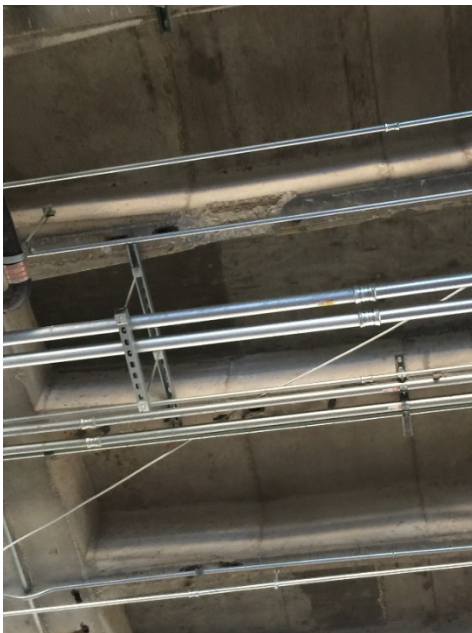
The original reinforced concrete pan joist slab systems are currently in satisfactory condition. No major cracks or widespread spalling was observed. However, minor cracking and some spalling exists which has exposed the reinforcement in the concourse at the top of section 234, as shown in [Figure S-3](#). Minor cracking and spalling was also observed while standing in the concourse at the top of section 312, shown in [Figure S-4](#).

**Figure S-3: Exposed Reinforcement**  
**Location: Concourse 03.10.01**

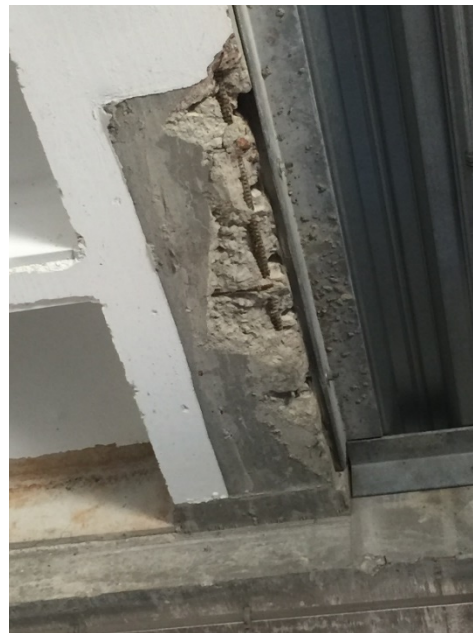
**Figure S-4: Exposed Reinforcement**  
**Location: Adjacent to Signature Suite 05.17.01**

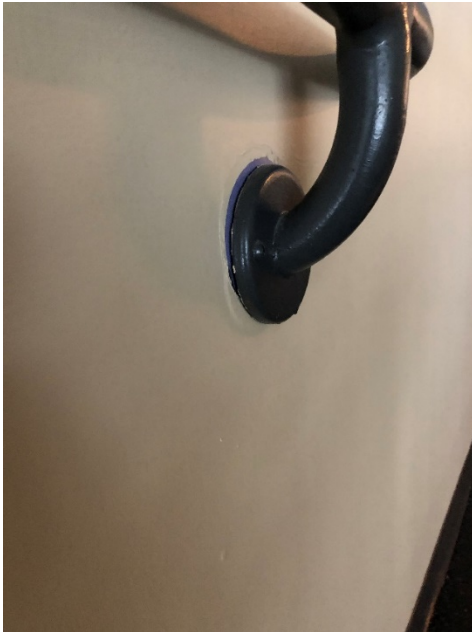
Handrails and handrail anchorage was inspected in various locations throughout the stadium. At (2) locations inspected, it was observed that anchorage was either loose, as shown in **Figure S-5**, or missing. Additionally, various washers and anchors associated with the handrails surrounding the Hall of Fame Suite have developed rust.

**Figure S-5: Loose Handrail Anchors**  
**Location:** Stair 16 Room S16.01

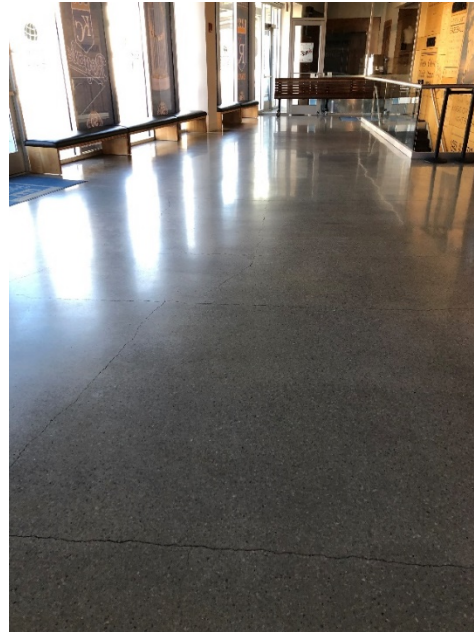
**Figure S-6: Cracking of Slab-on-grade**  
**Location:** Hall of Fame Entrance

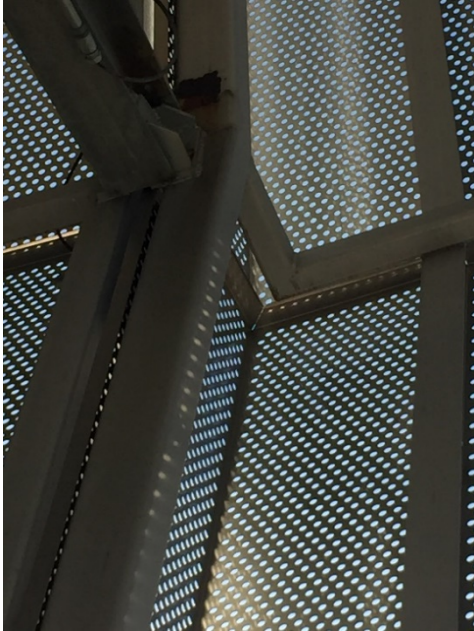
Exterior ungalvanized steel was present at several locations throughout the stadium. This was mostly likely due to paint peeling or chipping off. **Figure S-7** shows paint missing on the external perforated metal panel system. **Figure S-8** shows paint missing on the outfield steel light tower columns.

**Figure S-7: Exposed Ungalvanized Steel**  
**Location:** Adjacent to Escalator ES01.03

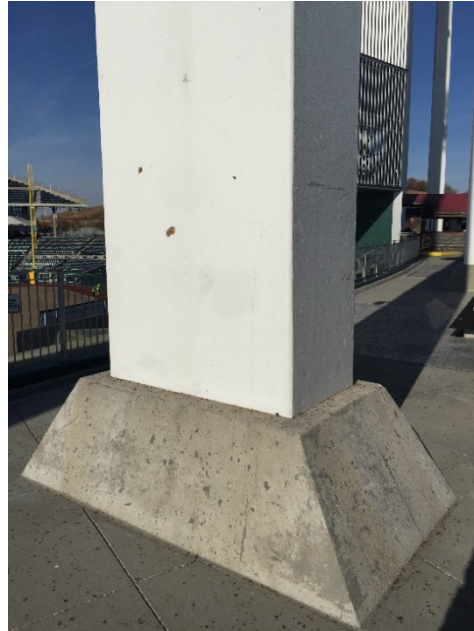
**Figure S-8: Paint Chipping**  
**Location:** Outside Steel Light Towers

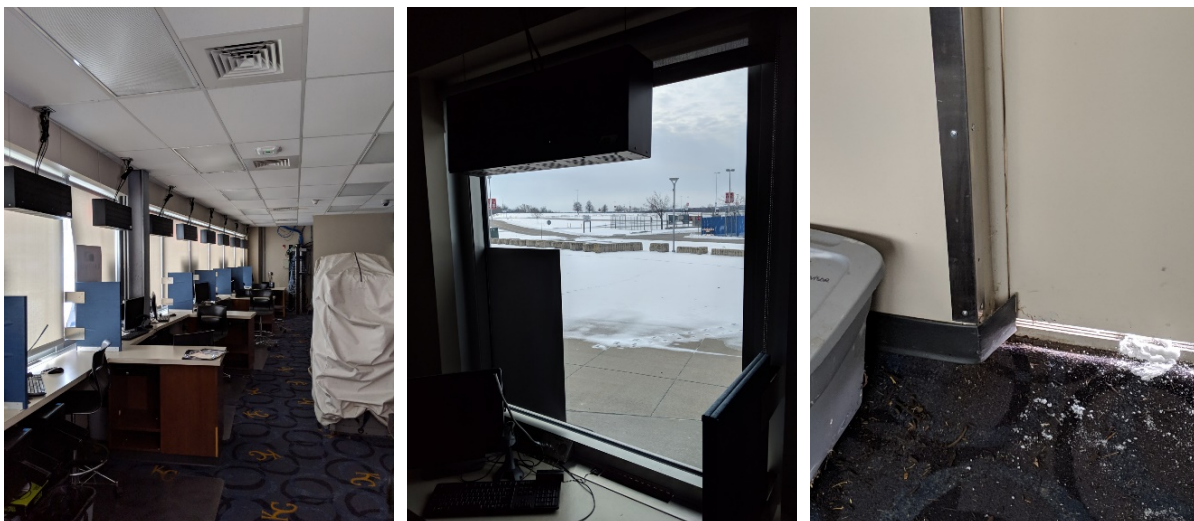
Glazing, in general, appears to be free of damage or defects. It was noted in previous year reports various ticketing windows had minor cracks. Images were taken at ticketing structure 03.17.01 as shown in [Figure AF-4](#). All ticketing windows have since been replaced and repaired as necessary. Upon exiting the ticketing structure, we observed the rubber base is no longer adhered to the wall, causing the door to catch on it. We also observed there is a significant gap between the floor transition strip and the bottom of the door leaf, allowing large amounts of cold air and moisture to enter.

**Figure AF-4: Repaired Glass at Ticketing Building (left, middle) and loose wall base (right)**

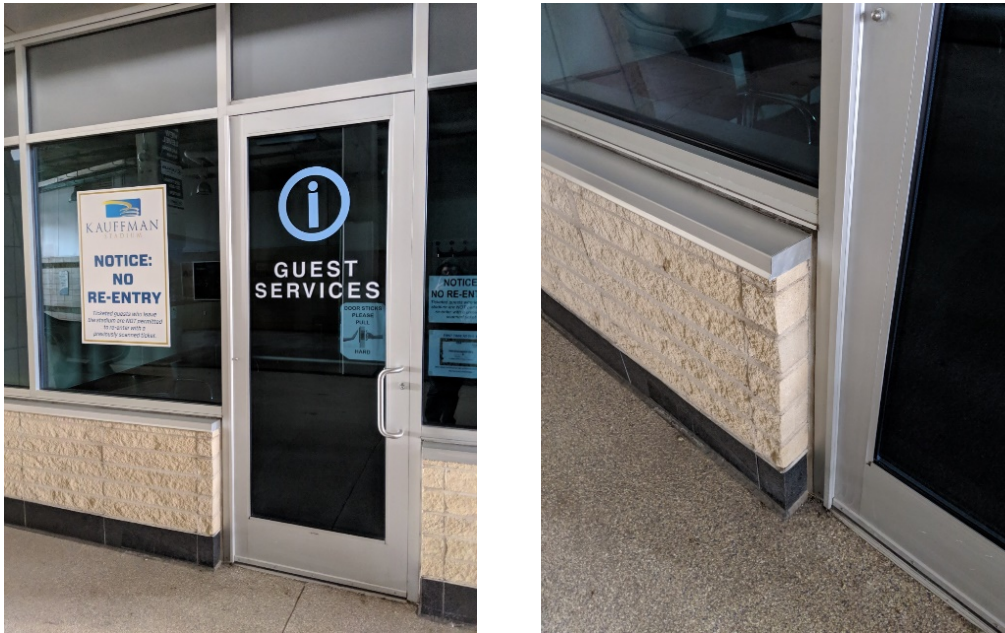
Additionally, internal storefront systems appear to be in satisfactory conditions, as shown in **Figure AF-5**. Aluminum frame and mullions were observed to be free of staining, fading, or degradation of any kind. Seals and flashing around storefront appear to be in satisfactory condition. It was noted in the 2017 report storefront flashing outside room 03.23.02 was bent outwards exposing an opening in the system. We observed the storefront flashing had since been repaired.

**Figure AF-5: Interior Storefront (left) and Storefront Flashing (right)**  
**Location:** Plaza Level 3 – 03.23.02 Fan Accommodations

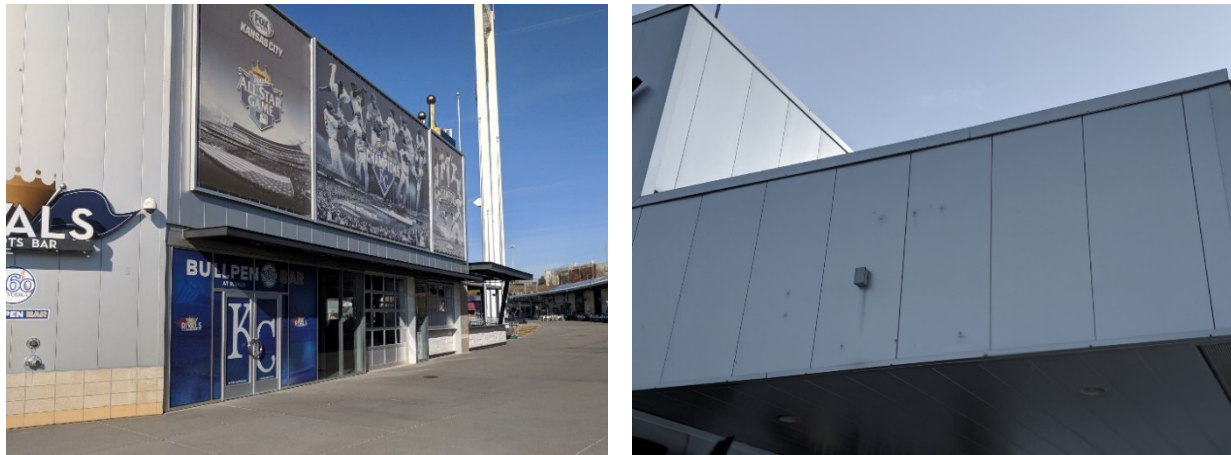
Insulated metal panels systems were observed to be in satisfactory condition. In general, no oil canning, staining, or degradation of any kind was observed, as shown in [Figure AF-6](#) (left). However, on the South-Western face of the Rivals Sports Bar, minimal amounts of rust and streaking was observed at locations of penetrations. This was noted in the 2017 report and still exists today as shown in [Figure AF-6](#) (right).

**Figure AF-6: Insulated Metal Panel System**  
**Location: Plaza Level 3 - 03.78.01 Rivals Sports Bar**

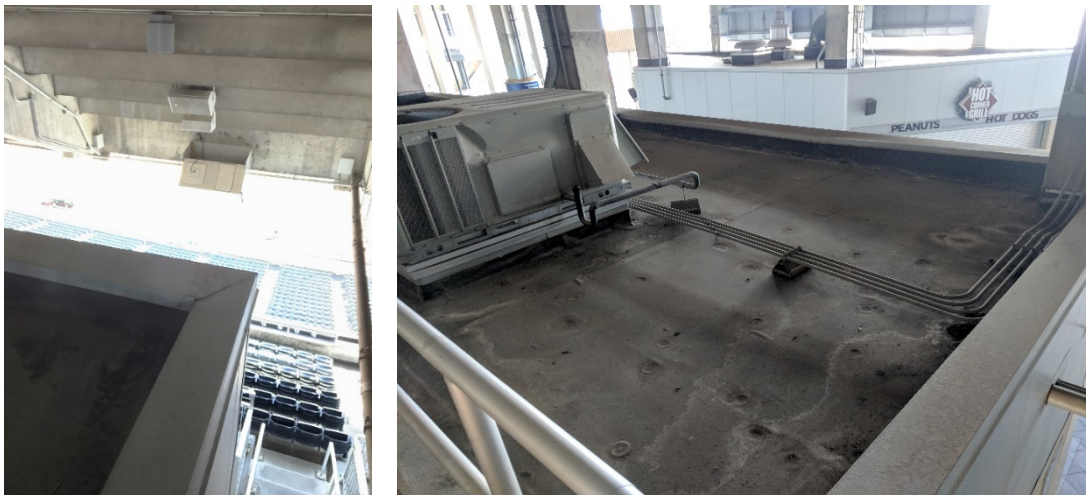
**Figure AR-1: Coping (left) and Roofing Membrane (right)**  
**Location: Catwalk on Press Level**

Coping and fascia panels at roof eaves and parapets were observed to be in satisfactory condition. Though pooling was not observed at the time of observation, the membrane roof observed from the catwalk area at the Writing Press Level shows evidence that pooling still occurs as noted in the 2017 assessment.

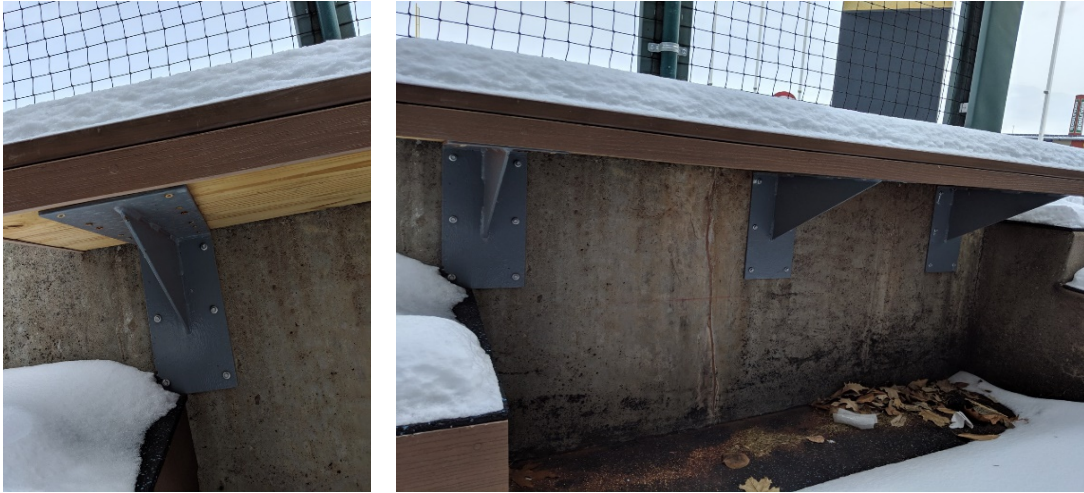
At the home dugout, the platform structure paint was observed to be chipping off and exposing the raw steel in the 2017 report. The steel shows surface rust, which was also noted in the 2016 report. It was observed the platforms within the dugout had been replaced completely, as shown in **Figure AME-1**.

**Figure AME-1: Surface Rust on Platform Support Brackets**  
**Location:** Clubhouse Level 1 - Royal's Dugout

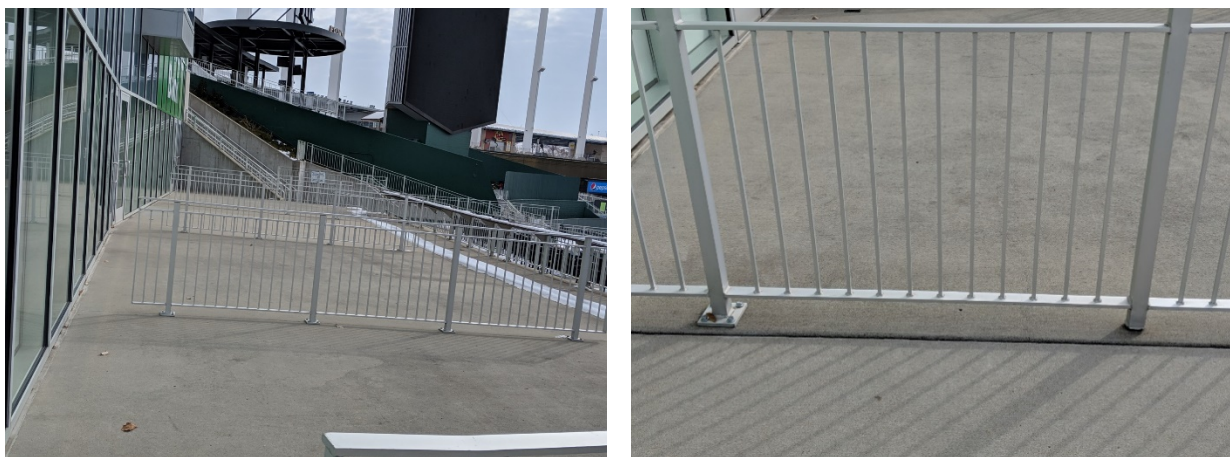
At the patio deck outside the storefront glazing system of Taking the Field 03.51.01, it had been observed some of the metal plates anchoring various railings to the concrete were missing, as shown in **Figure AME-2**. While under pressure from fans using the facility, these missing plates can compromise the railing's structural integrity and safety. Without the various plates in place, the railing has the ability to move back and forth quite easily in the horizontal direction.

**Figure AME-2: Missing Support Base Plates**  
**Location:** Plaza Level 3 - 03.51.01 Exterior Patio – Taking the Field

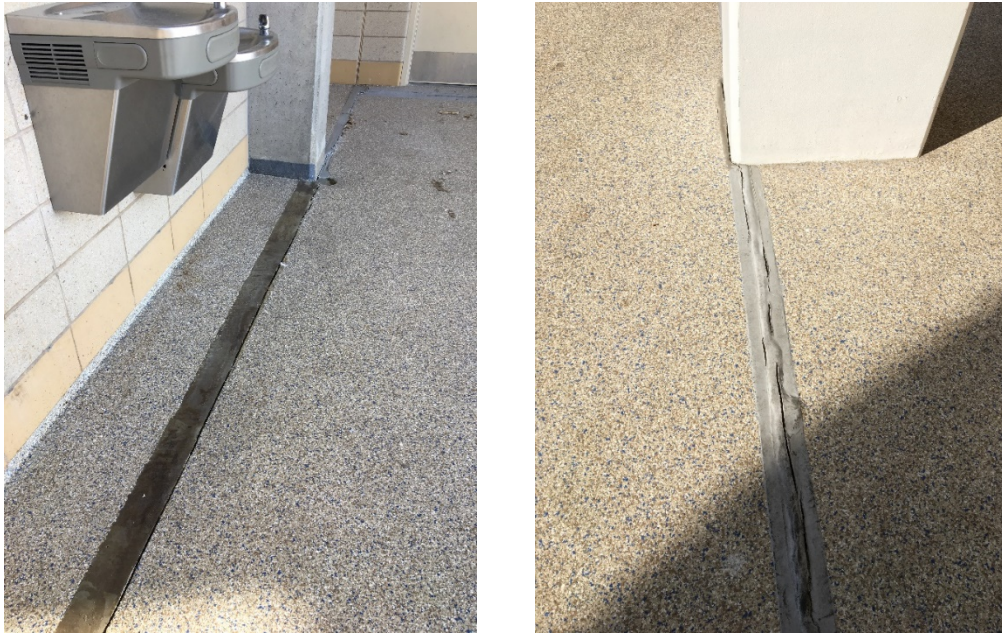
In most locations joint sealant and caulking appears to be in satisfactory condition. However, at various locations throughout the stadium, sealant was observed to be cracked or separating, as shown in **Figure AME-3**, in the South-West Plaza Concourse near 03.14.01. This condition may create a potential moisture problem in various service spaces under the stadium.

**Figure AME-3: Joint Sealant**  
**Location:** South-West Plaza Level 3 - Concourse near 03.14.01

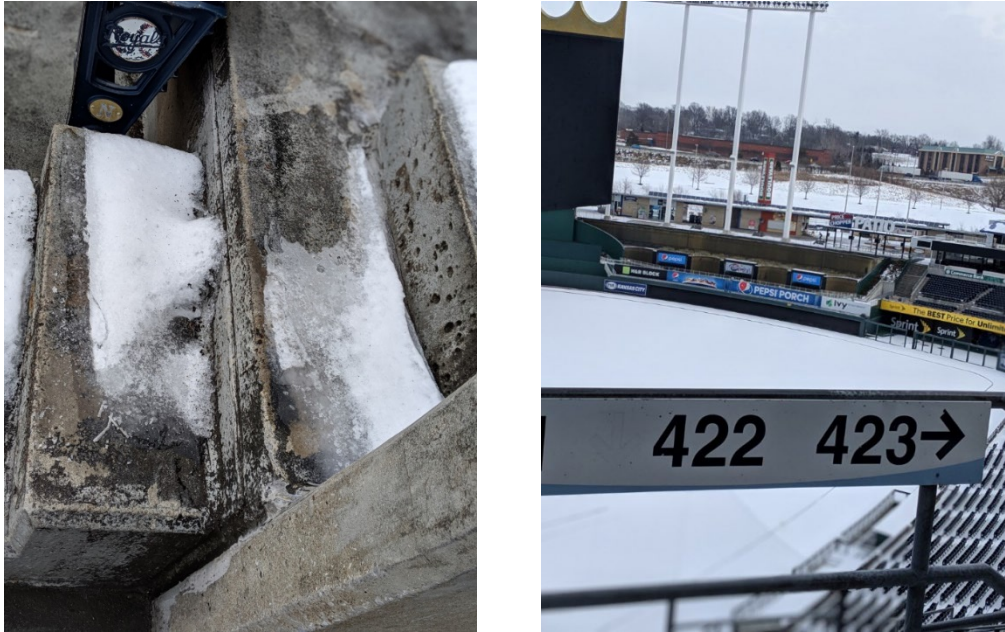
It was observed that the non-slip texture is beginning to wear away from typical use in various locations in the Upper Seating Bowl 07.18.23, as shown in **Figure AME-4**. This could become a slip and fall hazard to patrons, especially during the earlier and later portions of the MLB season.

**Figure AME-4:** Non-Slip Coating

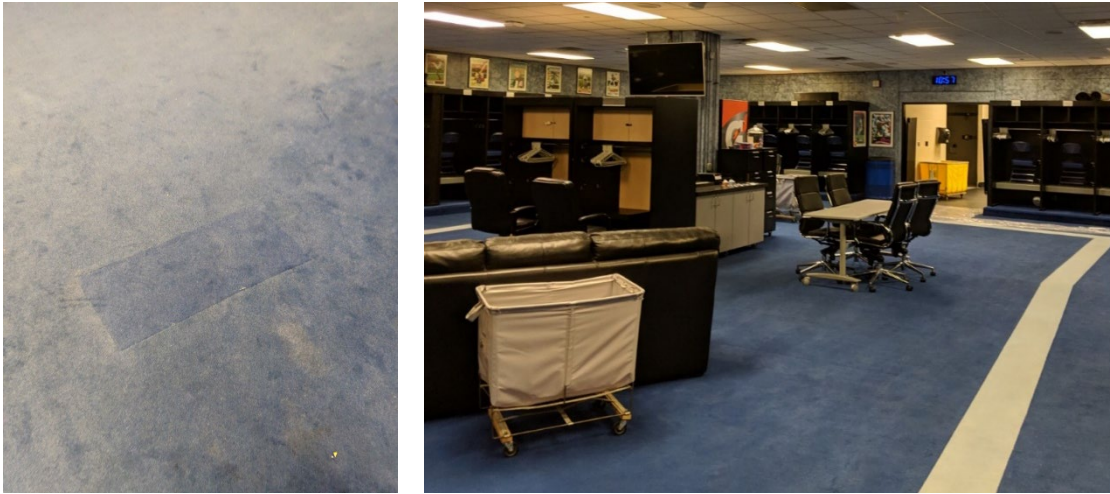
Carpet flooring was generally observed to be in satisfactory condition. No signs of rips, tears, or discoloration were observed aside from what is considered normal wear and tear. In the 2017 report, it was noted that a large stain was prominent on the carpet at the Visitor's Locker Room 01.27.03, as shown in [Figure AI-3](#). This stain appeared to be fixed by cutting, pulling up, and patching the carpet at that location.

**Figure AI-3: Carpet Flooring**  
**Location:** Clubhouse Level 1 - 01.27.03 Visitor's Locker Room

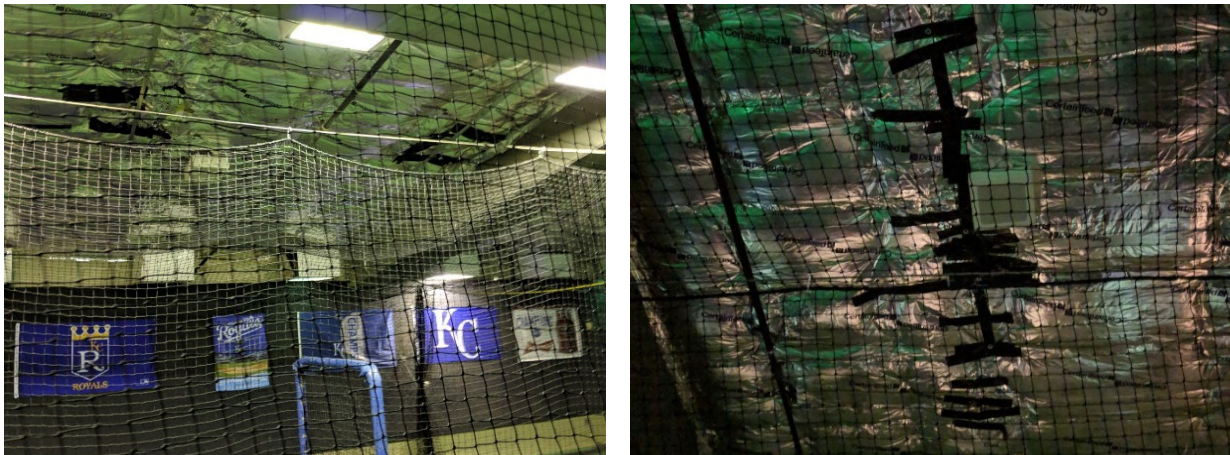
Exposed ceilings typically appear to be in satisfactory condition. It had been observed in the 2016 and 2017 assessments that several foil-faced batt insulation sections in the Clubhouse Batting Tunnels 01.13.01 were hanging down due to suspected impact from baseballs or a potential gap in the expansion joint above. From observation underneath, the issue appears to have been resolved as well as the outlier area noted in the 2017 report as shown in **Figure AI-8** (right).

**Figure AI-8: Foil Faced Batt Insulation**  
**Location: Clubhouse Level 1 - Batting Tunnels 01.13.01**

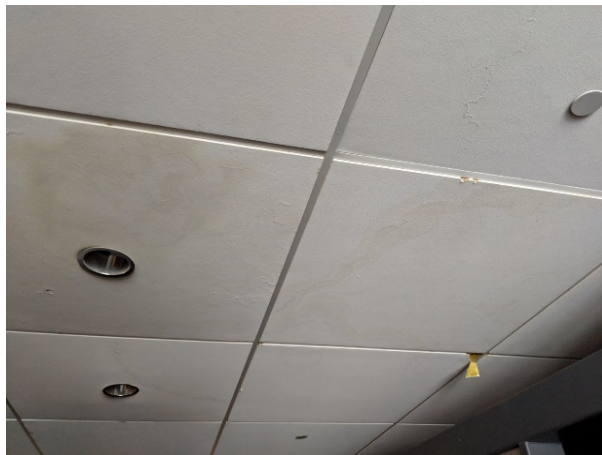
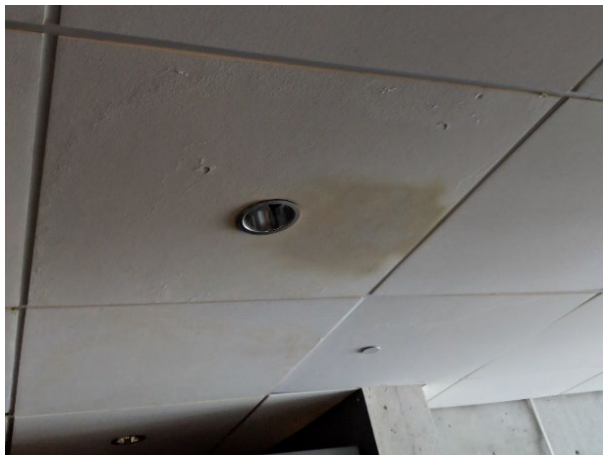
Acoustical ceiling tile is the primary material used for interior spaces. The typical condition of the acoustical ceiling tile appears to be in satisfactory condition. Refer to **Figure AI-10** for typical condition at observed interior ACT ceilings. Previously noted in the 2017 report, locations in the Dugout Concourse 02.11.02 were observed to have been stained, as shown in **Figure AI-11, right & left**.

**Figure AI-11: Stained Acoustic Ceiling Tile**  
**Location (right):** Service Level 2 - 02.11.02 Dugout Concourse

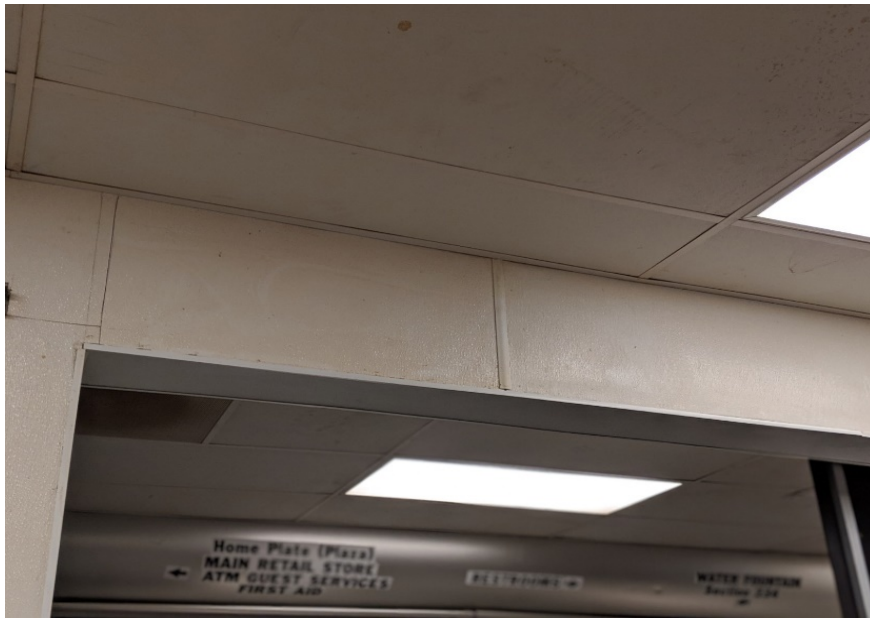
It was noted in the 2017 report that upon observation of Concessions 03.14.01 fiberglass reinforced plastic at the head of an opening had fallen off and left the underside exposed. During the walk-through, it appeared the condition was repaired as shown in **Figure AMI-1**. Exposure of construction adhesive materials in a concession environment may not comply with retail / health standards and the potential safety hazard was identified.

**Figure AMI-1:** Missing Header Cap  
**Location:** Plaza Level 3 - 03.14.01 Concession Stand

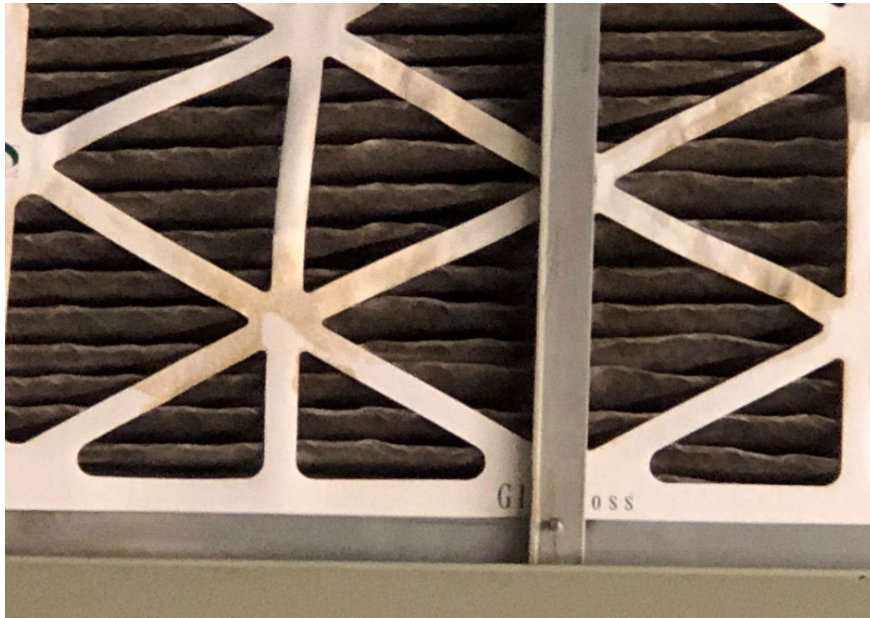
There were a few general maintenance items that were noted during the assessment. First, some filters on equipment appeared to be excessively dirty and should be changed to keep the equipment operating at maximum efficiency. A blower coil unit in Electrical Room 02.19.01 was specifically observed to have dirty filters, as shown in [Figure M-1](#), but all filters should be checked to make sure they have been recently changed.

**Figure M-1: Dirty Filter on Blower Coil Unit**  
**Location: Service Level – 02.19.01 Electrical Room**

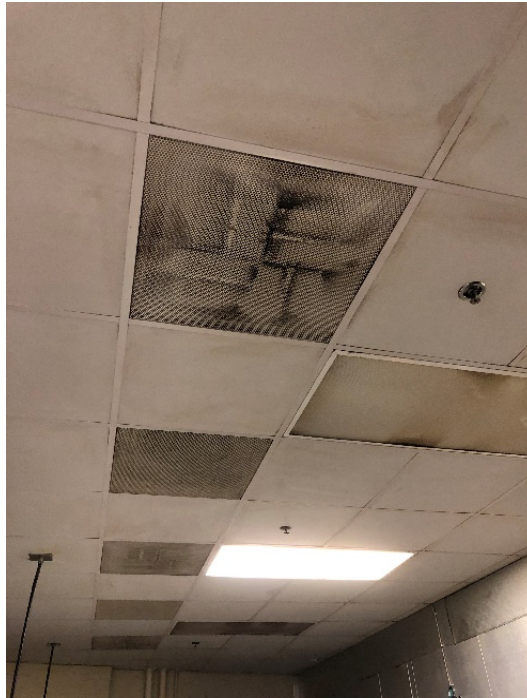
**Figure M-2: Dirty Ceiling Grilles**  
**Location:** Service Level – 02.04.01 Vendor Commissary

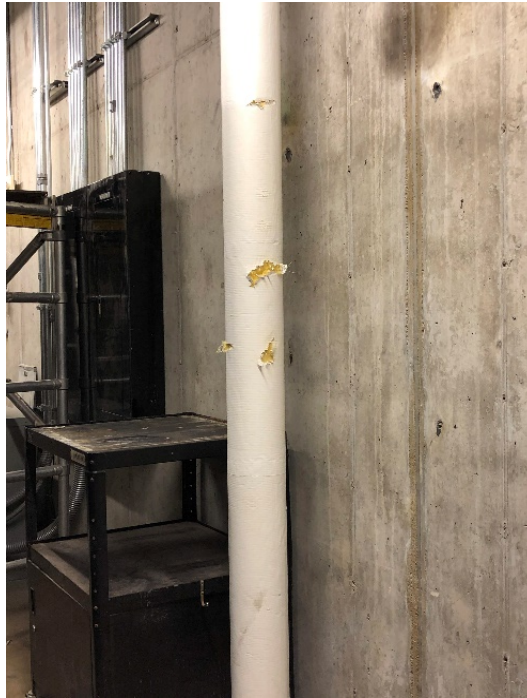
**Figure M-3: Torn Piping Insulation and Jacketing**  
**Location: Service Level – 02.28.06 Electrical Room**

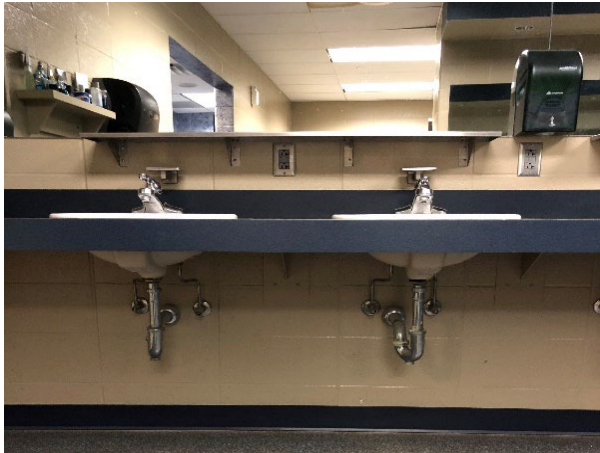
**Figure M-4: Missing Insulation**  
**Location:** Clubhouse Level – 01.21.03

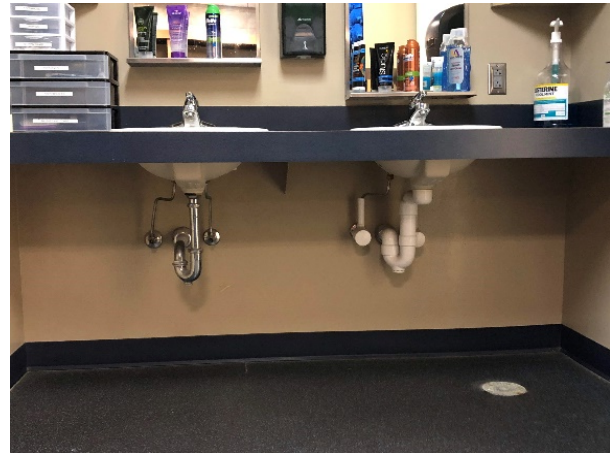
**Figure M-5: Missing Insulation**  
**Location:** Clubhouse Level – 01.21.02

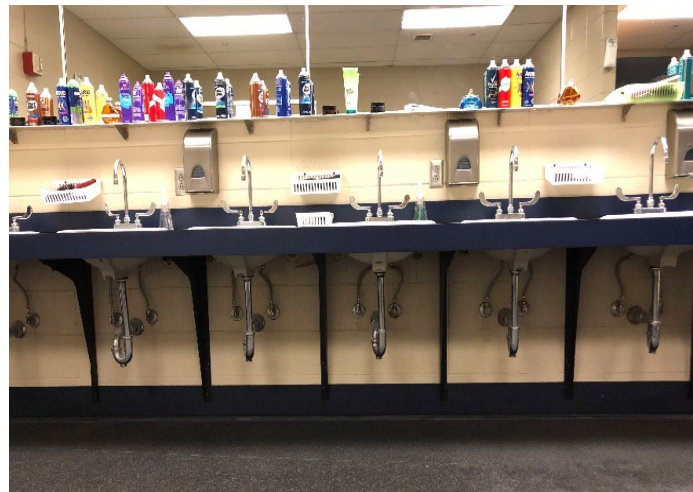
**Figure M-6: Missing Insulation**  
**Location:** Clubhouse Level – 01.27.03 Visiting Lockers

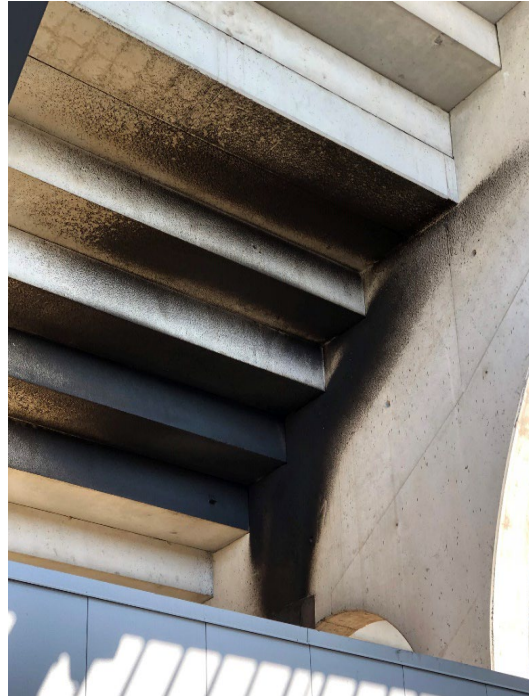
**Figure M-7: Discharge from Kitchen Exhaust Fan**  
**Location: View Level – 07.24.03 Satellite Retail**

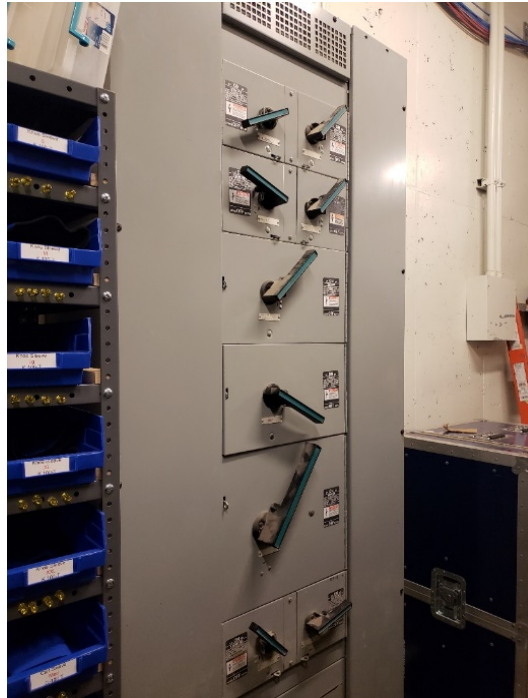
**Figure E-3: Fuse Labeling**  
**Location: Mechanical Room 01.15.02**

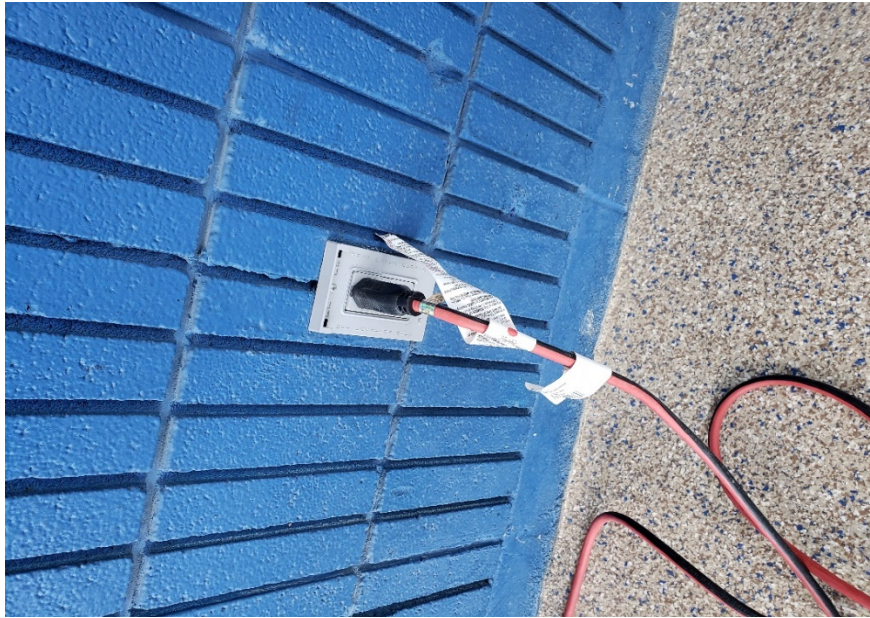
**Figure E-13: Receptacle Cover Missing**  
**Location: Column 26, Concourse 07.25.05**
