# Kauffman Stadium Assessment

## JCSCA + Burns & McDonnell

This document contains information pertaining to the condition of Kauffman Stadium as documented by the Jackson County Sports Complex Authority (JCSCA), including descriptions, conditions, and exhibits which have been reviewed by Burns & McDonnell and documented in this report.

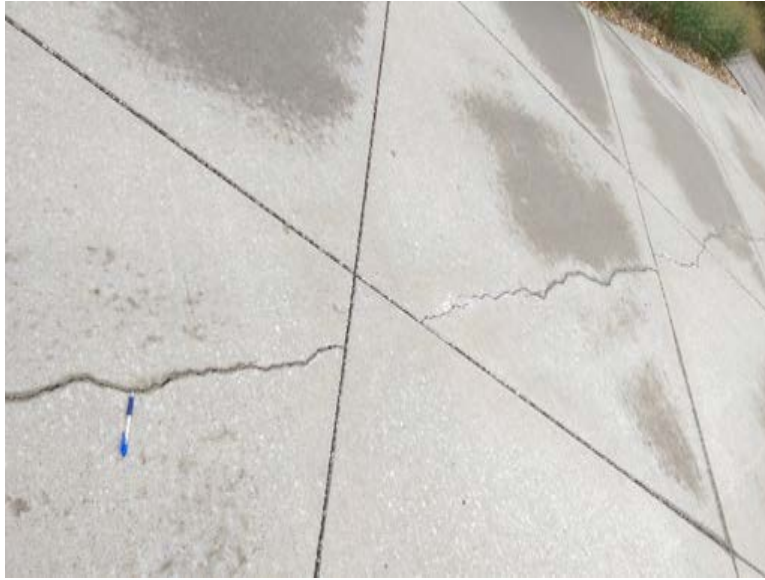
**Figure C-1: Minor Cracking at Concrete Walkways**

The majority of distresses observed consisted of minor cracking, spalling, and faulting of concrete flatwork. The figure above, located south of Gate A inside the stadium, shows an example of the minor cracking observed during the walkthrough. Minor vertical hairline cracking along with minor web cracking was observed in some retaining walls. Moderate faulting was observed at a joint within the range of pedestrian traffic as shown in **Figures C-2** and **C-3**. Joints faulting within the natural flow of foot traffic pose a tripping hazard.

The majority of the concrete flatwork elements were observed to be in satisfactory condition. Continue to perform routine maintenance to seal and repair minor cracking observed along walkways and concourses. Cracks and spalling where rebar is exposed should be repaired to prevent further weakening. Areas of with severe cracking or spalling should be repaired or replaced to prevent these locations from becoming tripping hazards. Replace any missing, damaged, or otherwise unsatisfactory joint sealant and/or backer rod required for concrete joints.

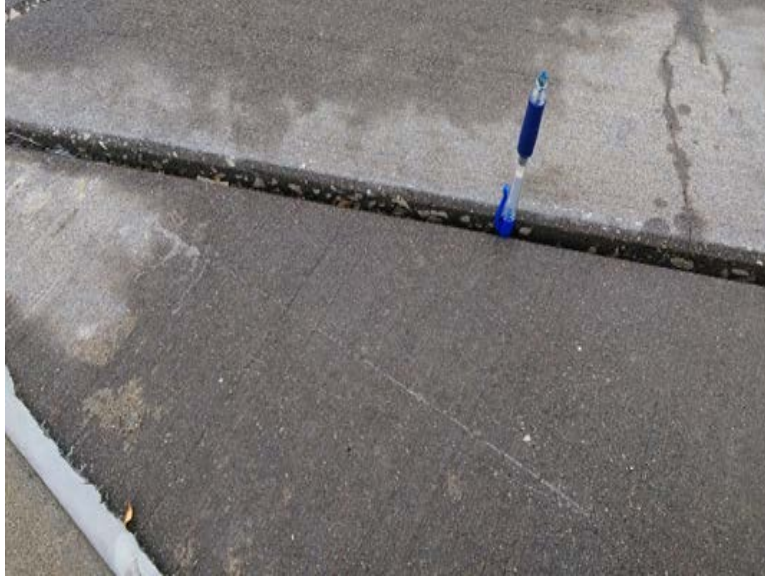
**Figure C-2: Joint Fault near Stairs to Gate A**

- Monitor any minor faulting slabs in walkways for progression of the faulting. If faulting becomes more severe, repair or replacement of concrete may be necessary. To protect pedestrian safety and provide a full ADA compliant route, repair and/or replace any faulting panels or pavers to maintain a consistent surface where faulting has resulted in a drastic elevation change.
- Replace or secure any trench drain or drainage structure as necessary to prevent it from being accidentally or intentionally dislodged and maintain design inflow capacities. Loose trench drain covers could be a tripping hazard for pedestrians.

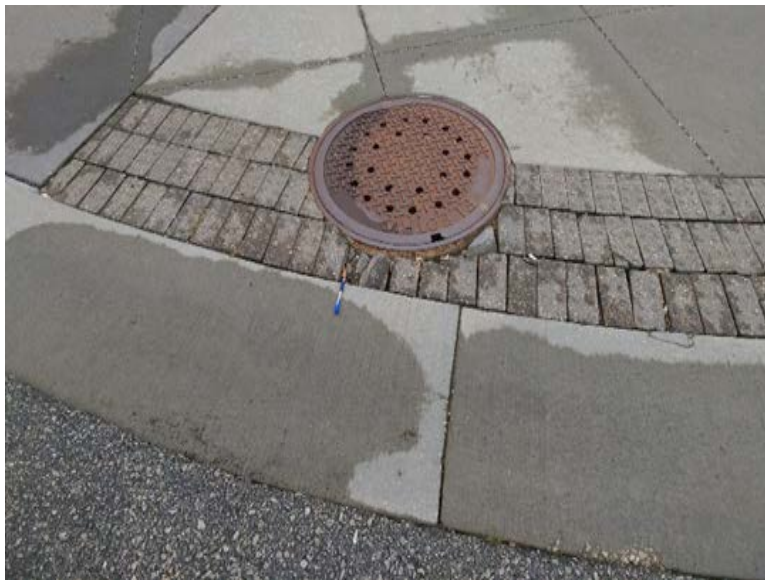
**Figure C-3: Broken Pavers and Settling at Crosswalk East of Gate D**

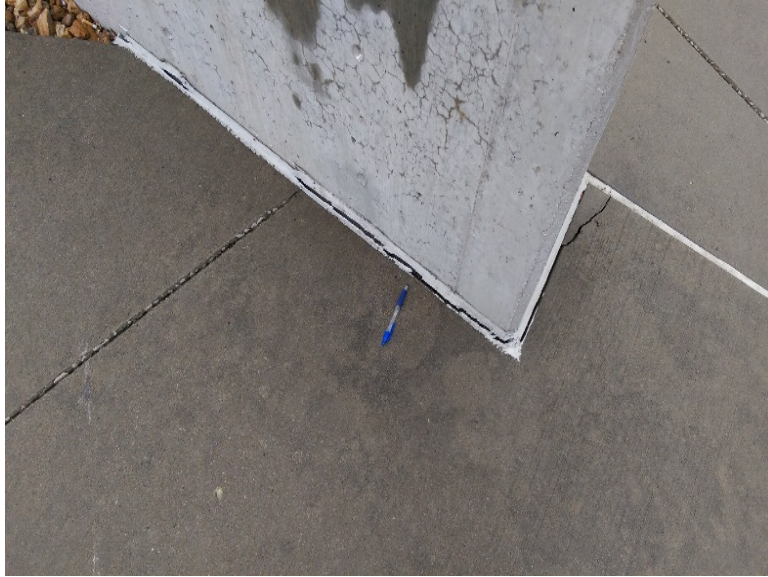
Joint distress is another common deficiency in concrete pavement that was observed in the pavement at Kauffman. At several locations, joint failure was observed both at the face of structures, and within walkway pavement. At some of these joints, missing sealant or differential settlement was observed as shown in [Figures C-4](#) and [C-5](#). Failed joint sealant allows water to penetrate the joint which can decrease the life of the concrete through freeze-thaw degradation. In locations where the paved surface or stairs settle at a different rate than the adjacent structure, sealant has pulled away from the joint rendering it ineffective.

**Figure C-4:** Interface of Stairs and Retaining Wall, Gate A

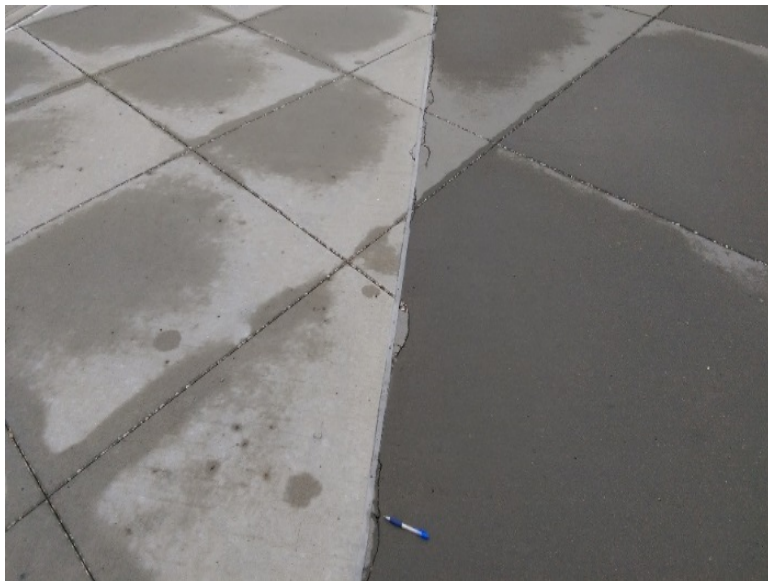
**Figure C-5:** Moderate Severity Joint Spalling at North Building Façade

At several locations, both at the face of structures and within walkway pavement, higher severity spalling was observed. In many cases, this spalling was coupled with missing or damaged sealant. These two deficiencies combined can amplify the negative effects of one another and increase the rate of degradation of the pavement. Refer to [Figure C-5](#) and [C-6](#).

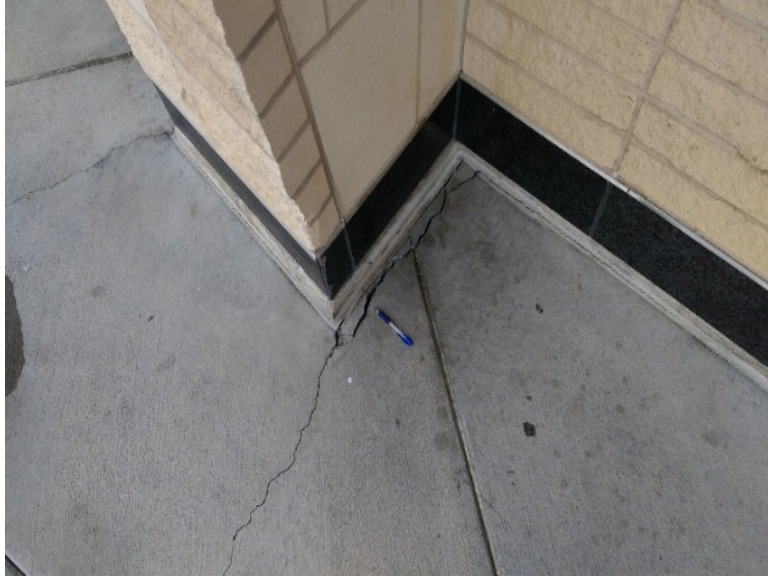
**Figure C-6: Spalling of Concrete along Joint at Outfield Concourse**

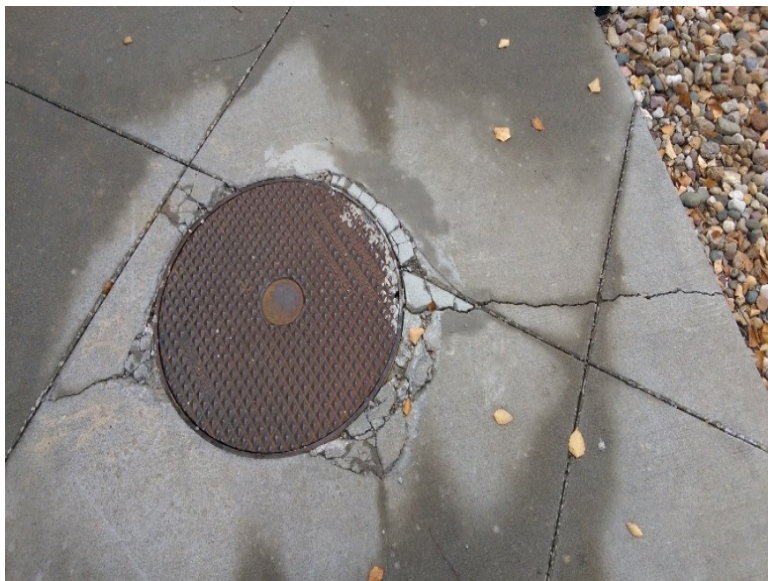
A few areas were observed with moderate to heavy cracking and spalling. Refer to [Figures C-7, C-8, and C-9](#) for a few examples of these areas.

**Figure C-7: Moderate Spalling and Cracking at Drainage Structure, near Mini-Golf**

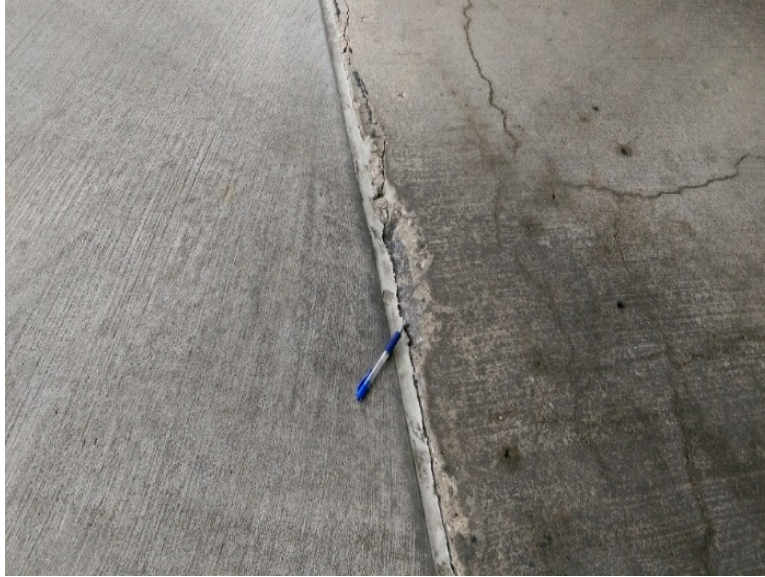
**Figure C-8:** Severe Spalling of Joint with Rebar Exposed inside Gate E, near Seating Stairway

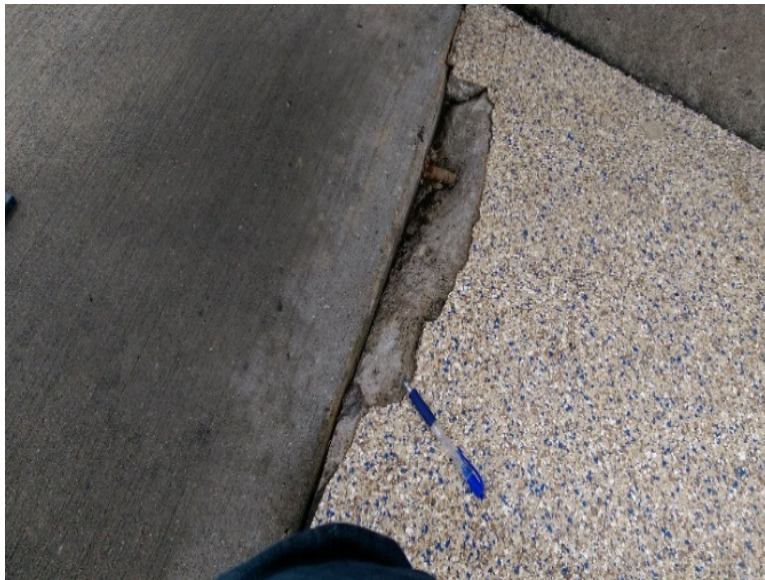
**Figure C-9:** Moderate Edge Spalling at Gate B Spiral Ramp

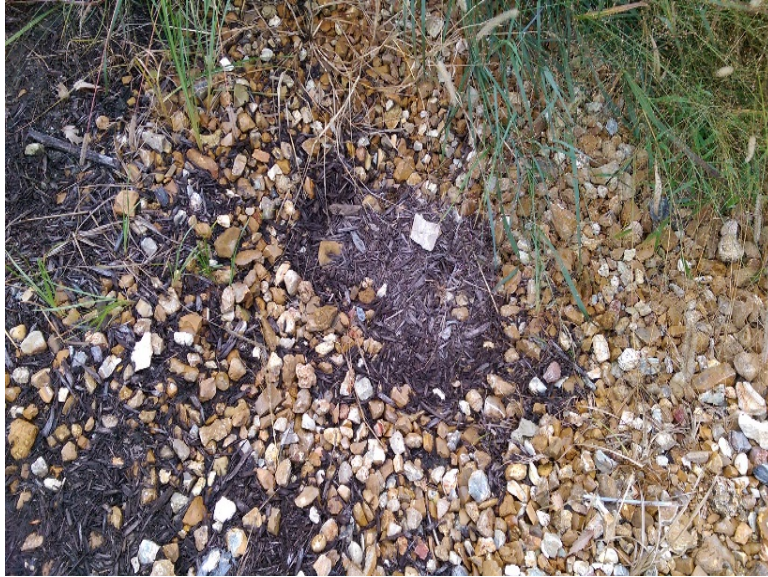
Landscaping was observed in satisfactory condition at the time of the assessment. Grasses, trees, and other vegetation appears to be healthy. Irrigation systems were observed as operational and control boxes appeared to be intact. Area drains within landscaping were observed to be clogged with mulch and other landscape materials, as shown in [Figure L-1](#).

**Figure L-1: Drain Covered by Landscape Material**

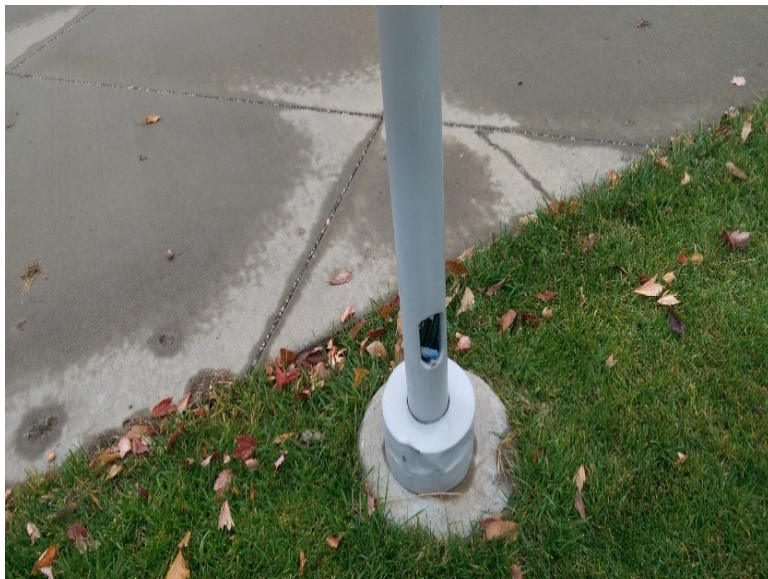
**Figure L-2: Hand Hole in Light Pole Missing Cover**

- Replace hand hole and outlet covers on light poles and outdoor electrical outlets, as shown in [Figures L-2](#) and [L-3](#).
- Route exposed wiring into control boxes and conduit to prevent further weathering and potential tampering from the public.

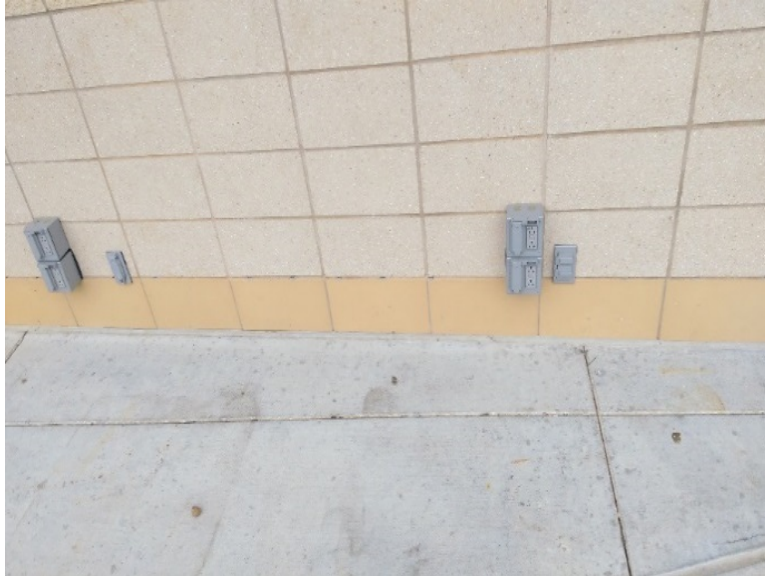
**Figure L-3:** Outdoor Electrical Outlets Missing Covers

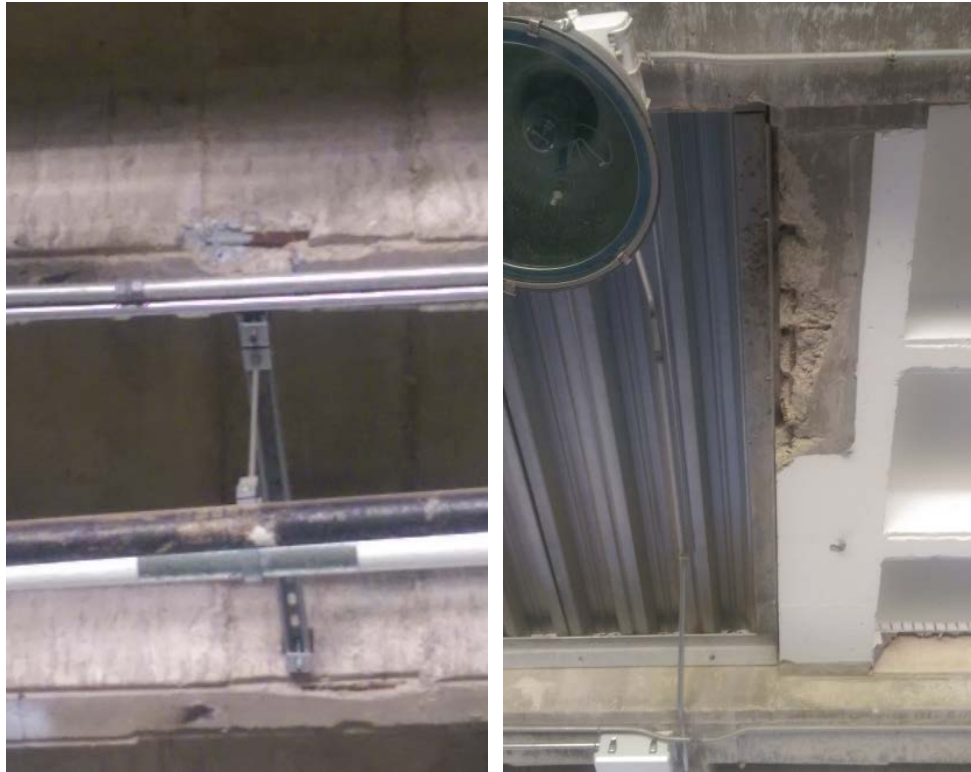
The original reinforced concrete pan joist slab systems are currently in satisfactory condition. No major cracks or spalling was observed. However, minor cracking and spalling exists which has exposed the reinforcement in the concourse at the top of section 220, as shown in [Figure S-2](#) (left). Minor cracking and spalling was also observed while standing in the concourse at the top of section 312, shown in [Figure S-2](#) (right).

**Figure S-2:** Concrete Spalling, Exposing Reinforcement at Sections 220 and 312

Minor cracking and spalling was observed at the original concrete pan joist system in sections 220 and 312, as shown in [Figure S-2](#). This has led to the exposure of reinforcement. Other areas of the stadium have similar conditions.

- Concrete cracking and spalling should be routinely monitored and patched to insure rebar corrosion does not worsen.
- Continued, routine monitoring of these areas is recommended. Concrete patchwork is recommended within the next 1 to 2 years.

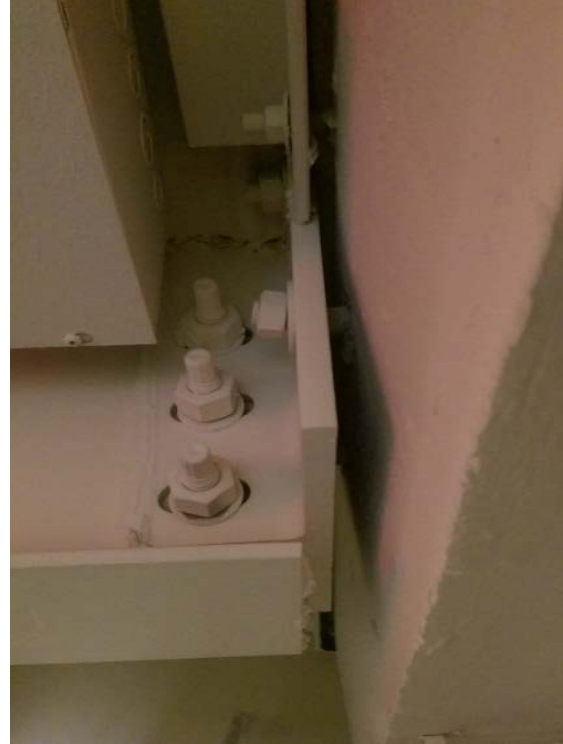
The reinforced concrete walls of the renovation stage are in satisfactory condition. No major cracks or spalling was observed and the vertical wall surface is flat and smooth. The steel beams and connections of the renovation stage are generally in satisfactory condition. No corrosion or deflection was observed, as shown in [Figure S-3](#). Concrete anchors are not fully embedded in a few locations as shown in [Figure S-4](#). This image was captured outside of the broadcast booths at the Press Level. This appears to be an installation issue rather than a maintenance concern.

**Figure S-4: Concrete Anchor not fully embedded in concrete beam (installation)**

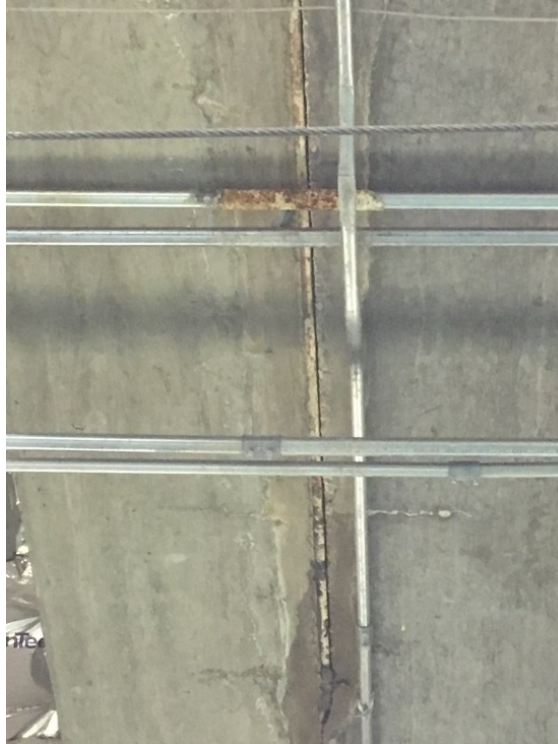
An expansion joint issue was observed above the home batting practice cages. Signs of water leaking are evident and have corroded pipe conduit below as can be seen in [Figure S-5](#) below. Water dripping was occurring during our visit. The source may be related to stadium seating connection in and around the expansion joint above. This area should be further investigated and repaired to prevent further water damage. Also, refer to architectural [Figures AI-3](#) and [AI-8](#) related to this issue.

**Figure S-5: Conduit Corrosion in Home Batting Tunnels**

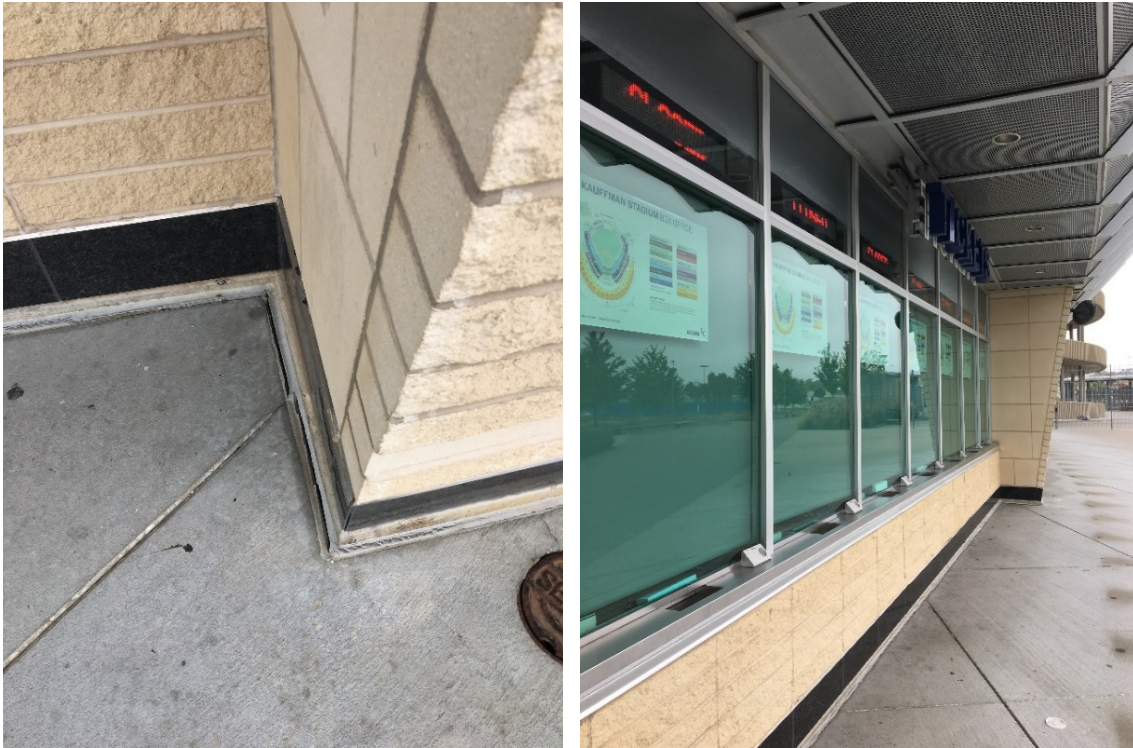
Stone cladding systems appear to be in satisfactory condition, as shown in [Figure AF-3](#). No chipping or staining of the stone or grout was observed. However, sealant between the base of the stone wall and concrete sidewalk was observed to be pulling away from the concrete at the ticketing counter just east of the main entry, as shown in [Figure AF-3](#) (right). This condition may create a potential moisture problem in various service spaces under the stadium.

**Figure AF-3: External Ticketing and Stone Veneer (left), Unsatisfactory Sealant Joint (right)**

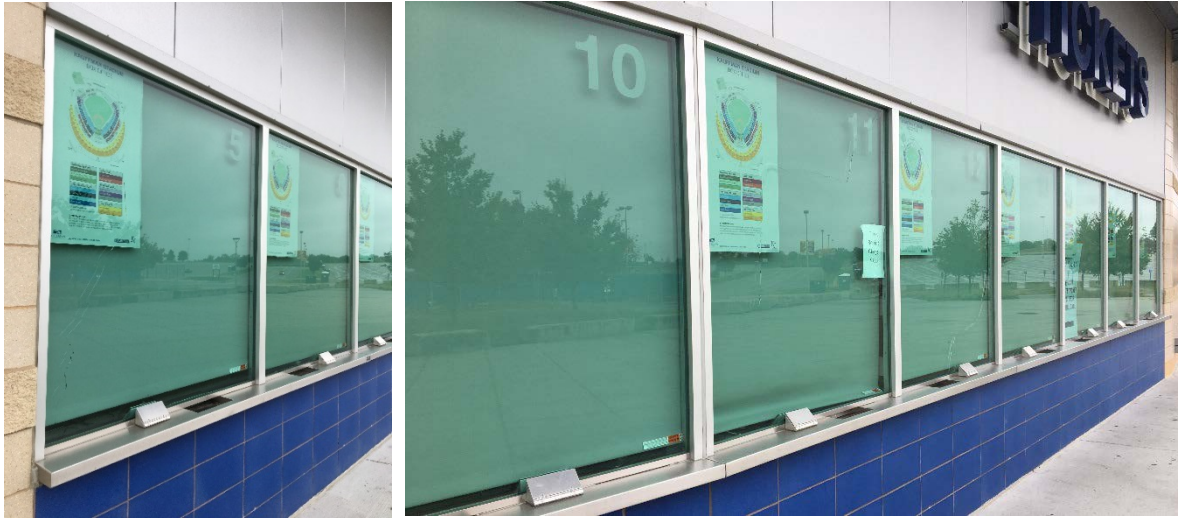
Insulated metal panels and glass storefront systems at the ticketing structures, in general, appear to be in satisfactory condition. However, glass at ticketing windows 5, 11, and 12 were observed to be cracking as shown in [Figures AF-4](#). This image was taken at the ticketing structure on the Southeast side of the stadium. We note that the cracked glass at window 5 was observed to be cracked during the 2015 assessment while windows 11 and 12 have since been damaged as well.

**Figure AF-4: Cracked Glass, Storefront System at Southeast Ticketing Counter**

Glass storefronts, in general, appear to be in satisfactory condition. However, glass panels at a few of the ticketing windows on the Southeast Ticketing structure were observed to be cracking as shown in [Figure AF-4](#).

- Consider repairing or replacing the damaged glass to maintain a quality appearance at the entry to the facility and to prevent further damage to the glass or aluminum frames.

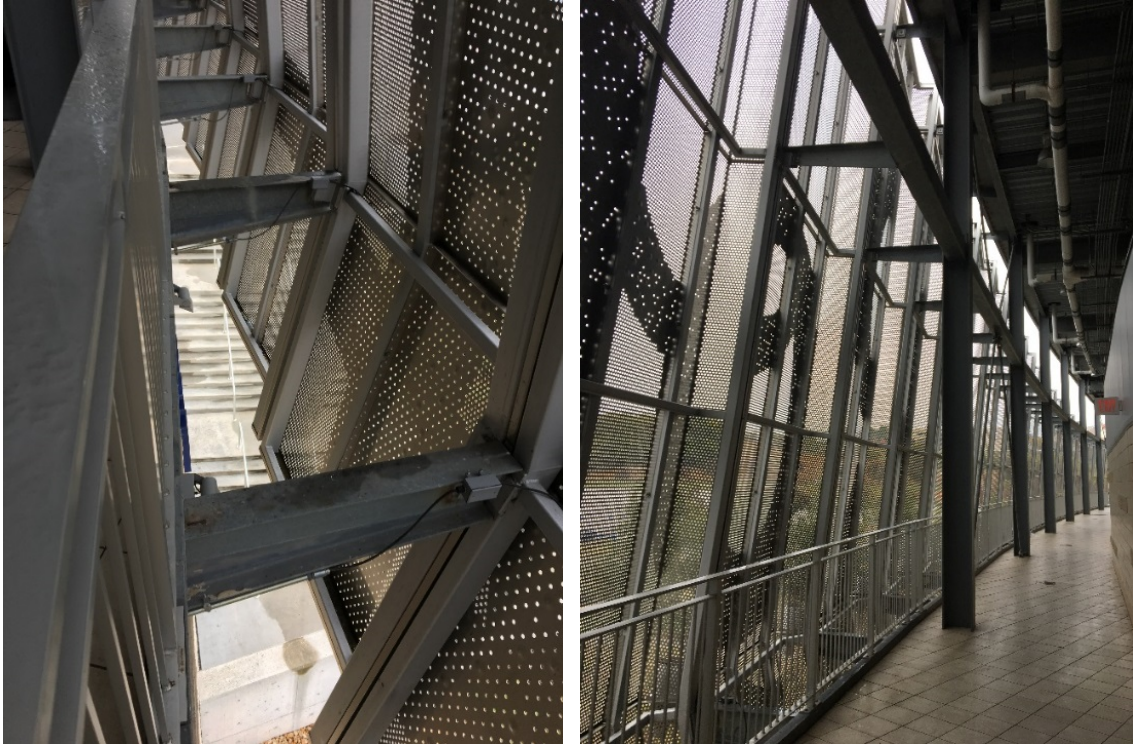
The galvanized sub-structure for the perforated metal panel system appears to be free of corrosion or rust in general. However, small areas of rust are beginning to develop in some locations, as shown in [Figure AF-7](#) (right). Additionally, trash was observed in the crevice between the perforated metal panel and the sub frame structure, as shown in [Figure AF-7](#) (right).

**Figure AF-7: External Perforated Metal Panel Systems Details, Trash Observed in Base Frame (right)**

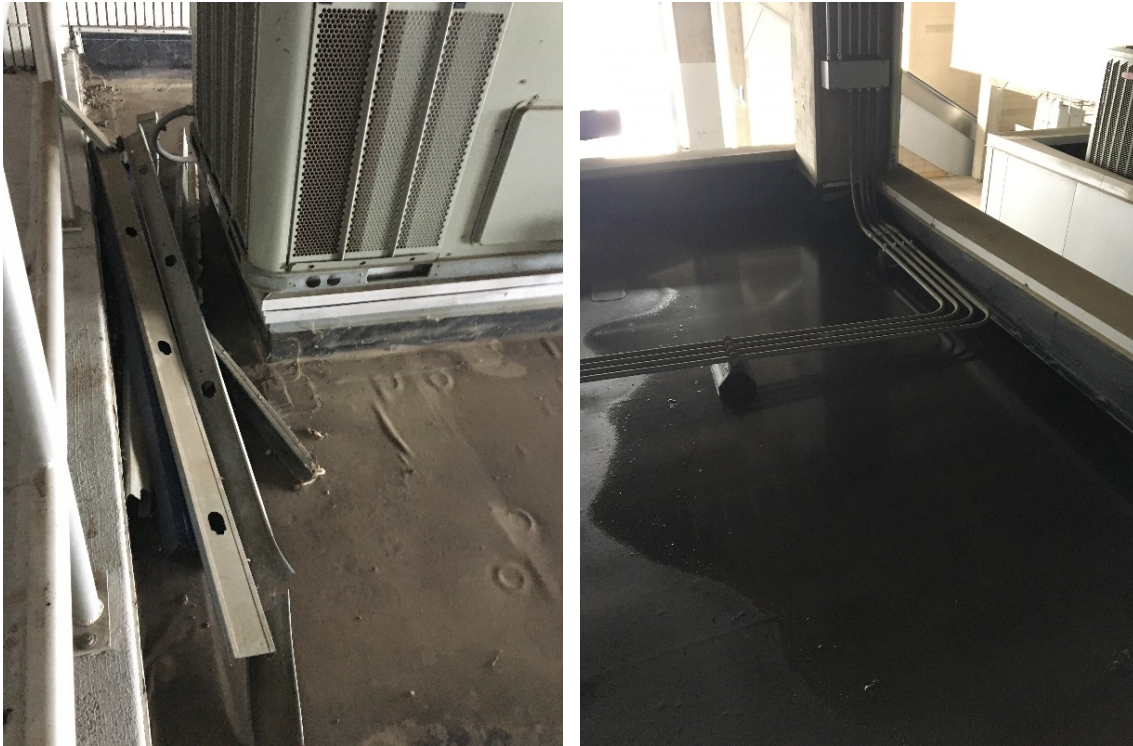
Roofing membranes appear to be in satisfactory condition. Roofing membranes observed were free of rips, tears, or defects. However, construction debris was observed at the catwalk area between the roof and HVAC unit at the Writing Press Level, as shown in [Figure AR-1](#) (left). Additionally, standing water was observed at the same catwalk, as shown in [Figure AR-1](#) (right).

**Figure AR-1: Roofing Membrane (left) and Standing Seam/Perforated Metal Panel (right)**

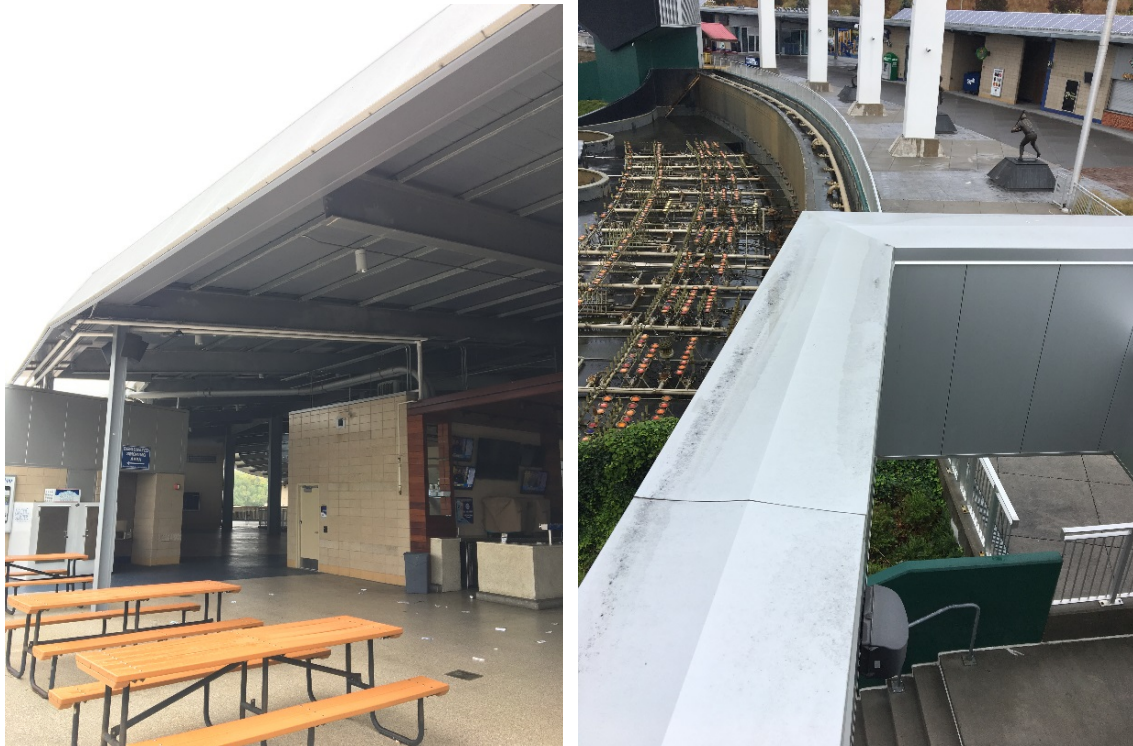
Coping and fascia panels at roof eaves and parapets were observed to be in satisfactory condition, typically. Rust at the View Level bar areas, noted in the 2015 assessment, appear to have been addressed and repainted to avoid further degradation, as shown in **Figure AR-2** (right).

**Figure AR-2:** Roof Coping at Outfield Experience (left), Fascia Panels at Roof Eaves (right)

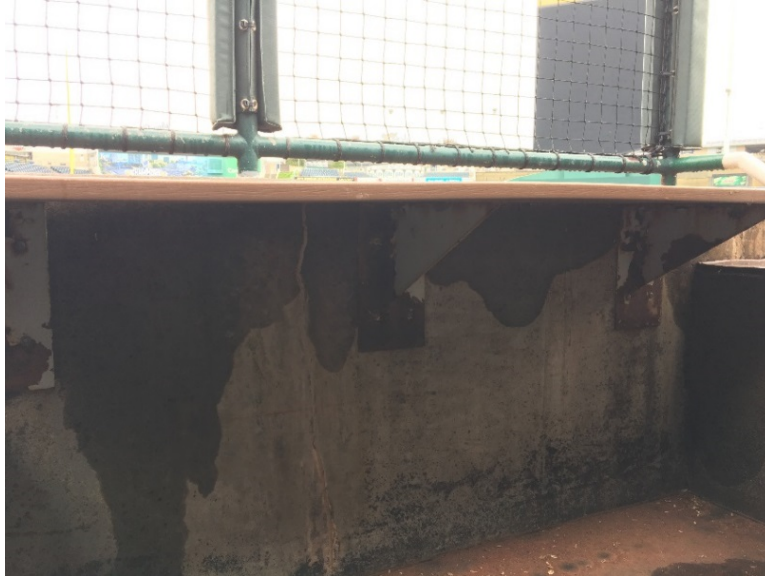
At the home dugout, the platform structure paint was observed to be chipping off and exposing the raw steel as shown in **Figure AME-1**. The steel shows surface rust, which if not properly treated will eventually compromise the structural integrity of the supports. This may be a safety issue if not properly maintained, due to multiple players or coaches standing on this structure.

**Figure AME-1: Rust at Home Dugout Bench/Platform**

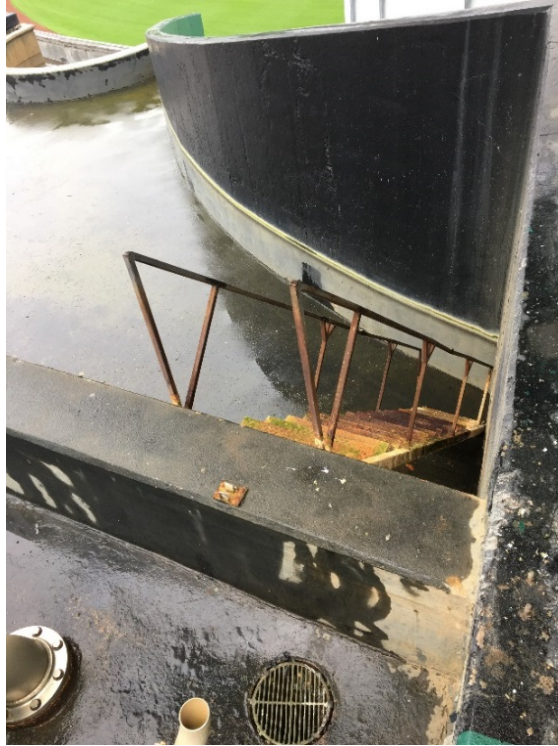
At the East fountain, rust was observed on the metal stair leading into the pool as shown in **Figure AME-2**. It is unclear to what extent the rust has damaged this stair, however, if the rust has weakened any portion of this stair structure it may pose a potential safety hazard. It is advisable that in the very near future this stair be replaced with a new stair or ladder constructed of stainless steel or another material which will be more suitable for such a corrosive environment.

It should also be noted that the West fountain stair was observed to be in roughly the same condition. The structural integrity of both stairs is questionable.

**Figure AME-2: Severe Rust at East Fountain Stair**

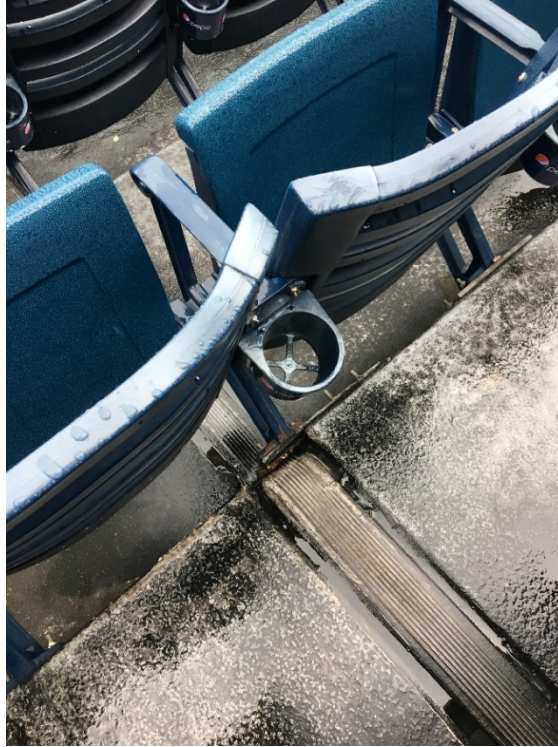
Generally speaking, the expansion joint seals appeared to be in satisfactory condition. However, minor leaking was noted in the batting tunnels at the Clubhouse Level which appears to be due to anchor bolts which penetrate these seals at the plaza level seating as shown in [Figure AI-3](#). This is likely a condition at multiple locations throughout the stadium, as a result of the design and construction.

**Figure AI-3: Expansion Joint at Plaza Level Seating Bowl**

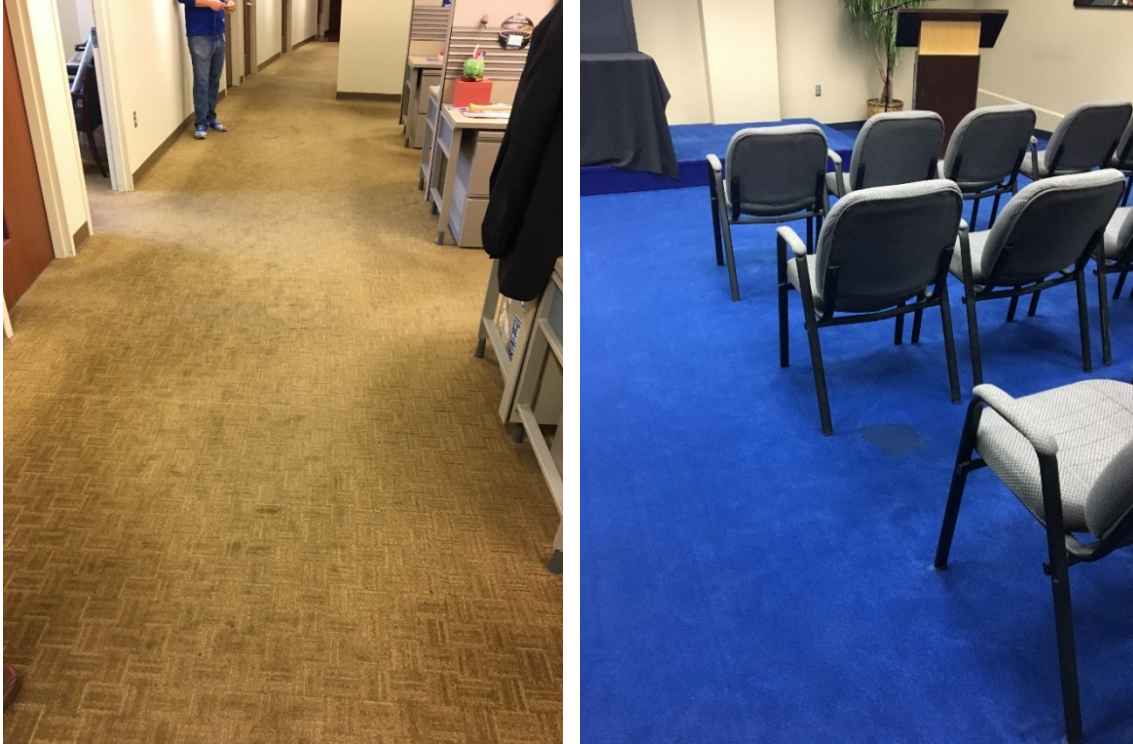
Carpet flooring was generally observed to be in satisfactory condition. No signs of rips, tears, or discoloration were observed. A few stains were observed at the clubhouse level media room, as shown in [Figure AI-4](#) (right).

**Figure AI-4: Carpet Flooring at Open Office (left) and Clubhouse Media Room (right)**

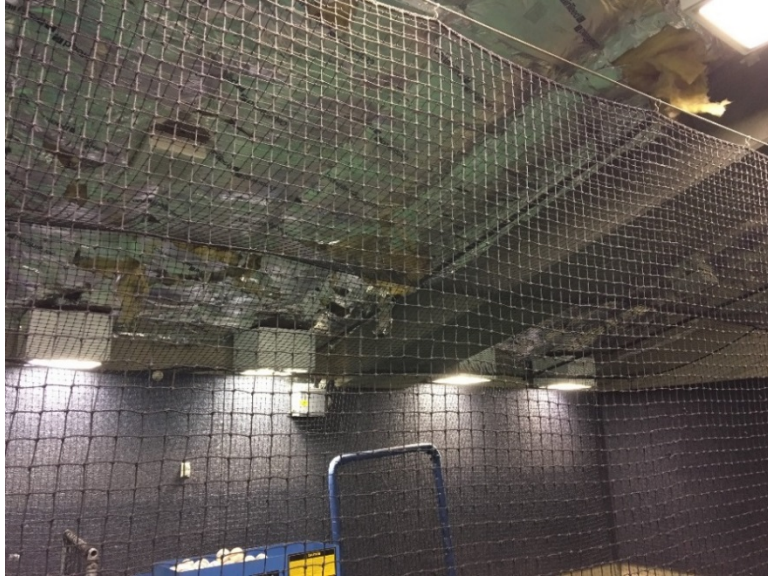
Exposed ceilings appear to be in satisfactory condition, typically. However, several foil faced batt insulation pieces at the Clubhouse Batting Tunnels were observed to be hanging down, as shown in [Figure AI-8](#). This may be in part due to baseballs hitting the ceiling, through the net. However, it may also be a result of leakage through the plaza level seating anchors as previously described and shown in [Figure AI-3](#).

**Figure AI-8: Foil Faced Batt Insulation at Clubhouse Batting Tunnels**

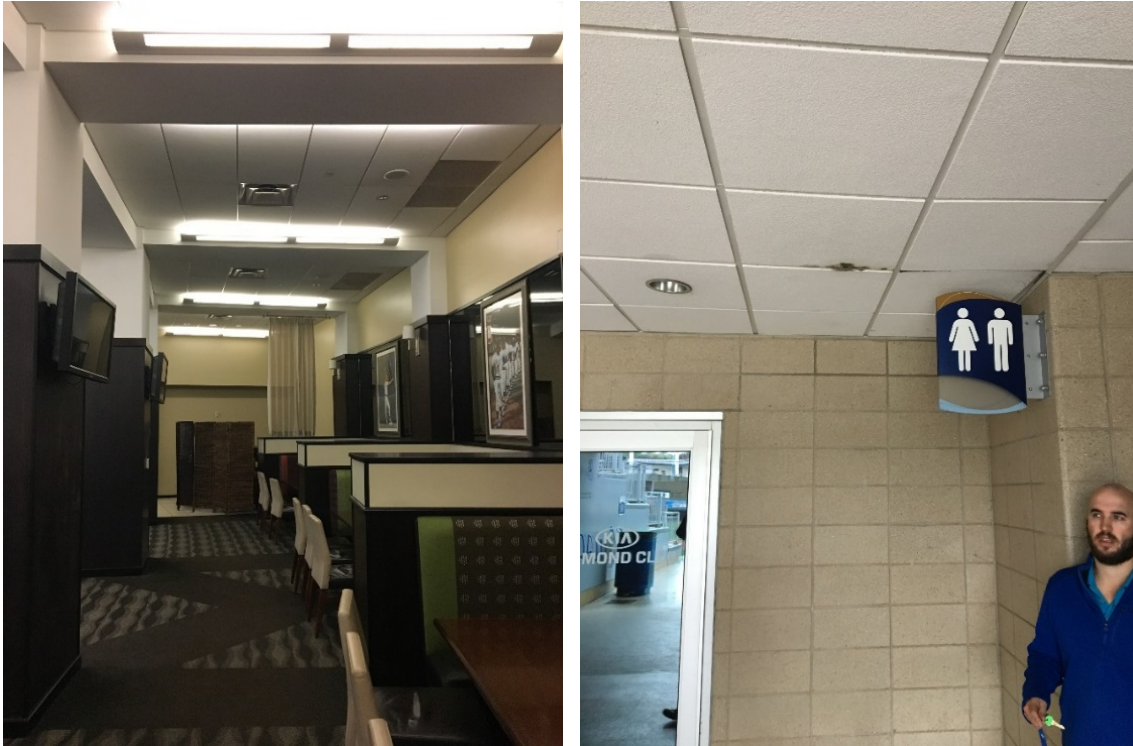
Acoustical ceiling tiles appear to be in satisfactory condition, generally. Refer to **Figure AI-10** (left) for typical condition at observed interior ACT ceilings. Exterior ceiling tiles leading out of the central elevator lobby area at the Service Level were observed to be stained, as shown in **Figure AI-10** (right).

**Figure AI-10: Interior (left) and Exterior (right) Acoustical Ceiling Tiles**

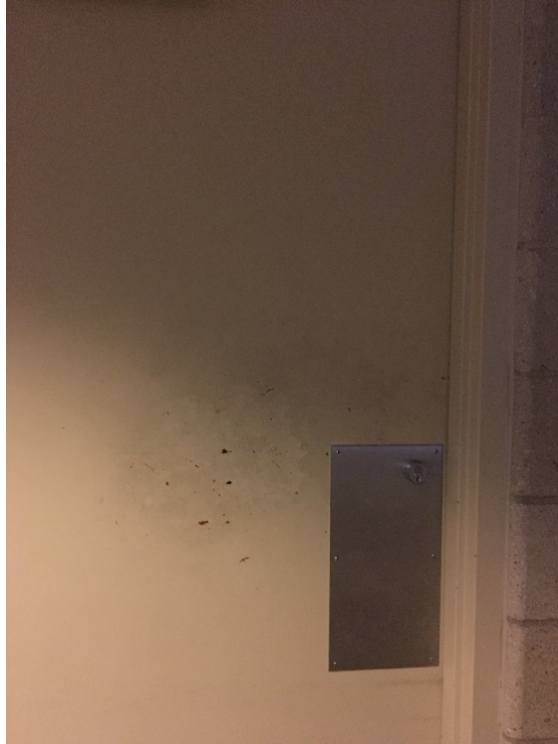
Generally, painted hollow metal doors were observed to be in satisfactory condition. However, at the Men's restroom door located just outside the Diamond Club the hollow metal door was observed to have several scuffs and scratches as shown in **Figure AI-12**.

**Figure AI-12:** Hollow Metal Door at Men's Restroom adjacent to the Diamond Club

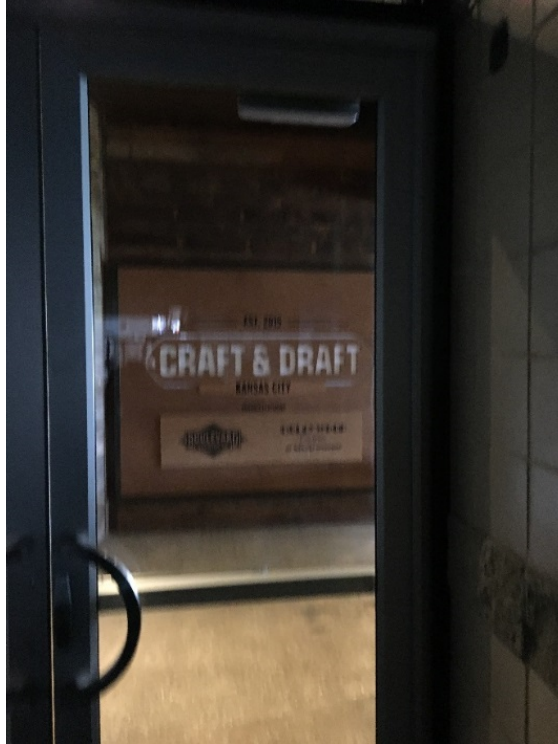
Interior storefront doors were general found to be in satisfactory condition. It was observed, however, that the aluminum framed glass door at the Craft and Draft bar area did not have a proper door stop installed or engaged within the closer. This may create a “pinch” point for guest fingers or may also damage the door and/or wall over time. Refer to [Figure AI-13](#).

**Figure AI-13:** Aluminum Framed Glass Door at Craft & Draft Bar

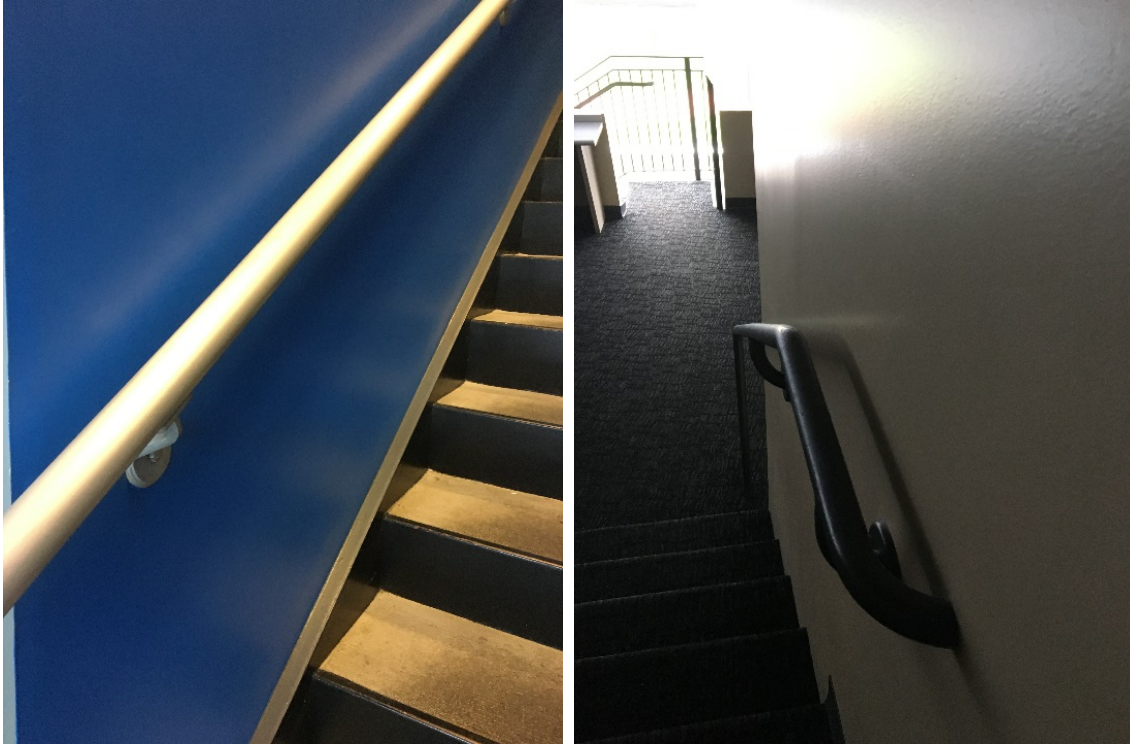
The railing at the stairs leading from the clubhouse corridor to the batting tunnels and home dugout was observed to be loose. Refer to **Figure AMI-1** (left). Additionally, the same condition was observed at the handrail in the Press Dining area, as shown in **Figure AMI-1** (right). These conditions may pose a potential safety concern if the railings were to fail.

**Figure AMI-1: Stair Railing to Home Dugout (left) and Press Dining (right)**

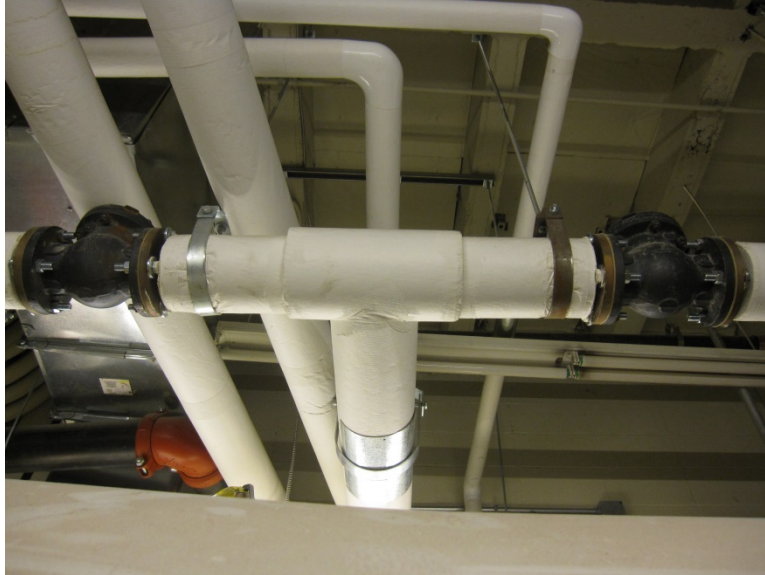
As noted within the 2015 assessment of Kauffman Stadium, several piping insulation shields were not present, as shown in [Figure M-1](#). Over time, the weight of the piping will “crush” the piping insulation thus degrading the effectiveness of the insulation. Evidence of this “crushing effect” has already begun to occur.

**Figure M-1: Piping Hangers Missing Insulation Shields**

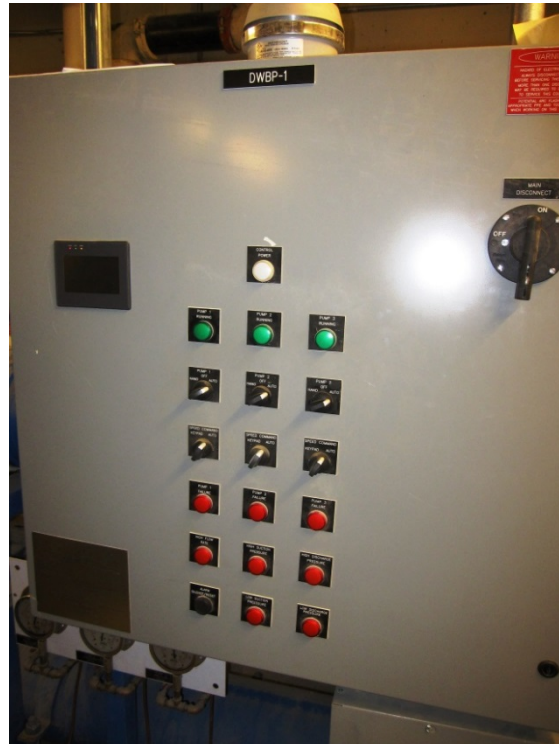
Indication lights were observed to be burned out at the domestic water booster pump control panel, specifically for pump #2 as shown in **Figure M-2**. Pump #1 light was burned out during the 2015 assessment of Kauffman Stadium. This #1 light could not be verified “fixed” during this year’s assessment.

**Figure M-2: Missing Indicator Lights at Domestic Water Control Panel**

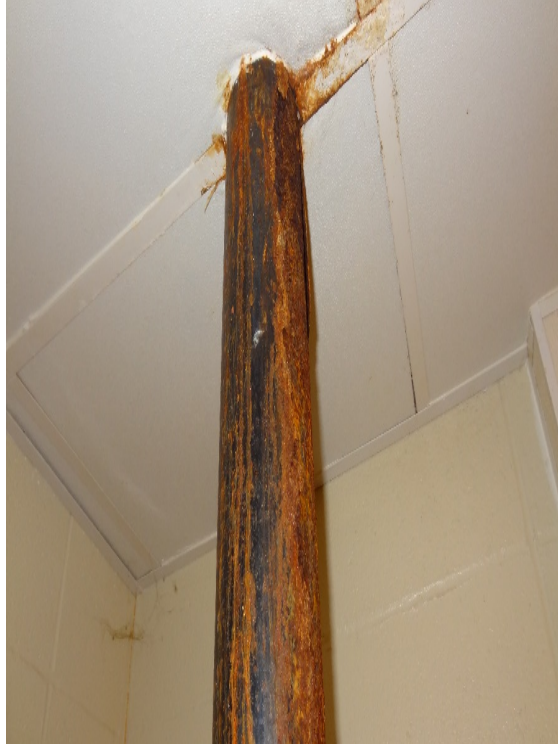
As stated within the 2015 assessment of Kauffman Stadium, the steel piping associated with this dry-pipe system has severe corrosion/deterioration. **Figure M-4** shows the level of severity of this pipe. Layers of exterior piping have corroded away, leaving a thinner piping sidewall. This corroded, thinner pipe wall is under high pressure. As previously stated, we **STRONGLY** recommend addressing or replacing this particular section of piping.

**Figure M-4: Hot Water Boiler Temperature Gauge**

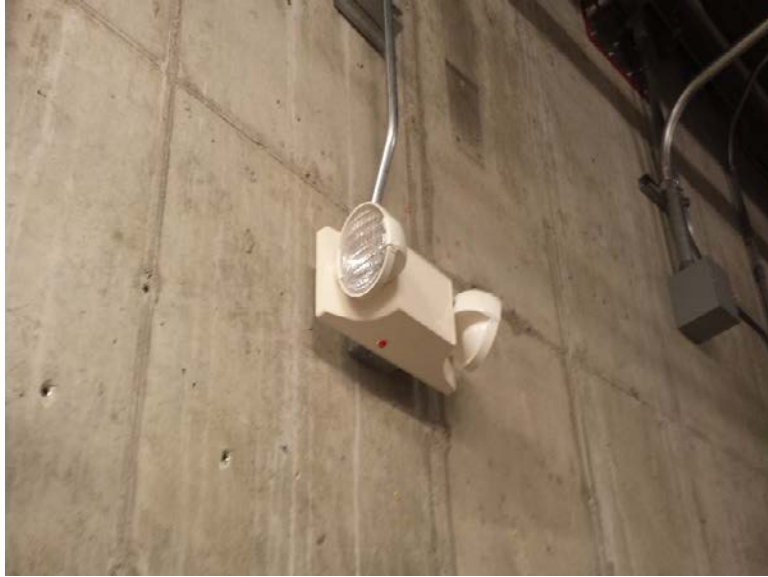
The emergency bug-eyed battery units in the electrical rooms were evaluated in 2015 and found to be non-operational. The assessment performed in 2016 has found that the bug-eyed fixtures have not been addressed and are still non-operational. Refer to [Figure E-1](#).

**Figure E-1: Emergency Bug-Eyed Unit**

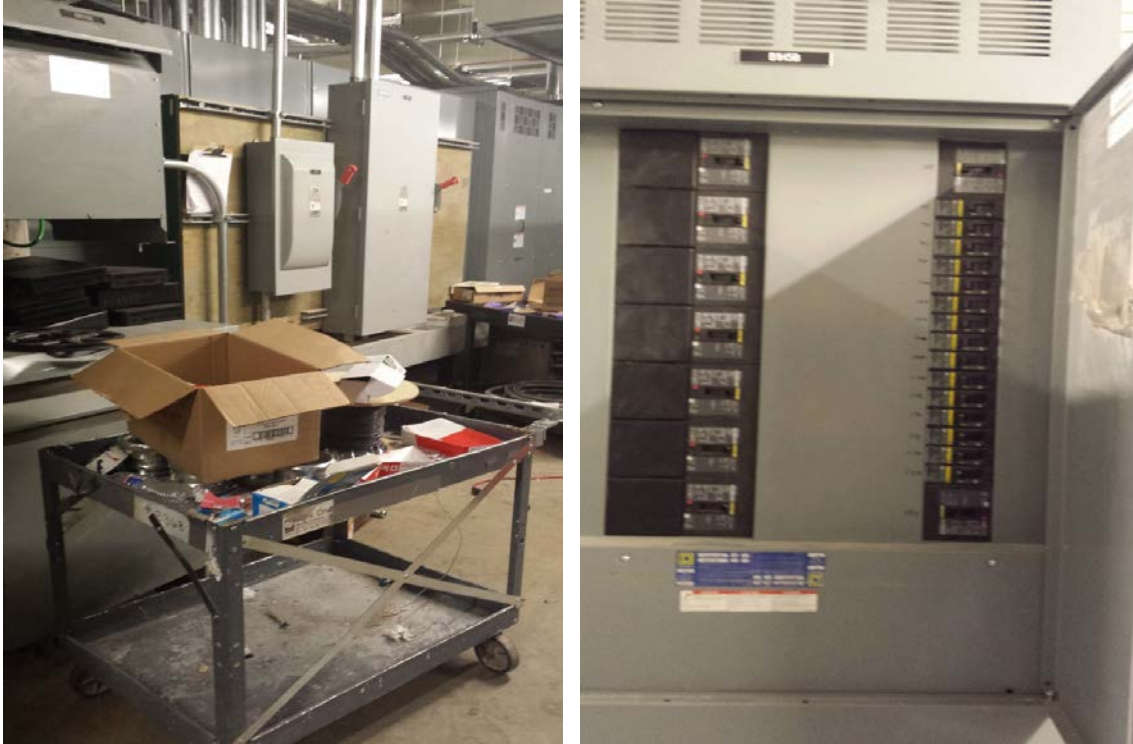
Electrical rooms were evaluated and found to be used as storage, typically. The rooms have equipment and ladders in front of panelboards, inhibiting access and clearance in front of panelboard doors and around equipment. Refer to **Figure E-2** (left).

**Figure E-2:** Electrical Room (left), Panelboard B1H5B Schedule (right)
