# Arrowhead Stadium Assessment

## JCSCA + Burns & McDonnell

This document contains information pertaining to the condition of Arrowhead Stadium as documented by the Jackson County Sports Complex Authority (JCSCA), including descriptions, conditions, and exhibits which have been reviewed by Burns & McDonnell and documented in this report.

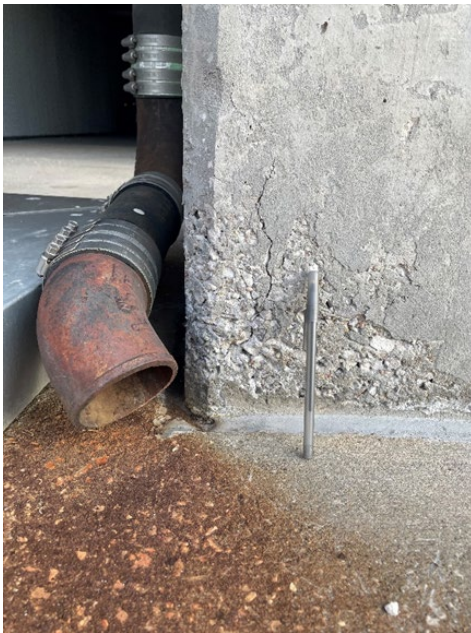
The most common site defect observed on site was rusted metal features and discolored concrete due to the rusted features. This feature is assumed to be an overflow roof drain and should therefore only be active when there is significant ponding on the roof. Inspection of the primary roof drains is warranted. The rusted roof drain downspout is shown in **Figure C-1.1** conveys water toward the GEHA Gate. This concrete discoloration spans the area shown in **Figure C-1.2**.

**Figure C-1.1:** Concrete Discoloration and Eroded Concrete Column  
**Location:** Outside of Security, Between Gate C & T-Mobile Gate

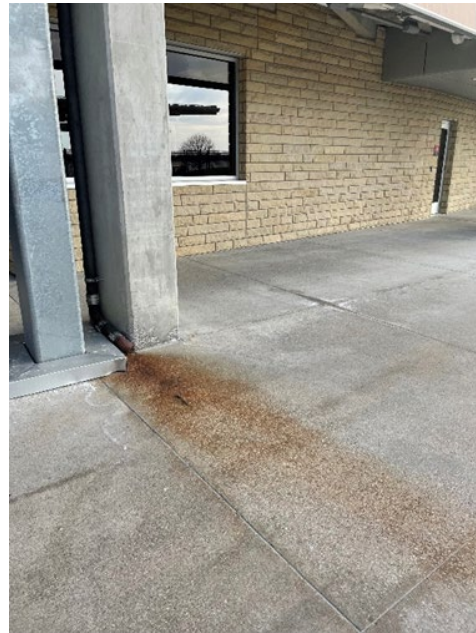
**Figure C-1.2:** Wider View of Figure C-1  
Concrete Discoloration  
**Location:** Outside of Security, Between Gate C and T-Mobile Gate

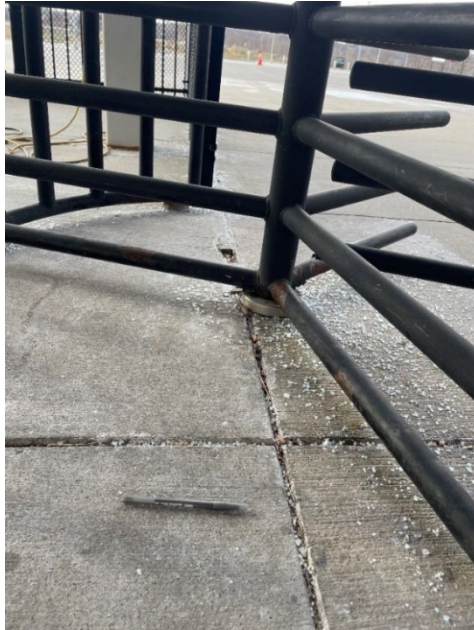
At the pedestrian turnstile at the GEHA Gate, rust and time have eroded the bottom structural elements, shown in **Figure C-2.1**, **Figure C-2.2** and **Figure C-2.3**. Other examples of discoloration are seen in **Figure C-3**, on the GEHA Gate canopy column.

**Figure C-2.1:** Rusted, Deteriorated Pedestrian Turnstile  
**Location:** GEHA Gate

- Rusted Pedestrian Turnstile will need to be replaced, as shown in **Figure C-2.1, Figure C-2.2, Figure C-2.3** and **Figure C-3**.
- Tripping hazards shall be removed, brought to visual attention, or altered such that passersby will not have the opportunity to trip, or will have appropriate visual warning when approaching a noted tripping hazard, as shown in **Figure C-4, Figure C-5, and Figure C-6**.

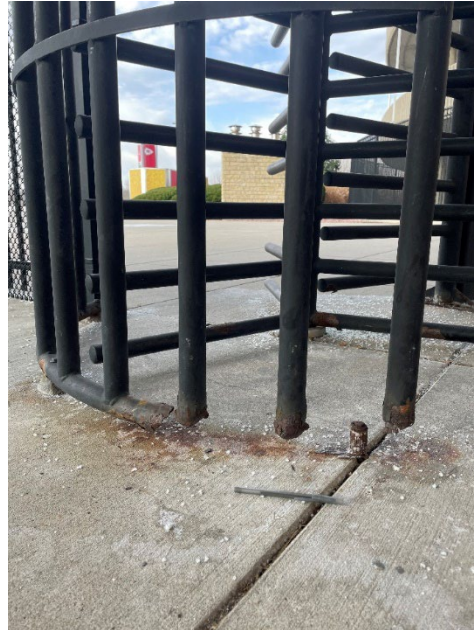
**Figure C-2.2:** Rusted, Deteriorated Pedestrian Turnstile  
**Location:** GEHA Gate

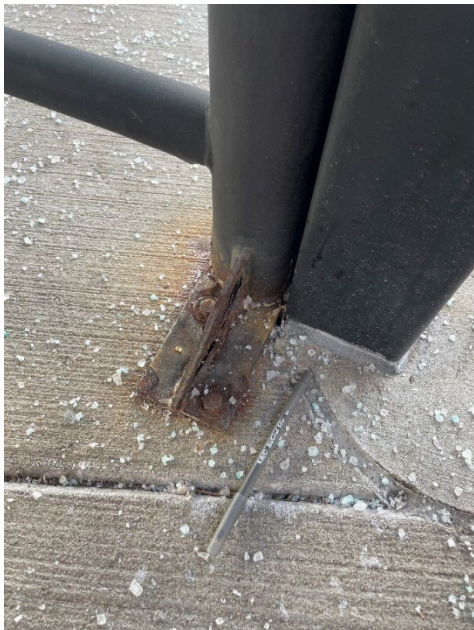
**Figure C-2.3:** Rusted, Deteriorated Pedestrian Turnstile  
**Location:** GEHA Gate

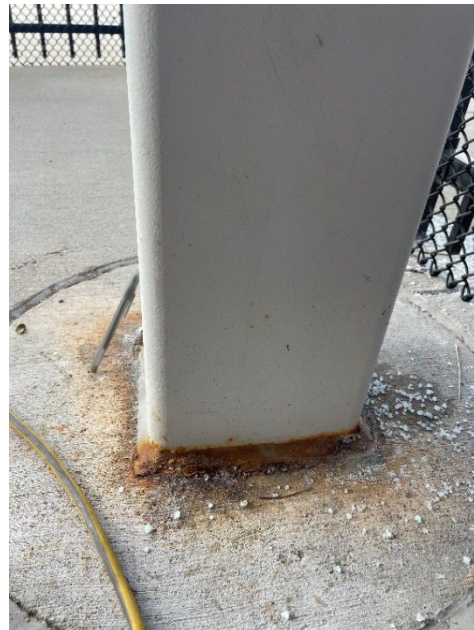
**Figure C-3:** Discolored Sealant on Canopy Post  
**Location:** GEHA Gate

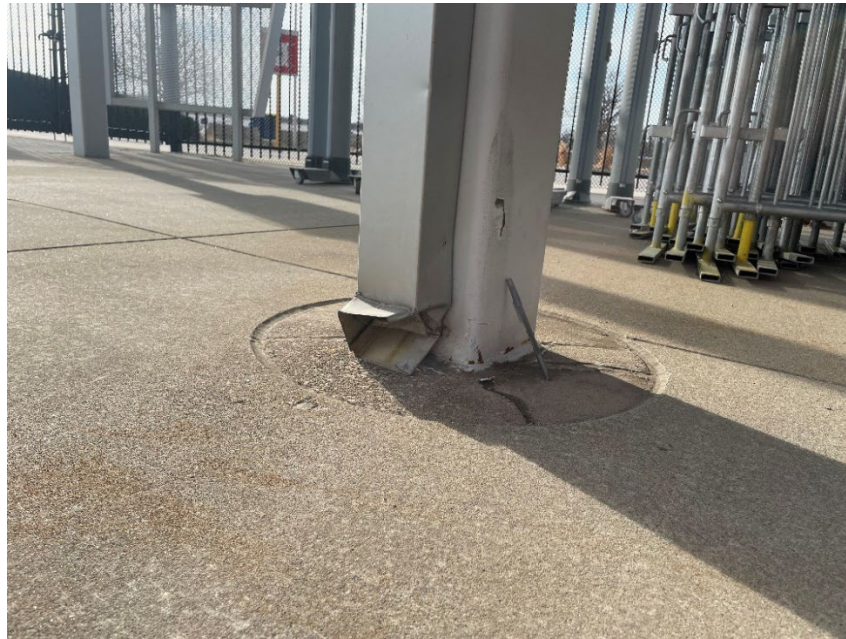
An example of a non-critical hazard is shown in **Figure C-4**, a dented roof drain, whereas **Figure C-5** shows a metal protrusion extending from the concrete, a high-risk tripping hazard. These protrusions were seen at all gates—their use is unknown.

**Figure C-4:** Dented Rainspout on Canopy Column  
**Location:** GEHA Gate

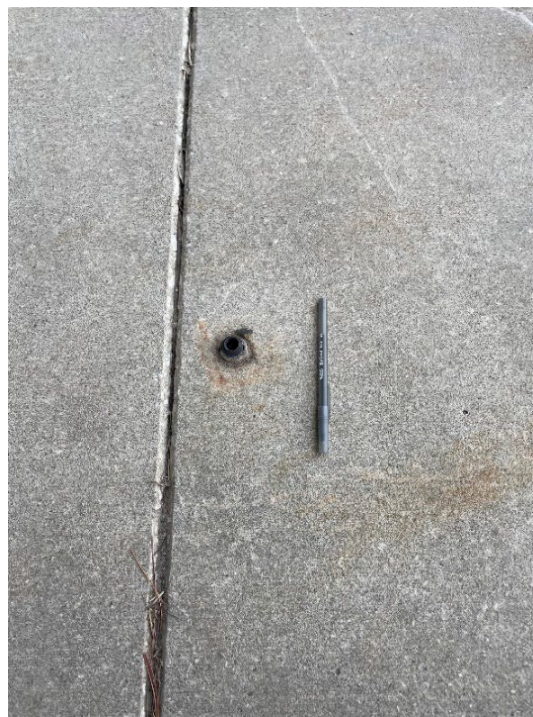
**Figure C-5:** Tripping Hazard, Exposed Metal Piece  
**Location:** All Gates

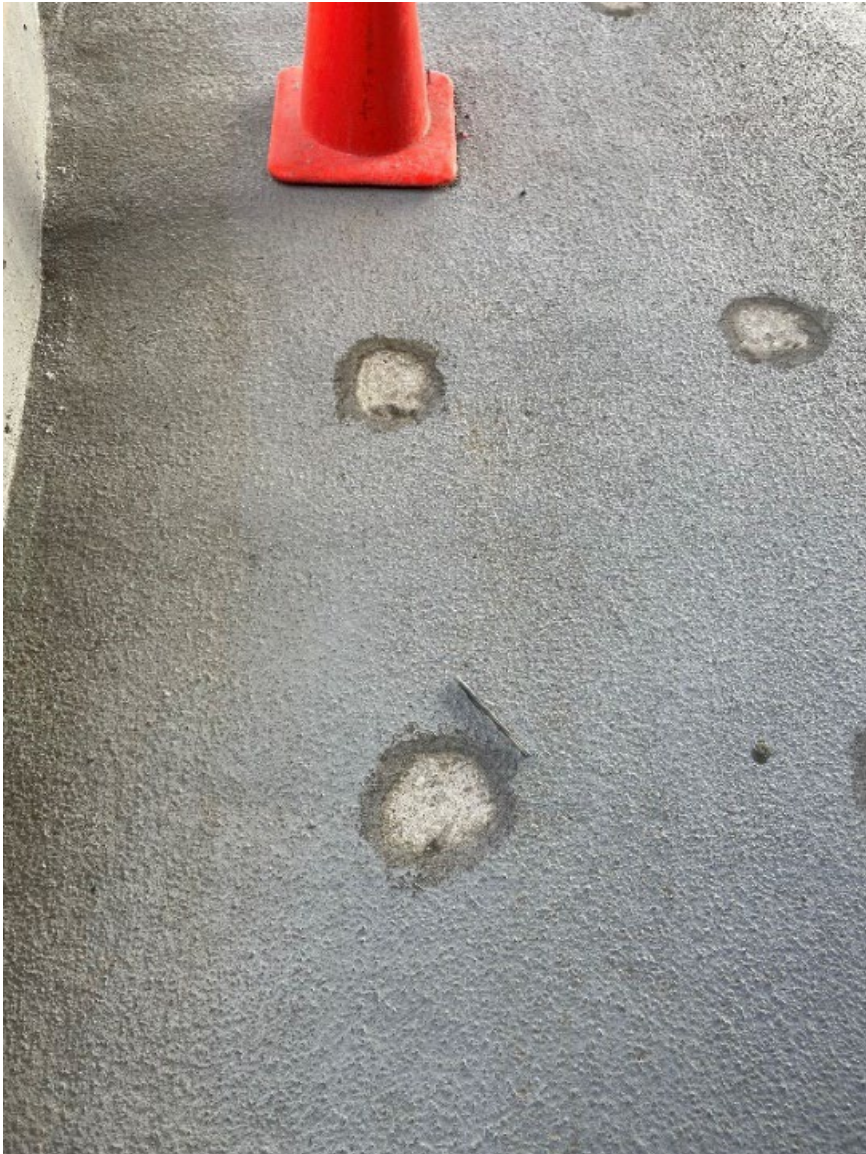
During the assessment, epoxy testing was taking place on the helix ramps. All testing points are potential tripping hazards, see **Figure C-6**.

**Figure C-6:** Epoxy Testing Areas, Tripping Hazard  
**Location:** All Helix Ramps

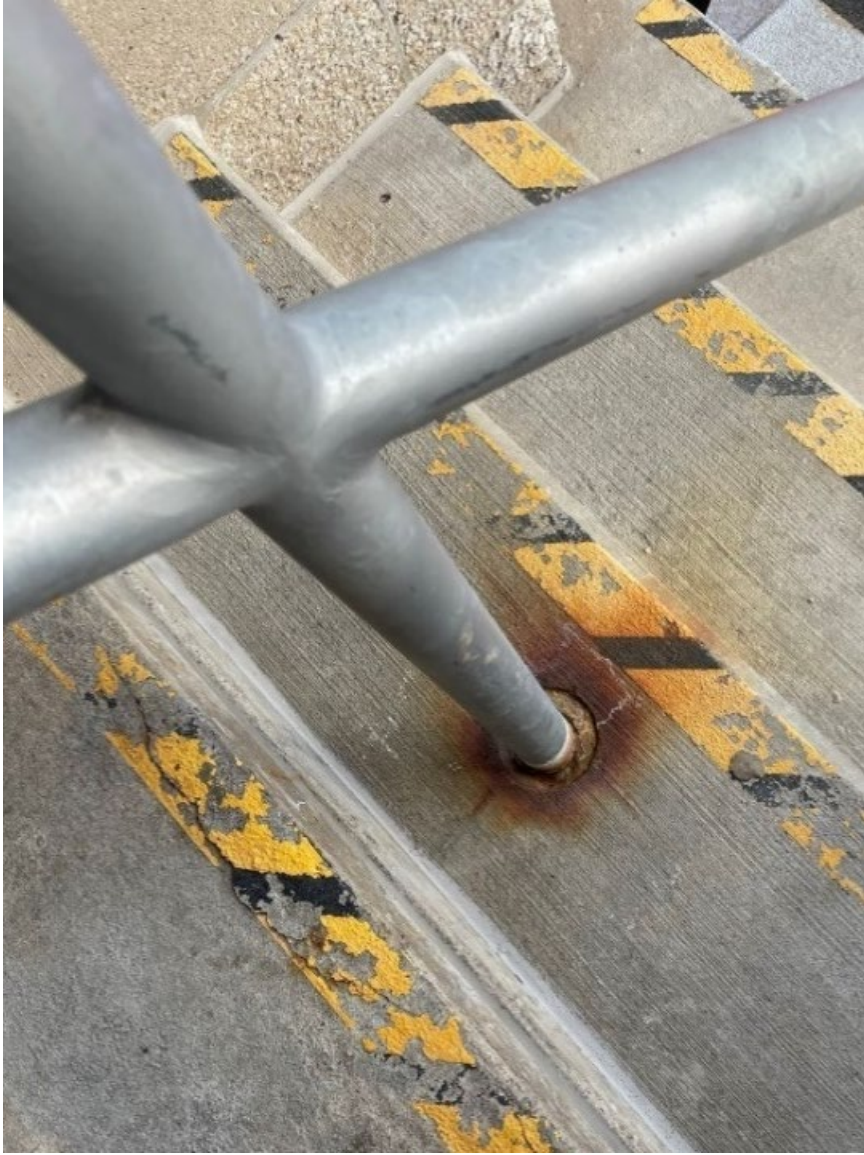
Other site appurtenances on site were evaluated, this included fencing, decorative walls, hand railings, and drainage structures. Minor site defects were observed and most of which was deemed to be in fair condition. **Figure C-7** shows some discoloration and corrosion at the handrail foundation.

**Figure C-7: Rusted Railing Foundation**  
**Location: Fan Zone Seating**

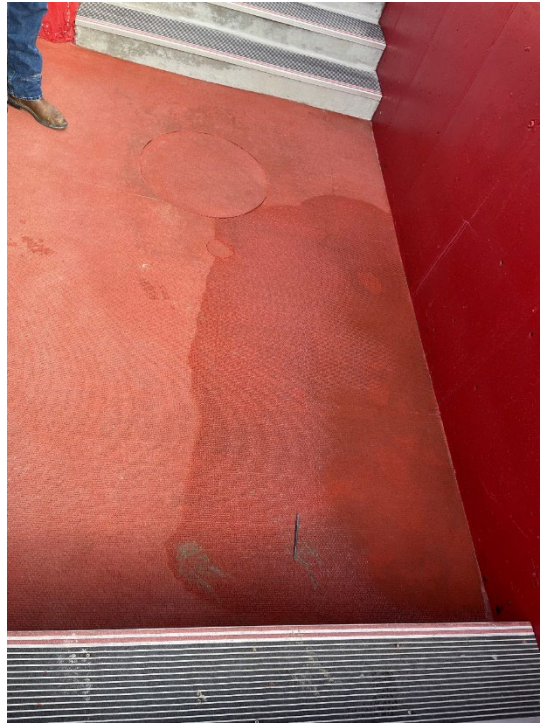
**Figure C-8.1** and **Figure C-8.2** display areas that hold water; this material can pose a greater tripping hazard when wet.

**Figure C-8.1: Wet Walking Area**  
**Location:** Adjacent To Chief's Locker Room Tunnel

- Any areas that are holding water need to be further evaluated to determine the reason for the ponding. See **Figure C-8.1, Figure C-8.2** and **Figure C-11** for examples.

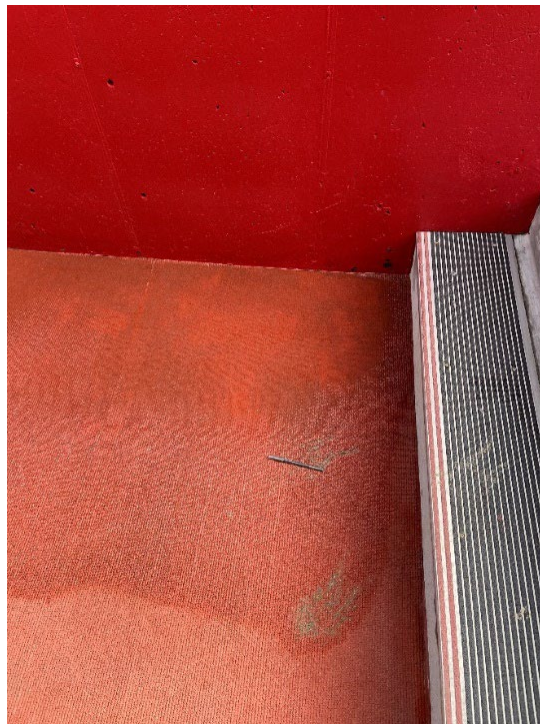
**Figure C-8.2: Wet Walking Area**  
**Location:** Adjacent To Chief's Locker Room Tunnel

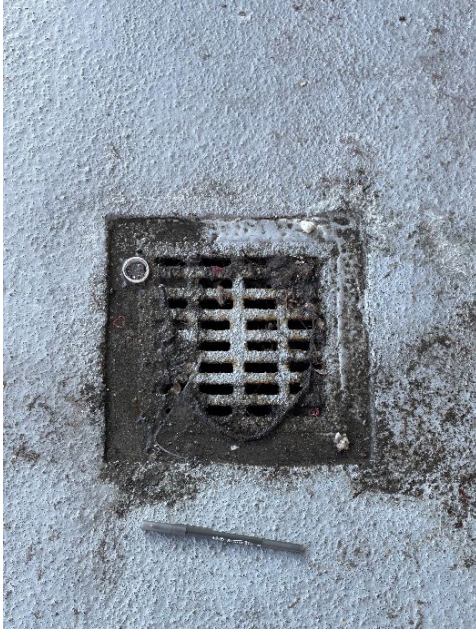
**Figure C-9.1** and **Figure C-9.2** displays an area drain that is covered with trash, debris, dirt, and other blockages which will inhibit proper drainage.

**Figure C-9.1:** Dirty Floor Drain Grate  
**Location:** Upper Concourse

- Clear any area drains from obstructions. Blocked area drains will not allow rainwater to run into and through it's intended structure. See **Figure C-9.1, Figure C-9.2, Figure C-10** and **Figure C-12** for examples.

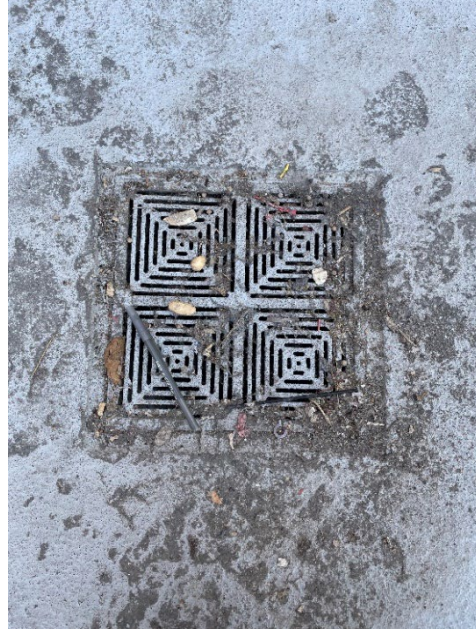
**Figure C-9.2:** Dirty Floor Drain Grate  
**Location:** Upper Concourse

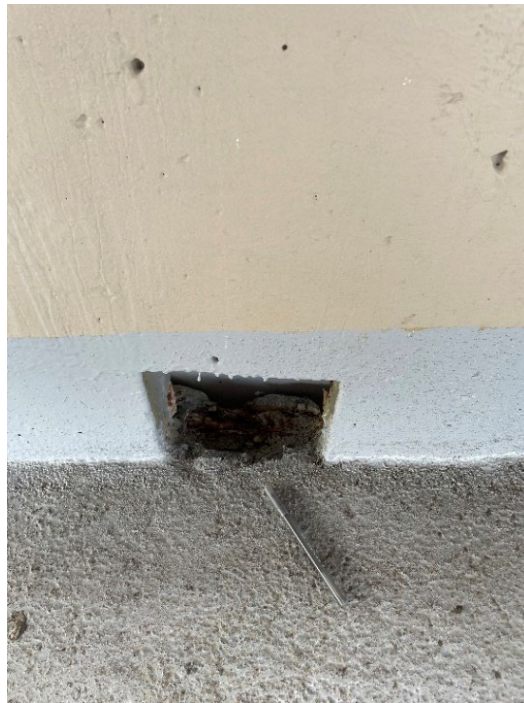
**Figure C-10** shows a drainage port on the interior curve of the helix ramp that has started to rust.

**Figure C-10:** Drainage Ports Rusted  
**Location:** All Helix Ramps

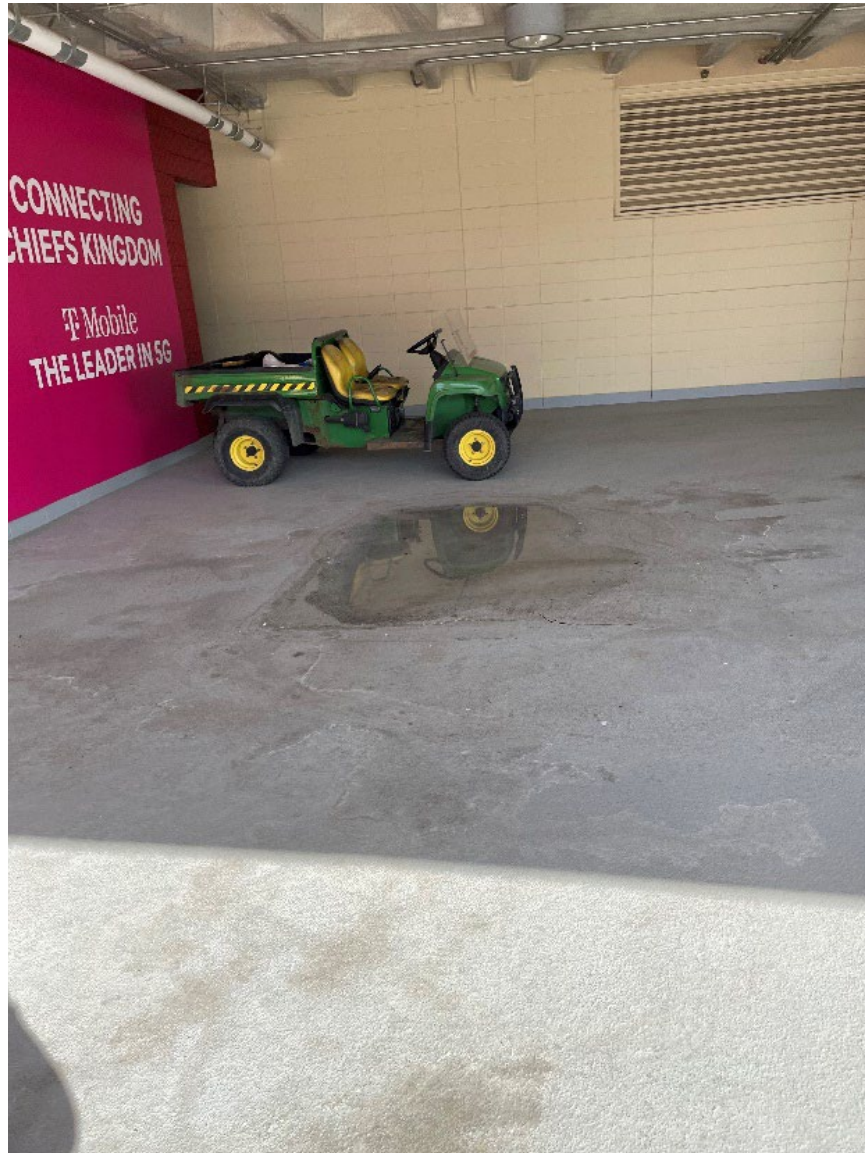
Site drainage was evaluated inside of the security fence. In addition to [Figure C-8.1](#) and [Figure C-8.2](#), areas on the upper concourse were holding water at relative low points, shown in [Figure C-11](#).

**Figure C-11: Upper Concourse Holding Water**  
**Location: Top Level, T-Mobile Helix Ramp**

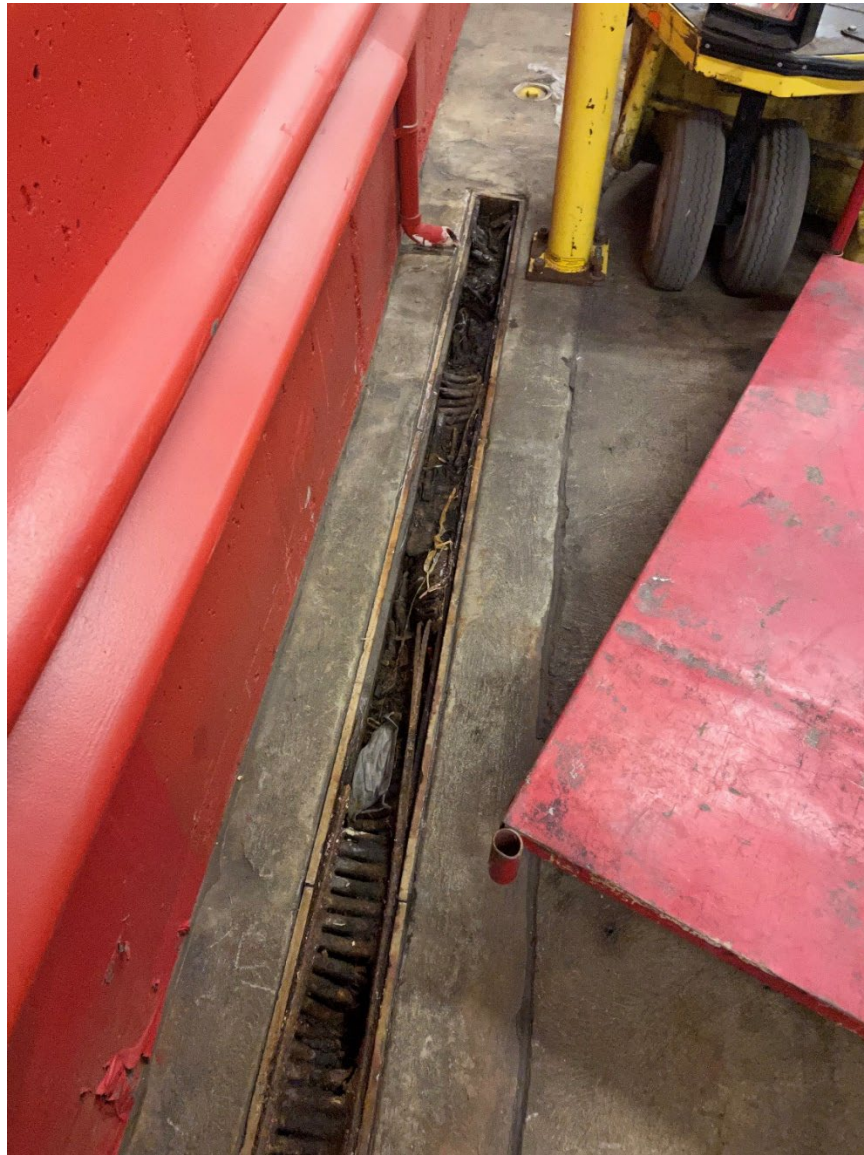
In the underground service corridor, existing trench drains were eroded, broken, dirty, and full of debris, impairing their primary function of conveying water away, shown in **Figure C-12**.

**Figure C-12: Rusted, Deteriorated Trench Drain, Full of Trash**  
**Location: Chief's Side, Underground Service Corridor**

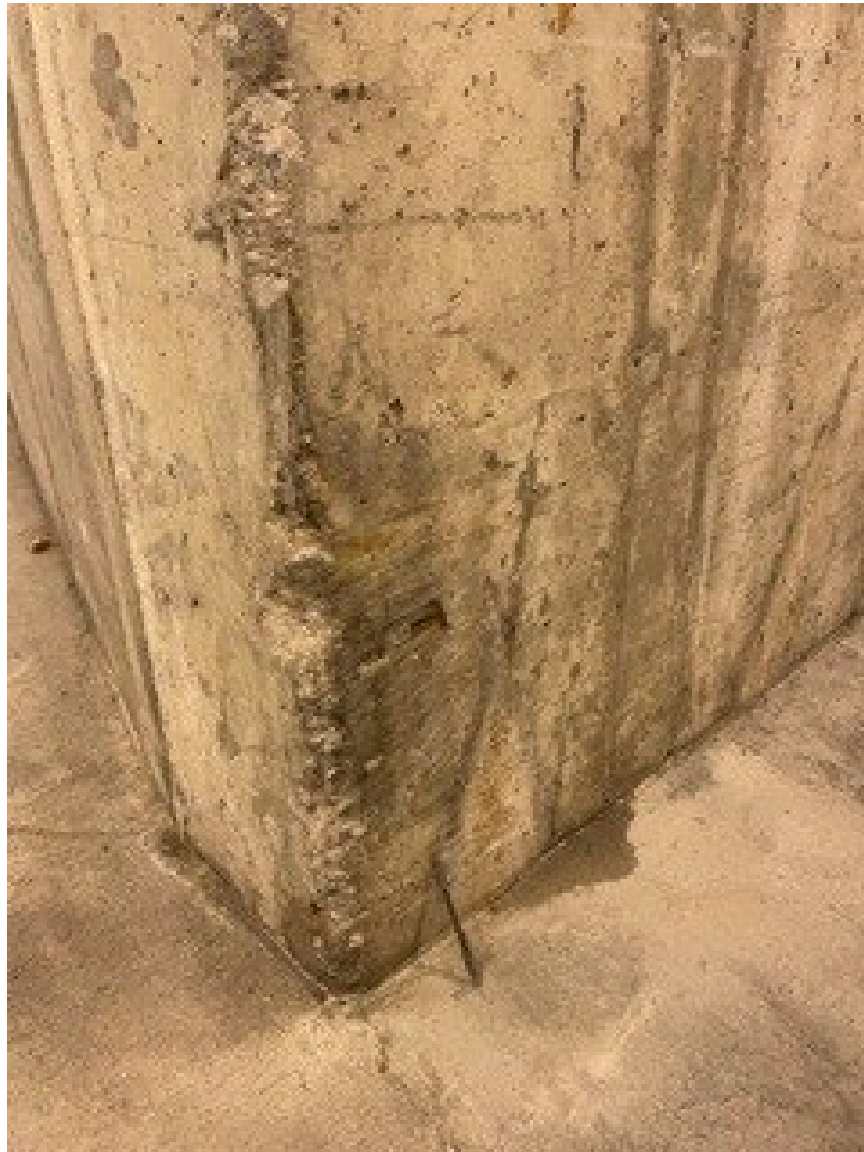
No significant settlement of the structure was observed. The slab-on-grade is primarily in satisfactory condition. No major cracks or spalling of the concrete were observed, however minor spalling was encountered in a few spots as shown in **Figure S-1**. Control joints and expansion joints are in satisfactory condition.

**Figure S-1: Concrete Spalling**  
**Location: Typical Outdoor Spaces**

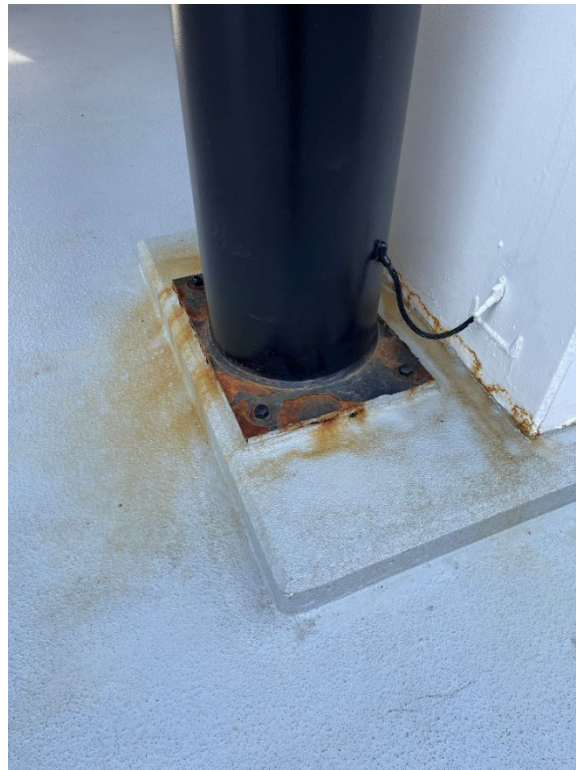
The steel wide flange columns and beams are in satisfactory condition. Rust and corrosion was observed at the base of the column as shown in [Figure S-2](#).

**Figure S-2: Rust & Corrosion of Column**  
**Location: Level 6 Upper Concourse**

- Remove rust and corrosion with wire brush and apply touchup paint in accordance with

manufacturer's instructions to steel column to prevent further corrosion and rust as shown in **Figure S-2**.

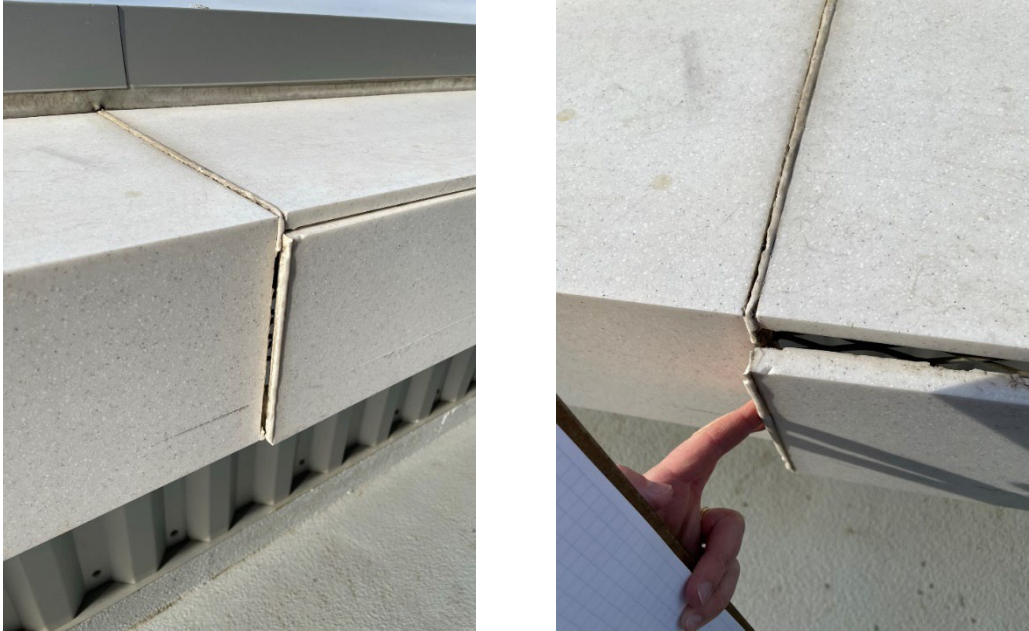
At the outdoor area of the Fan Zone, the stone skirt along the drink rail shown in **Figures S-3**, was loose. If not maintained, this could pose potential hazards to the occupants.

**Figure S-3:** Loose Stone Edge  
**Location:** Level 8 Fan Zone

- Repair handrail anchor supports immediately to avoid life safety concerns as shown in **Figure S-4, Figure S-5, Figure S-6, and Figure S-7**.
- Repair loose stone at drink ledge immediately to avoid injuring occupants below from falling stone as shown in **Figure S-3**.

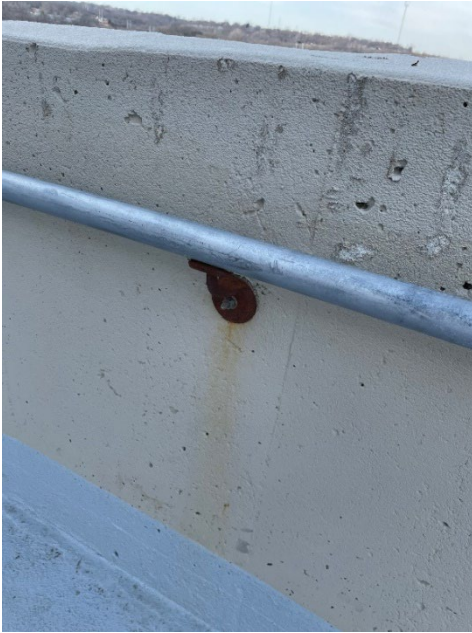
The handrails were observed at various locations throughout the stadium, and specifically along the spiral ramps to have rusted anchors or broken parts. A few examples as shown **Figure S-4.1, 4.2, 4.3 & 4.4.**

**Figure S-4.1: Rusting Handrail Support**  
**Location: All Helix Ramps**

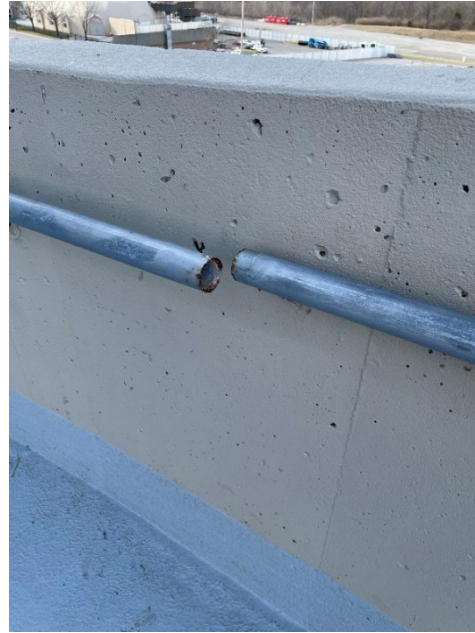
**Figure S-4.2: Broken Connection**  
**Location: All Helix Ramps**

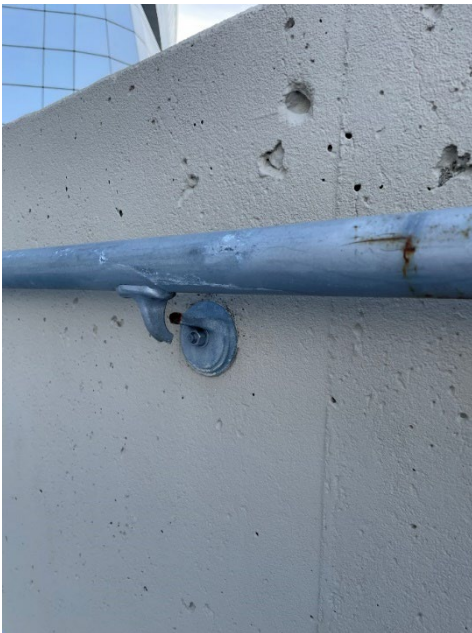
**Figure S-4.3: Broken Handrail Support**  
**Location: All Helix Ramps**

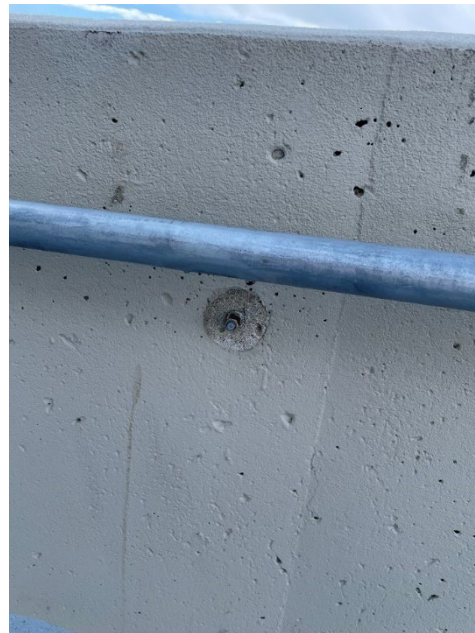
**Figure S-4.4: Missing Handrail Support**  
**Location: All Helix Ramps**

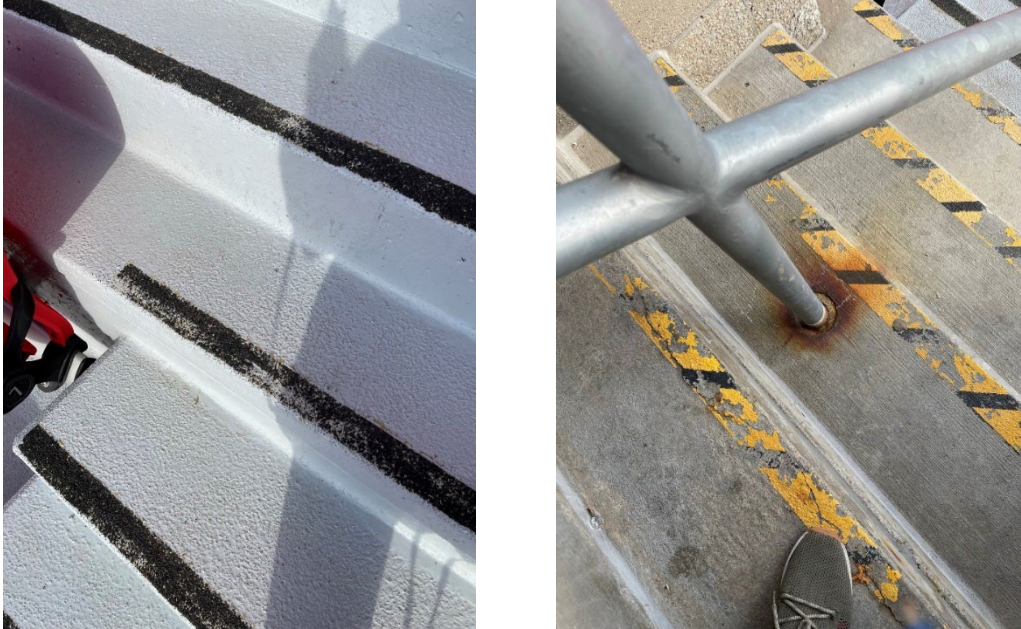
In previous year reports, several stairs within the facility were noted to have missing or partially damaged/torn slip resistant caution tape. Upon observation overall, the current slip resistant tape is in need of repair, as shown in **Figure AME-1**.

**Figure AME-1: Replaced Slip Resistant Caution Tape**  
**Location: Typical at all Bowl Aisles**

In previous year reports, several stairs within the facility were noted to have missing or partially damaged/torn slip resistant caution tape. The condition has gotten worse since previous reports and it is recommended that all slip resistant tape is repaired or replaced to avoid tripping or falling hazard.

- Continue the diligence of tracking down any missing or damaged slip resistant tape as the throughout each season and off-season to maintain proper safety within the facility.

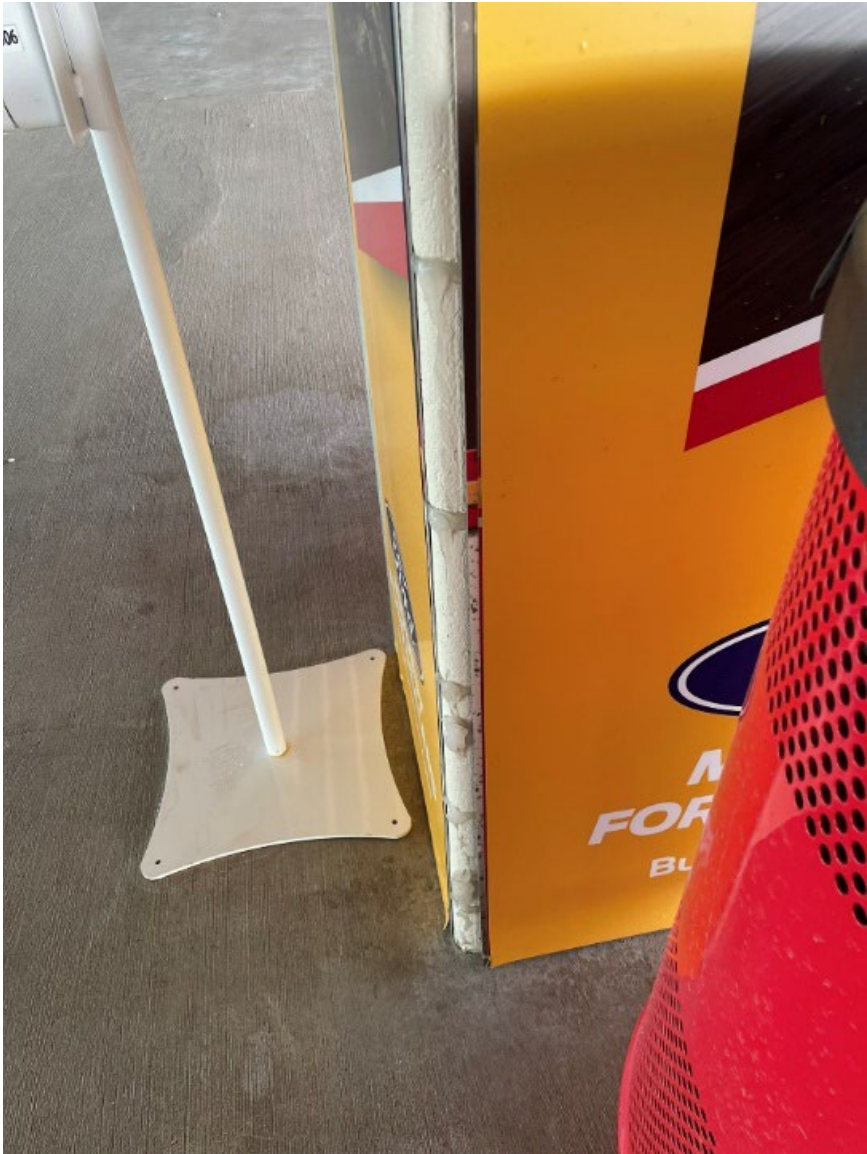
Majority of the columns appear to be in good shape. Noted below is a missing corner guard, as shown in **Figure AME-2**.

**Figure AME-2: Missing Corner Guard**  
**Location: Level 8 - Outdoor**

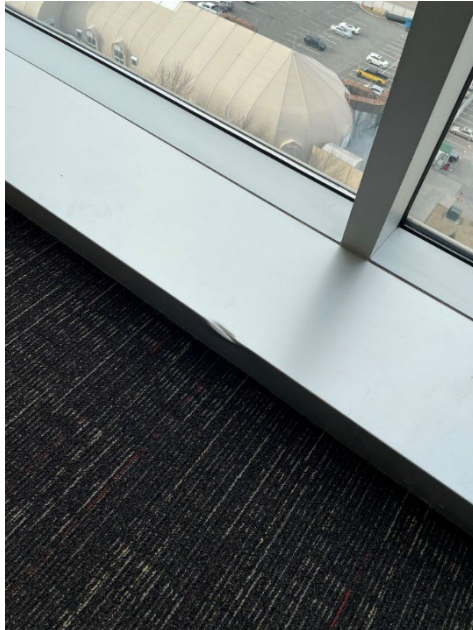
On the Level 9 Press and Penthouse area near the Elevators, as shown in **Figure AMI-1**.

**Figure AMI-1: Dent in Aluminum Storefront**  
**Location: Level 9 Press & Penthouse**

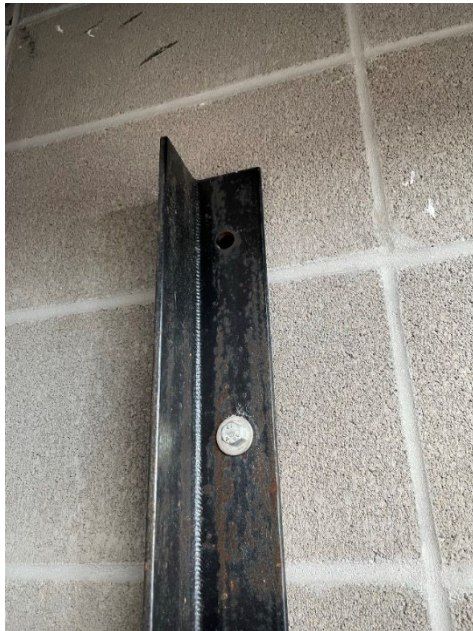
On the Level 8, one of the bolts to a bracket holding a water heater was missing, as shown in **Figure AMI-2**.

**Figure AMI-2: Missing Bolt**  
**Location: Janitor Closet - Level 08 North East**

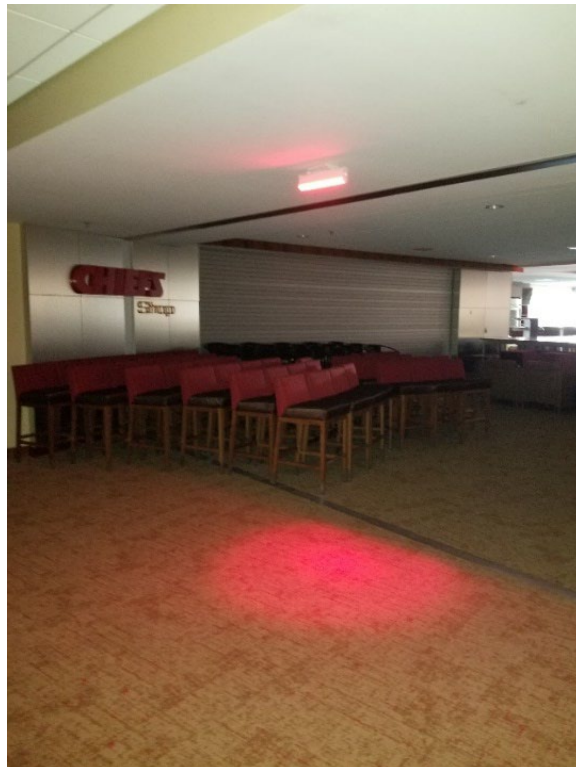
An exit sign on the club level was missing its face near suite 240R as shown in [Figure E-1](#).

**Figure E-1: Exit Sign Missing**  
**Location: Outside Suite 240R**

An exit sign on the club level was missing its face near suite 240R as shown in **Figure E-1**.

- It is recommended to install the exit sign to ensure proper exit sign coverage and spacing per NFPA 101 Life Safety Code.

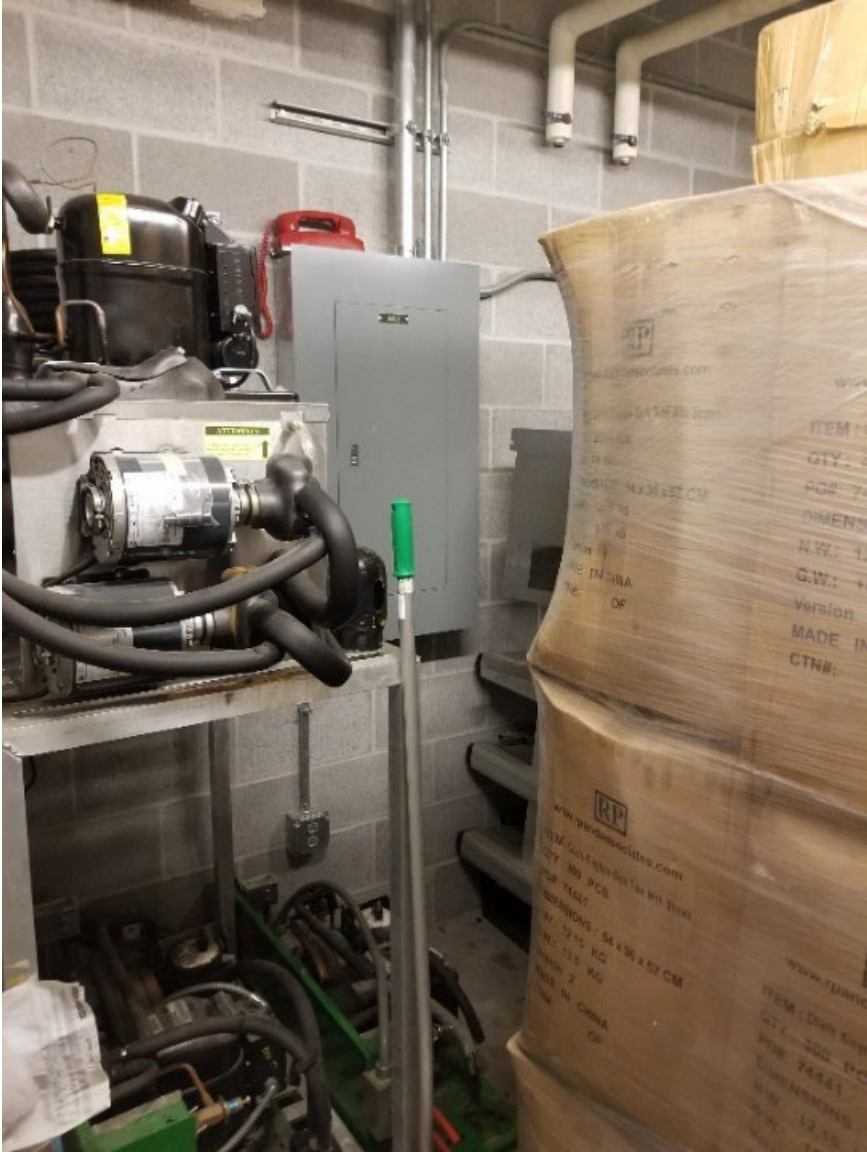
There are boxes stacked in front of panel 3A3L2 in Electrical Room P251, as shown in **Figure E-2**, that impedes the working clearance.

**Figure E-2: Inaccessible Panelboard**  
**Location: Electrical Room P251**

- It is recommended to update panelboard directory indicate load descriptions and spare branch circuit breakers as indicated in the National Electrical Code 2017 (NEC) article 408.4.

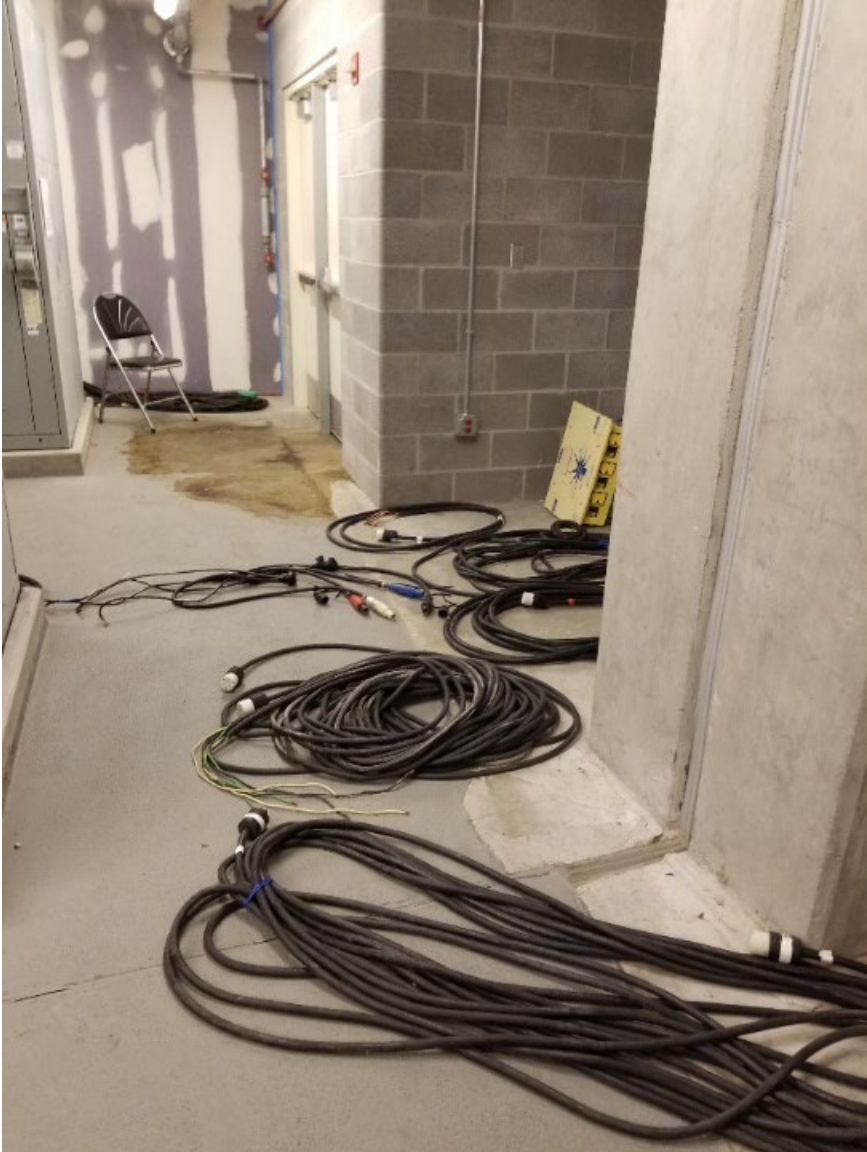
Electrical room 03.42.02, as shown in **Figure E-3**, (P 40) had extension cords on the floor. Floor located power cords pose as a trip hazard.

**Figure E-3: Cords on the Floor**  
**Location: Electrical Room 03.42.02**

Electrical Room 03.42.02 (P 252) had extension cords on the floor. Floor located power cords pose as a trip hazard. Refer to **Figure E-3**.

- It is recommended to clear floor area and store power cords appropriately to avoid tripping conditions in the electrical room.

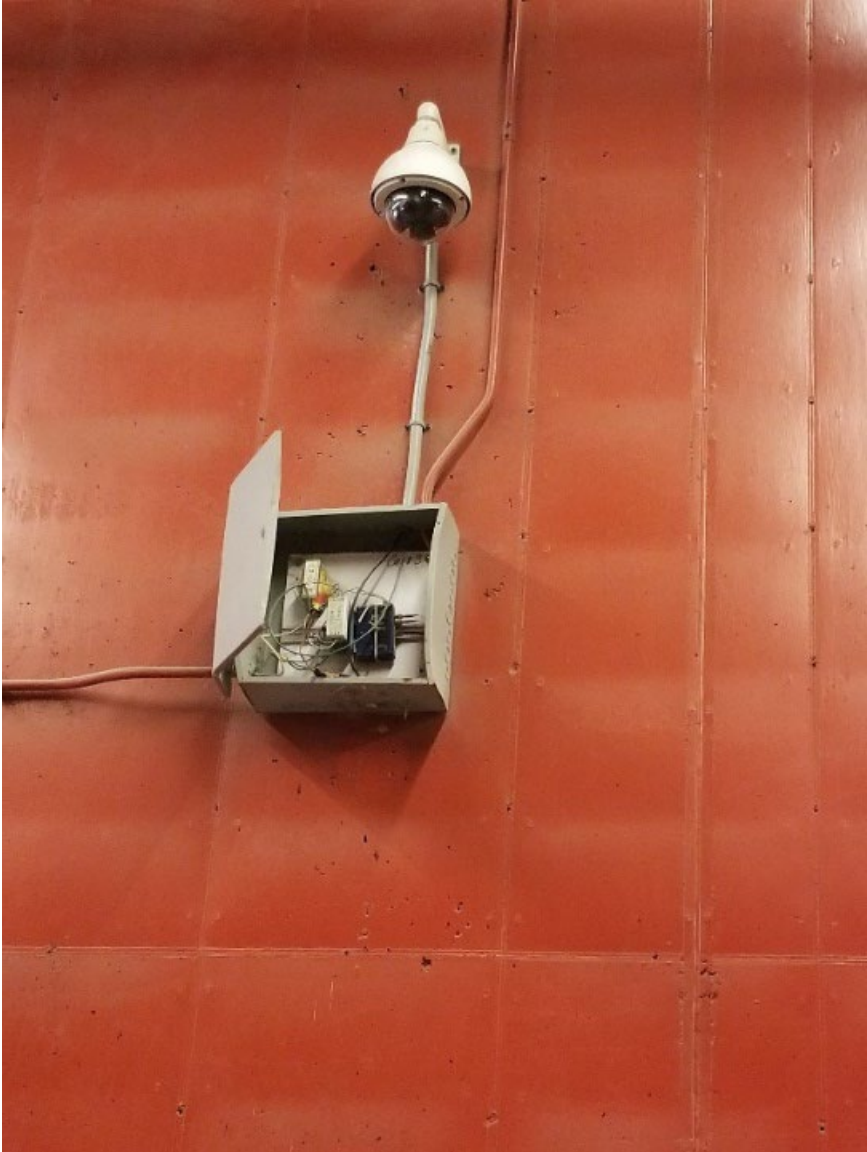
Tunnel 01.55.01 going down to the field has many fire alarm devices, receptacles, and enclosures that have sustained damage from vehicles, as shown in [Figure E-4](#).

**Figure E-4: Exposed Security Enclosure**  
**Location: Tunnel 01.55.01**

Tunnel 01.55.01 going down to the field has many fire alarm devices, receptacles, and enclosures that have sustained damage from vehicles. Refer to **Figure E-4**.

- It is recommended that damaged devices and enclosures be repaired or replaced to prevent damage to the device internal wiring.

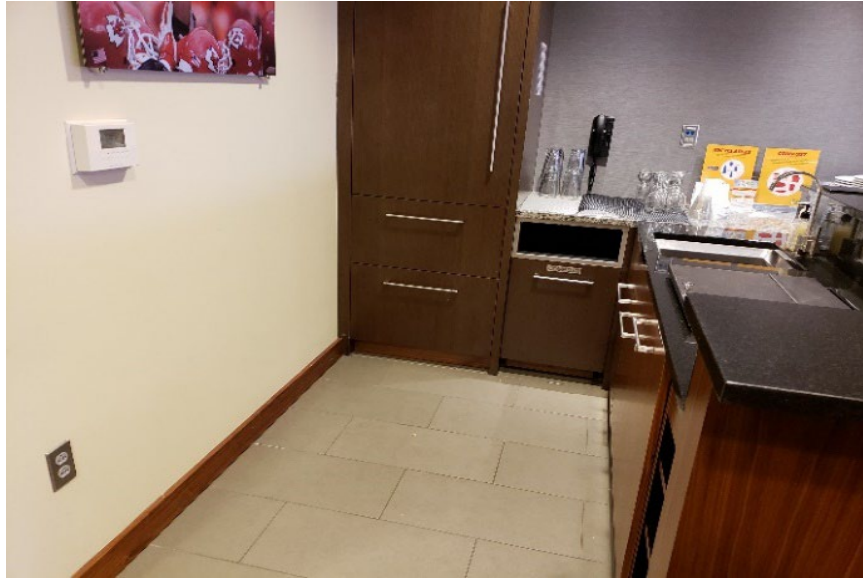
Receptacles within 6'-0" of a sink in suite 04.67.01, as shown in **Figure E-5**, and the 30A twist lock receptacle above the sink in Concessions 06.15.01, as shown in **Figure E-6**, do not appear to be GFCI protected.

**Figure E-5: Receptacle**  
**Location: Suite 04.67.01**

- It is recommended that all devices be GFCI protected if they are within 6'-0" of a sink. Per 2017 NEC.

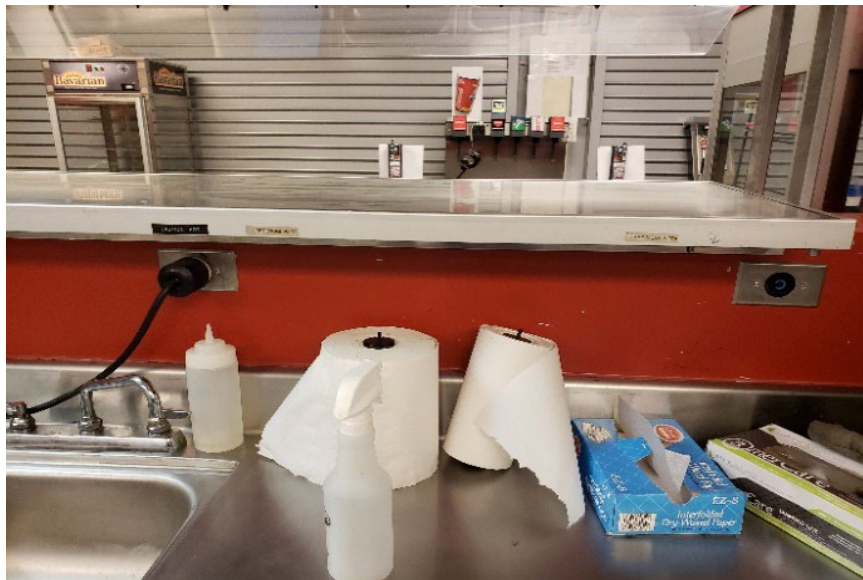
**Figure E-6: Receptacle**  
**Location: Concession 06.15.01**
