# Arrowhead Stadium Assessment | 2014

## JCSCA + Burns & McDonnell

This document contains information pertaining to the condition of Arrowhead Stadium as documented by the Jackson County Sports Complex Authority, including descriptions, conditions, and exhibits which have been written and verified by Burns & McDonnell.

2 / 14 / 2014

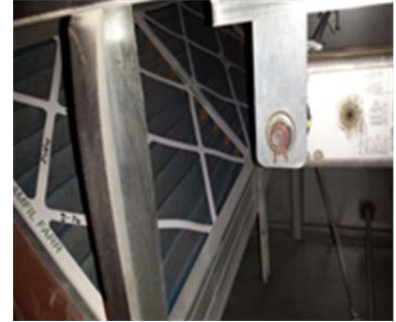
**HVAC Images:**[Exhibit D2.4](#)

- Air Handling Units
  - Deficiencies
    - Filters – On more than one observation the filters appeared to be dirty and past due for replacement. Approximately half the equipment filters were dated with black Sharpie on filter casing at the time of replacement making it easy for maintenance staff to see when filters are out of date when periodic checks are performed. Reference HVAC Images: [Exhibit D2.4](#) (right). It is suggested to replace filters every 3 to 6 months depending on equipment use. Dirty filters and equipment casing were observed as shown in HVAC Images: [Exhibit D2.5](#) and [D2.6](#) (right).
