Arrowhead Stadium Assessment

JCSCA + Burns & McDonnell

This document contains information pertaining to the condition of Arrowhead Stadium as documented by the Jackson County Sports Complex Authority (JCSCA), including descriptions, conditions, and exhibits which have been reviewed by Burns & McDonnell and documented in this report.

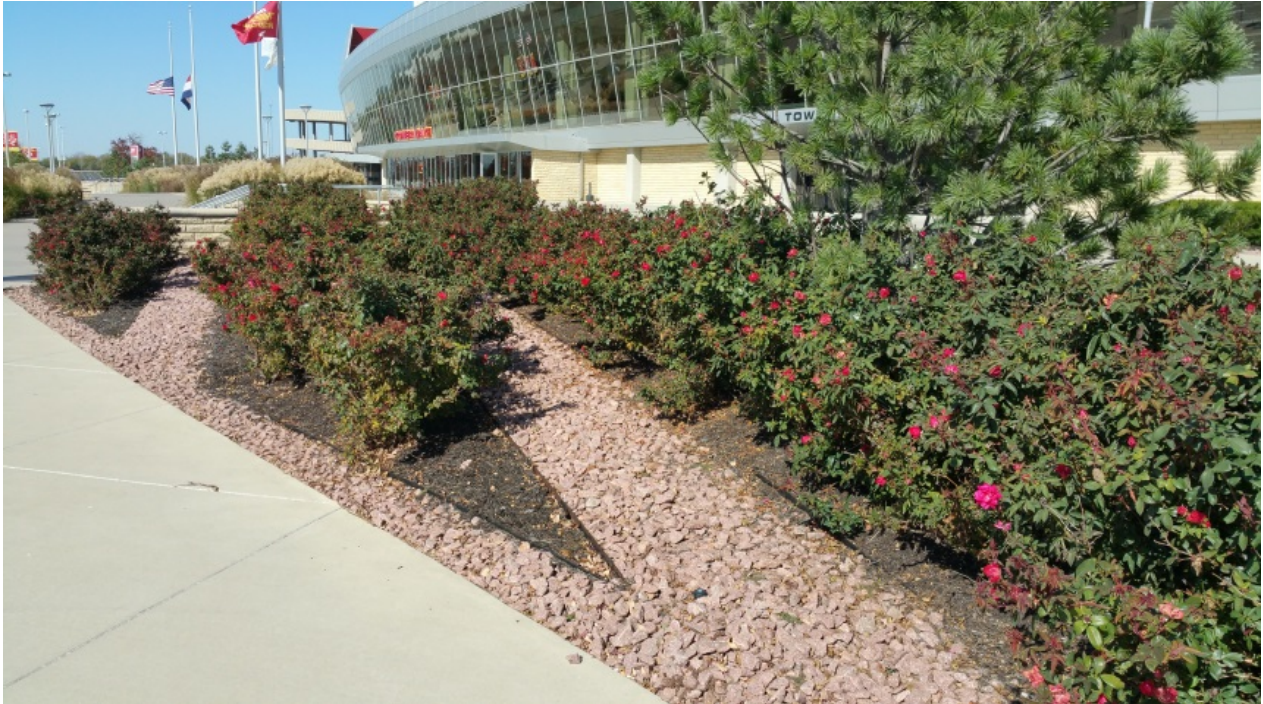
Figure L-1: Typical Landscaping Surrounding the Stadium

Various species of native planting and grass can be found between walkways and within planting beds surrounding the stadium. Landscaping around the stadium improves aesthetic appeal of the facility, and provides visual breaks within the otherwise largely paved surface, as shown in Figure L-1 below.

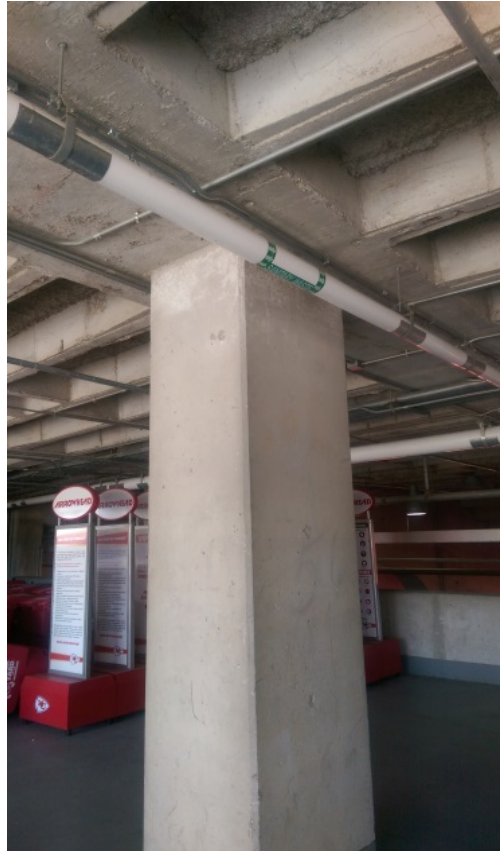
Figure S-2: CIP Reinforced Column with Pan Joist Slab System

The original superstructure is primarily cast-in-place (CIP) reinforced concrete columns and walls for the vertical support system with reinforced concrete pan joist slab system, as shown in Figure S-2. During the renovations, additions were constructed which consisted primarily of CIP reinforced concrete columns. Other vertical support systems include Hollow Structural Section (HSS) columns, CIP reinforced concrete and concrete masonry (CMU) load bearing shear walls.

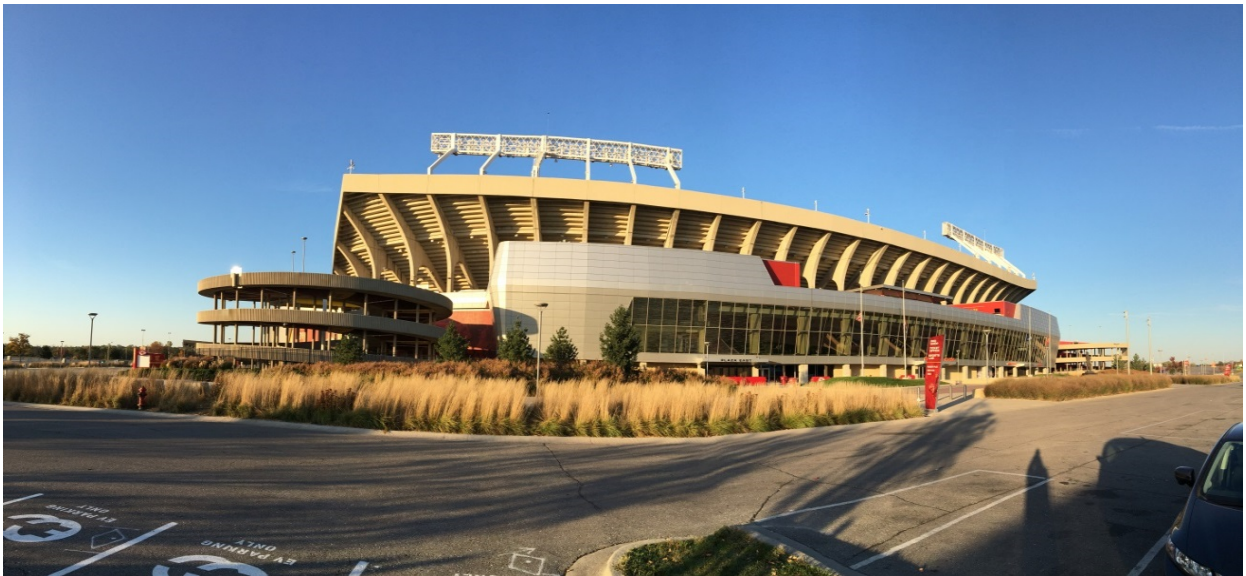
Figure AF-1: Arrowhead Stadium Overall Exterior

Arrowhead Stadium incorporates a variety of finish materials that are used in the composition of the exterior façade, as shown in Figure AF-1. The primary surface materials include structural concrete, insulated metal panel, curtainwalls, and graphic mesh fabric on galvanized steel framing.

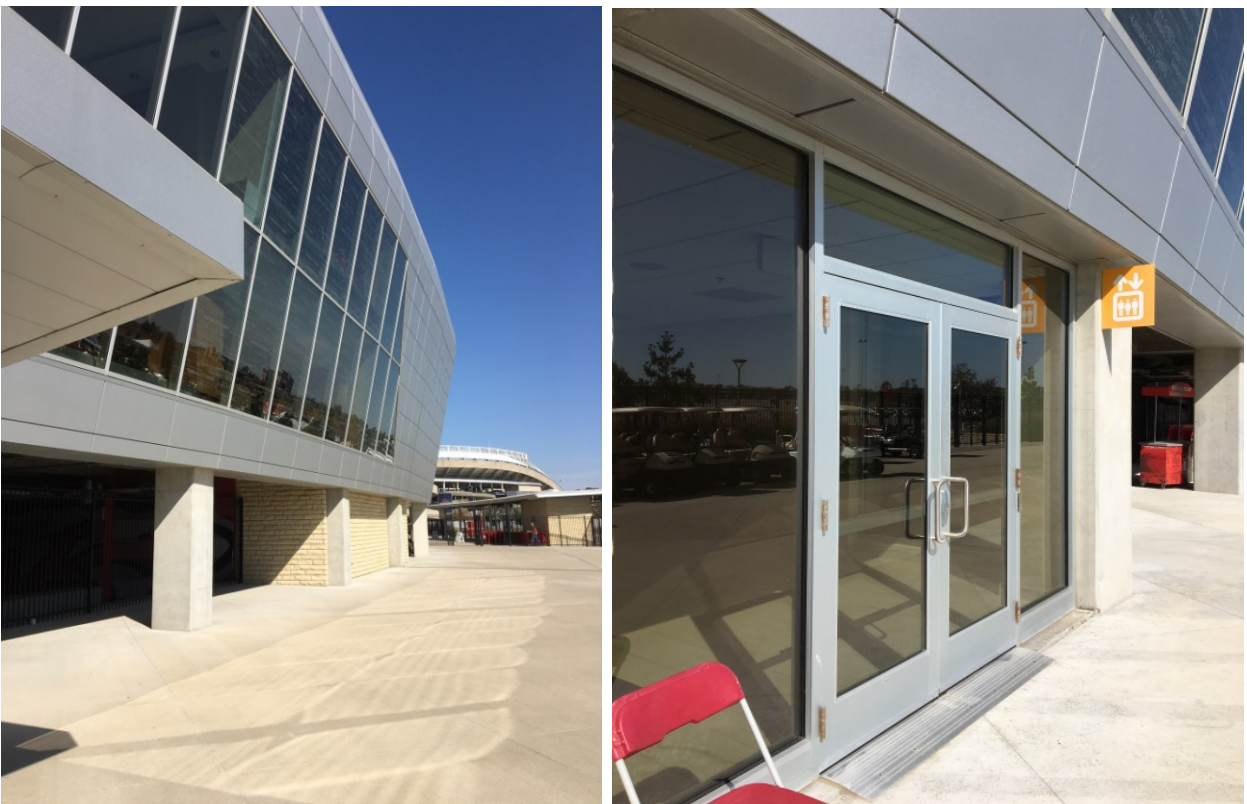
Figure AF-2: External Glass Curtainwalls and Storefronts

All facades, in general, appear to be in satisfactory condition. Glass storefronts and curtainwall systems appear to be in satisfactory condition, as shown in Figures AF-2. Aluminum frame and mullions were observed to be free of staining, fading, or degradation of any kind. Seals and flashing around storefronts appear to be in satisfactory condition. Glazing was observed to be free of defects, including cracking or chipping.

Insulated metal panel systems appear to be in satisfactory condition, as shown in Figures AF-2. No oil canning, staining, or degradation of any kind was observed.

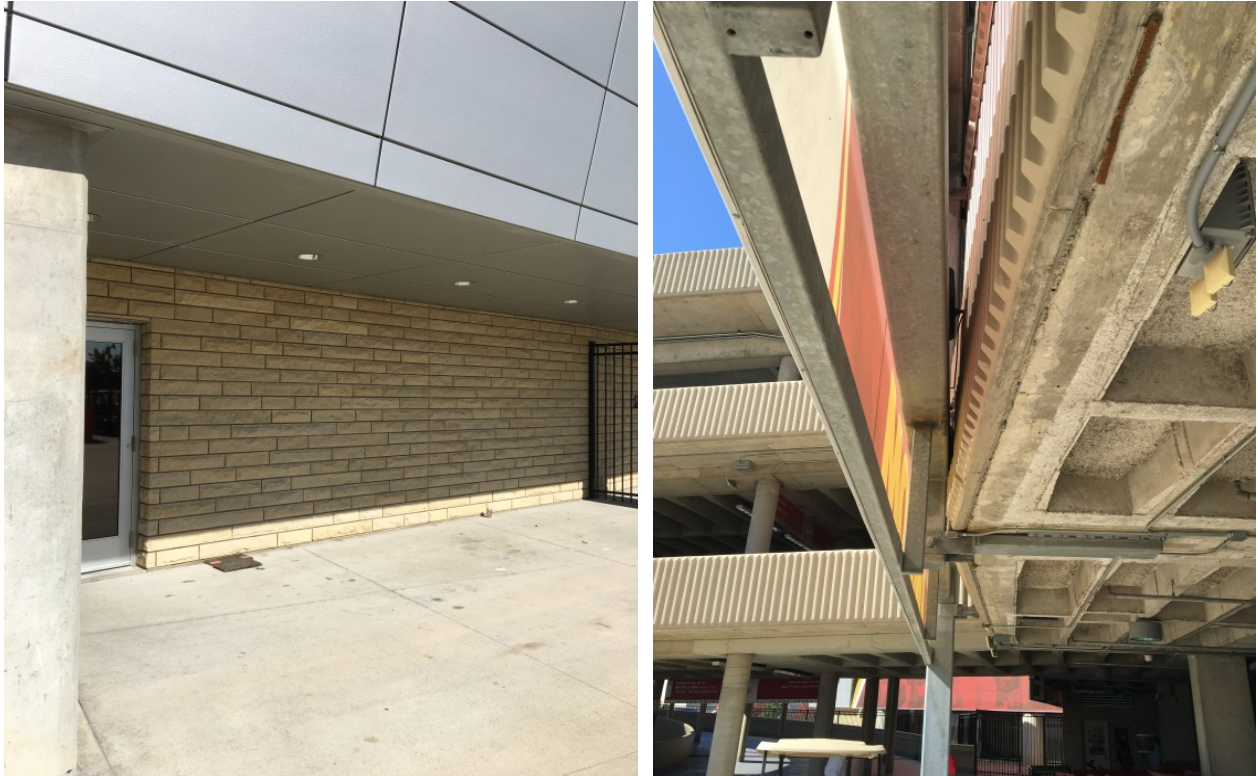
Figure AF-3: Stone Veneer Wall (left) and Graphic Fabric Mesh System (right)

Stone cladding systems appear to be in satisfactory condition, as shown in Figure AF-3 (left image). No chipping or staining of the stone or grout was observed.

Graphic mesh fabric systems anchored to galvanized steel framing was observed to be in satisfactory condition, as shown in Figure AF-3 (right image). No signs of corrosion or rust on framing exist and fabric mesh panels appear to be free of rips, tears, or fading.

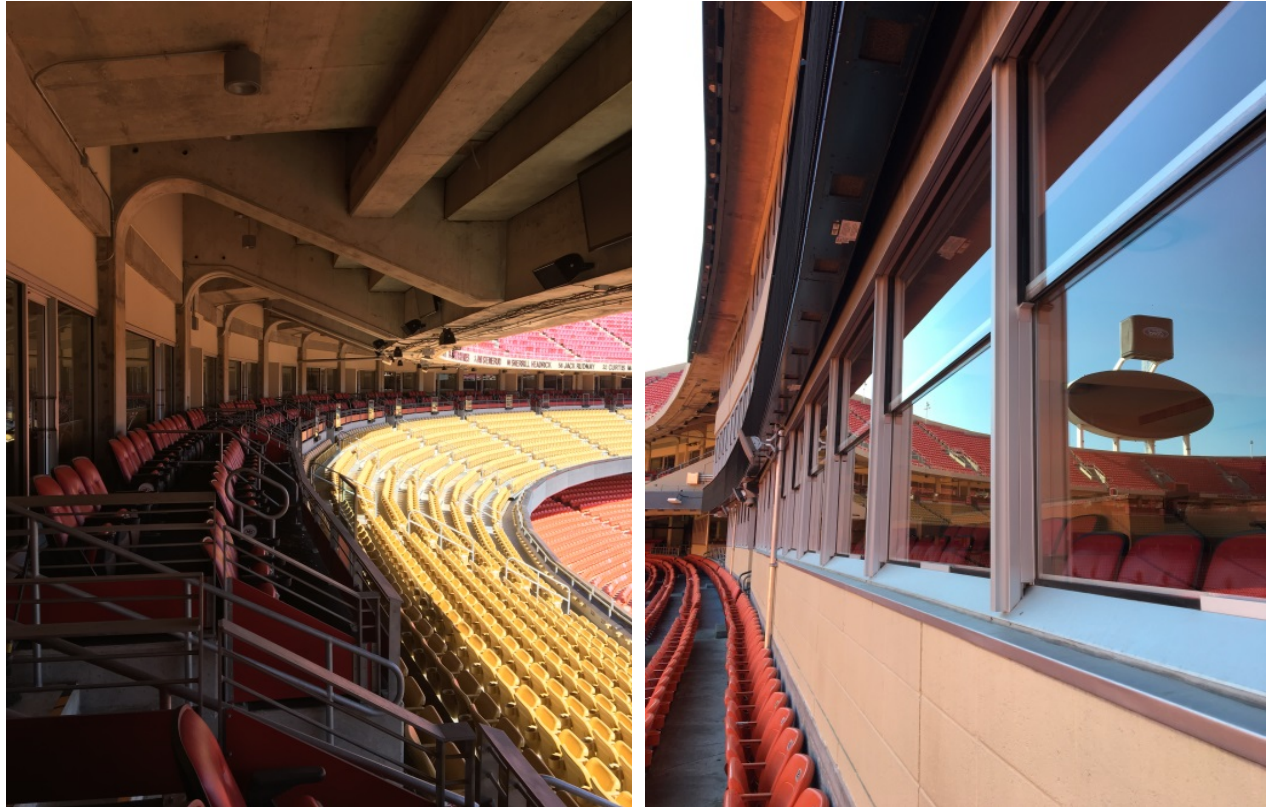
Figure AF-4: Internal Windows, Storefront, and Sliding Glass Wall System

Internal storefront and sliding glass wall systems appear to be in satisfactory condition, as shown in Figure AF-4. Aluminum frame and mullions were observed to be free of staining, fading, or degradation of any kind. Seals and flashing around storefronts appear to be in satisfactory condition. Glazing was observed to be free of defects, including cracking or chipping.

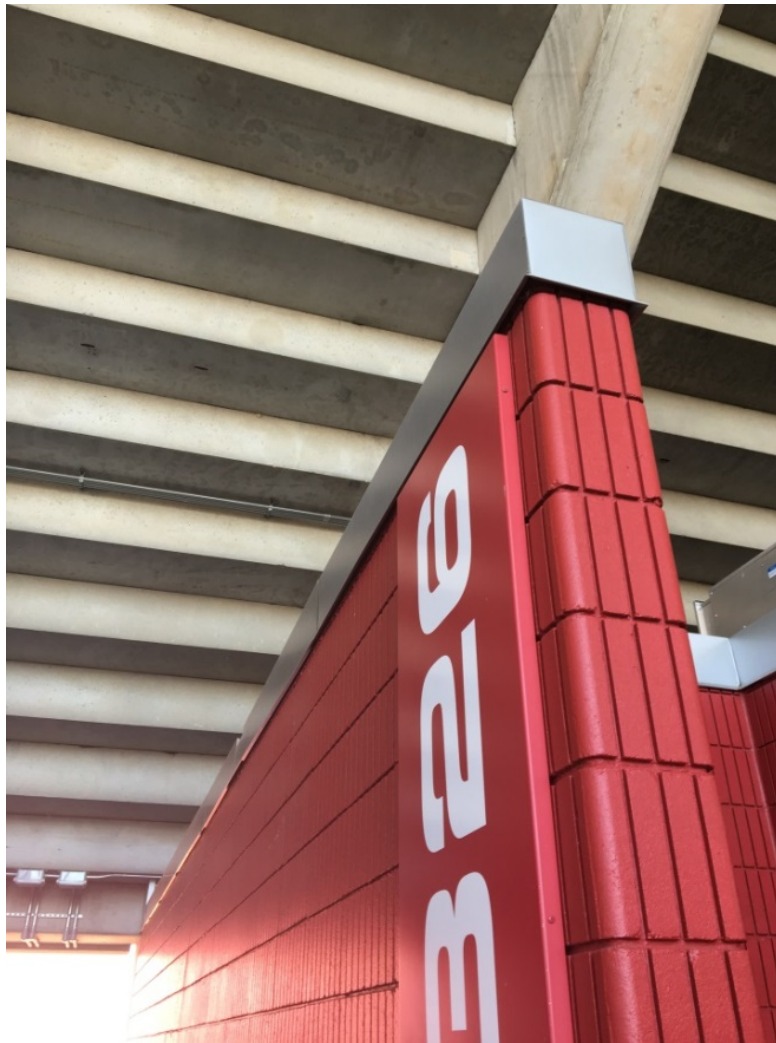
Figure AR-1: Typical Prefinished Metal Coping at Concourse

Roofing membranes were observed to be in satisfactory condition. No rips, tears, or other failures were observed. All observed copings, flashings, etc. appear to be in satisfactory condition, as shown in Figure AR-1.

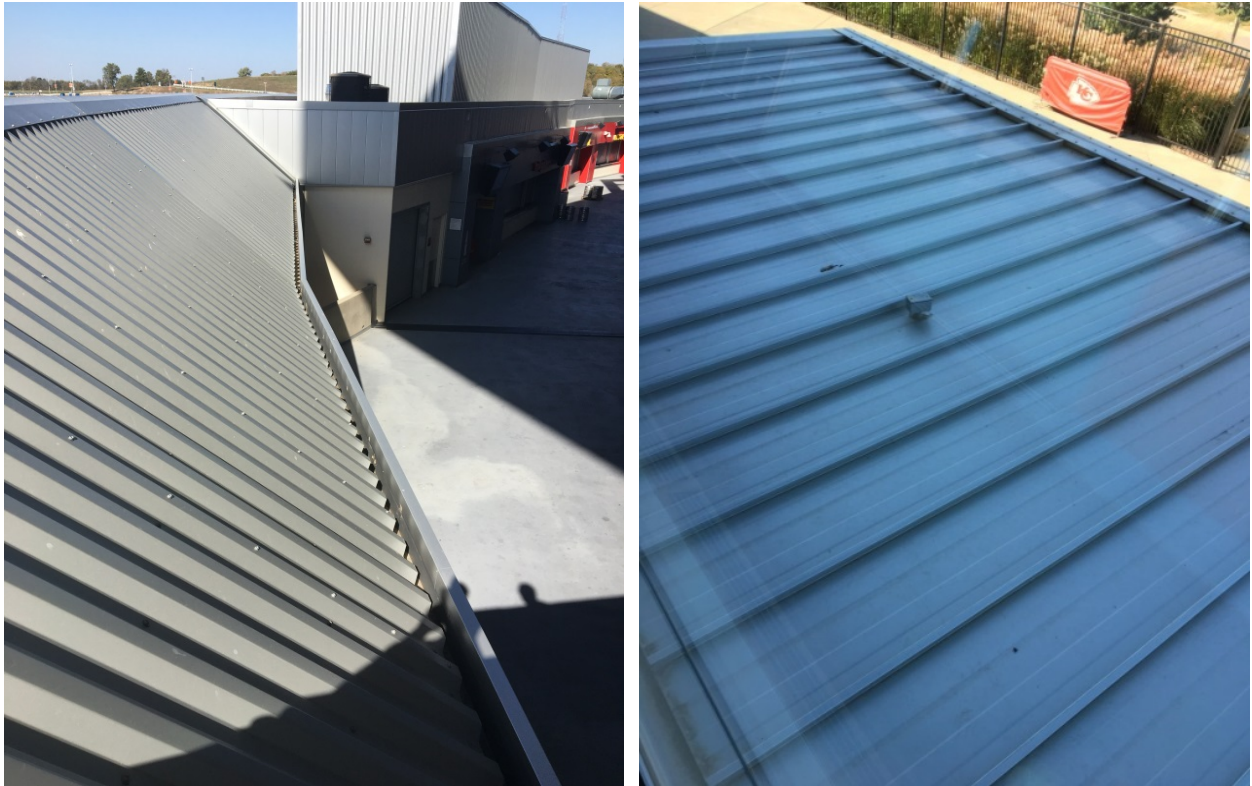
Figure AR-2: Standing Seam Metal Roof Panels

Standing seam metal roof panels appear to be in satisfactory condition, as shown in Figure AR-2. No signs of rust, staining, or other failures were observed.

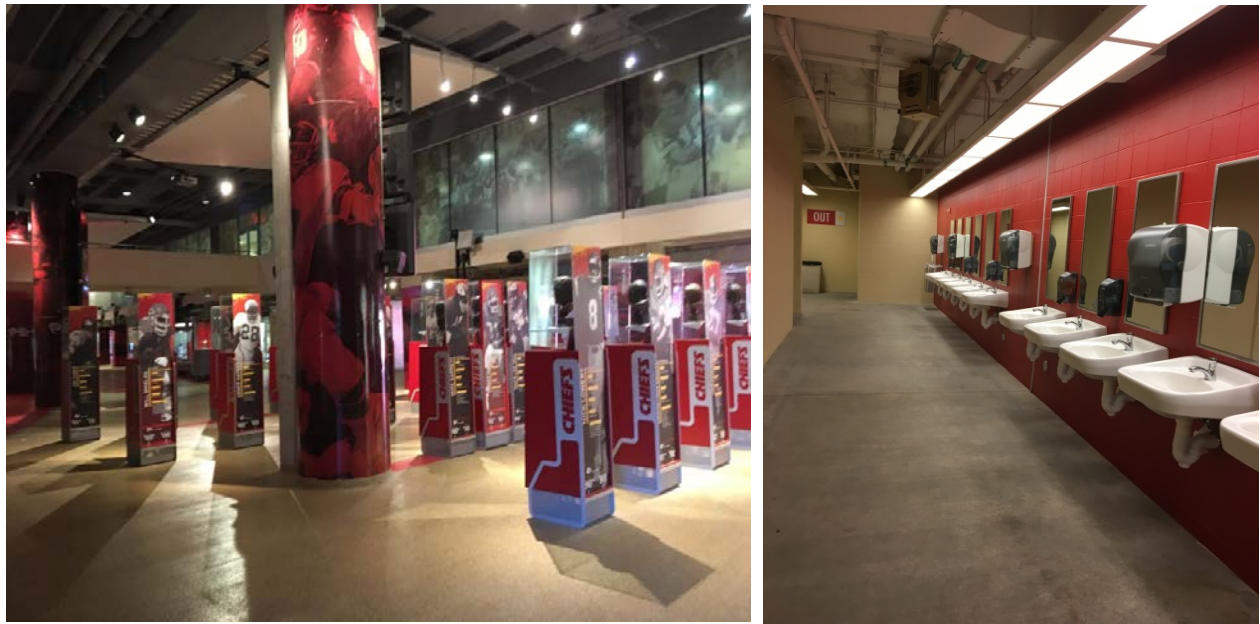
Figure AI-1: Epoxy Flooring (left) and Exposed Concrete (right) Throughout Facility

Interior finishes within Arrowhead Stadium encompass a broad range of materials for floors, walls, and ceilings. The primary flooring systems are composed of epoxy and sealed concrete, as shown in Figure AI-1.

These surfaces were observed to be in satisfactory condition, typically. Minor cracking was observed at various locations throughout the facility, which is considered normal given the expansion and contraction properties of the material and their exposure to outside air temperatures. No excessive cracking was observed during the walk-through.

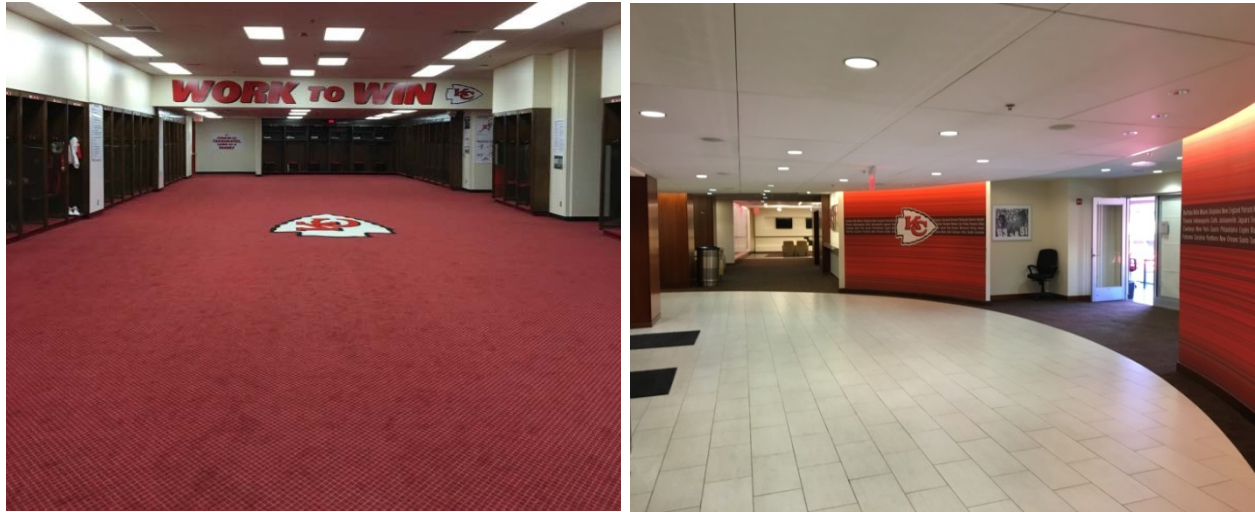
Figure AI-2: Carpet Flooring (left) and Porcelain Tile Flooring (right)

Carpet flooring was generally observed to be in satisfactory condition. No signs of rips, tears, stains, or discoloration were observed, as shown in Figure AI-2 (left image). Porcelain/Ceramic tile flooring areas appear to be in satisfactory condition, as shown in Figure AI-2 (right image). No signs of grout discoloration or cracking were observed, typically.

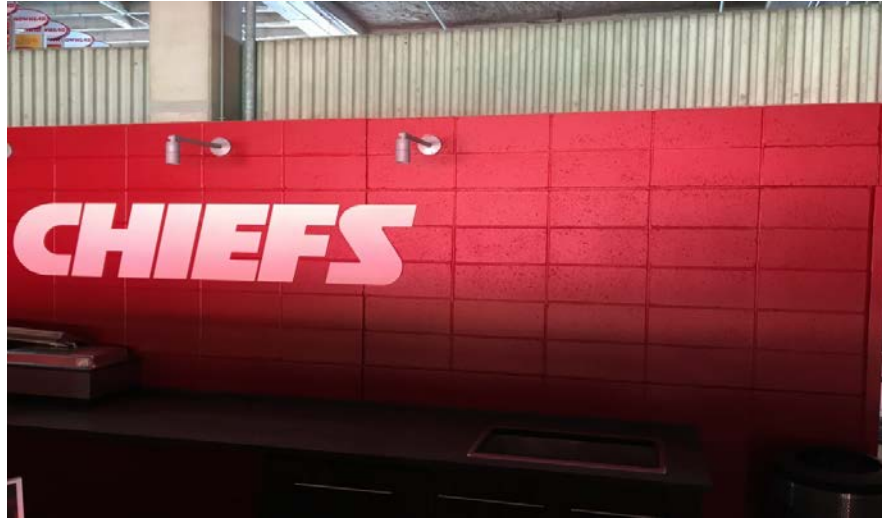
Figure AI-3: Painted, Exposed CMU Block Wall

Generally, painted CMU walls were observed to be in satisfactory condition, as shown in Figure AI-3. No signs of chipping, flaking, or cracking of the applied paint system were observed.

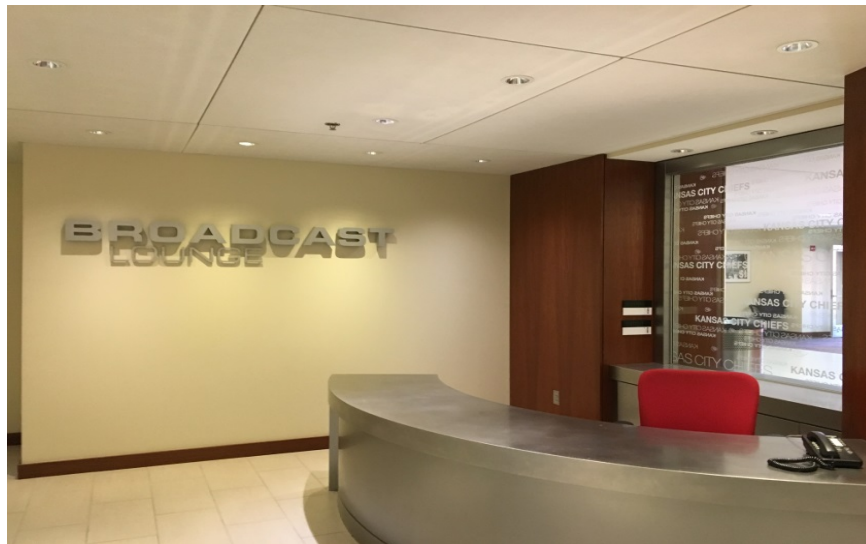
Figure AI-4: Painted Gypsum Board Walls

Painted Gypsum board walls appear to be in satisfactory condition, typically, as shown in Figure AI-4. No signs of punctures or holes in the gypsum board materials were observed.

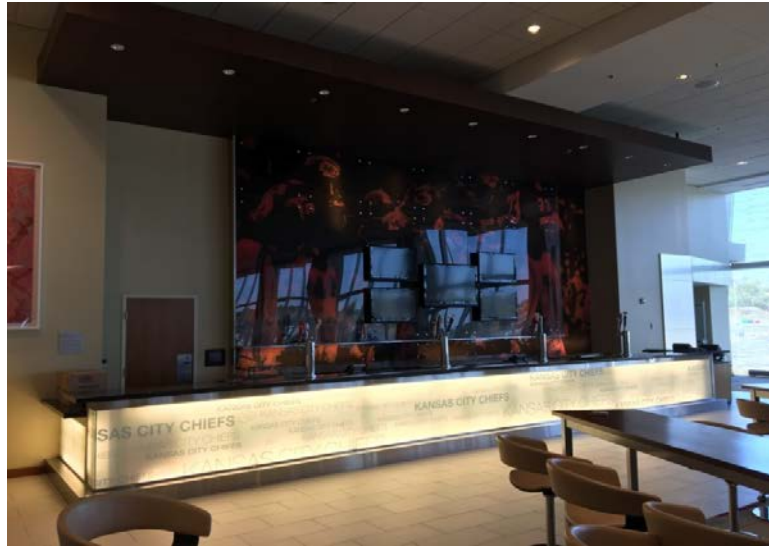
Figure AI-7: Gypsum Board Ceiling, Painted

Gypsum board ceilings appear to be in satisfactory condition, typically. No punctures, stains, scrapes, or tears were observed. Refer to Figure AI-7 for typical condition.

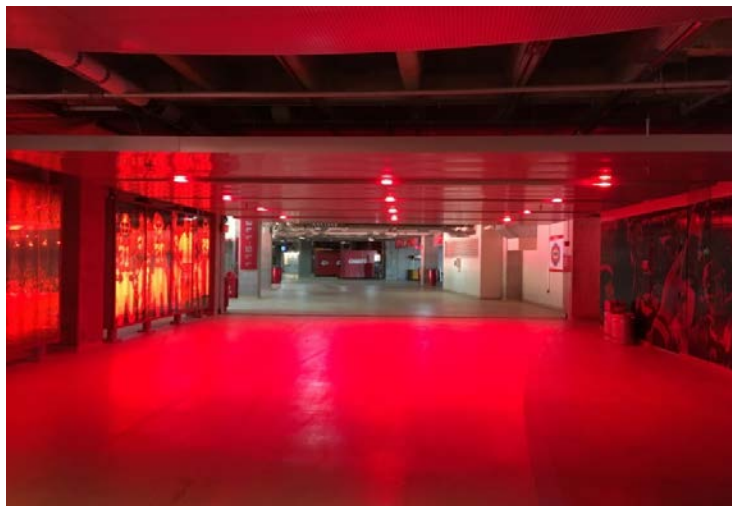
Figure AI-8: Lay-In Perforated Metal Ceiling Panels

Lay-in perforated metal ceiling tiles were observed to be in satisfactory condition. No signs of rust or finish deterioration was observed. Refer to Figure AI-8 for typical condition at exterior concourse.

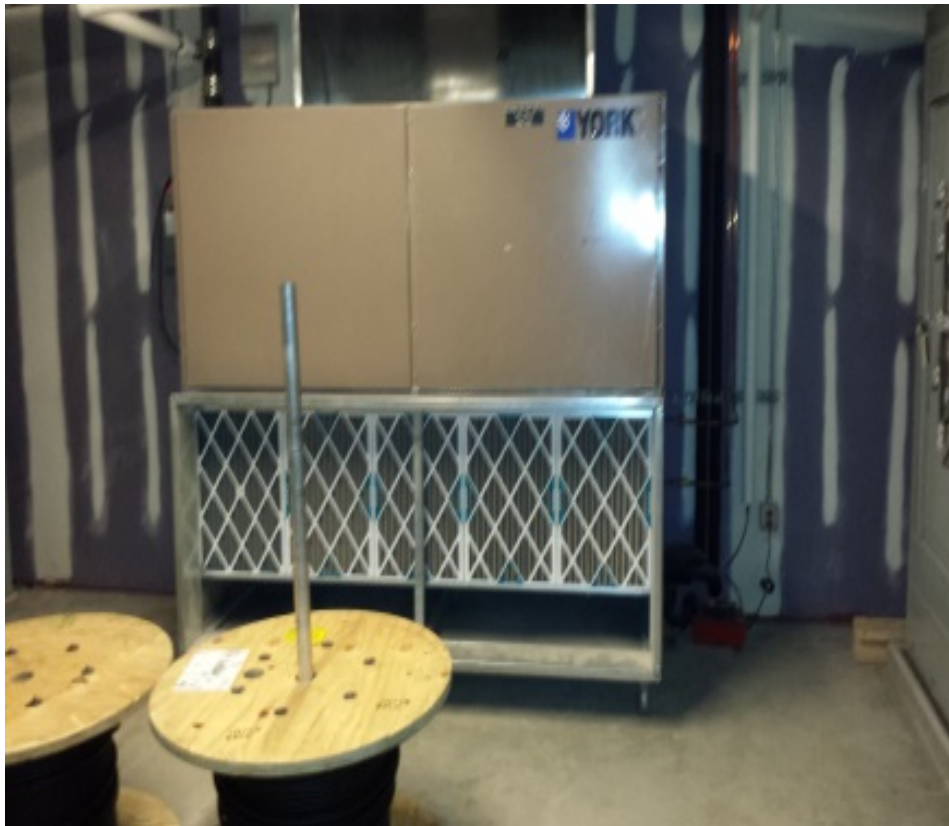
Figure M-1: Electrical Room Vertical Air-Conditioning Unit

There are four electrical rooms, each located along the exterior quadrant of the stadium. These spaces are temperature controlled by a vertical air-conditioning unit, as shown in Figure M-1. Typically, vertical air-conditioning units appear to be in satisfactory condition. The filters appeared to have little or no loading and most of them had been installed during April 2015.

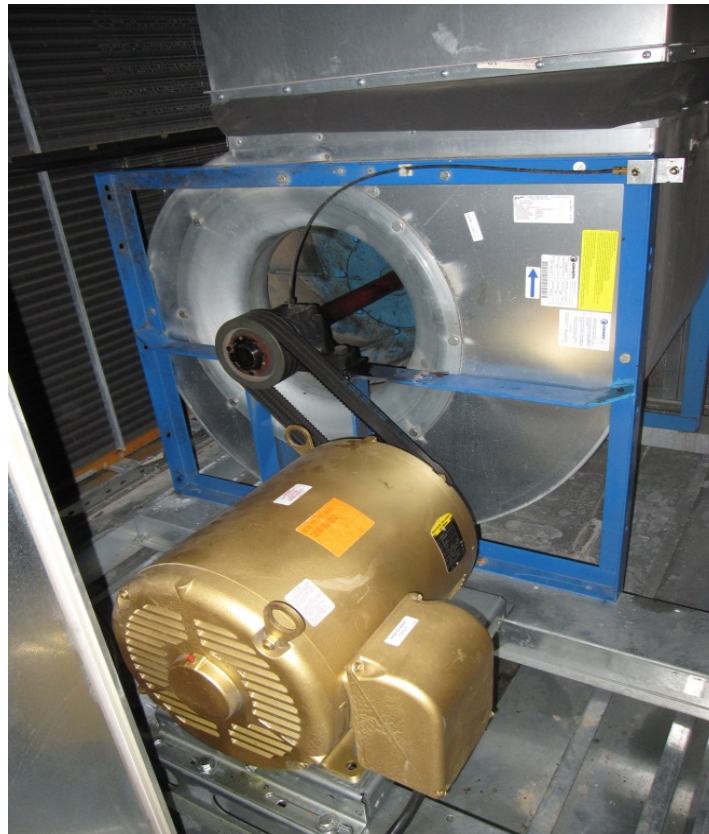
Figure M-2: AHU Fan and Motor

Adjacent to each of these electrical rooms is a mechanical room. Within these mechanical rooms are single zone air-handling units (AHU). The filters, fan motors, and belts were inspected within each unit. All of these components appeared to be in satisfactory condition. Figure M-2 shows the interior of the AHU located within Mechanical Room P250.
