Arrowhead Stadium Assessment

JCSCA + Burns & McDonnell

This document contains information pertaining to the condition of Arrowhead Stadium as documented by the Jackson County Sports Complex Authority (JCSCA), including descriptions, conditions, and exhibits which have been reviewed by Burns & McDonnell and documented in this report.

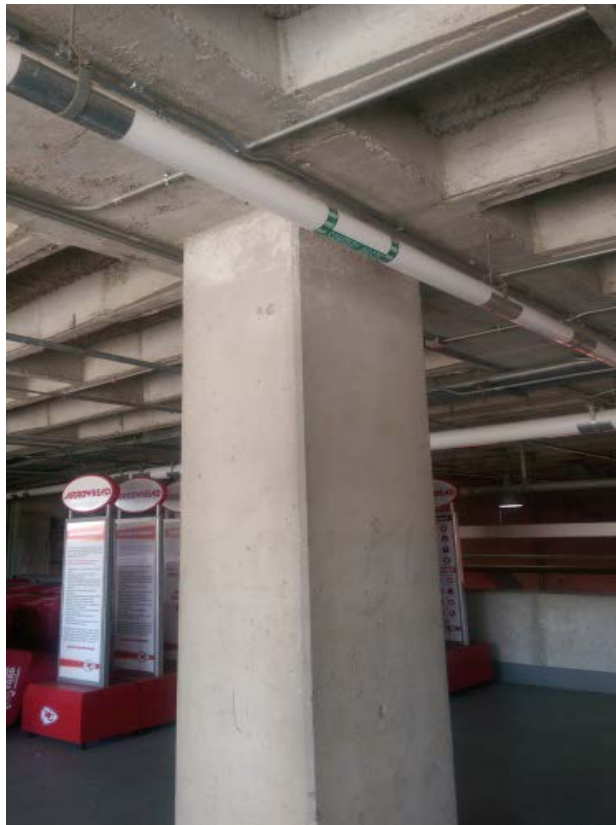
The original superstructure is primarily cast-in-place (CIP) reinforced concrete columns and walls for the vertical support system with reinforced concrete pan joist slab system, as shown in [Figure S-1](#). During the renovations, additions were constructed which consisted primarily of CIP reinforced concrete columns. Other vertical support systems include Hollow Structural Section (HSS) columns, CIP reinforced concrete and concrete masonry (CMU) load bearing shear walls.

Figure S-1: CIP Reinforced Column with Pan Joist Slab System.

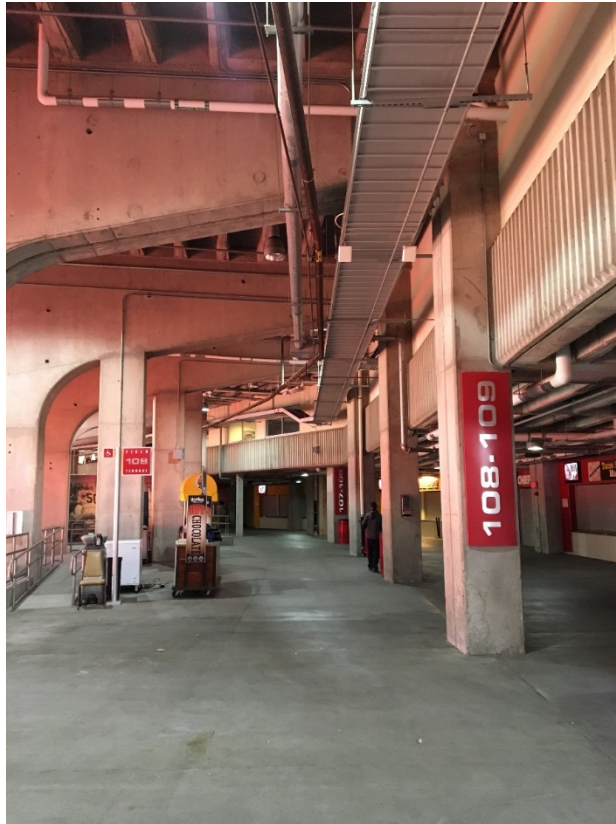
The Plaza, Club, Lower-Upper Concourse and Upper Concourse levels consist primarily of reinforced concrete pan and joist slab system as shown in [Figure S-2](#) below. The Horizon and Press level consists of light weight composite deck supported by steel wide flange beams. The roof levels primarily consist of steel roof deck supported by steel wide flange beams. Other roof systems consist of cold form metal joists with steel roof deck. The lateral resisting system consists of reinforced concrete load bearing shear walls. The scoreboard and advertising boards consists of built-up hollow steel shapes.

Figure S-2: Typical Concourse Structure.

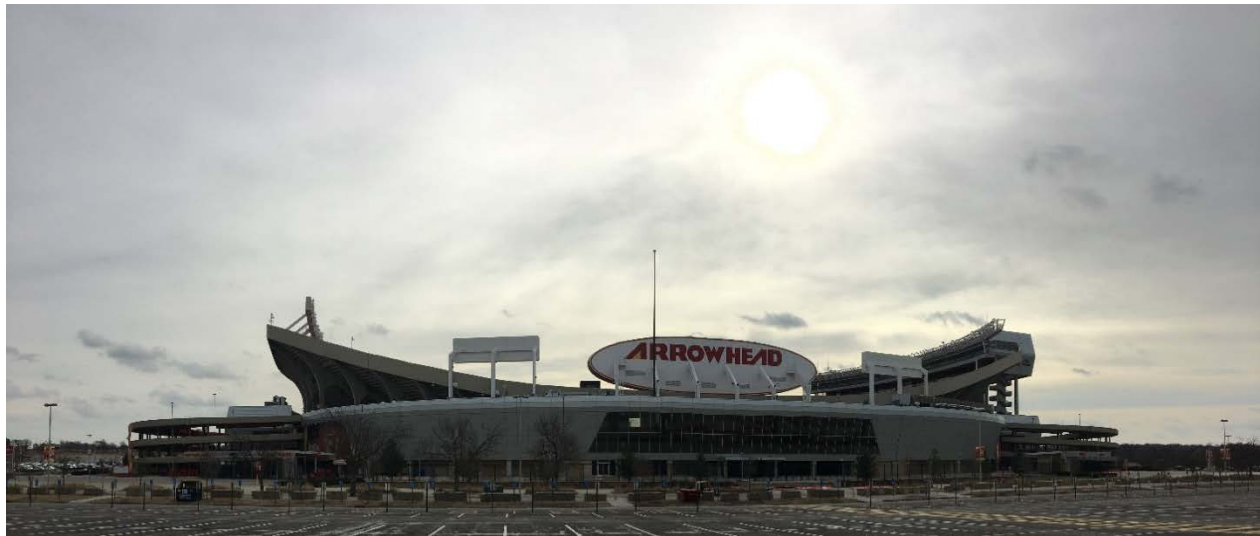
Arrowhead Stadium incorporates a variety of finish materials that are used in the composition of the exterior façade, as shown in [Figure AF-1](#). The primary surface materials include structural concrete, insulated metal panel, curtainwalls, and graphic mesh fabric on galvanized steel framing.

Figure AF-1: Arrowhead Stadium Overall Exterior.

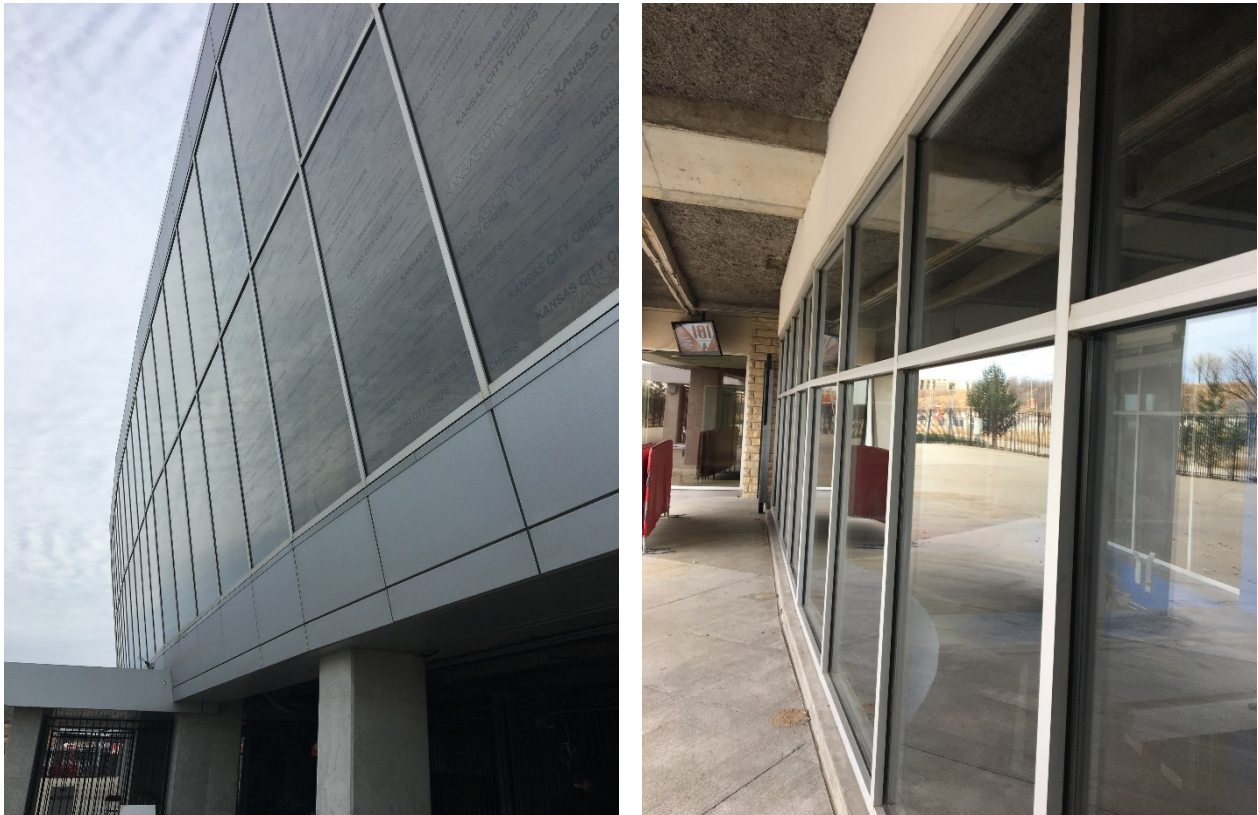
All facades, in general, appear to be in satisfactory condition. Glass storefronts and curtainwall systems appear to be in satisfactory condition, as shown in [Figures AF-2](#). Aluminum frame and mullions were observed to be free of staining, fading, or degradation of any kind. Seals and flashing around storefronts appear to be in satisfactory condition. Glazing was observed to be free of defects, including cracking or chipping. At the time of observation, glass curtainwalls were being cleaned on the interior side of the system.

Insulated metal panel systems appear to be in satisfactory condition, as shown in [Figures AF-2](#). No oil canning, staining, or degradation of any kind was observed.

Figure AF-2: External Glass Curtainwalls and Storefronts.

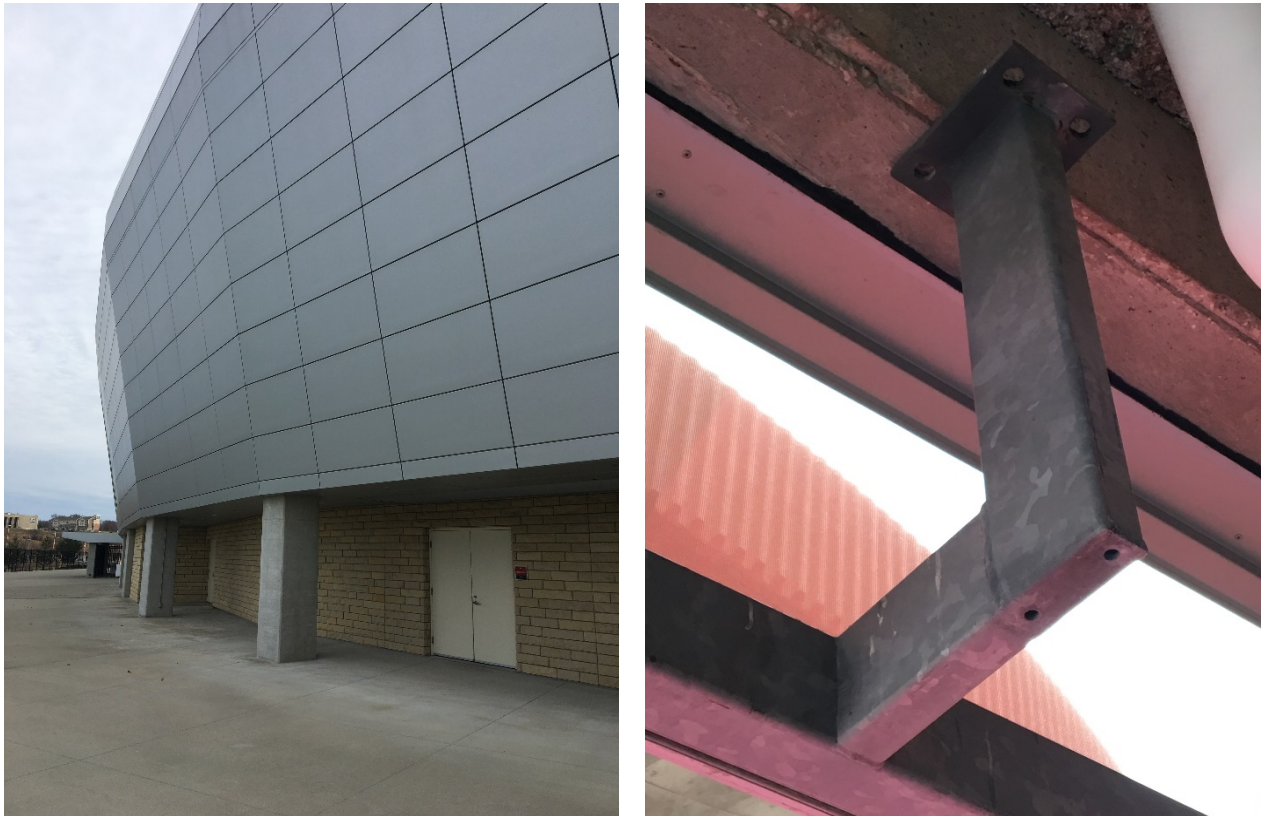
Stone cladding systems appear to be in satisfactory condition, as shown in [Figure AF-4](#) (left image). No chipping or staining of the stone or grout was observed.

Graphic mesh fabric systems anchored to galvanized steel framing was observed to be in satisfactory condition, typically. No signs of corrosion or rust on framing exist and fabric mesh panels appear to be free of rips, tears, or fading. Anchor bolts appeared to be missing from the galvanized support structure at the Hy-Vee Gate shown in [Figure AF-4](#) (right image). Bolts should be added as required to insure all elements of the sub-structure are adequately anchored to the concrete superstructure.

Figure AF-4: Stone Veneer Wall (left) and Graphic Fabric Mesh System (right).

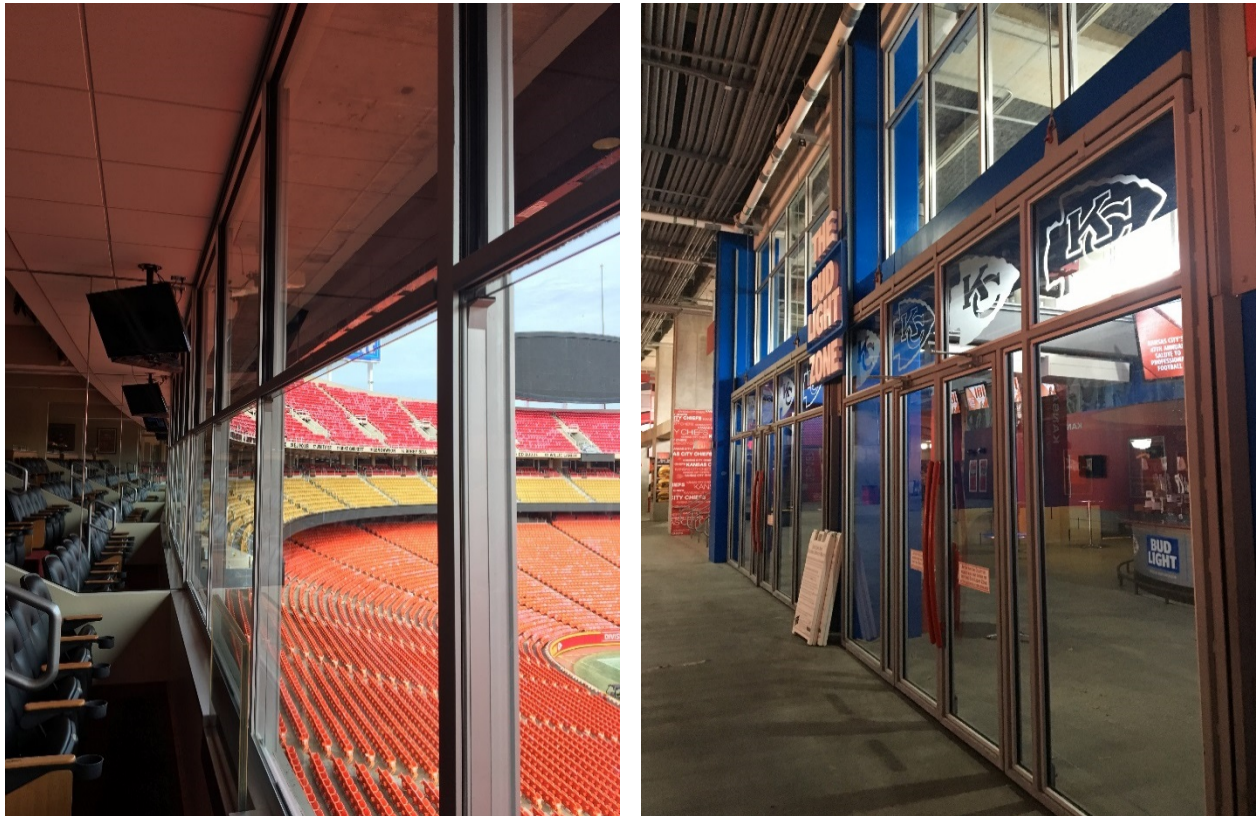
Internal storefront and sliding glass wall systems appear to be in satisfactory condition, as shown in [Figures AF-5](#). Aluminum frame and mullions were observed to be free of staining, fading, or degradation of any kind. Seals and flashing around storefronts appear to be in satisfactory condition. Glazing was observed to be free of defects, including cracking or chipping.

Figures AF-5: Internal Windows, Storefront, and Sliding Glass Wall System.

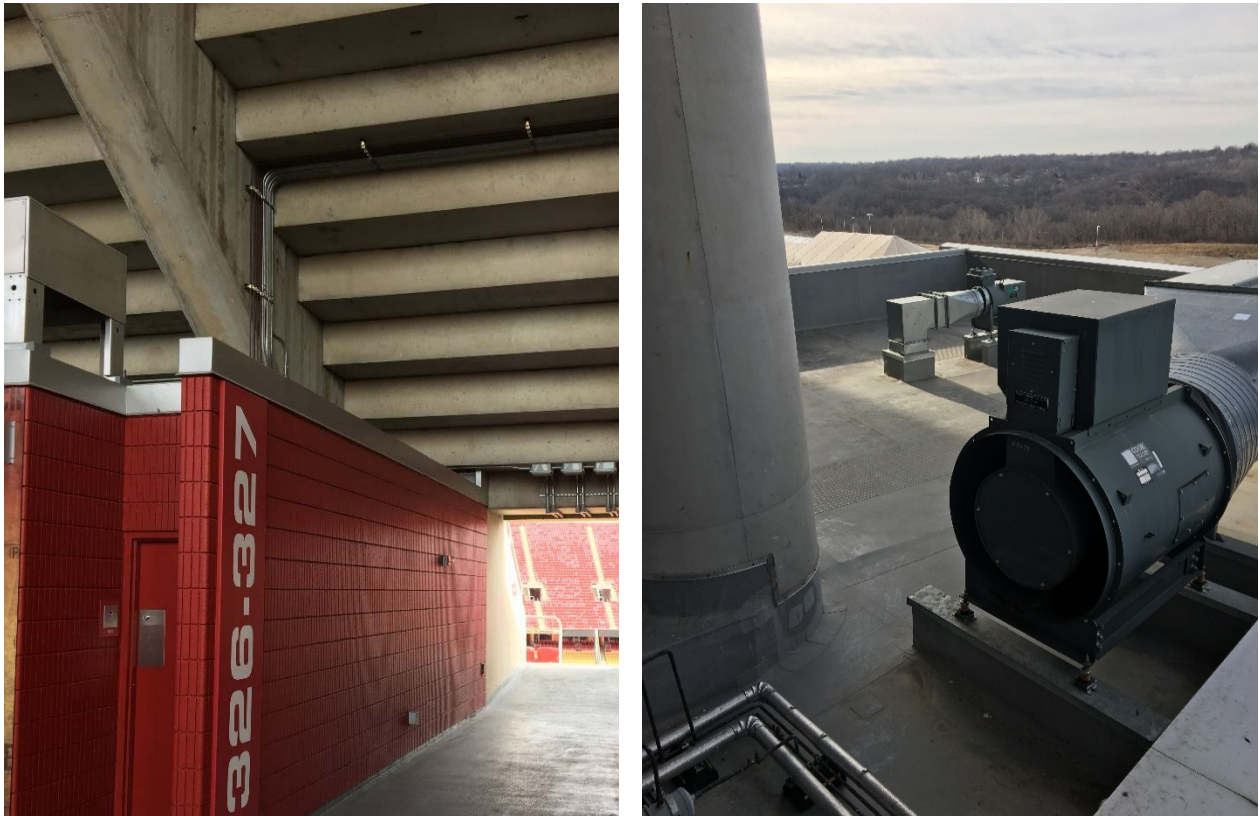
Roofing membranes were observed to be in satisfactory condition. No rips, tears, or other failures were observed. All observed copings, flashings, and sealants appear to be in satisfactory condition, as shown in [Figure AR-1](#).

Figure AR-1: Membrane Roofing (right) and Typical Prefinished Metal Coping at Concourse (left).

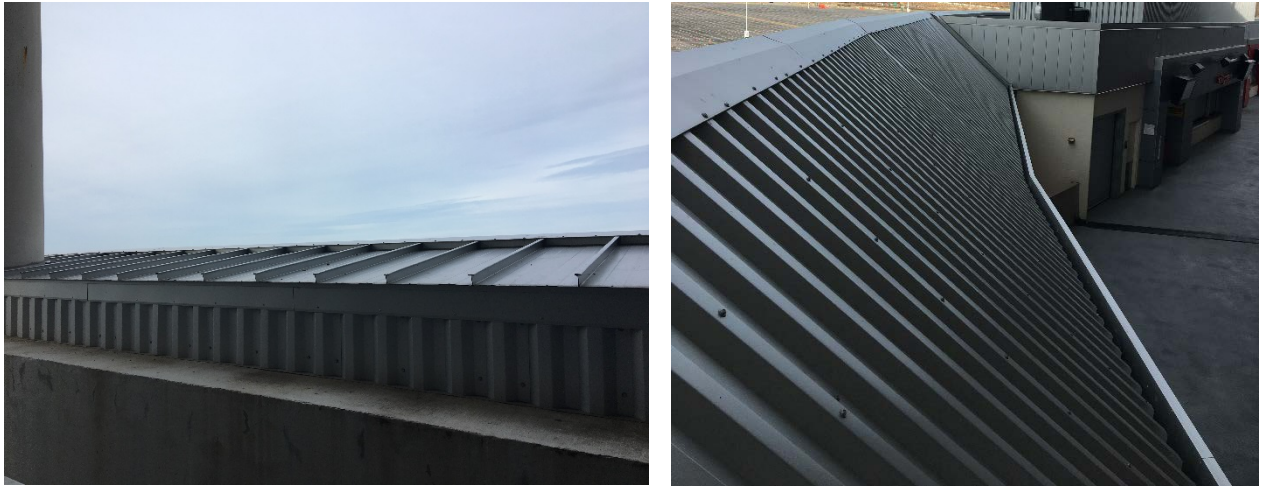
Standing seam metal roof panels appear to be in satisfactory condition, as shown in [Figures AR-2](#). No signs of rust, staining, or other failures were observed.

Figures AR-2: Standing Seam Metal Roof Panels.

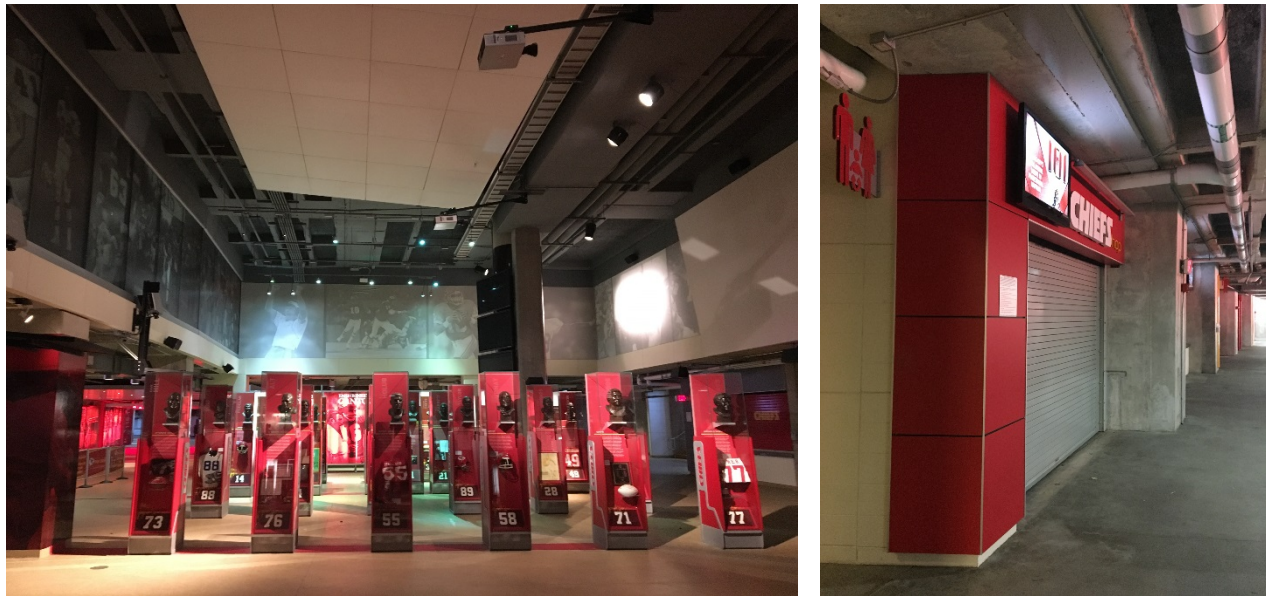
Interior finishes within Arrowhead Stadium encompass a broad range of materials for floors, walls, and ceilings. The primary flooring systems are composed of epoxy and sealed concrete, as shown in [Figure AI-1](#).

These surfaces were observed to be in satisfactory condition, typically. Minor cracking was observed at various locations throughout the facility, which is considered normal given the expansion and contraction properties of the material and their exposure to outside air temperatures. No excessive cracking was observed during the walk-through.

Figure AI-1: Epoxy Flooring (left) and Exposed Concrete (right) throughout Facility.

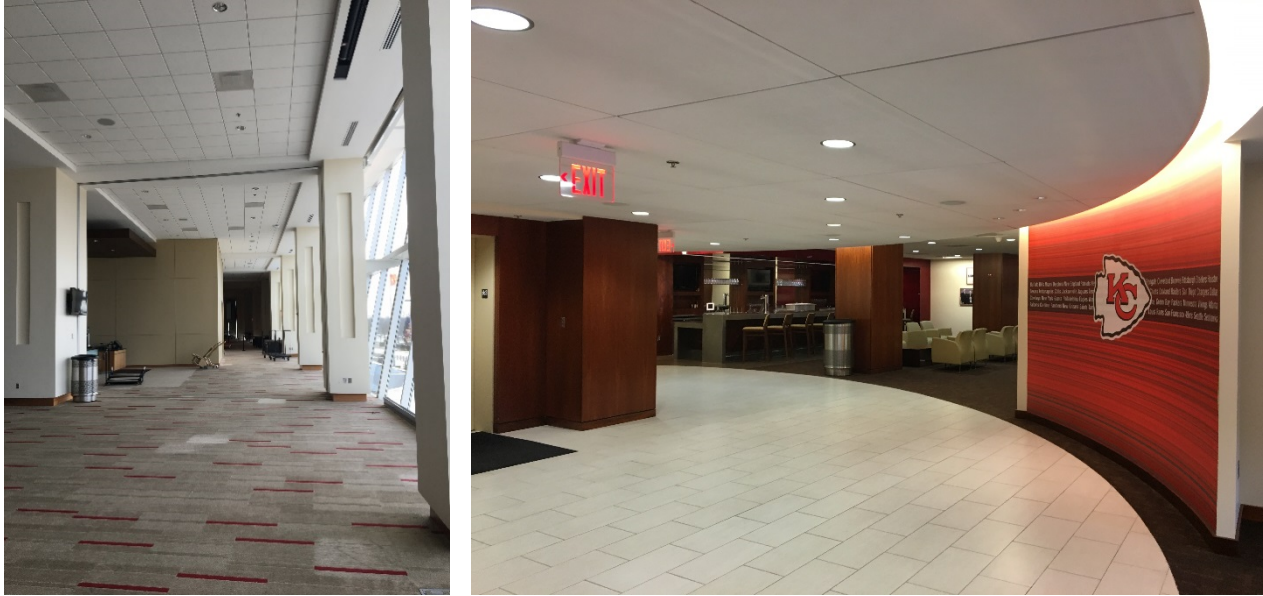
Carpet flooring was generally observed to be in satisfactory condition. No signs of rips, tears, stains, or discoloration were observed, as shown in [Figure AI-2](#) (left image). Porcelain/Ceramic tile flooring areas appear to be in satisfactory condition, as shown in [Figure AI-2](#) (right image). No signs of grout discoloration or cracking were observed, typically.

Figure AI-2: Carpet Flooring (left) and Porcelain Tile Flooring (right).

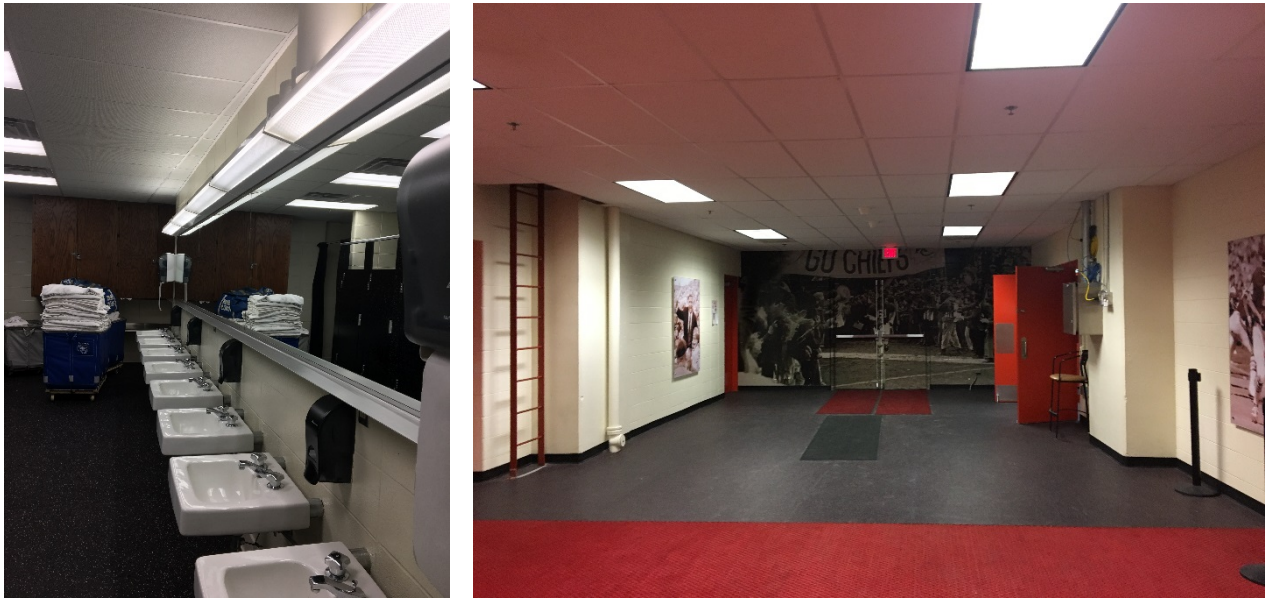
Less abundant areas of flooring materials include vinyl composition tile (VCT) and athletic rubber flooring. These materials are generally found in service areas or back-of-house type areas which are less visible to the public. All observed materials of this type were observed to be in satisfactory condition, as shown in [Figure Al-3](#).

Figure Al-3: Rubber Flooring (left) and VCT Flooring (right).

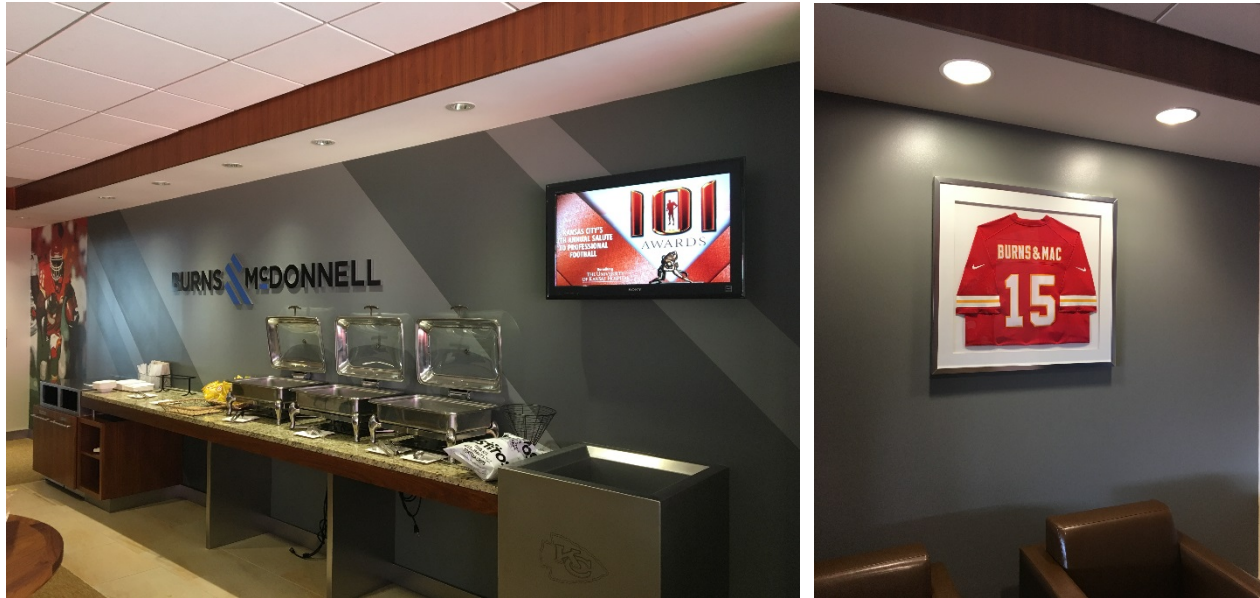
Painted Gypsum board walls appear to be in satisfactory condition, typically, as shown in [Figure AI-4](#). No signs of punctures or holes in the gypsum board materials were observed.

Figure AI-4: Painted Gypsum Board Walls.

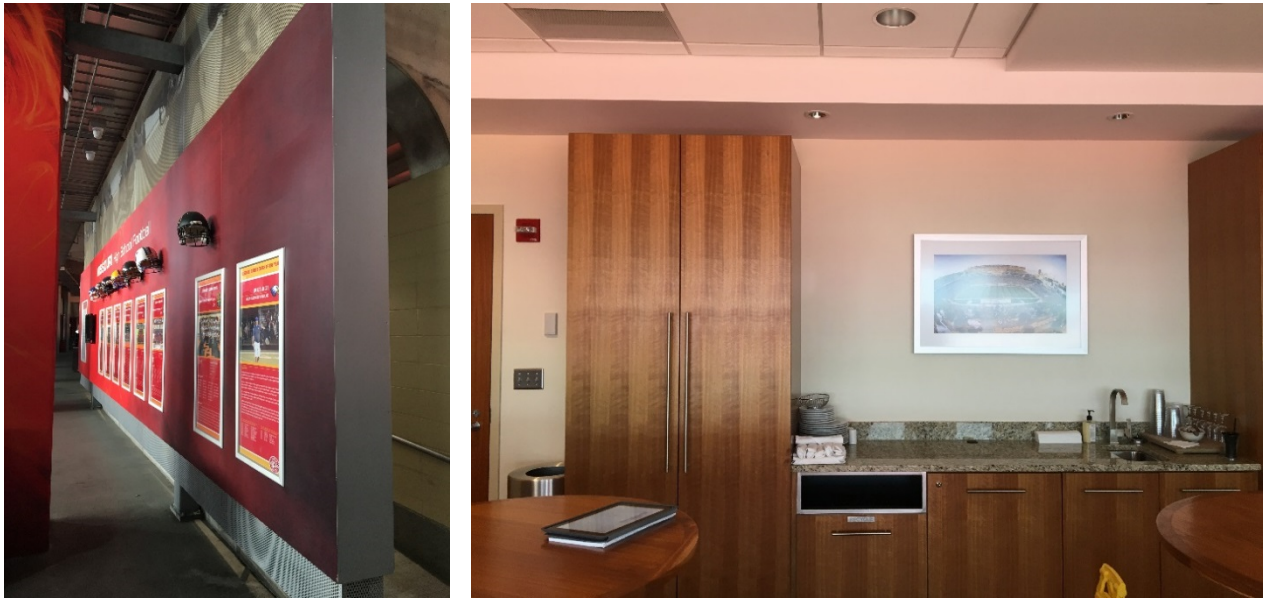
Graphic applied presentation boards throughout the stadium appear to be in satisfactory condition, as shown in [Figure AI-5](#) (left image). No signs of scratching or delamination were observed. Wood veneer panel at interior walls appear to be in satisfactory condition, as shown in [Figure AI-5](#) (right image). No scratches, scuffs, or fading of any kind was observed.

Figure AI-5: Graphic Applied Presentation Board (left) and Wood Veneer Paneling Wall (right).

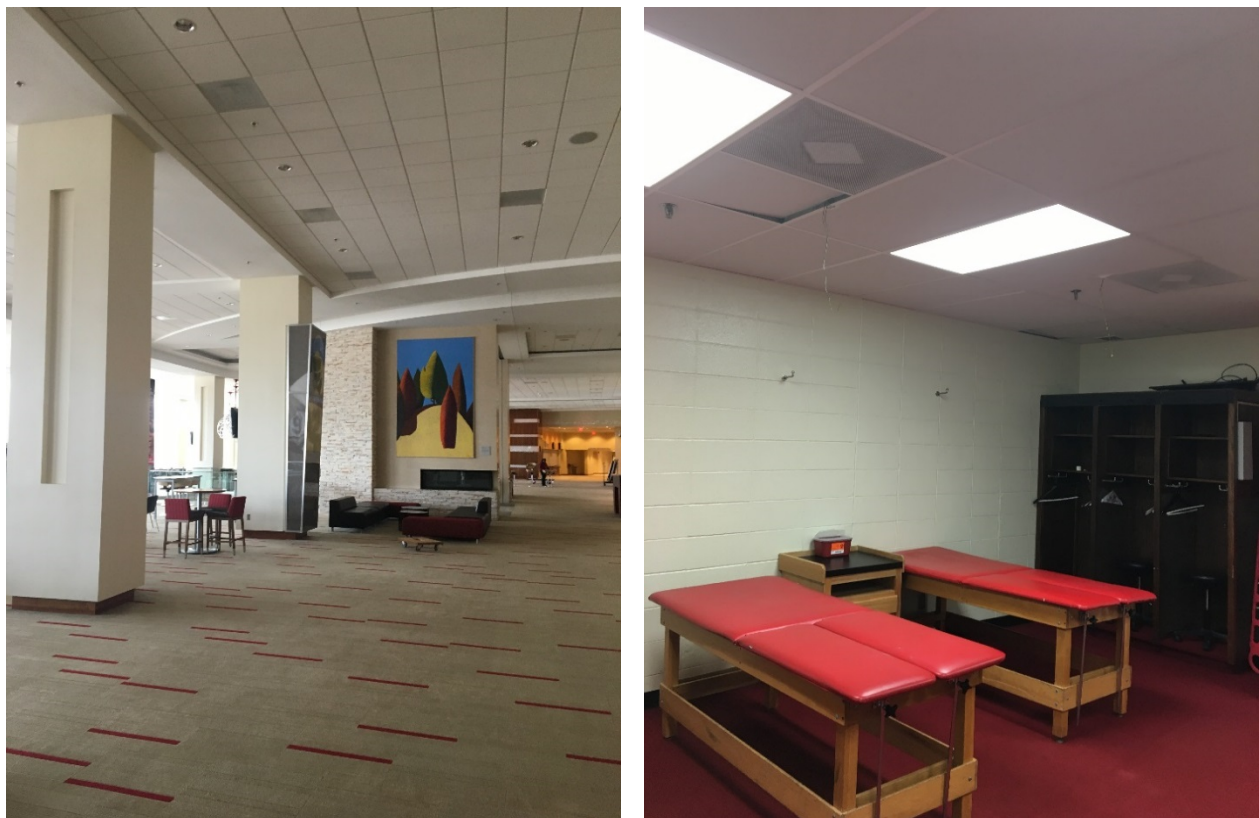
Acoustic ceiling tiles appear to be in satisfactory condition, generally. A typical condition at the Club Level lounge area is shown in [Figure AI-6](#) (left image). Ceiling tile in these spaces do not show signs of stains or deterioration of any kind. However, at a few locations at the Service Level some ceiling tiles were observed to be damaged around the corners or were not properly set within the ceiling grid. One location where damaged ceilings tiles were observed was at the visiting locker observation room in the Service Level, as shown in [Figure AI-6](#) (right image). It appears that visiting teams require ceiling mounted hooks. To avoid future damage of the ceiling grid and tiles in these areas, provide permanent hook anchors to suit the needs of visiting teams.

Figure AI-6: Acoustic Ceiling Tile at Event Space (left) and at Service Level Coach Room (right).

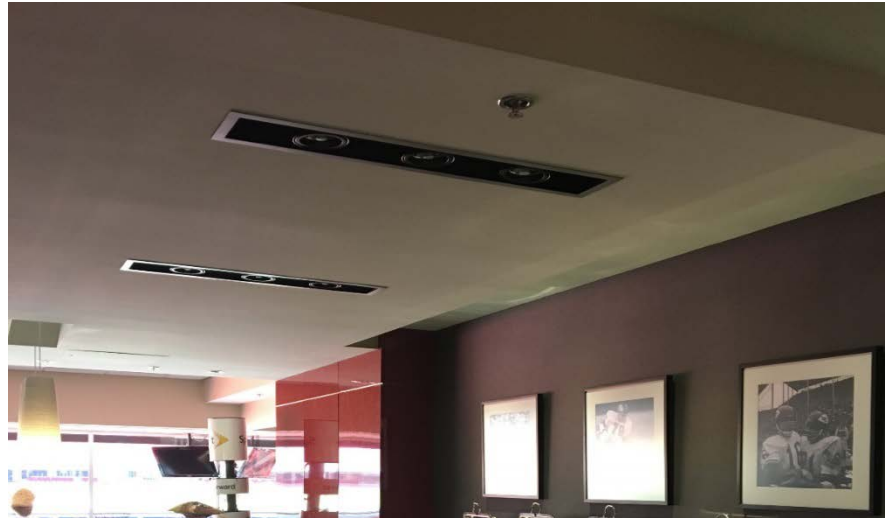
Gypsum board ceilings appear to be in satisfactory condition, typically. No punctures, stains, scrapes, or tears were observed. Refer to [Figure AI-7](#) for typical condition.

Figure AI-7: Gypsum Board Ceiling, Painted.

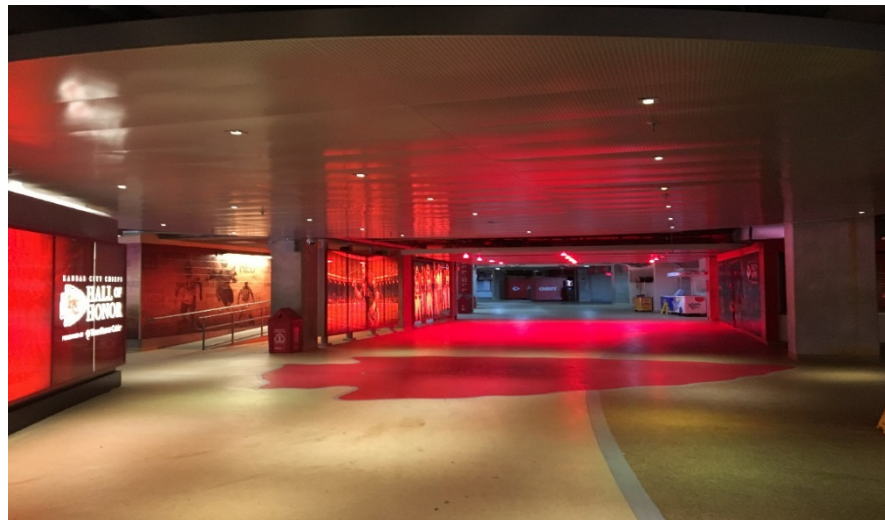
Lay-in perforated metal ceiling tiles were observed to be in satisfactory condition. No signs of rust or finish deterioration was observed. Refer to [Figure AI-8](#) for typical condition at exterior concourse.

Figure AI-8: Lay-In Perforated Metal Ceiling Panels.

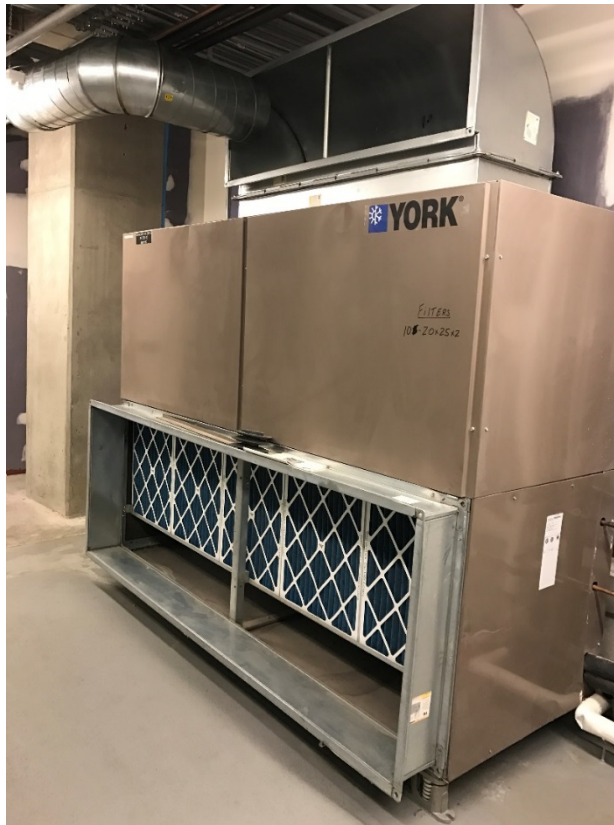
Electrical rooms on the exterior of the stadium are temperature controlled by vertical air-conditioning units, as shown in [Figure M-1](#). These units appear to be in satisfactory condition.

Figure M-1: Electrical Room Vertical Air-Conditioning Unit.

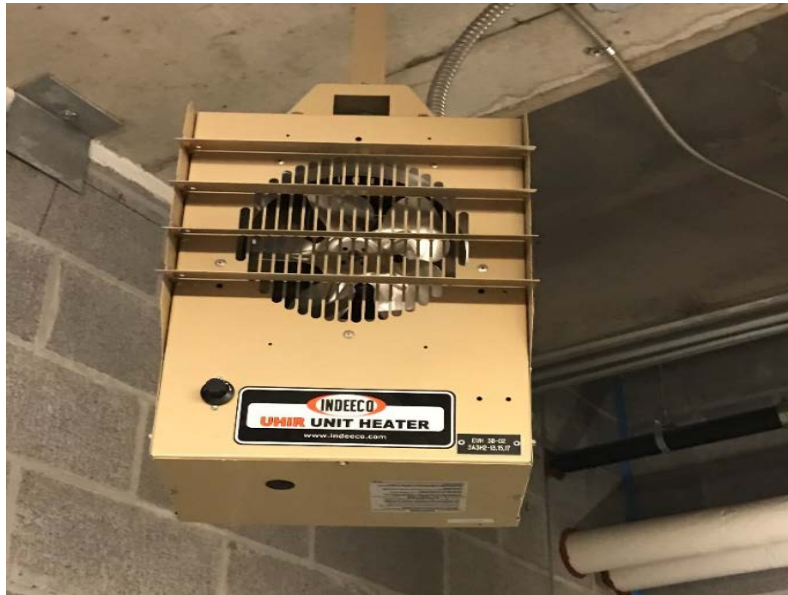
Electric unit heaters were located in various mechanical rooms and storage spaces throughout the stadium, as shown in [Figure M-6](#). All observed electric unit heaters appeared to be in satisfactory condition.

Figure M-6: Electric Unit Heaters.

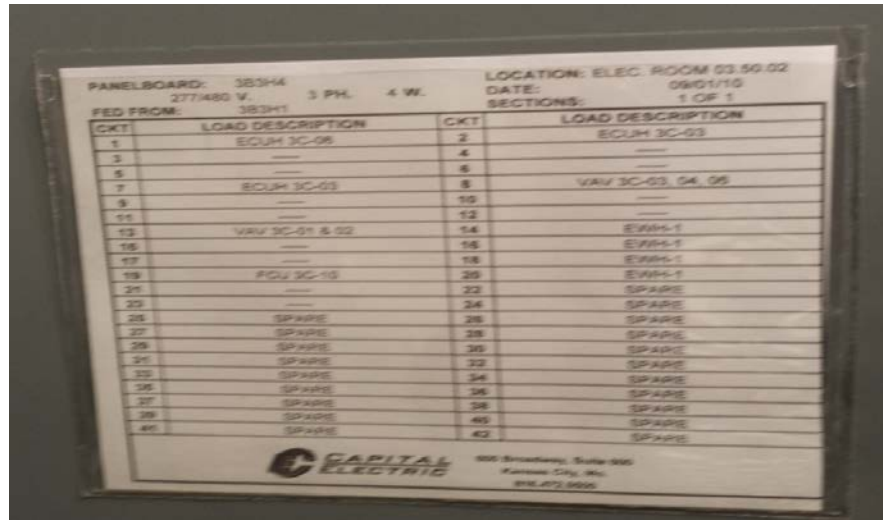
- Panelboard 3B3H4 branch circuit directory do not indicate load description for 3-pole, branch circuit 38, 40 and 42. Refer to [Figures E-3](#) and [E-4](#) shown below.

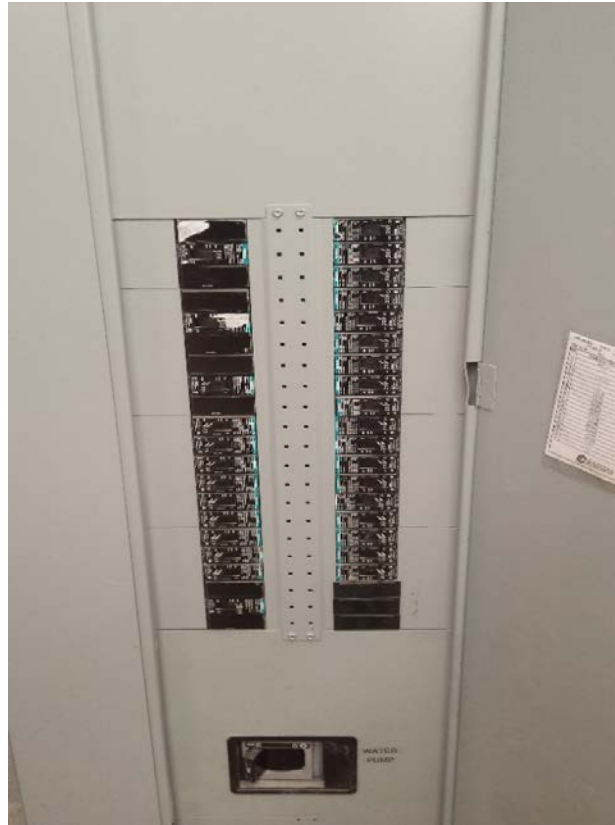
Figure E-5: Panelboard 3B3H4 Branch Circuit Breakers.

- Panelboard 6B3H2 branch circuits in the Fire Pump room do not have circuit numbers adjacent to the branch circuit breakers, as shown in [Figure E-5](#) below.
