# Arrowhead Stadium Assessment

## JCSCA + Burns & McDonnell

This document contains information pertaining to the condition of Arrowhead Stadium as documented by the Jackson County Sports Complex Authority (JCSCA), including descriptions, conditions, and exhibits which have been reviewed by Burns & McDonnell and documented in this report.

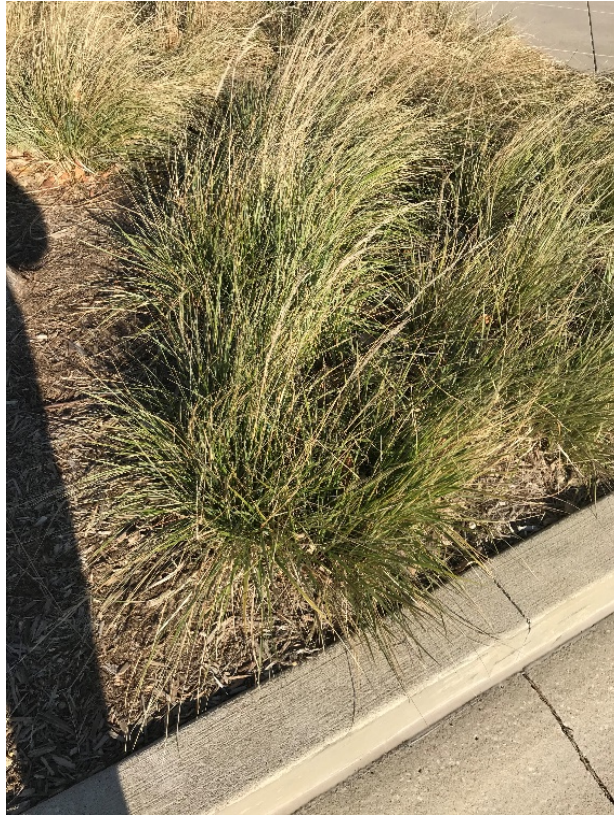
**Figure L-2: Healthy Planting**  
**Location: Directly East of Gate D**

Healthy plantings and grasses were commonly seen among landscape beds around the stadium, close regulation and regular maintenance should be performed to ensure an acceptable condition is maintained, [Figure L-2](#) shows an example of a healthy planting. Landscape beds should also be kept clear of unsightly debris that may accumulate through the year to maintain a pleasant aesthetic and allow access to irrigation valves, [Figure L-3](#) shows an irrigation water valve that is free of debris.

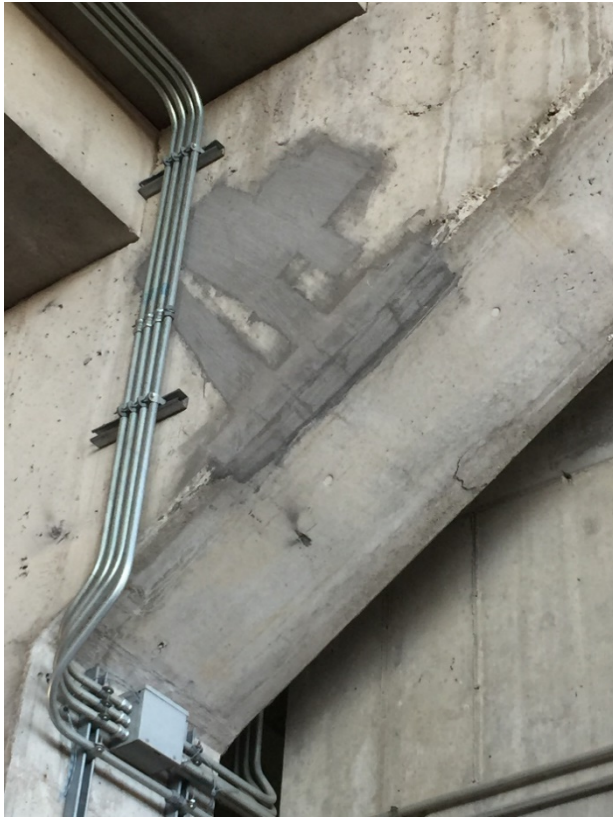
**Figure S-3: Concrete Patchwork**  
**Location:** Concourse 05.83.03

The original reinforced concrete columns and walls are in satisfactory condition. No major cracks or spalling was observed. The vertical column and wall surfaces are flat and smooth. Concrete patchwork of the original structure is in satisfactory condition, as shown in [Figure S-3](#).

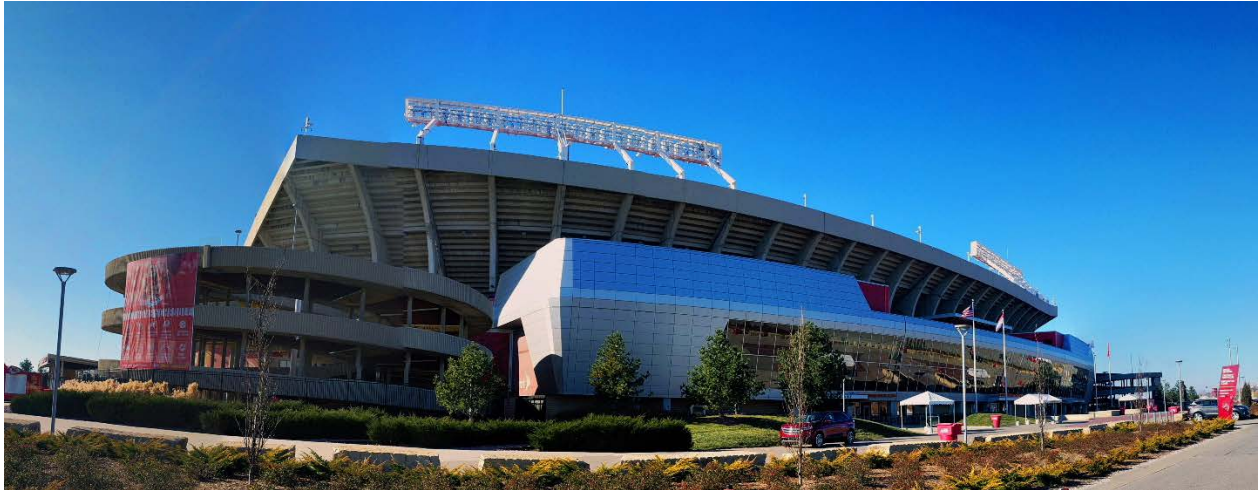
**Figure AF-1: Arrowhead Stadium Overall Exterior**  
**Location: North East Parking**

Arrowhead Stadium incorporates a variety of finish materials that are used in the composition of the exterior façade, as shown in [Figure AF-1](#). The primary surface materials include structural concrete, insulated metal panel, curtainwalls, and graphic mesh fabric on galvanized steel framing.

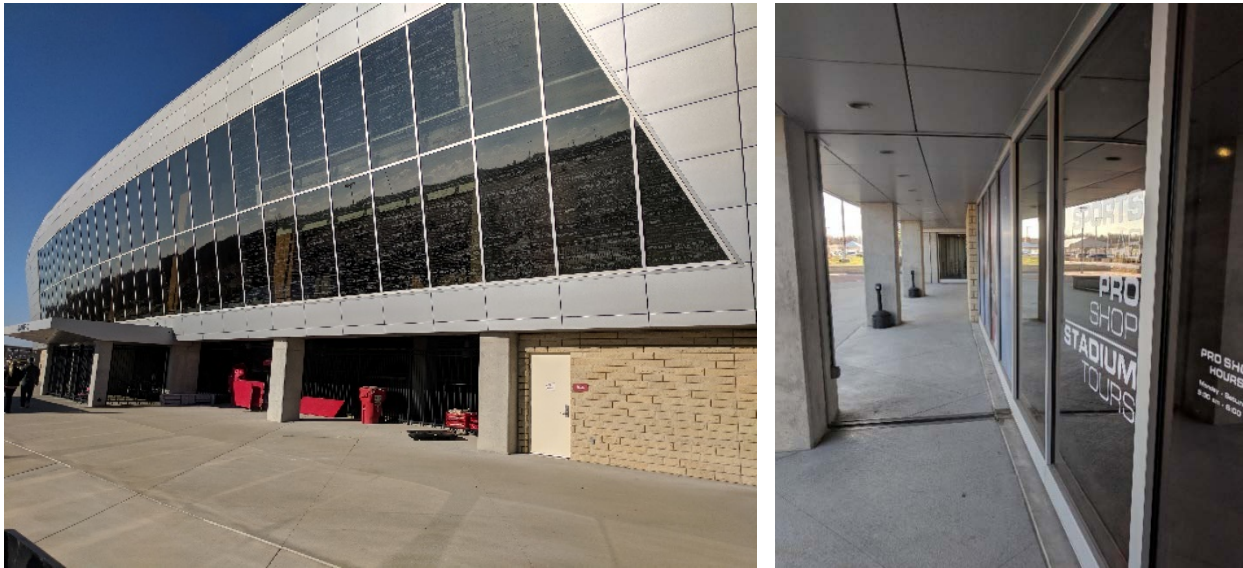
**Figure AF-2: External Glass Curtainwalls and Storefronts**  
**Location:** South East Exterior

All facades, in general, appear to be in satisfactory condition. Glass storefronts and curtainwall systems appear to be in satisfactory condition, as shown in [Figure AF-2](#). Aluminum frame and mullions were observed to be free of staining, fading, or degradation of any kind. Seals and flashing around storefronts appear to be in satisfactory condition. Glazing was observed to be free of defects, including cracking or chipping.

Insulated metal panel systems appear to be in satisfactory condition, as shown in [Figure AF-2](#). No oil canning, staining, or degradation of any kind was observed.

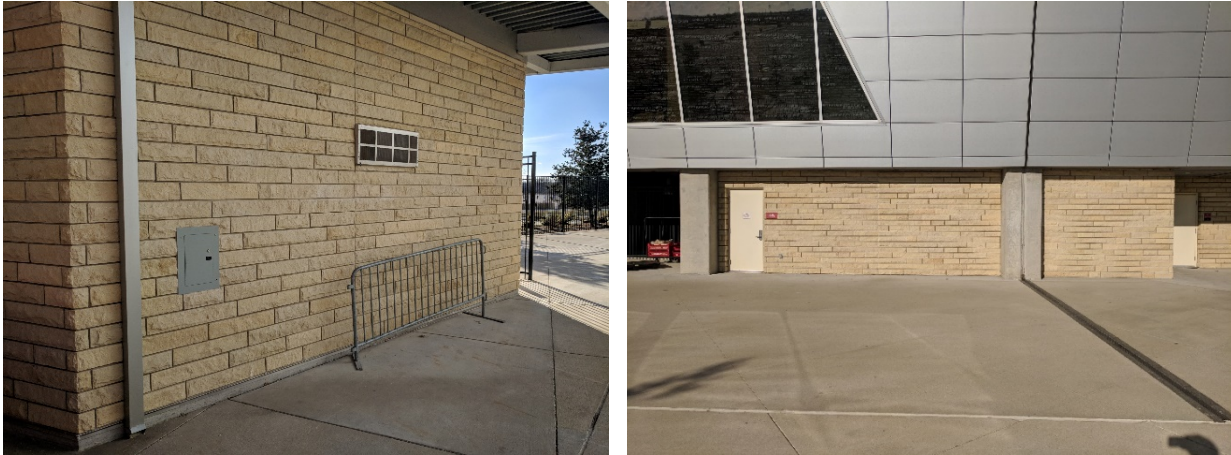
**Figure AF-4: Stone Veneer Wall**  
**Location: Plaza Level 3 - Southern Ticketing Kiosk**

Stone cladding systems appear to be in satisfactory condition, as shown in [Figure AF-4](#). No chipping or staining of the stone or grout was observed.

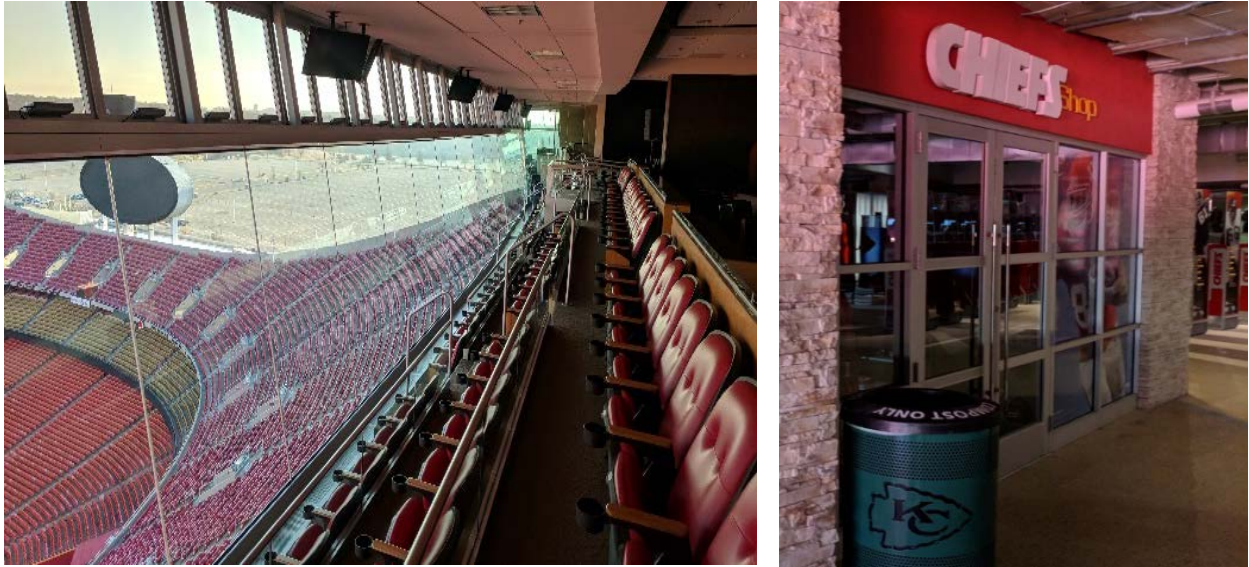
**Figure AF-5: Windows, Storefront, and Sliding Glass Wall System**  
**Location:** Press Level 9 - 09.17.01 Cabaret Seating

Internal storefront and glass wall systems appear to be in satisfactory condition, as shown in [Figures AF-5](#). Aluminum frame and mullions were observed to be free of staining, fading, or degradation of any kind. Seals and flashing around storefronts appear to be in satisfactory condition. Glazing was observed to be free of defects, including cracking or chipping.

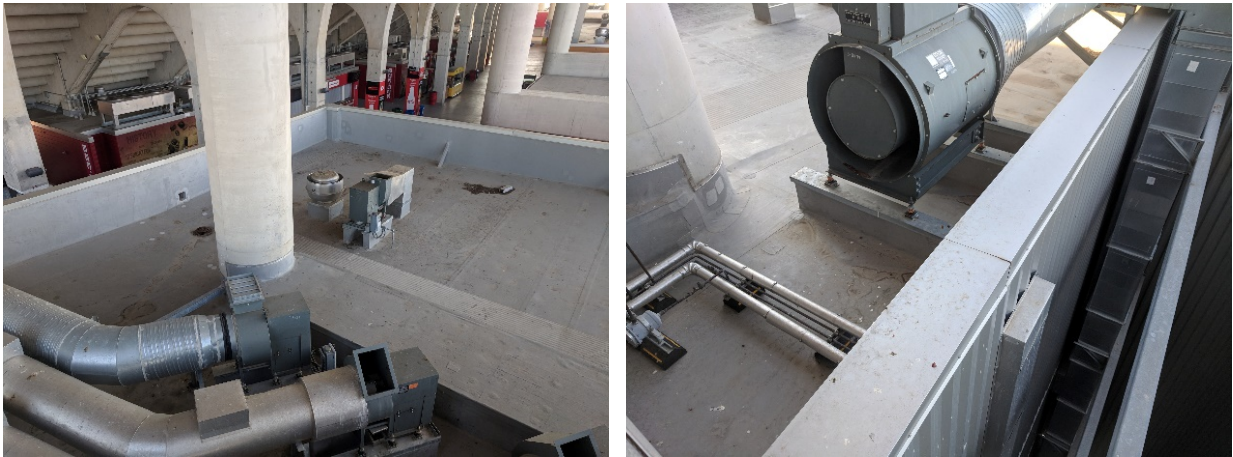
**Figure AR-1:** Membrane Roofing (right) and Typical Prefinished Metal Coping at Concourse (left)  
**Location:** Upper Concourse Level 6 – 06.76.02 Cooking Concession & Restroom Building

Roofing membranes were observed to be in satisfactory condition. No rips, tears, or other failures were observed. All observed copings, flashings, and sealants appear to be in satisfactory condition, as shown in [Figure AR-1](#). However, debris was observed near the stair to the roof, as shown in [Figure AR-2](#).

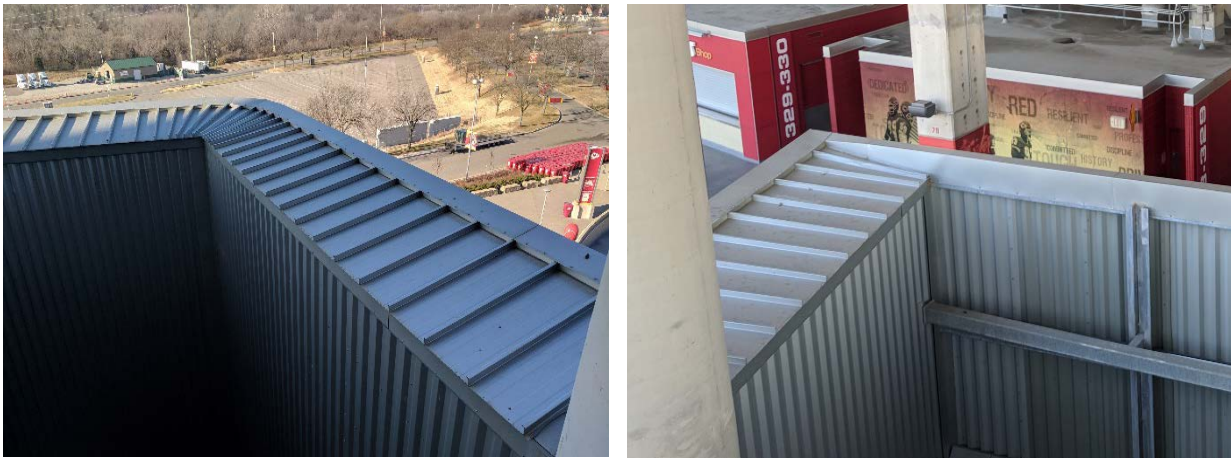
**Figure AR-3: Standing Seam Metal Roof Panels**  
**Location:** Upper Concourse Level 6 - 06.77.05 Stair #3

Standing seam metal roof panels appear to be in satisfactory condition, as shown in [Figure AR-3](#). No signs of rust, staining, or other failures were observed.

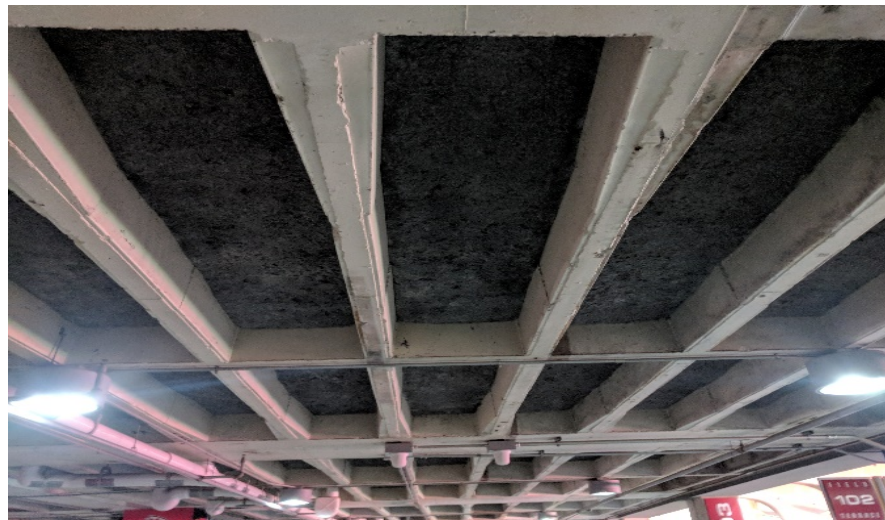
**Figure AME-1: Replaced Insulation to underside of Concrete Deck**  
**Location:** Field Level 02 - 02.23.05 Concourse

At the field level, in 2016's assessment, insulation applied to the underside of the concrete deck was observed to be deteriorating. Upon inspection it appears from the underside, that the insulation has been replaced. Refer to [Figure AME-1](#).

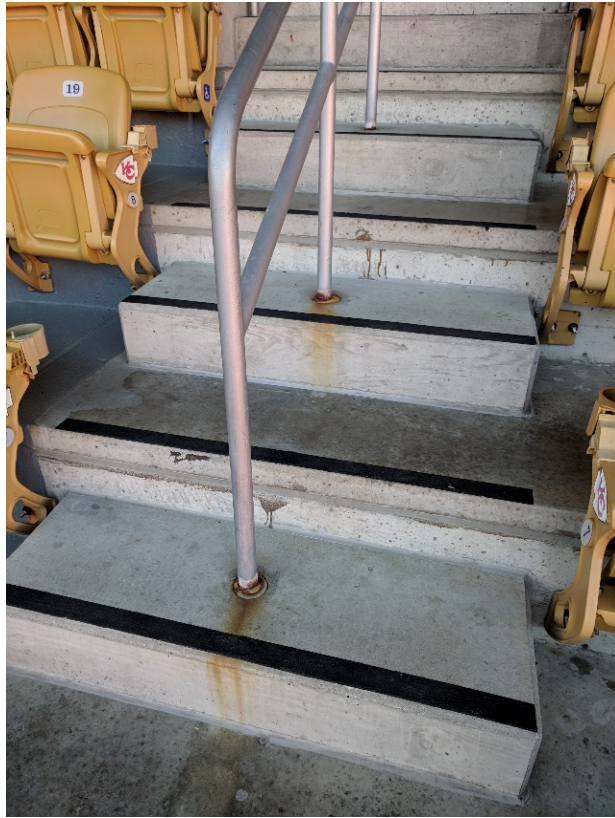
**Figure AME-2:** Replaced Slip Resistant Caution Tape at Club Level Stairs  
**Location:** Club Level 4 - 04.60.03 Seating Bowl

At several stairs within the club level seating bowl, nosing applied slip resistant caution tape was observed to be replaced after deteriorated or missing strips were observed in 2017's assessment, refer to [Figure AME-2](#).

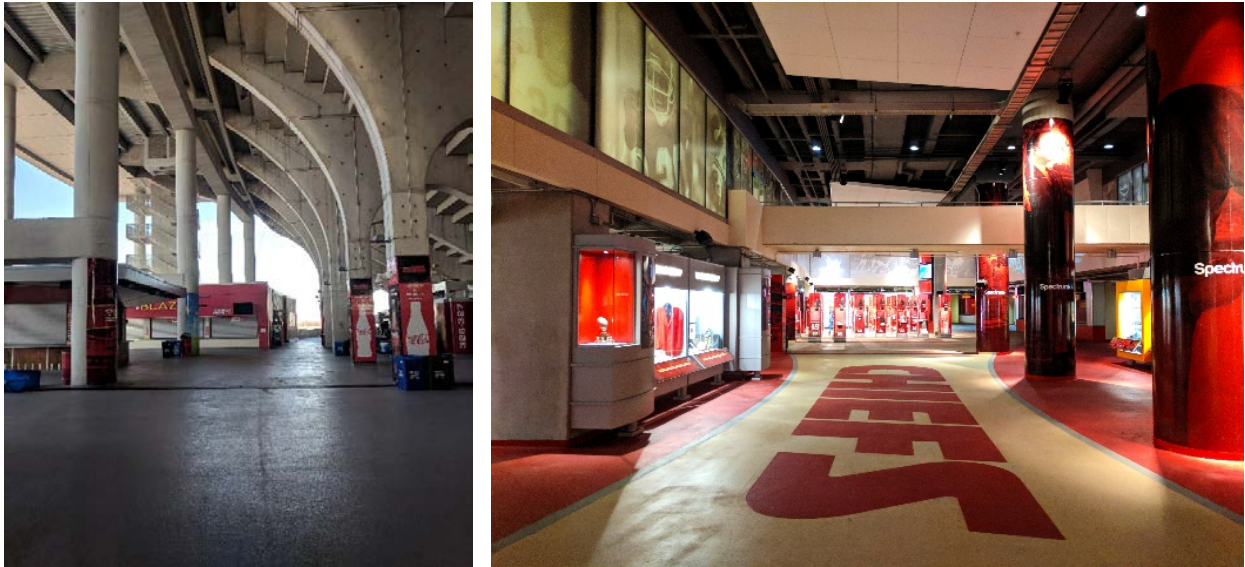
**Figure AI-1:** Exposed Concrete (left) and Epoxy Flooring (right)  
**Location:** Upper Concourse Level 6 - 06.80.02 Concourse (left) &  
Field Level 2 – 02.66.03 Hall of Honor (right)

Interior finishes within Arrowhead Stadium encompass a broad range of materials for floors, walls, and ceilings. The primary flooring systems are composed of epoxy and sealed concrete, as shown in [Figure AI-1](#).

These surfaces were observed to be in satisfactory condition, typically. Minor cracking was observed at various locations throughout the facility, which is considered normal given the expansion and contraction properties of the material and their exposure to outside air temperatures. No excessive cracking was observed during the walk-through.

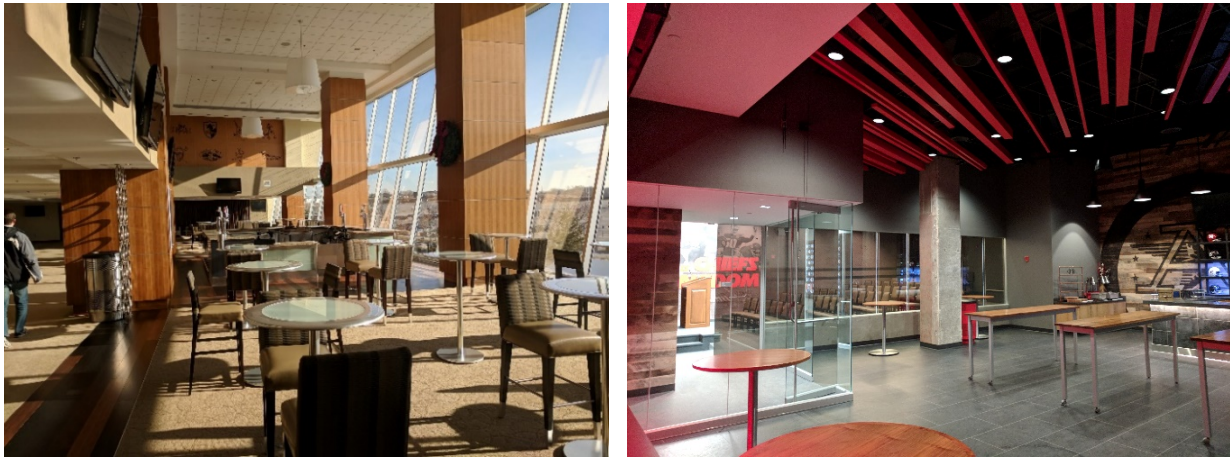
**Figure AI-2: Carpet Flooring (left) and Porcelain Tile Flooring (right)**  
**Location:** Club Level 4 - 04.46.02 Bar (left) and Service Level 1 – 01.72.03 Club (right)

Carpet flooring was typically observed to be in satisfactory condition. In general, no signs of rips, tears, stains, or discoloration were observed, as shown in [Figure AI-2](#) (left image). However, minimal stains were observed in the team store. Additionally, on the Club Level carpet tile at transitions to tile at food service locations were observed to begin showing signs of discoloration from typical use, as shown in [Figure AI-3](#) (right). Porcelain/Ceramic tile flooring areas appear to be in satisfactory condition, as shown in [Figure AI-2](#) (right image). No signs of grout discoloration or cracking were observed, typically.

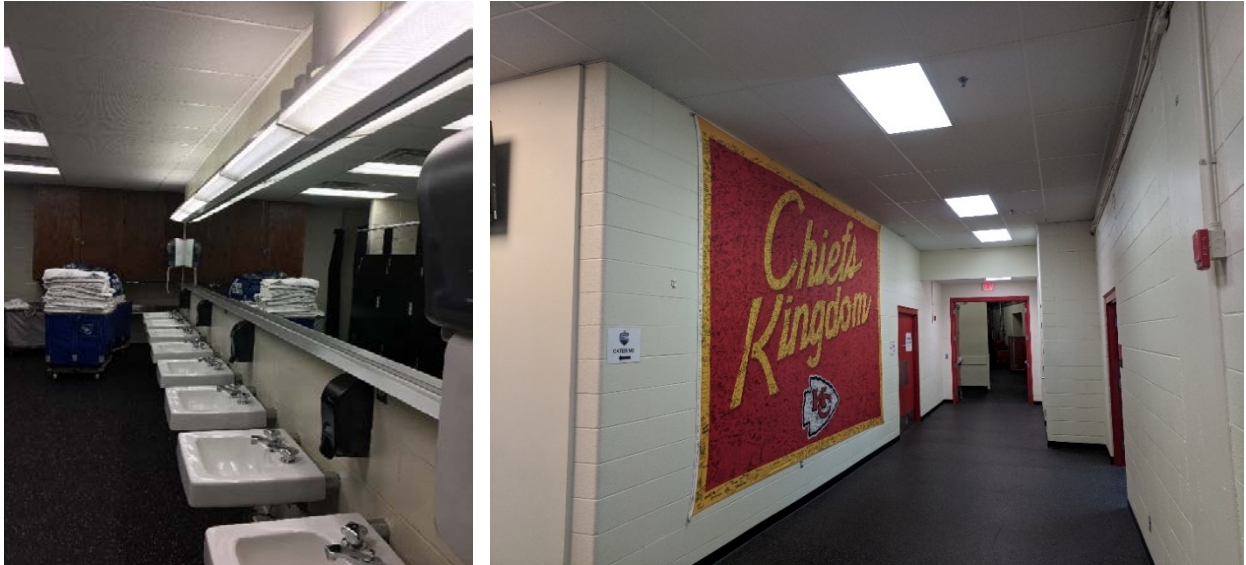
**Figure AI-4 Rubber Flooring (left) and VCT Flooring (right)**  
**Location:** Service Level 1 – 01.57.02 Toilet (left) & 01.61.04 Corridor (right)

Less abundant areas of flooring materials include vinyl composition tile (VCT) and athletic rubber flooring. These materials are generally found in service areas or back-of-house type areas which are less visible to the public. All observed materials of this type were observed to be in satisfactory condition, as shown in [Figure AI-4](#).

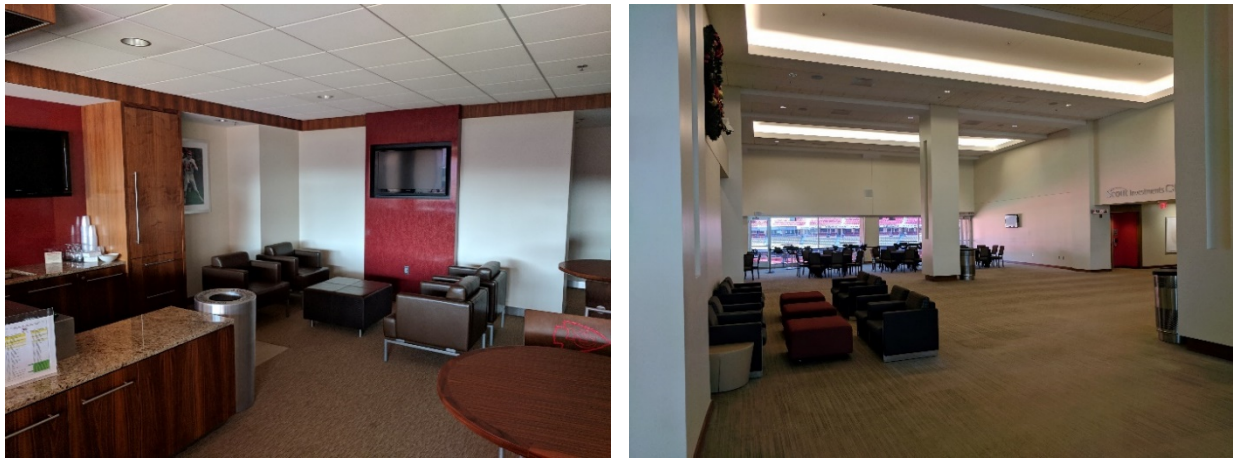
**Figure AI-5: Painted Gypsum Board Walls**  
**Location:** Club Level 4 – 04.41.01 Suite (left) & 04.28.02 Bar (right)

Painted Gypsum board walls appear to be in satisfactory condition, typically, as shown in [Figure AI-5](#). No signs of punctures or holes in the gypsum board materials were observed.

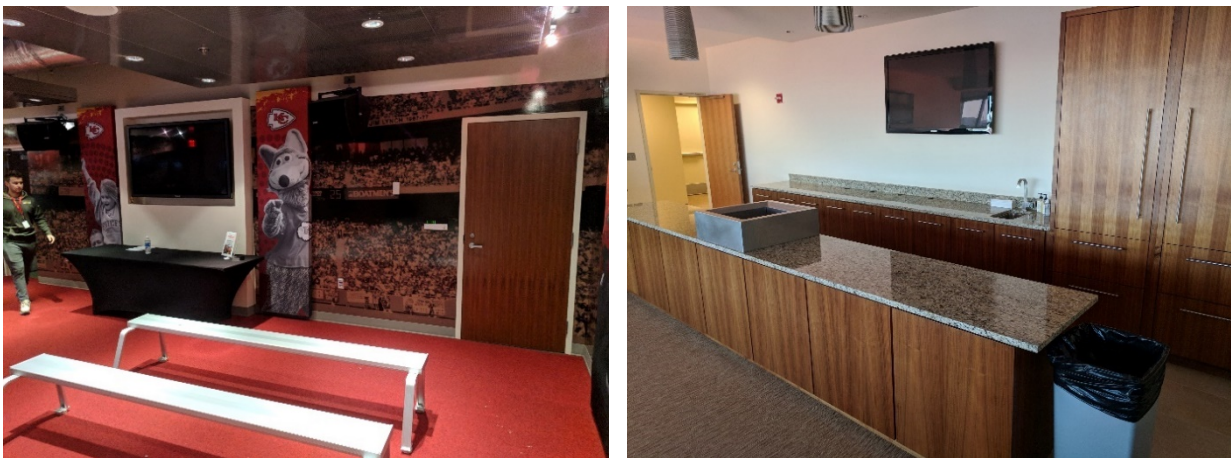
**Figure AI-6: Graphic Applied Presentation Board (left) and Wood Veneer Paneling Wall (right)**  
**Location:** Plaza Level 3 – 03.20.05 Theatre (left) and Press Level 9 – 09.63.02 Suite (right)

Graphic applied presentation boards throughout the stadium appear to be in satisfactory condition, as shown in [Figure AI-6](#) (left image). No signs of scratching or delamination were observed. Wood veneer panel at interior walls appear to be in satisfactory condition, as shown in [Figure AI-6](#) (right image). No scratches, scuffs, or fading of any kind was observed.

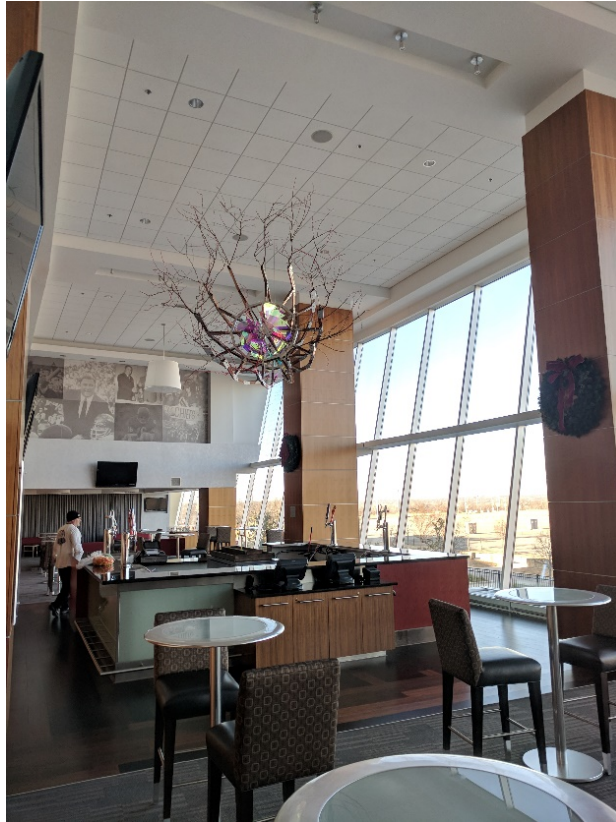
**Figure AI-7: Acoustic Ceiling Tile at Event Space**  
**Location: Club Level 4 - 04.92.03 Bar**

Acoustic ceiling tiles appear to be in satisfactory condition, generally. A typical condition at the Club Level lounge area is shown in [Figure AI-7](#) (left image). Ceiling tile in these spaces do not show signs of stains or deterioration of any kind.

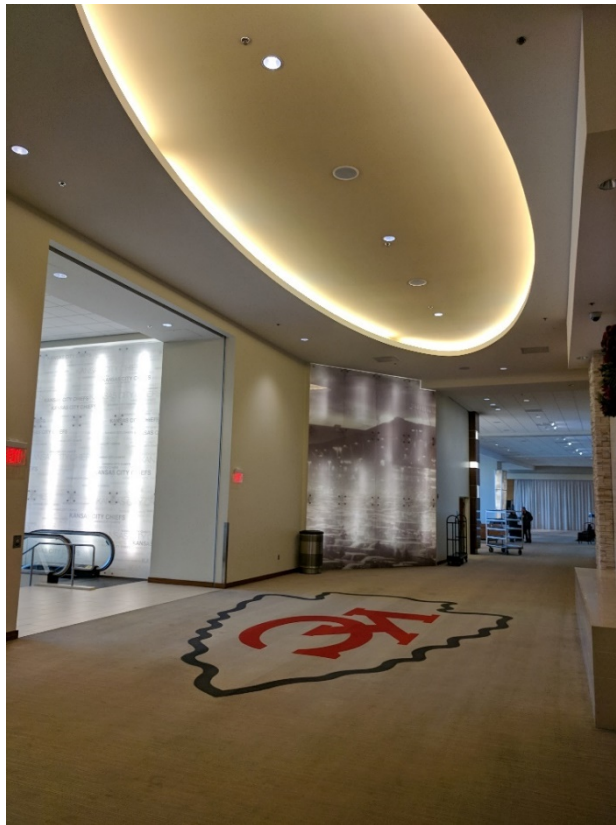
**Figure AI-8:** Gypsum Board Ceiling, Painted  
**Location:** Club Level 4 – 04.69.03 Club Concourse

Gypsum board ceilings appear to be in satisfactory condition, typically. No punctures, stains, scrapes, or tears were observed. Refer to [Figure AI-8](#) for typical condition.

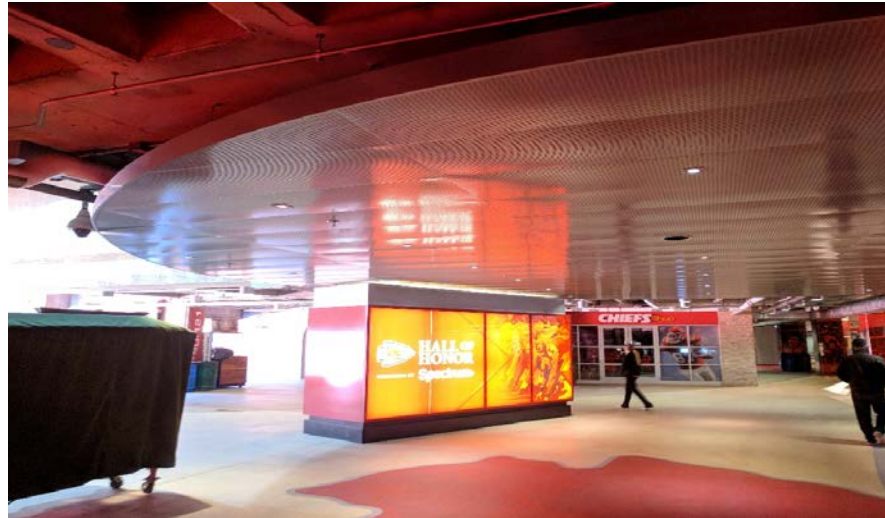
**Figure AI-9: Lay-In Perforated Metal Ceiling Panels**  
**Location: Field Level 2 – 02.23.05 Concourse**

Lay-in perforated metal ceiling tiles were observed to be in satisfactory condition. No signs of rust or finish deterioration was observed. Refer to [Figure AI-9](#) for typical condition at exterior concourse.

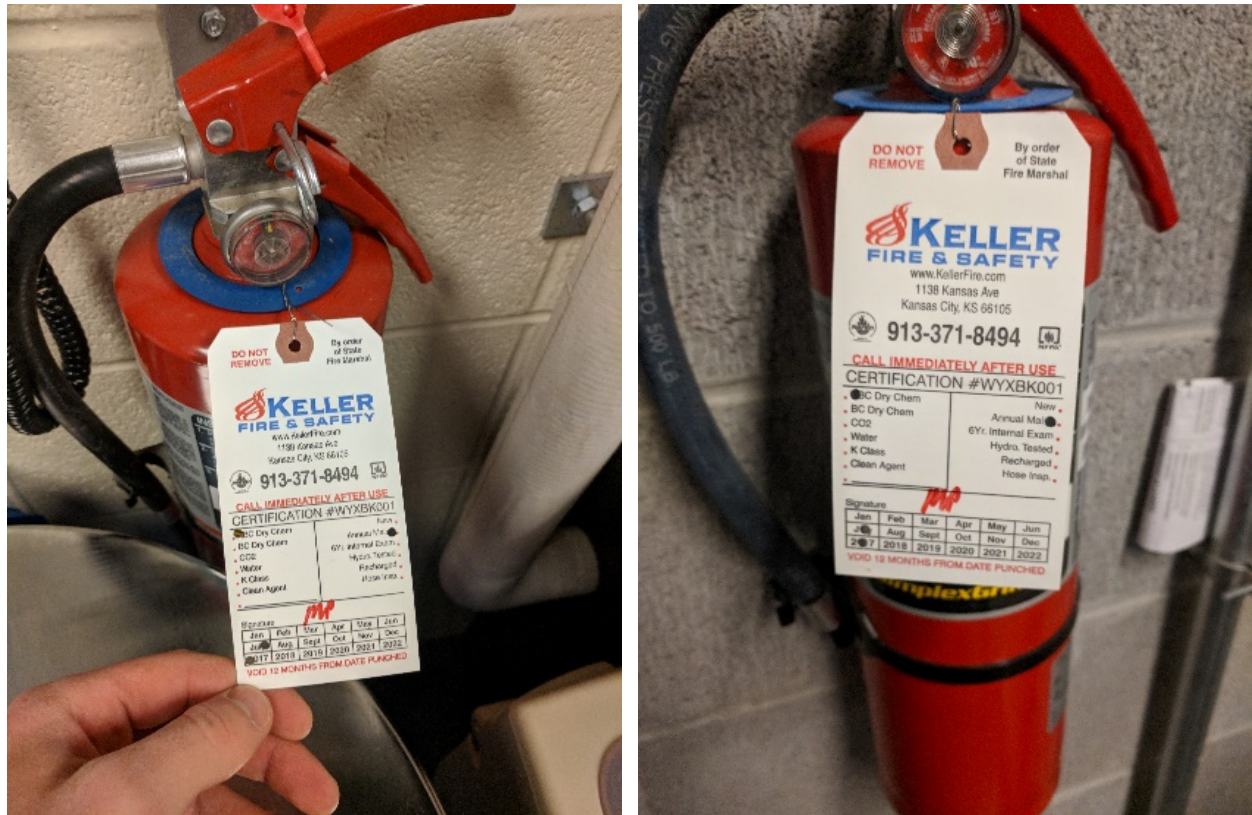
**Figure AMI-1: Fire Extinguishers**  
**Location: Various Locations**

Several fire extinguishers were checked for verification of updated inspection tags. All fire extinguishers observed were inspected and punched within the last year, as shown in [Figure AMI-1](#).

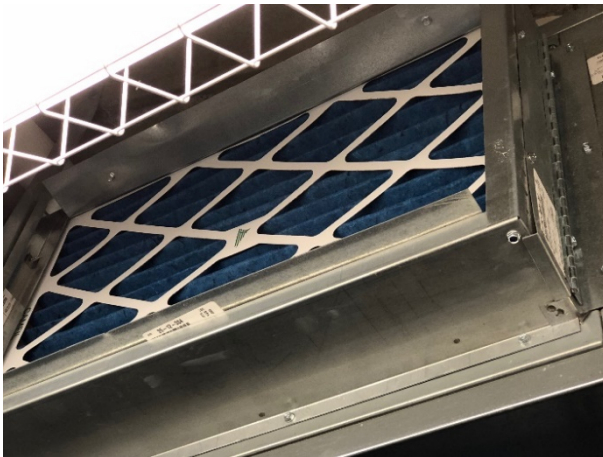
**Figure M-1:** Typical Clean Filter  
**Location:** Tele. 02.61.04

The 2016 assessment identified dirty or old filters as an action item. Upon review, most of the filters observed had been changed recently and appeared to be in good condition, as shown in [Figure M-1](#). One observed unit had filters dated from February 2017, as shown in [Figure M-2](#), these should be replaced along with any others of similar age.

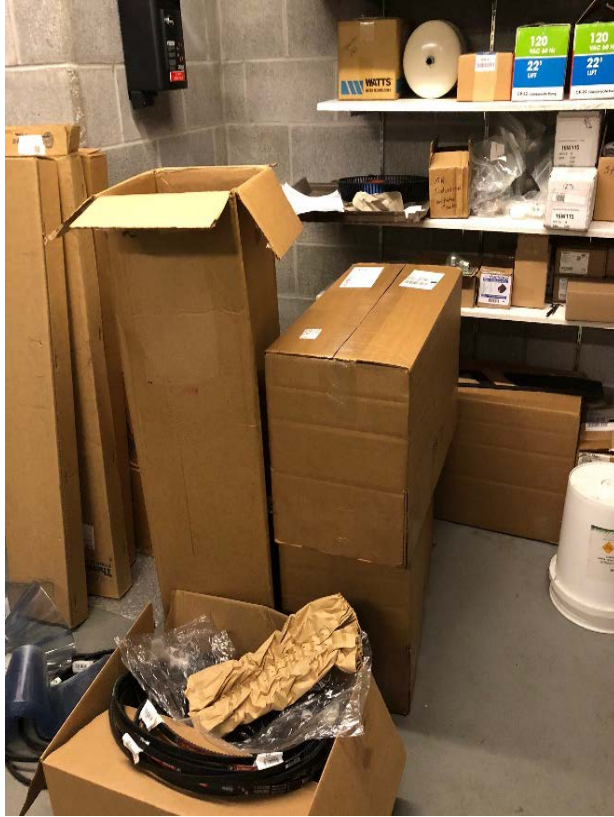
**Figure M-7: Spare Parts**  
**Location: Mech. 03.31.01**

Throughout the facility, there was evidence of regular maintenance. There are stockpiles of replacement parts, belts, and filters in many mechanical rooms ready to be installed, as shown in [Figures M-7 and M-8](#). The main chilled water pumps in Pump Room 05.40.03 appeared to be recently lubricated, as shown in [Figure M-9](#).

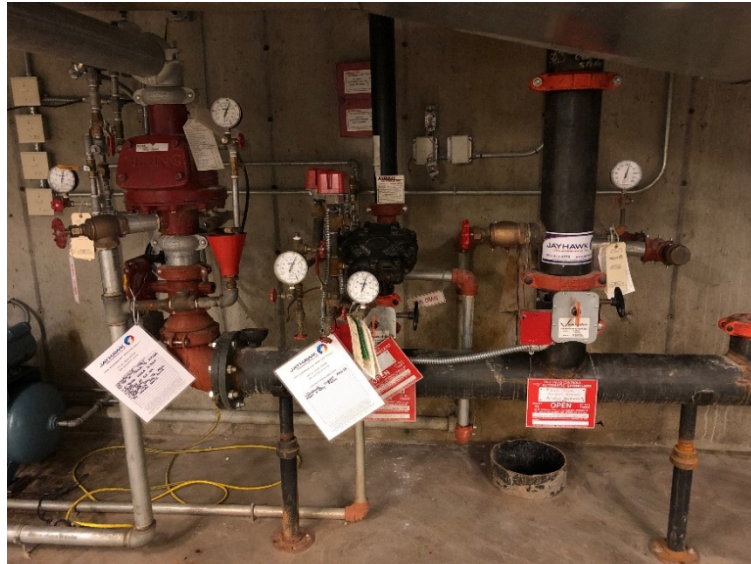
**Figure M-10: Fire Protection Valves**  
**Location: Mech. 01M.64.01**

All fire protection systems and assemblies observed were in good condition and had recent inspection tags, as shown in [Figure M-10](#). The clean agent systems in Scoreboard Equipment 09.61.07 and PA 09.60.01 also have current inspection tags and are appropriately charged, as shown in [Figure M-11](#).

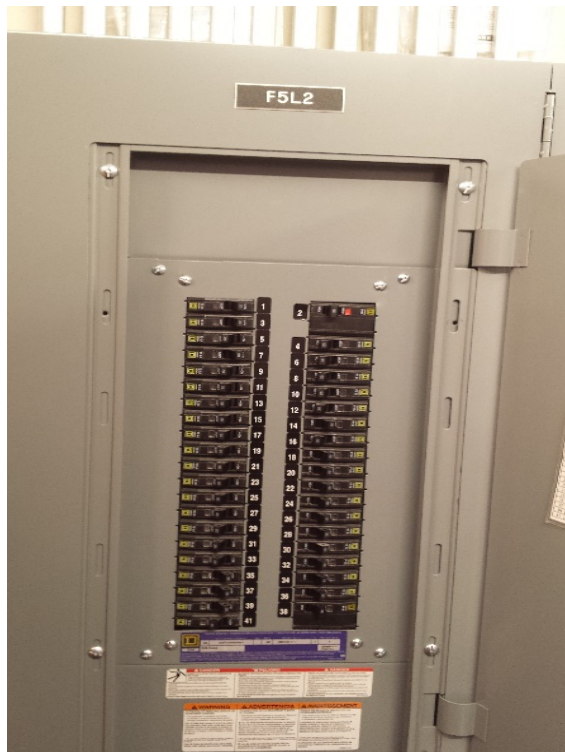
**Figure E-1: Panelboard F5L2**  
**Location: Room 01.70.06**

On the service level, panelboard F5L2 was found to not have all breakers labeled indicating load descriptions and spare breakers. Refer to [Figures E-1 and E-2](#).
