Arrowhead Stadium Assessment

JCSCA + Burns & McDonnell

This document contains information pertaining to the condition of Arrowhead Stadium as documented by the Jackson County Sports Complex Authority (JCSCA), including descriptions, conditions, and exhibits which have been reviewed by Burns & McDonnell and documented in this report.

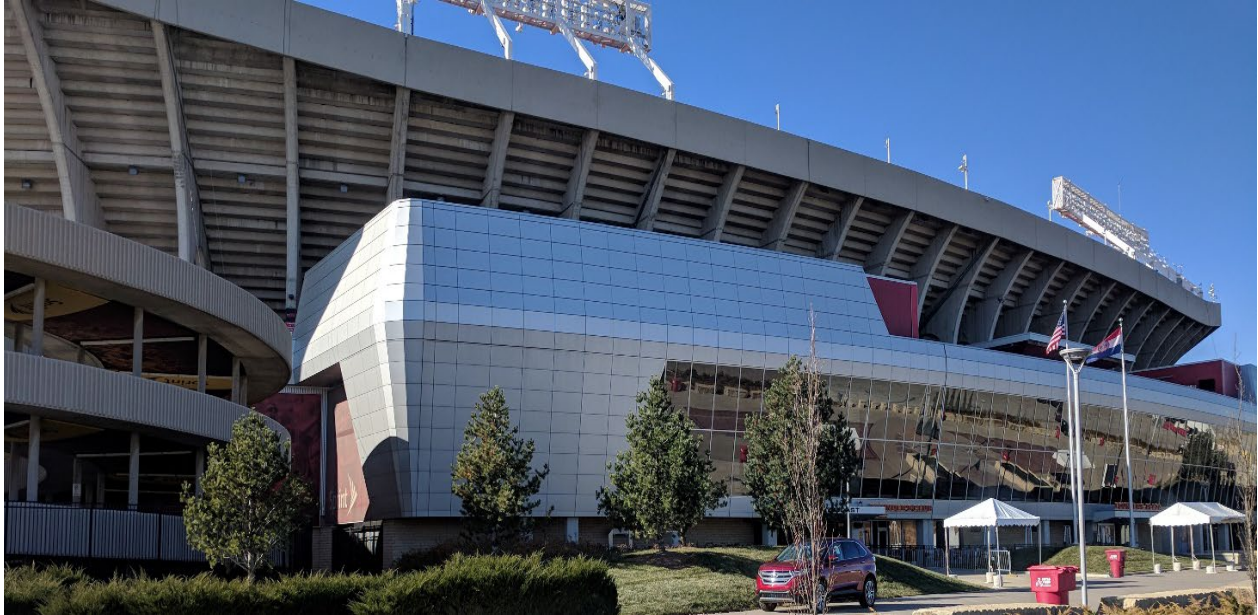
Figure AF-1: Arrowhead Stadium Overall Exterior
Location: North East Parking

Insulated metal panel systems appear to be in satisfactory condition, as shown in **Figure AF-1** and **Figure AF-2**. No oil canning, staining, or degradation of any kind was observed.

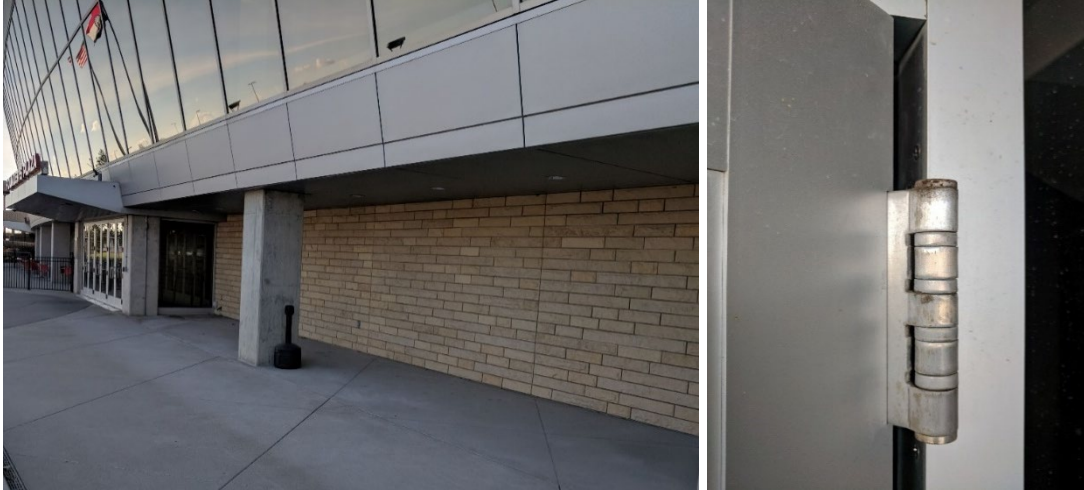
All facades, in general, appear to be in satisfactory condition. Glass storefronts and curtainwall systems appear to be in satisfactory condition, as shown in **Figure AF-2**. Aluminum frame and mullions were observed to be free of staining, fading, or degradation of any kind. Seals and flashing around storefronts appear to be in satisfactory condition. Glazing was observed to be free of defects, including cracking or chipping.

Figure AF-2: External Glass Curtainwall and Storefront Systems
Location: South East Exterior

Exterior doors at the exterior plaza level were observed to have minor deficiencies. As noted in the 2017 assessment, many of the door hinges in the various locations were showing signs of rust from the elements and again observed on the walk-through this year. Refer to **Figure AF-2** for the types of doors observed. To avoid rust stains or streaking on the aluminum frames, consider replacing hinges with an anti-corrosive material such as stainless steel.

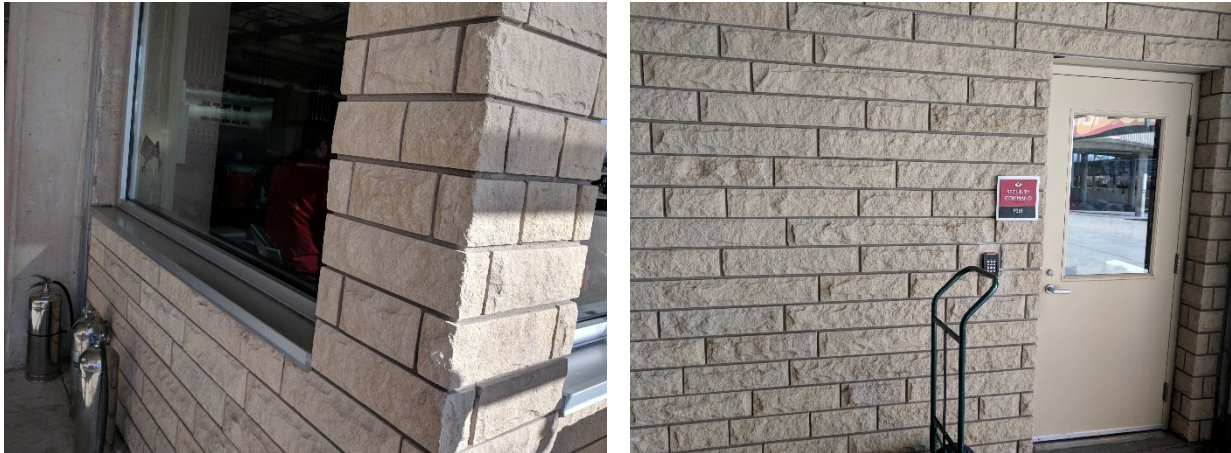
Stone cladding systems appear to be in satisfactory condition, as shown in [Figure AF-4](#). No chipping or staining of the stone or grout was observed.

Figure AF-4: Stone Veneer Wall
Location: Plaza Level 3 – 03.54.02 Security & Fire Command

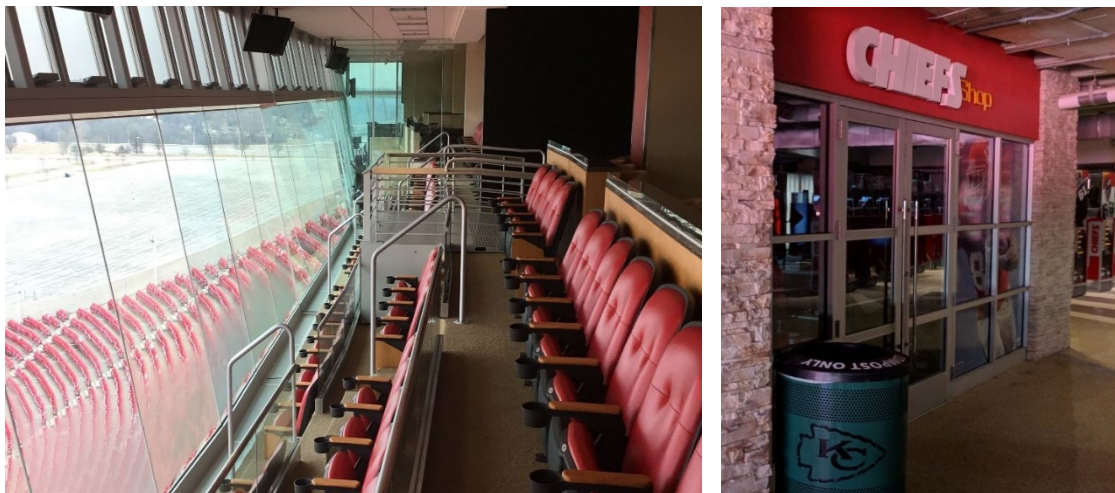
Internal storefront and glass wall systems appear to be in satisfactory condition, as shown in [Figure AF-5](#). Aluminum frame and mullions were observed to be free of staining, fading, or degradation of any kind. Seals and flashing around storefronts appear to be in satisfactory condition. Glazing was observed to be free of defects, including cracking or chipping.

Figure AF-5: Windows, Storefront, and Sliding Glass Wall System
Location: Press Level 9 - 09.17.01 Cabaret Seating

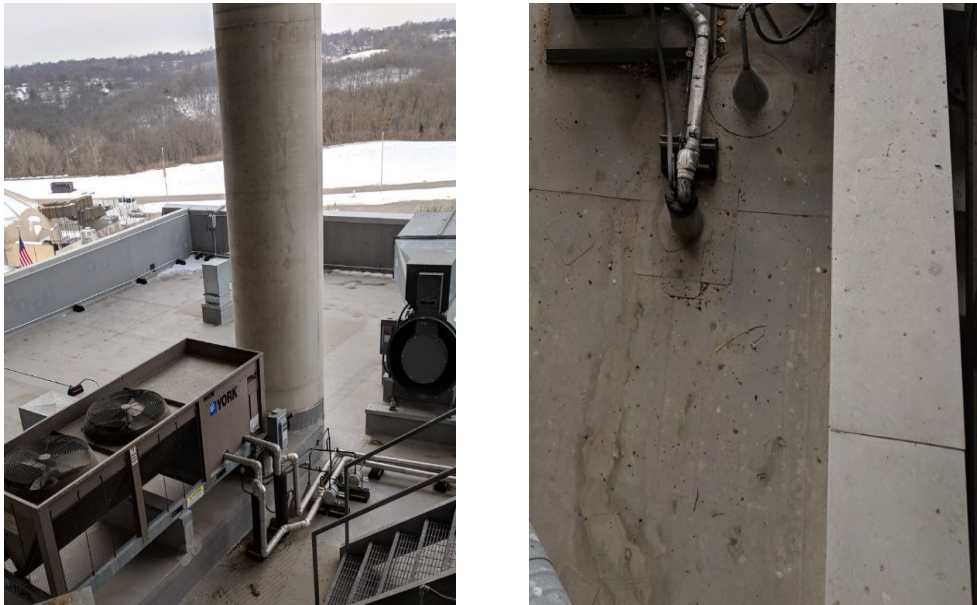
Roofing membranes were observed to be in satisfactory condition. No rips, tears, or other failures were observed. All observed copings, flashings, and sealants appear to be in satisfactory condition, as shown in [Figure AR-1](#). However, portions of the roofing membrane improperly placed were observed near the stair to the roof, as shown in [Figure AR-2](#).

Figure AR-1: Membrane Roofing (right) & Typical Prefinished Metal Coping at Concourse (left).
Location: Upper Concourse Level 6 – 06.76.02 Cooking Concession & Restroom Building

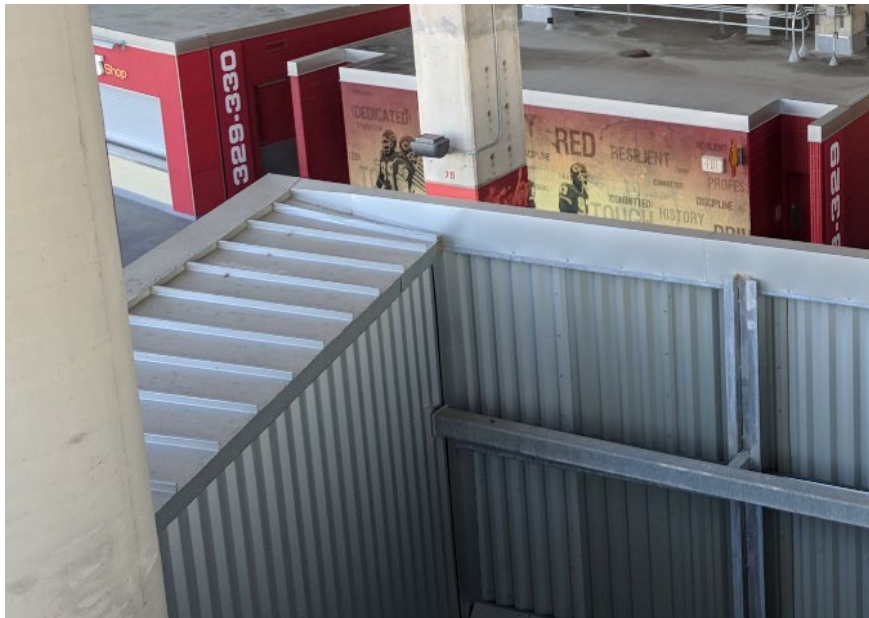
Standing seam metal roof panels appear to be in satisfactory condition, as shown in **Figure AR-3**. No signs of rust, staining, or other failures were observed from what is visible from stair or ramp.

Figure AR-3: Standing Seam Metal Roof Panels
Location: Upper Concourse Level 6 - 06.77.05 Stair #3

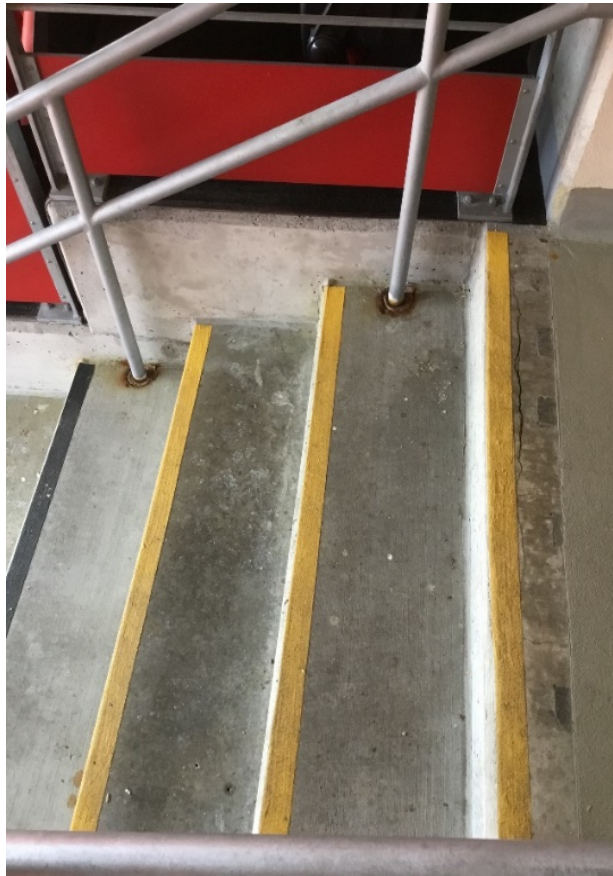
In previous year reports, several stairs within the facility were noted to have missing or partially damaged/torn slip resistant caution tape. Upon observation overall, the current slip resistant tape is in satisfactory condition, as shown in **Figure AME-1**.

Figure AME-1: Replaced Slip Resistant Caution Tape at Club Level Stairs
Location: Club Level 4 – 04.70.01 Super Suite Type B

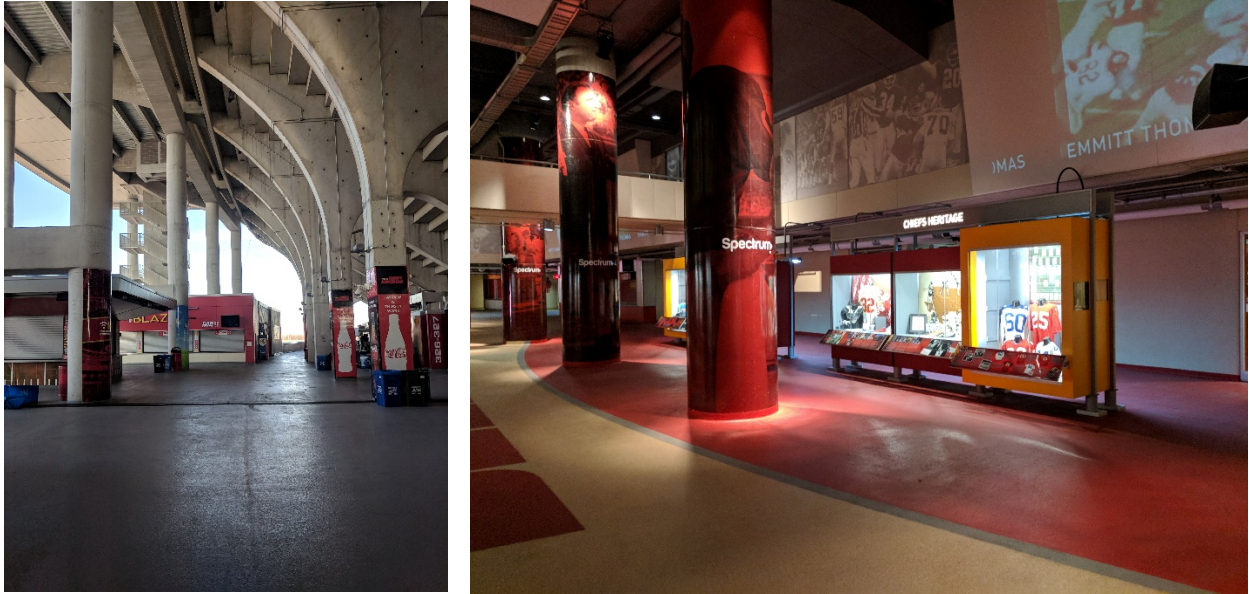
These surfaces were observed to be in satisfactory condition, typically. Minor cracking was observed at various locations throughout the facility, which is considered normal given the expansion and contraction properties of the material and their exposure to outside air temperatures. No excessive cracking was observed during the walk-through.

Figure AI-1: Exposed Concrete (left) & Epoxy Flooring (right)
Location: Upper Concourse Level 6 - 06.80.02 Concourse (left) &
Field Level 2 – 02.66.03 Hall of Honor (right)

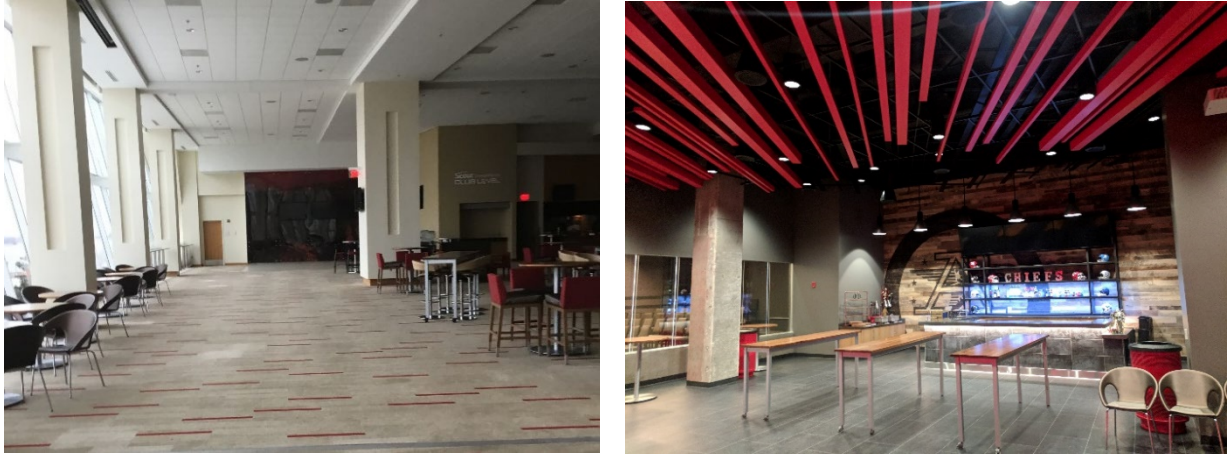
Carpet flooring was typically observed to be in satisfactory condition. In general, no signs of rips, tears, stains, or discoloration were observed, as shown in **Figure AI-2**. Porcelain/Ceramic tile flooring areas appear to be in satisfactory condition, as shown in **Figure AI-2**. No signs of grout discoloration or cracking were observed, typically.

Figure AI-2: Carpet Flooring (left) & Porcelain Tile Flooring (right)
Location: Club Level 4 - 04.46.02 Bar (left) & Service Level 1 – 01.72.03 Club (right)

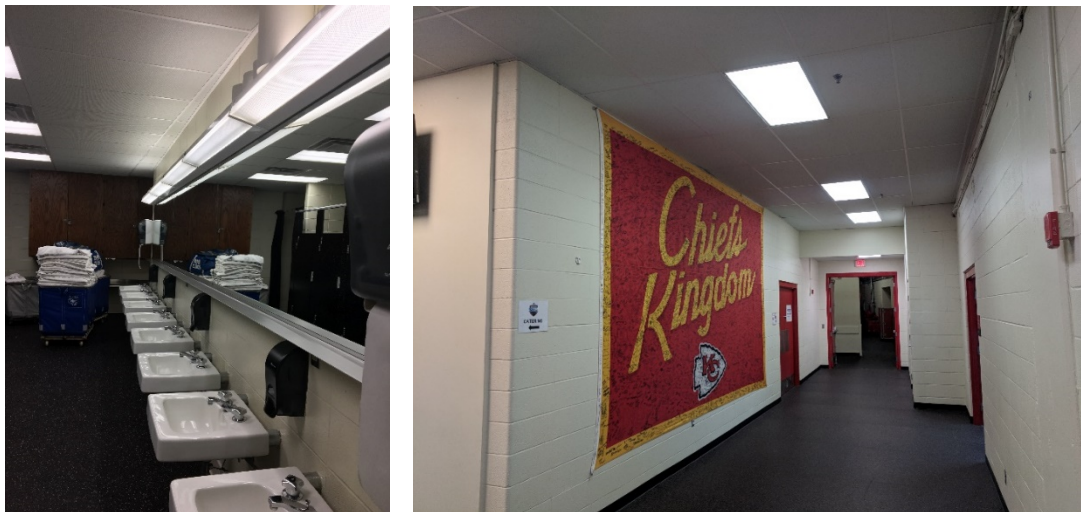
Location: Service Level 1 – 01.57.02 Toilet (left) & 01.61.04 Corridor (right)

Less abundant areas of flooring materials include vinyl composition tile (VCT) and athletic rubber flooring. These materials are generally found in service areas, camera/press booths or back-of-house type areas which are less visible to the public. Some VCT floor tiles were observed to be missing in 03.70.02 Cameras and 03.68.03 National Broadcast, as shown in [Figure AI-3](#). All other observed materials of this type were found to be in satisfactory condition, as shown in [Figure AI-4](#).

Figure AI-4 Rubber Flooring (left) & VCT Flooring (right)

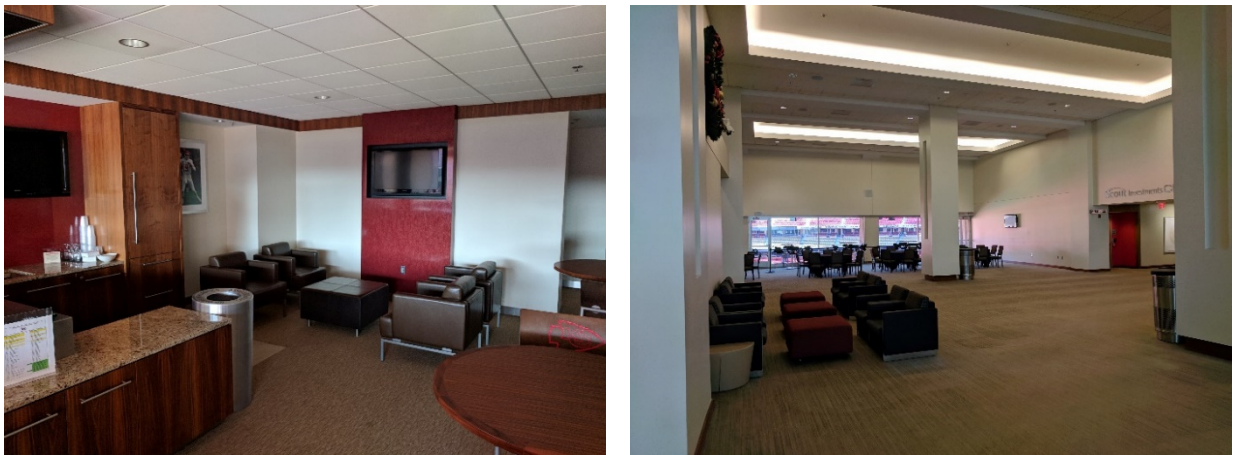
Painted Gypsum board walls appear to be in satisfactory condition, typically, as shown in [Figure AI-5](#). No signs of punctures or holes in the gypsum board materials were observed.

Figure AI-5: Painted Gypsum Board Walls
Location: Club Level 4 – 04.41.01 Suite (left) & 04.28.02 Bar (right)

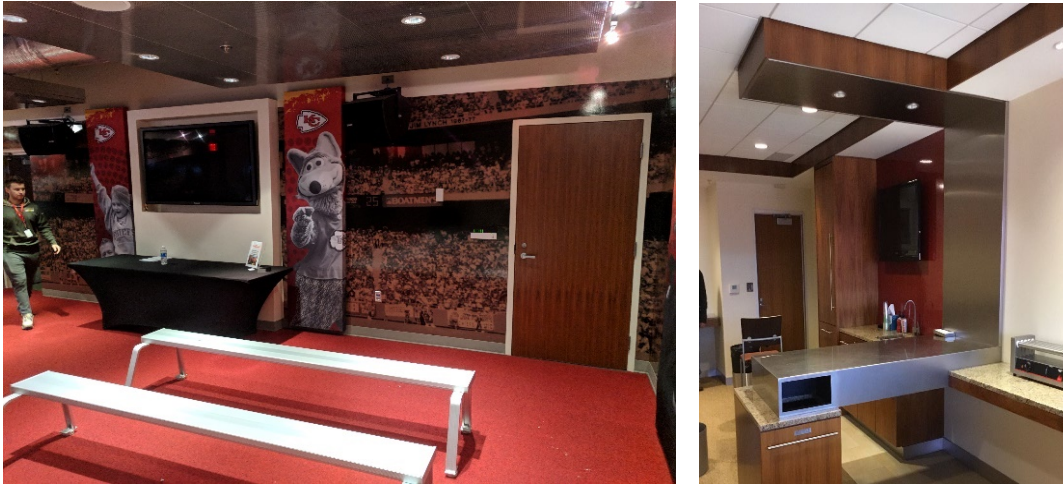
Graphic applied presentation boards throughout the stadium appear to be in satisfactory condition, as shown in **Figure AI-6**. No signs of scratching or delamination were observed. Wood veneer panel at interior walls appear to be in satisfactory condition, as shown in **Figure AI-6**. No scratches, scuffs, or fading of any kind was observed.

Figure AI-6: Graphic Applied Presentation Board and Wood Veneer Paneling
Location: Plaza Level 3 – 03.20.05 Theatre and Club Level 4 – 04.70.01 Super Suite Type B

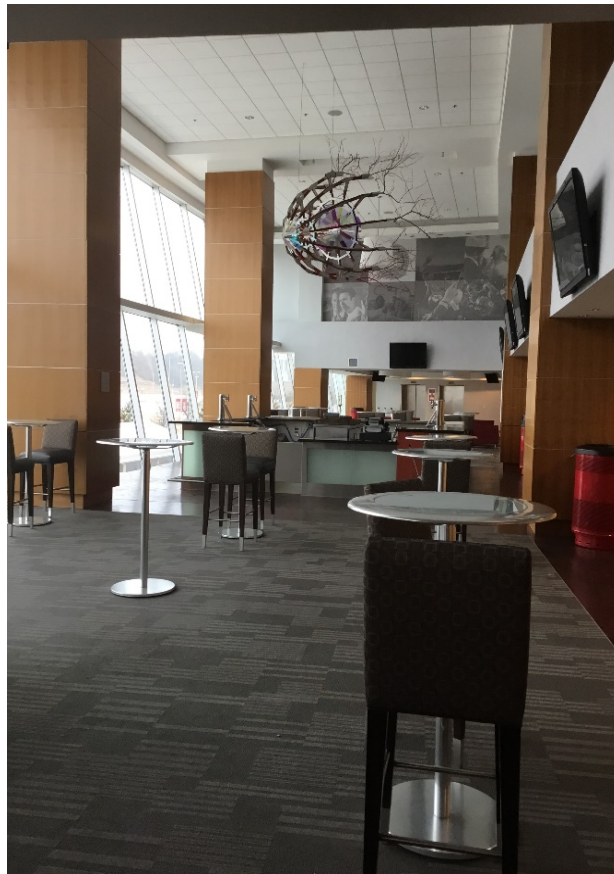
Acoustic ceiling tiles appear to be in satisfactory condition, generally. A typical condition at the Club Level lounge area is shown in **Figure AI-7**. Ceiling tile in these spaces do not show signs of stains or deterioration of any kind.

Figure AI-7: Acoustic Ceiling Tile at Event Space
Location: Club Level 4 - 04.92.03 Bar

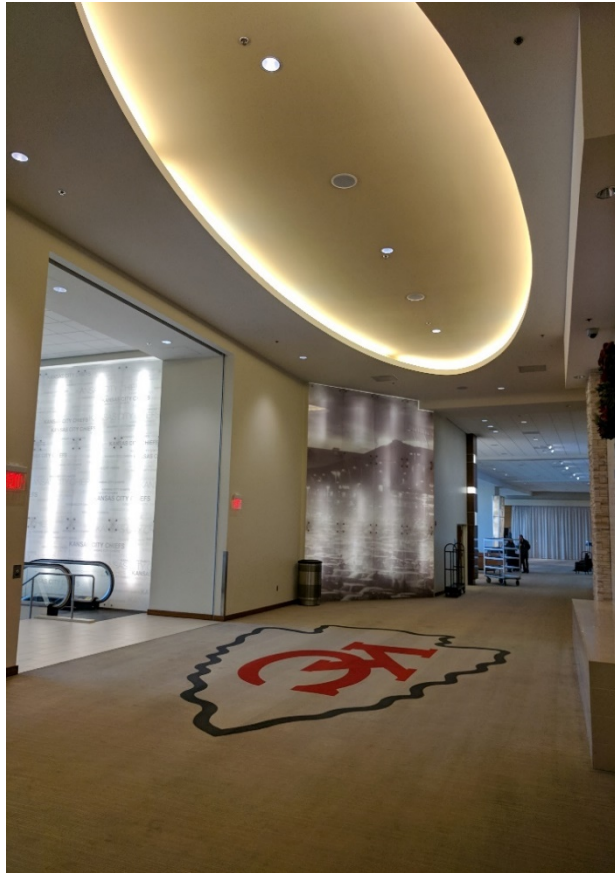
Gypsum board ceilings appear to be in satisfactory condition, typically. No punctures, stains, scrapes, or tears were observed. Refer to [Figure AI-8](#) for typical condition.

Figure AI-8: Gypsum Board Ceiling, Painted
Location: Club Level 4 – 04.69.03 Club Concourse

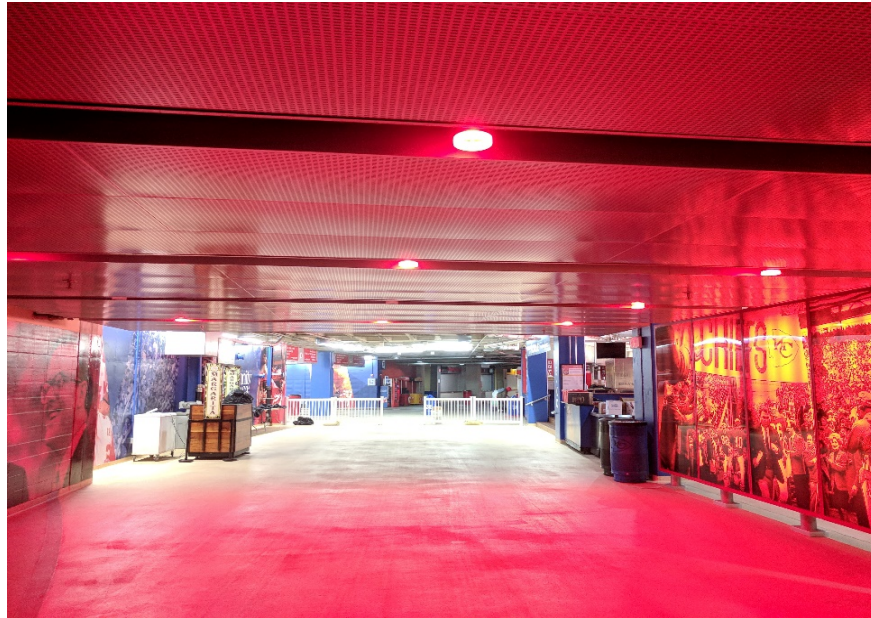
Lay-in perforated metal ceiling tiles were observed to be in satisfactory condition. No signs of rust or finish deterioration was observed at Field Level 2 Concourse 02.23.05. Refer to [Figure AI-9](#) for typical condition at exterior concourse.

Figure AI-9: Lay-In Perforated Metal Ceiling Panels
Location: Field Level 2 – 02.23.05 Concourse

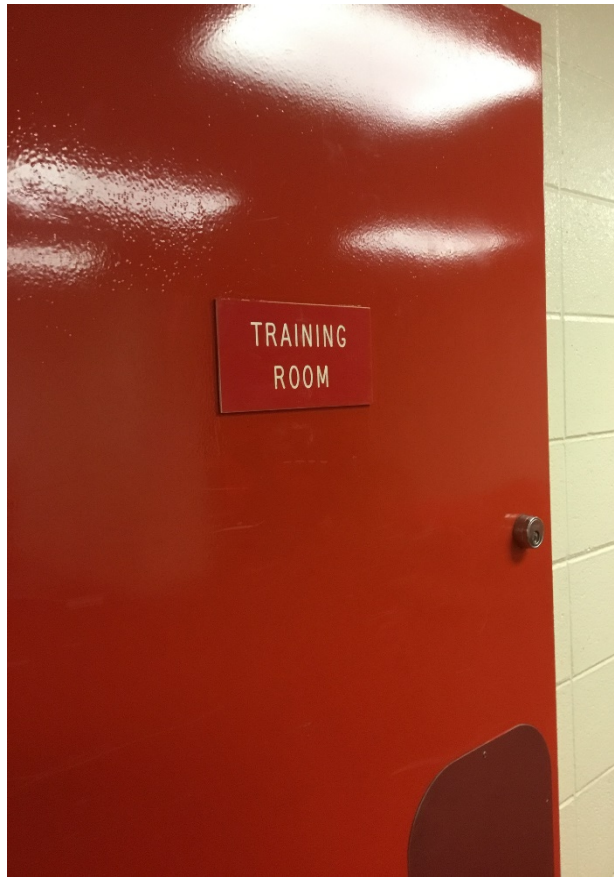
Generally, all doors were observed to be in satisfactory condition. Refer to [Figure AI-10](#).

Figure AI-10: Hollow Metal Doors at Training Room
Location: Service Level 1 – 01.63.01 Training Room

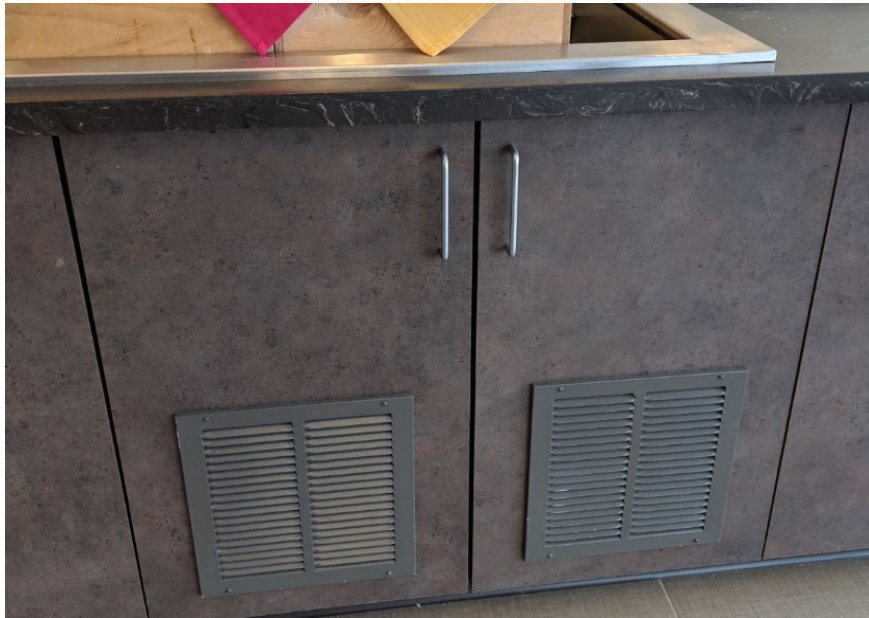
On the Press level, one of the cabinet doors at the Bar was observed to not close fully and no longer hung properly in the 2017 assessment. Upon observation, it appeared as though condition was addressed and properly repaired, as shown in **Figure AMI-1**.

Figure AMI-1: Cabinet Door Hung
Location: Press Level 08 – 08.72.01 Bar

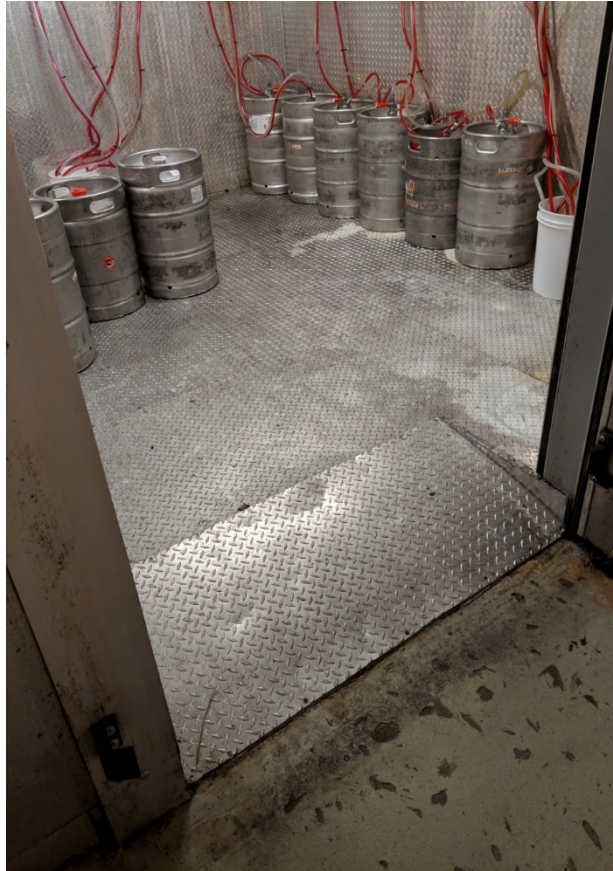
Observed service areas appeared to be generally in satisfactory condition. However, it was observed at the Club Beer Pump room in the 2017 assessment that IMP floors and ramp have been warped, most likely due to the weight on top of them. The significant warping of the entry ramp had created a high lip and a potential tripping hazard. Upon observation, it appeared as though the hazard was identified, and the ramp was replaced, as shown in [Figure AMI-2](#).

Figure AMI-2: Pump Room Ramp
Location: Plaza Level 3 – 03.29.03 Club Beer Pump Room

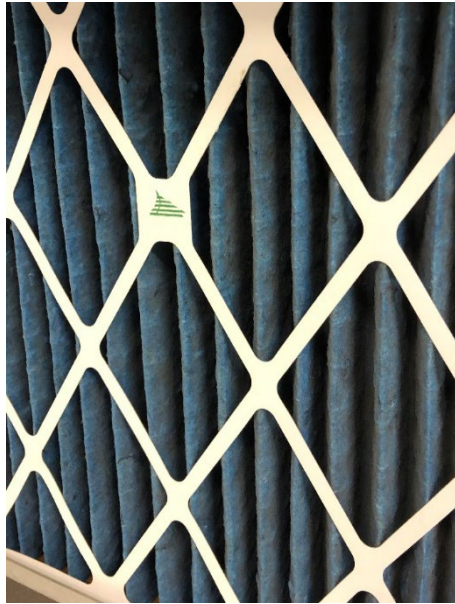
The 2017 assessment noted that some filters were observed to be in need of replacement due to visible dirt and indicated age. During this year's assessment, similar conditions were present. While some filters appeared clean, as shown in [Figure M-1](#), others were dated up to 6 months old and clearly in need of replacement, as shown in [Figure M-2](#).

Figure M-1: Typical Clean Filter
Location: Main Elec 03.42.02

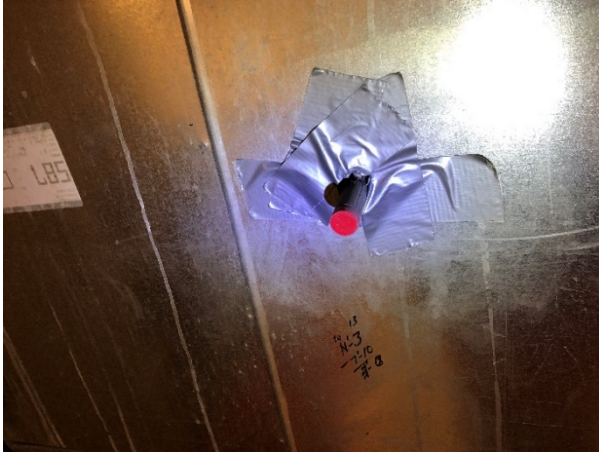
Figure M-3: Duct Smoke Detector
Location: Mech. 05.17.01

While in Mech. 05.17.01, some noise was observed from the chilled water pipes serving the air handling unit. The noise sounded like there could be air in the chilled water lines. It is recommended that the system be purged of all air and all air vents, automatic and manual, be checked for proper operation. Air in the piping can cause damage to equipment, corrosion, and loss of performance, so addressing this issue is a priority. In the same room, a duct smoke detector was observed to be sealed poorly to the surrounding duct, as shown in [Figure M-3](#), and a hole from a previous piece of equipment in the duct was not sealed at all, as shown in [Figure M-4](#).

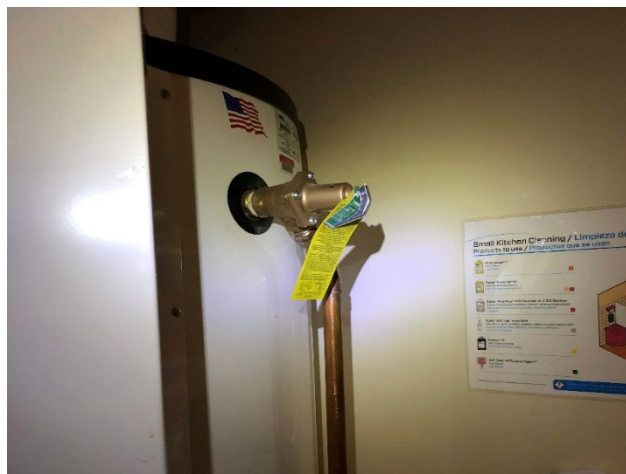
Figure M-5: Pressure/Temperature Valve
Location: Concession Prep. 04.17.06

Many water heaters were observed during the assessment, and all appeared in excellent condition. All pressure/temperature relief valves looked either like they had been recently replaced, or in excellent condition, as shown in [Figure M-5](#).

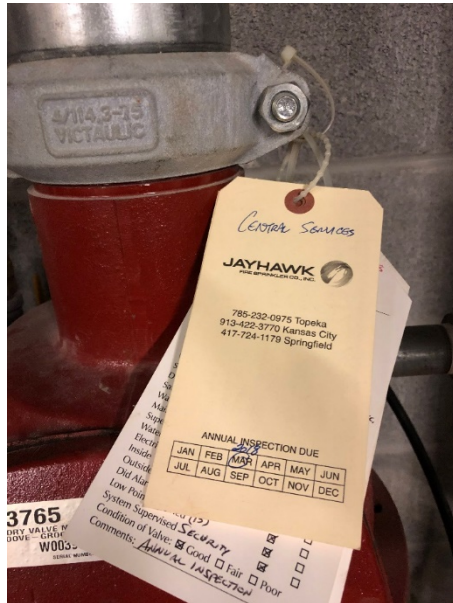
Figure M-6: Sprinkler Inspection Tag
Location: Elec. 04.15.06

Fire zone valves and dry-pipe valves that were observed all had recent inspection tags attached and appeared in good condition (Figure M-6). The clean agent system tanks serving the broadcast booth also had current inspection tags and appear in good condition, as shown in Figure M-7.

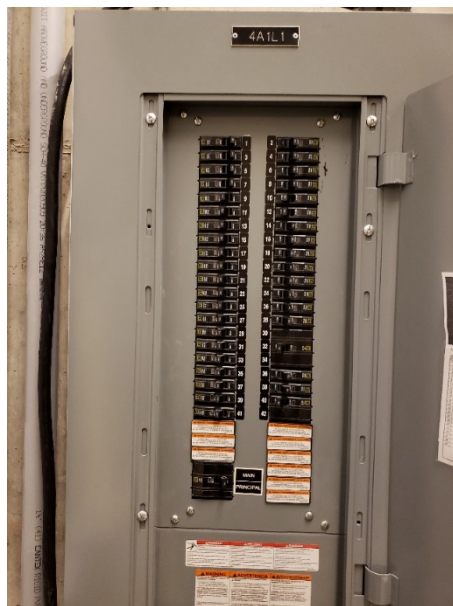
Figure E-1: Electrical Panel 4A1L1
Location: 01.68.08

The electrical room 01.68.08, as shown in [Figures E-1 and E-2](#), on the field level had two panels, 4A1L1 and E4A1H1, which had out of date schedules included on the panels.

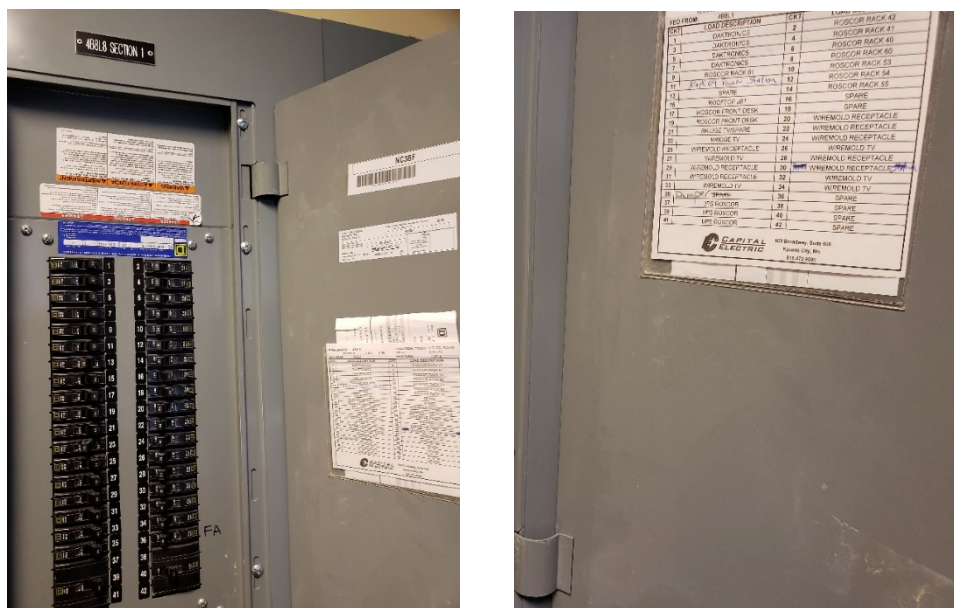
Figure E-3: Electrical Panel 4B8L8
Location: 09.61.07

On level 9 in room 09.61.07(520A), as shown in [Figure E-3](#), panel 4B8L8 section 1 did not have single pole branch circuit breaker 36 or the three-pole branch circuit breakers 38, 40 and 42 included on the schedule.

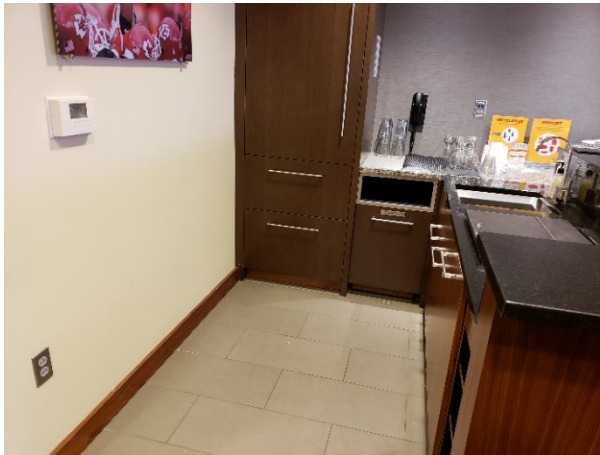
Figure E-4: Receptacle
Location: Suite 04.67.01

Receptacles within 6'-0" of a sink in suite 04.67.01, as shown in [Figure E-4](#), and the 30A twist lock receptacle above the sink in Concessions 06.15.01, as shown in [Figure E-5](#), (U343Az) do not appear to be GFCI protected.

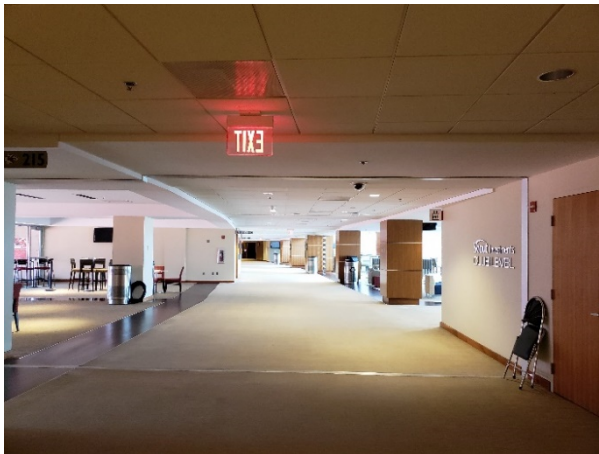
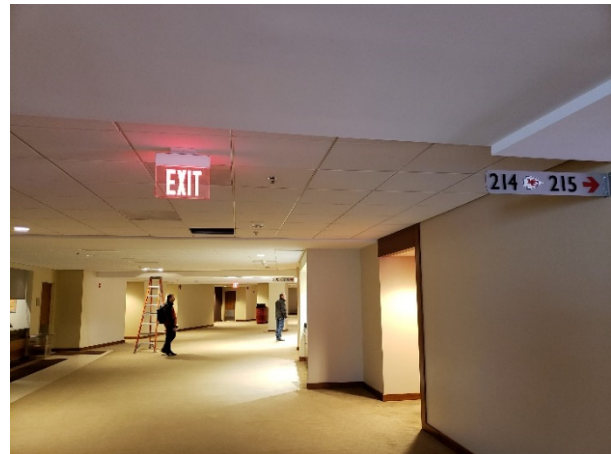
The exit signs on the club level outside electric room, as shown in [Figure E-8](#), 04.43.03 going south are facing backwards going against the egress path.

Figure E-8: Exit Sign
Location: Club level Quadrant B&C, 04.43.03
