# Arrowhead Stadium Assessment | 2015

## JCSCA + Burns & McDonnell

This document contains information pertaining to the condition of Arrowhead Stadium as documented by the Jackson County Sports Complex Authority (JCSCA), including descriptions, conditions, and exhibits which have been written and verified by Burns & McDonnell.

2 / 1 / 2015

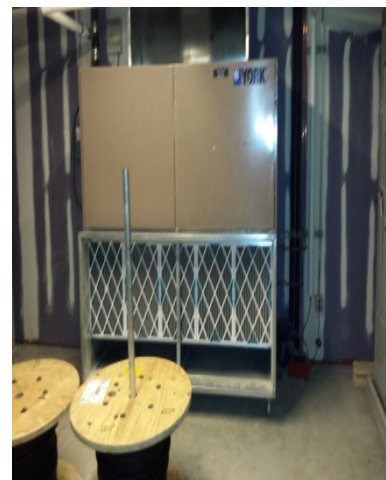
**HVAC Images:**[Exhibit D2.1](#)

- System Maintenance Checks Observed by Engineer
    - Equipment tagged.
    - Maintenance access acceptable for unit and components.
    - Piping complete, properly supported,
