Kauffman Stadium Assessment

JCSCA + Burns & McDonnell

This document contains information pertaining to the condition of Kauffman Stadium as documented by the Jackson County Sports Complex Authority (JCSCA), including descriptions, conditions, and exhibits which have been reviewed by Burns & McDonnell and documented in this report.

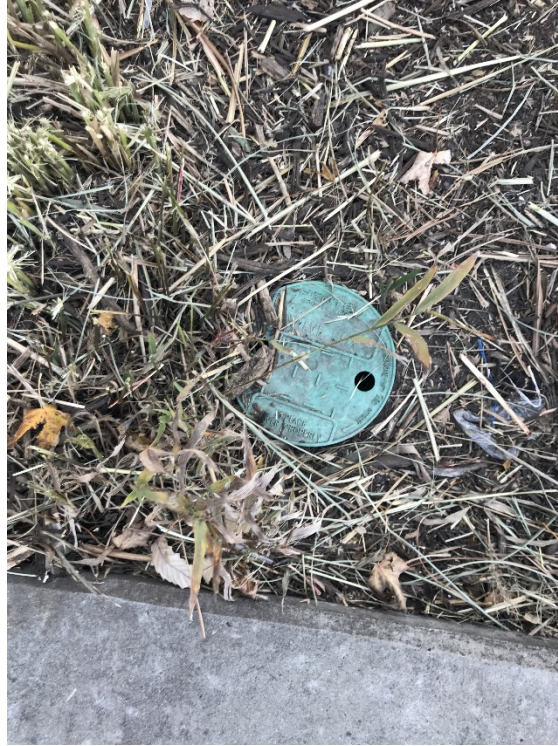
Area drains and valve covers appeared to be free of mulch and other landscape materials. **Figure L-1** shows an example of an acceptable landscape bed with water valve access. Other site appurtenances such as handrails and fencing were also inspected and found to be in acceptable condition. Yearly inspections should occur to ensure that these site items remain in an acceptable state to ensure the quality of the concourse landscaping.

Figure L-1: Clear Valve Covers
Location: Among Landscape

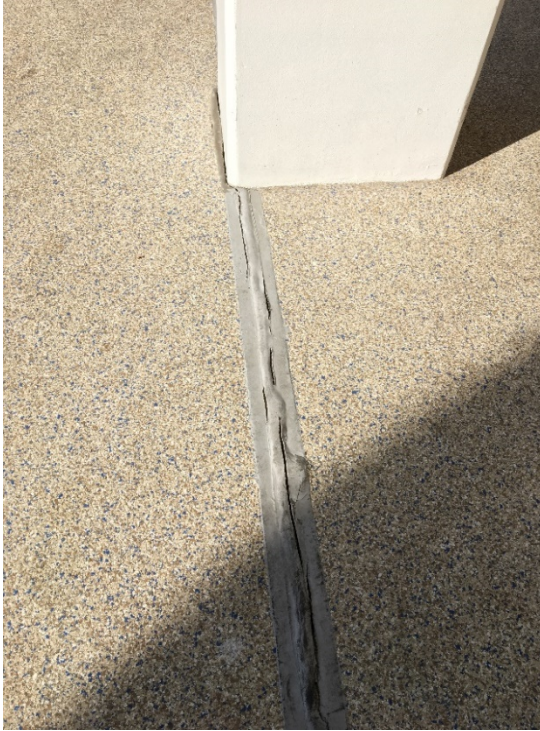
No significant settlement of the structure was observed. The slab-on-grade is primarily in satisfactory condition. No major cracks or spalling of the concrete slab-on-grade was observed. A few control joints and expansion joints need repair or replacement as shown in **Figure S-1**. Concrete was observed to be spalling around various steps and handrail posts as shown in **Figures S-2, S-3** and **S-4**.

Figure S-1: Slab-on-Grade Expansion Joint
Location: Various Locations including
 Special Outside Cooking Room 03.14.01

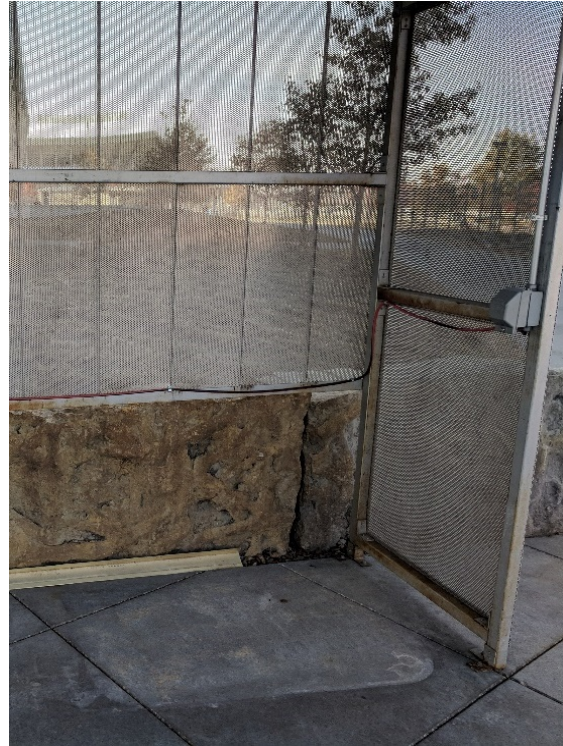
Temporary structures around the stadium were also inspected. The wood Leinenkugel stand beyond the scoreboard in the outfield has sustained wood degradation in a few spots (**Figure S-11**). The hot dog stand in the concourse beyond section 208 has developed rust in places (**Figure S-12**).

Figure S-12: Hot Dog Structure
Location: Beyond Section 208 in Concourse 03.38.01

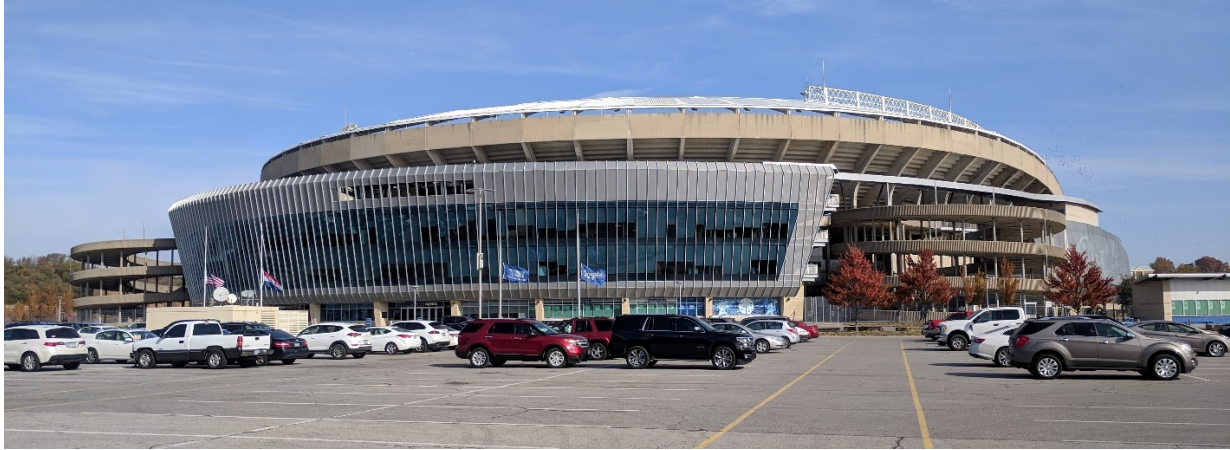
Kauffman stadium incorporates a variety of finish materials that are used in the composition of the exterior façade, as shown in **Figure AF-1**. The primary surface materials include structural concrete, insulated metal panel, curtainwall, and patterned perforated metal panels on galvanized steel structure.

Figure AF-1: Kauffman Stadium Overall Exterior
Location: South-West Parking Lot

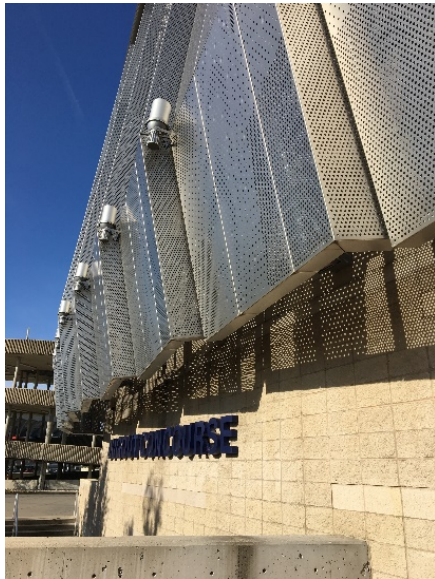
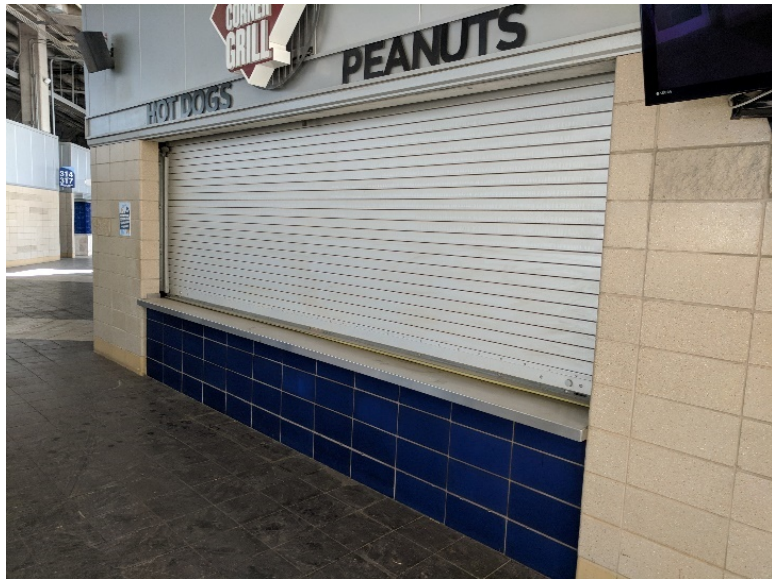
Figure AF-2: Masonry Cladding Systems Exterior (left) and Interior (right)
Location: Kauffman Stadium Exterior at Dugout Concourse and Concessions at View Level

Masonry cladding systems appear to be in satisfactory condition, as shown in **Figure AF-2**. No chipping or staining of the stone or grout was observed.

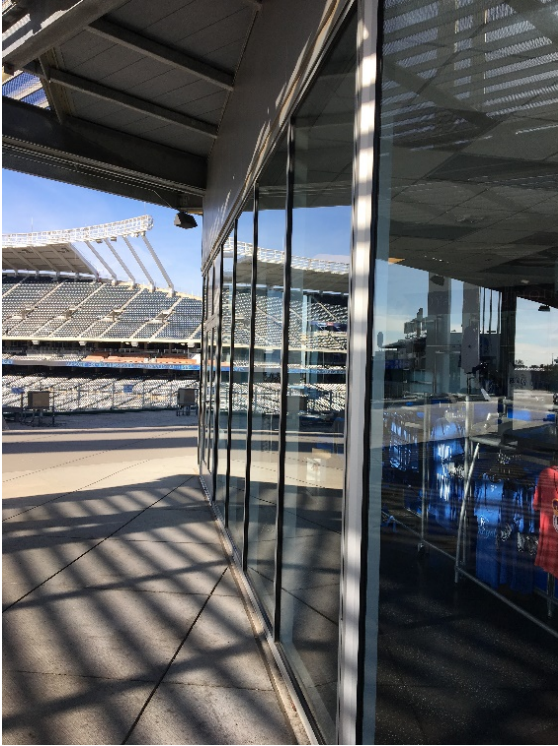
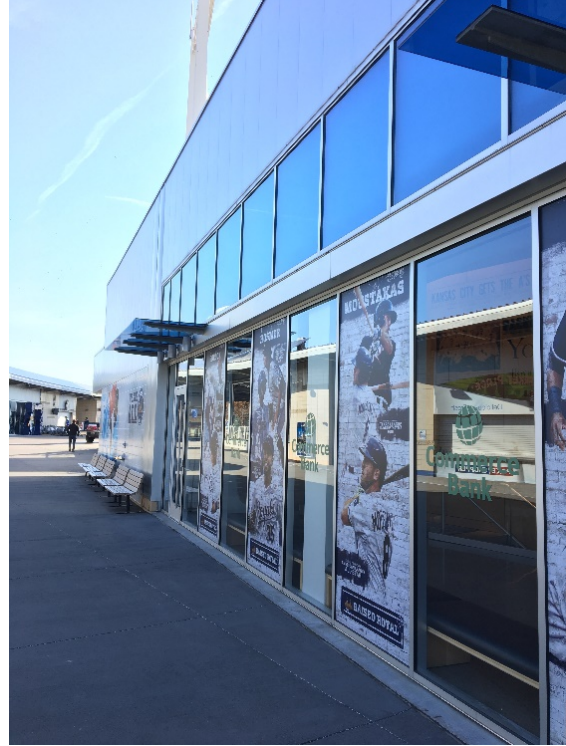
Figure AF-3: Glass Storefront Systems

Location: Plaza Level 3 - 3.63.01 Outfield Experience (left) & Hall of Fame Suites 03.51.03 (right)

Glass storefront systems appear to be in satisfactory conditions, as shown in **Figures AF-3**. Aluminum frame and mullions were observed to be free of staining, fading, or degradation of any kind. Seals and flashing around storefront appear to be in satisfactory condition

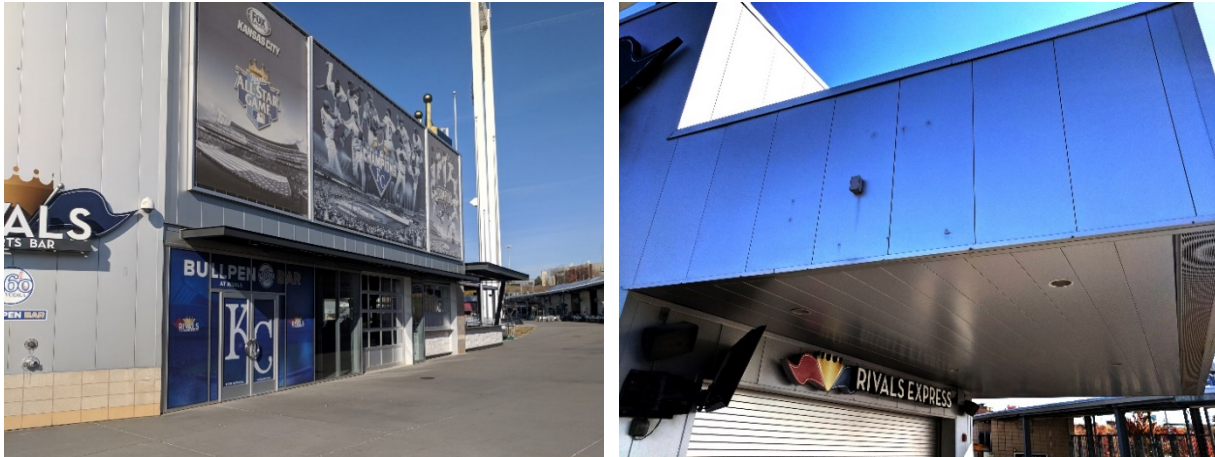
Insulated metal panels systems were observed to be in satisfactory condition. In general, no oil canning, staining, or degradation of any kind was observed, as shown in [Figure AF-6](#) (left). However, on the South-Western face of the Rivals Sports Bar, minimal amounts of rust and streaking was observed at locations of penetrations, as shown in [Figure AF-6](#) (right).

Figure AF-6: Insulated Metal Panel System
Location: Plaza Level 3 - 03.78.01 Rivals Sports Bar

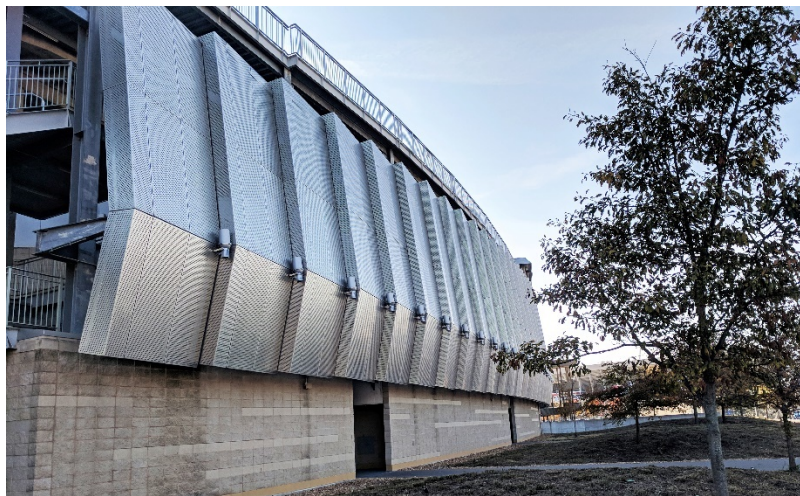
Perforated metal panels and graphic mesh systems appear to be in satisfactory condition, as shown in [Figures AF-7](#). No oil canning, staining, or degradation of any kind was observed and galvanized sub-structure appears to be free of corrosion or rust.

Figure AF-7: Kauffman Image
Location: Kauffman Stadium North-West Exterior

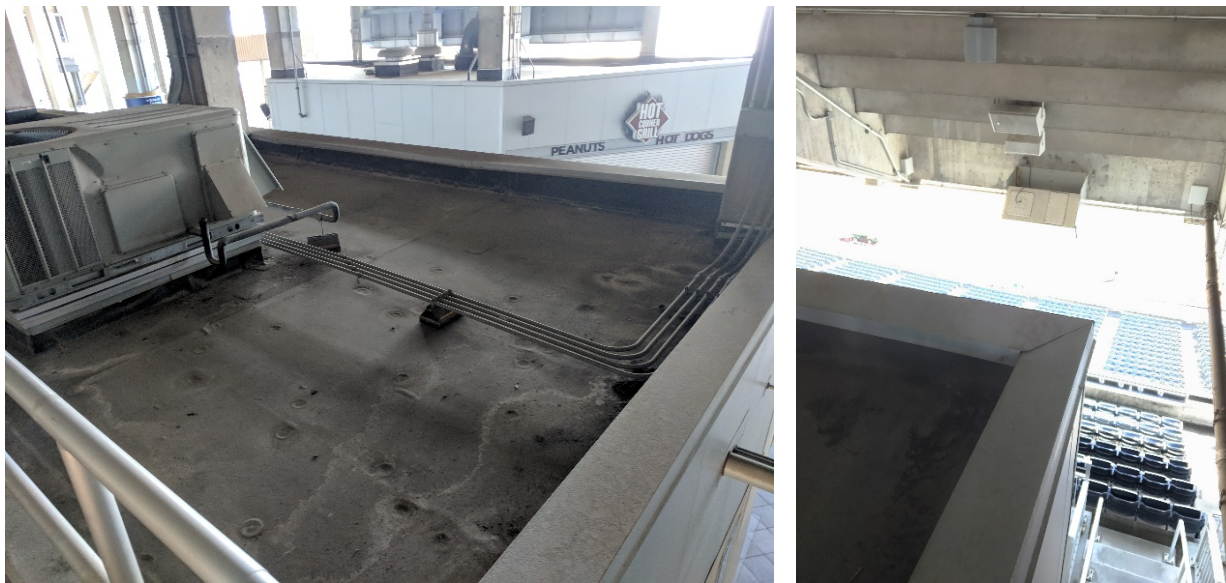
Roofing membranes appear to be in satisfactory condition. Roofing membranes observed were free of rips, tears, or defects. as shown in [Figure AR-1](#).

Figure AR-1: Roofing Membrane (left) and Coping (right)
Location: Catwalk on Press Level

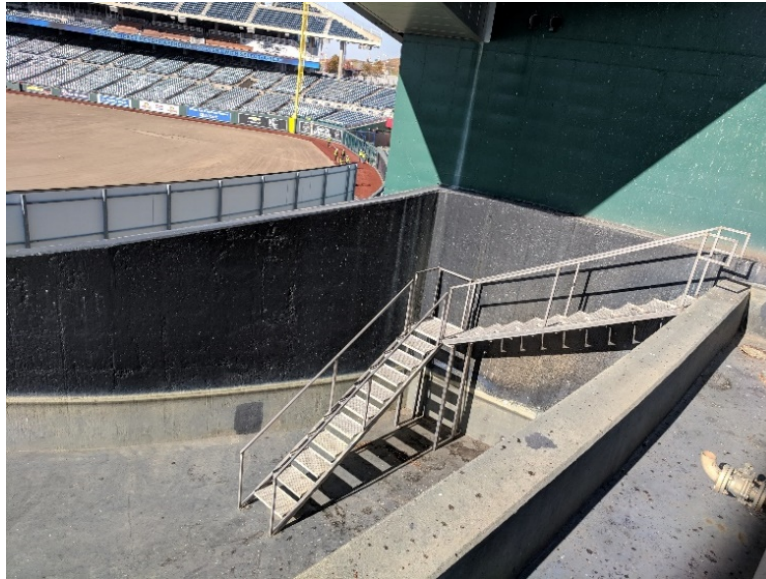
Figure AME-2: New Stair

At the East fountain, it had been observed in the 2016 report that rust had potentially begun to compromise the metal structural integrity and safety. It was observed that stairs into the East and West fountains had been replaced with what appears to be solid, robust stainless tube steel posts, stringers, handrail, and treads, as shown in [Figure AME-2](#).

Location: East Fountain in the Outfield Concourse

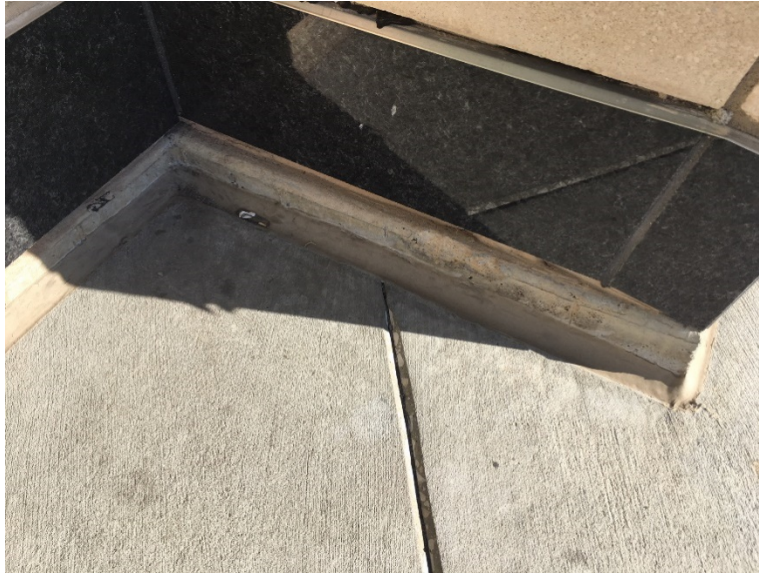
At the Ticketing Building 03.17.01, it had been observed in the 2016 report that the base sealant had begun to pull away from the concrete at the ticketing counter. Upon observation the sealant has been replaced.

Figure AME-6: Base Sealant
Location: Plaza Level 3 - 03.17.01 Ticketing Building

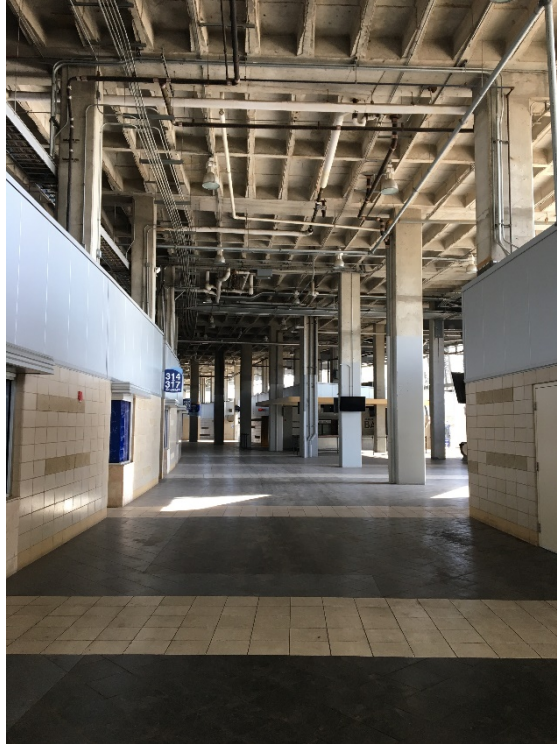
Interior finishes within Kauffman stadium encompass a broad range of materials for floors, walls, and ceilings. The primary flooring systems are composed of epoxy and sealed concrete, as shown in [Figures AI-1](#) and [AI-2](#). These surfaces were observed to be in satisfactory condition, typically. Minor cracking was observed at various locations throughout the facility, which is considered normal given the expansion and contraction properties of the materials. No excessive cracking was observed during the walk-through.

Figure AI-1: Tile Floor at the View Level
Location: View Level 7 – South West Concourse

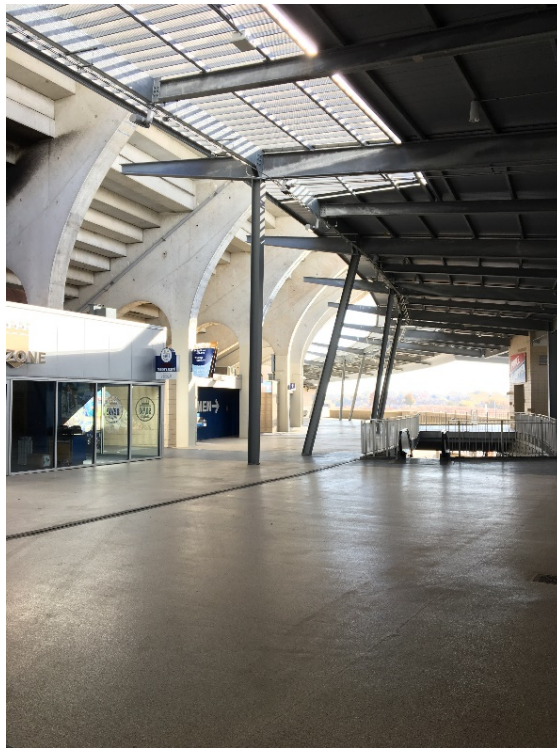
Figure AI-2: Epoxy Floor at the View Level
Location: View Level 7 – South West Concourse

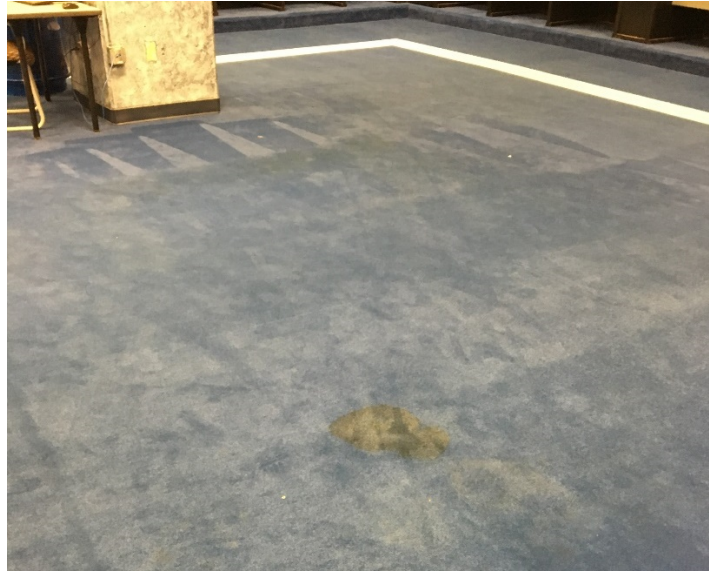
Carpet flooring was generally observed to be in satisfactory condition. No signs of rips, tears, or discoloration were observed. Various stains were observed at the Visiting Team's Locker Room 01.27.03, as shown in [Figure AI-4](#).

Figure AI-3: Carpet Flooring
Location: Clubhouse Level 1 Visitor's Locker Room

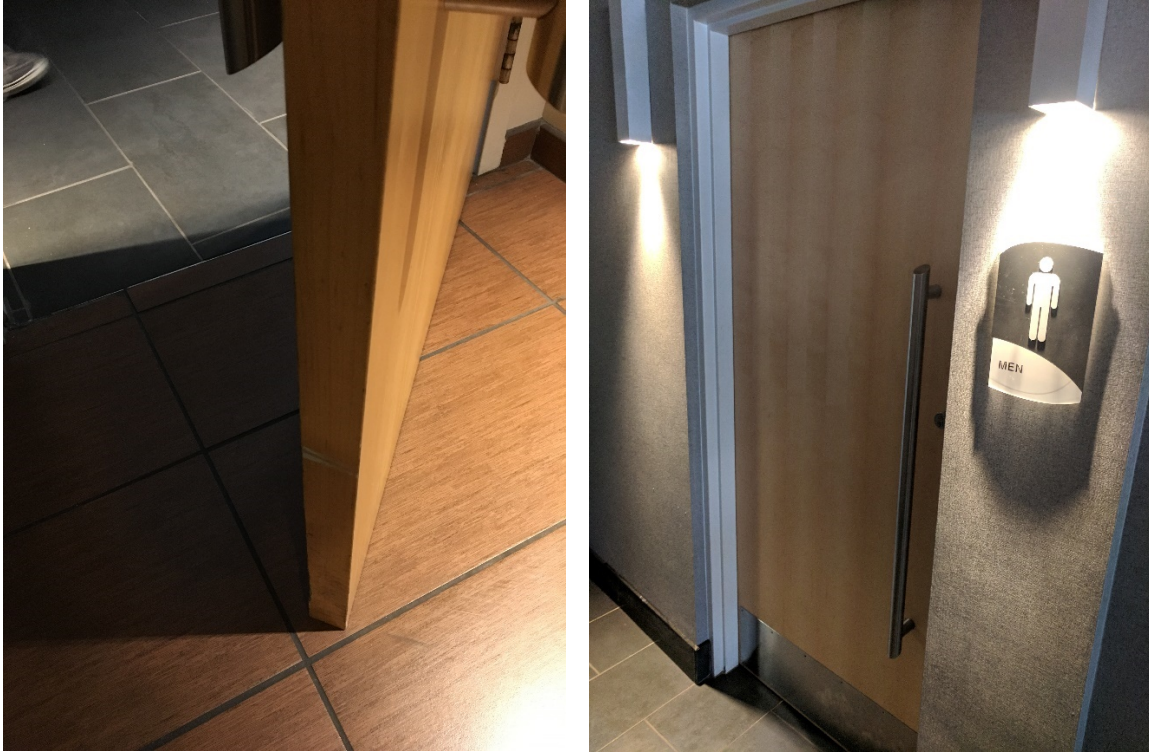
Figure AI-4: Ceramic Tile Flooring

Porcelain/Ceramic tile flooring areas appear to be in satisfactory condition. No signs of grout discoloration or cracking were observed. However, it was observed that the door to the Men's Restroom 03.23.01 in the Diamond Club drags on the floor during when opening and has begun to wear on the tile flooring, as shown in [Figure AI-5](#).

Location: Plaza Level 3 - 03.23.01 Diamond Club Men's Restroom

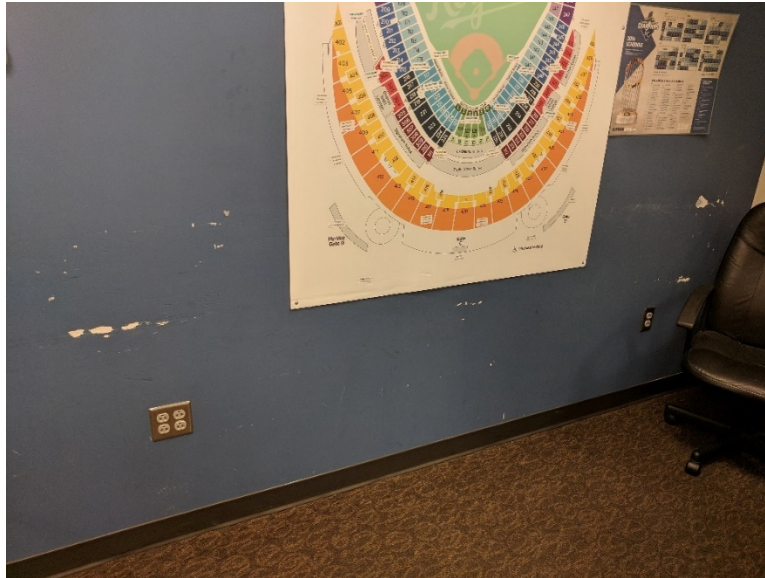
Figure AI-5: Gypsum Board

In general, interior wall surfaces were observed to be in satisfactory condition. Painted gypsum board walls appear to be in satisfactory condition. In general, no punctures, holes, or scratches were observed. However, In the Police Open Office 02.26.07 a significant amount of damage to the gypsum board was observed, typically at standard chair heights, as shown in [Figure AI-6](#).

Location: Service Level 2 - 02.26.07 Police Open Office

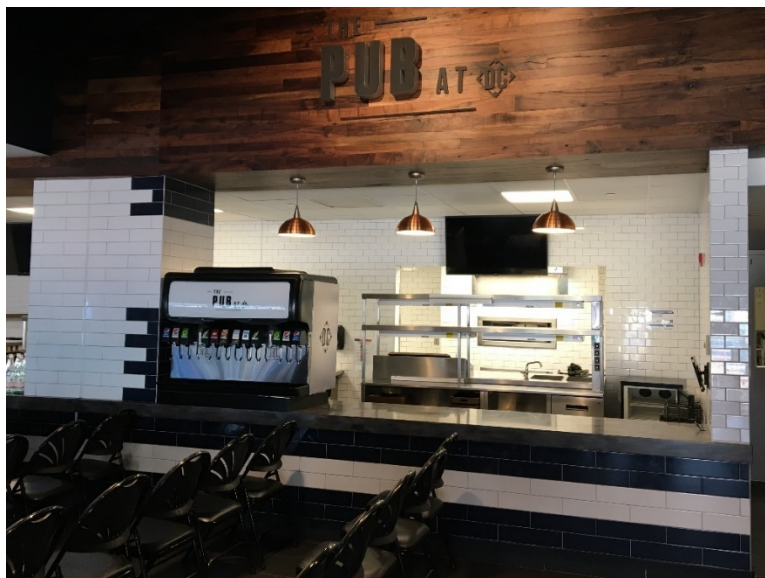
Figure AI-6: Ceramic Tile

Ceramic tile walls generally appear to be in satisfactory condition, as shown in [Figure AI-7](#). No visible chipping, flaking, or cracking of the tile or grout was observed.

Location: Club Level 3 – 03.22.01 Diamond Club

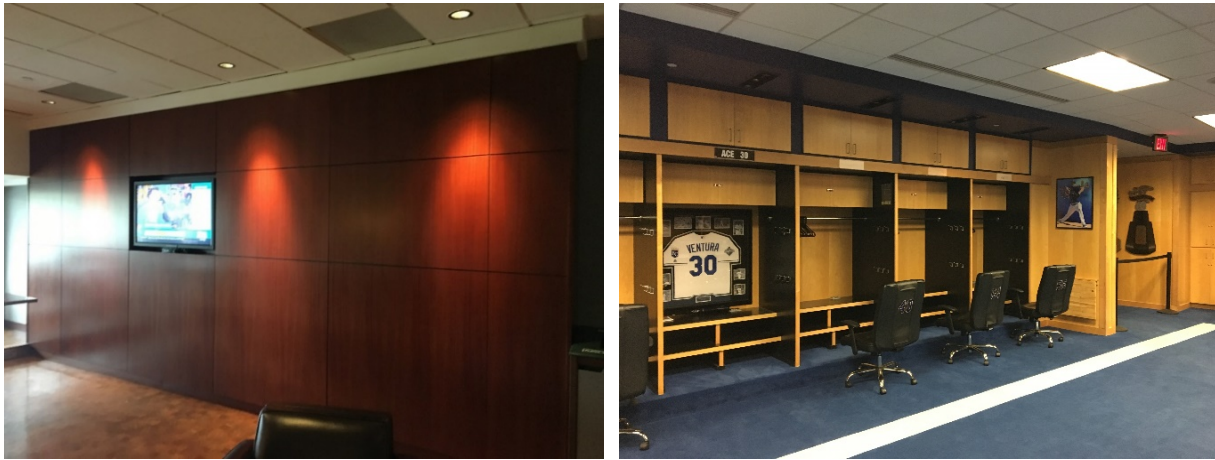
Figure AI-7: Wood Veneer Panel Wall

Wood paneling, typically, is in satisfactory condition. As shown in **Figure AI-7**, no signs of scratching, fading, or deterioration of any kind were observed at the Triple Crown Suites or the Royal's Clubhouse.

Location (left): Loge Level 5 - 05.24.01 Triple Crown Suite

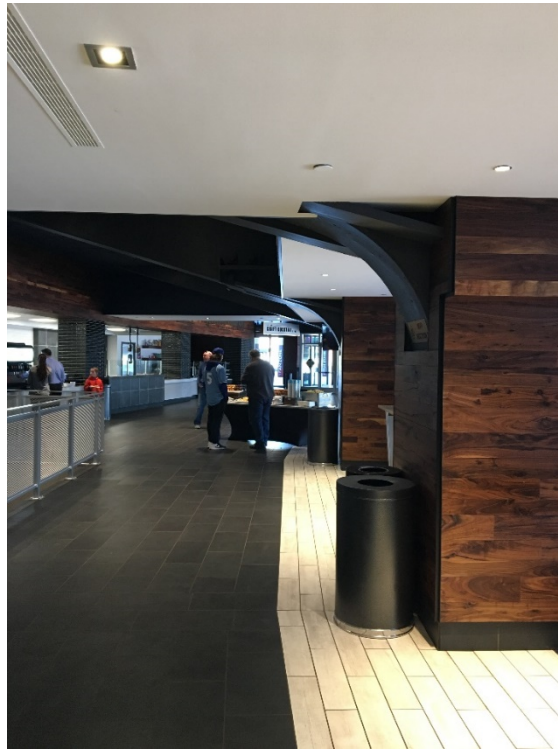
Gypsum board ceilings appear to be in satisfactory condition, typically. No punctures, stains, scrapes, or tears were observed. Refer to **Figure AI-9** for typical condition.

Figure AI-9: Gypsum Board Ceilings
Location: Club Level 3 – 03.22.01 Diamond Club

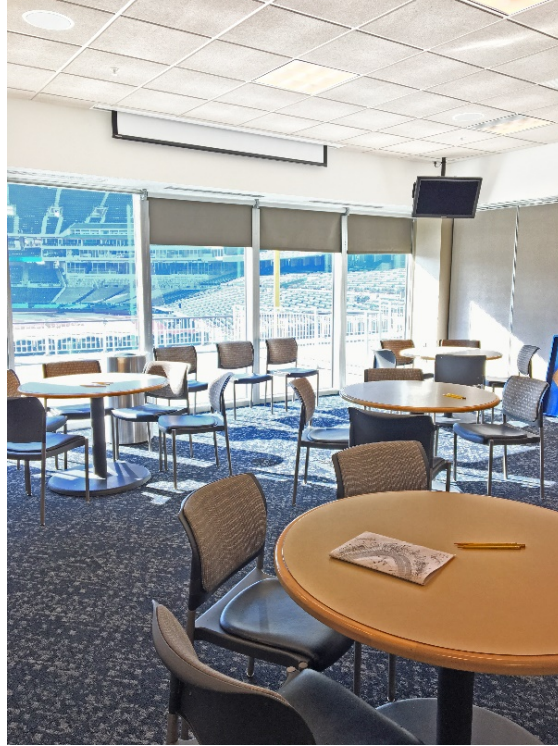
Acoustical ceiling tile is the primary material used for interior spaces. The typical condition of the acoustical ceiling tile appears to be in satisfactory condition. Refer to [Figure AI-10](#) for typical condition at observed interior ACT ceilings. However, locations in the Triple Crown Suites 05.24.01 and Dugout Concourse 02.11.02 were observed to have been stained, as shown in [Figure AI-11](#).

Figure AI-10: Acoustic Ceiling Tile
Location: Plaza Level 3 – 03.51.02 Hall of Fame Suites

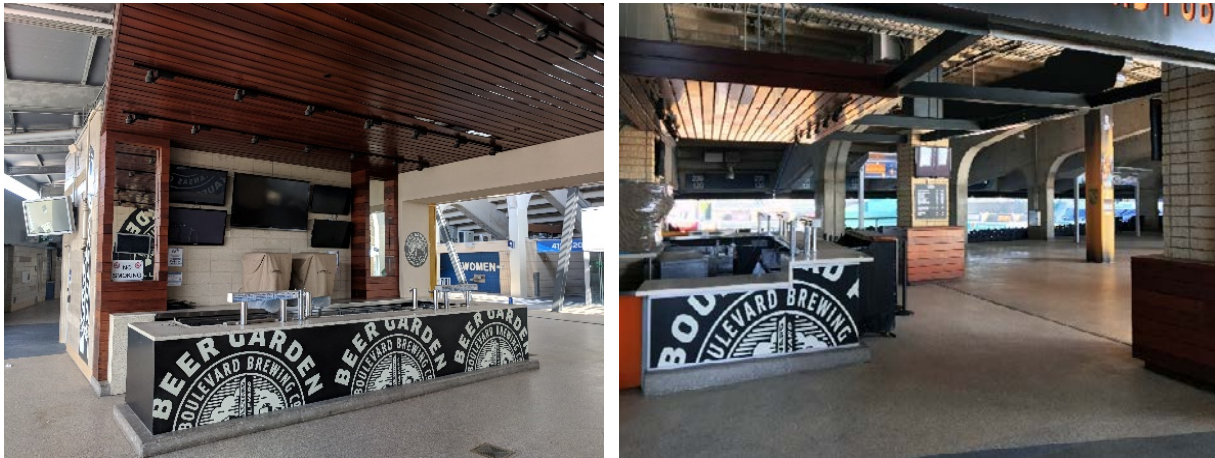
Figure AI-12: Wood Plank Ceilings and Accents

Wood ceiling panels, where present, were observed to be in satisfactory condition. Surface conditions appear to be new and are free of scuffs, scratches, warps, or deterioration as shown in [Figure AI-12](#).

Location (right): View Level 7 – 07.24.05 Boulevard Concessions

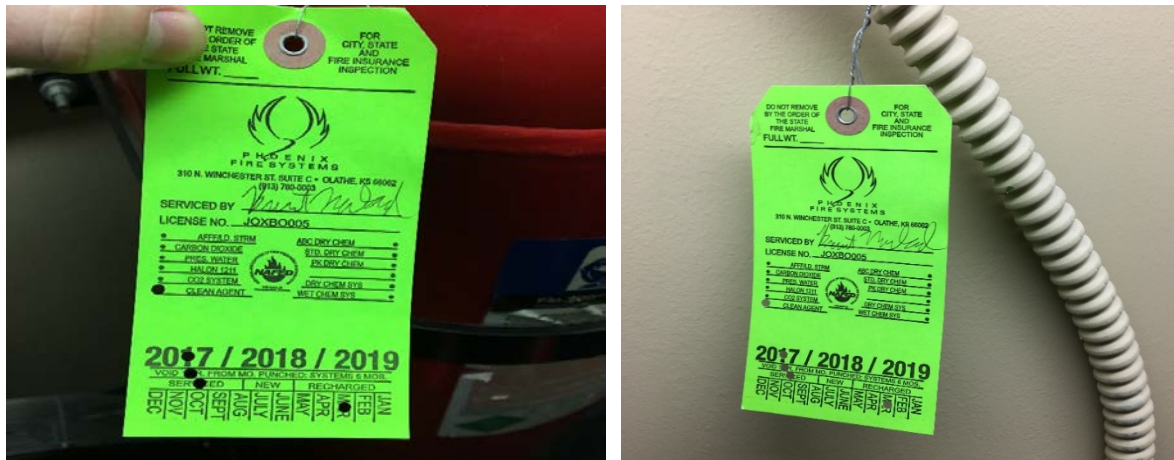
Several fire extinguishers were checked for verification of updated inspection tags. All fire extinguishers observed were inspected and punched within the last year, as shown in **Figure AMI-2**.

Figure AMI-2: Fire Extinguisher Inspection Tags
Location: Broadcast Level 4 – 04.21.03 Corridor

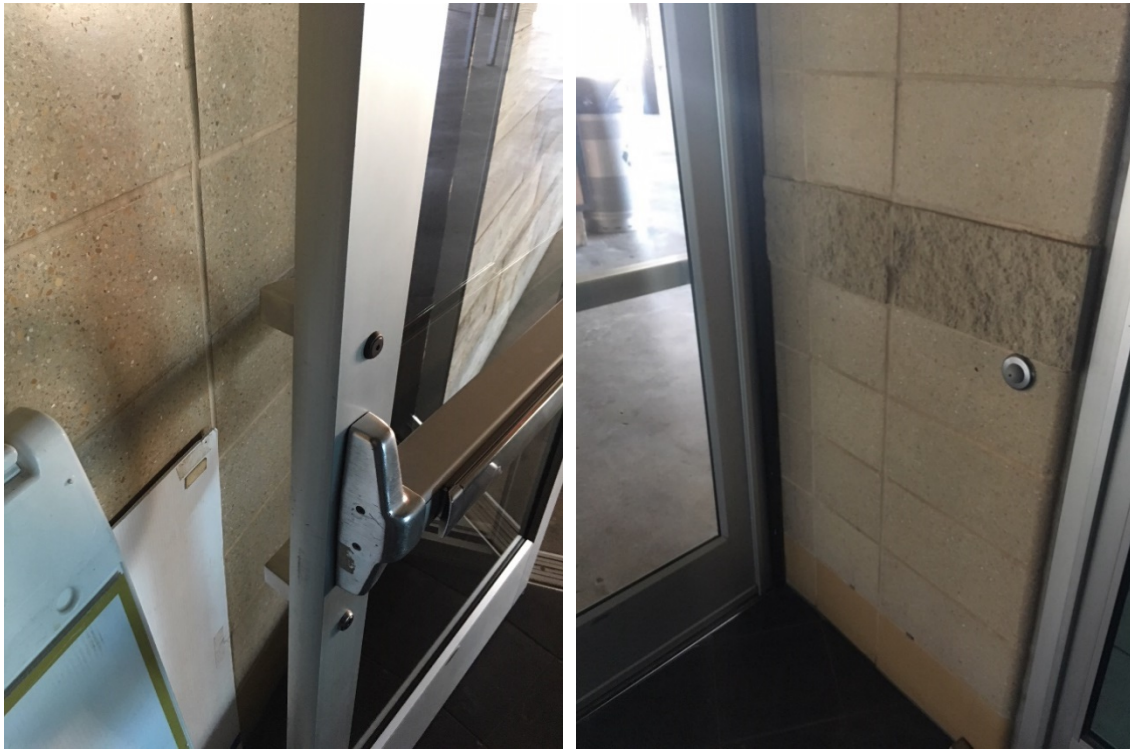
At the entrance to the Craft & Draft Bar 05.42.01, it had been observed in the 2016 report door was lacking a proper door stop or closer engaged creating a pinch point. Upon review it appears that a proper closer is installed no longer creating a pinch point.

Figure AMI-3: Aluminum Framed Glass Door
Location: Lobe Level – 05.42.01 Stadium Club Reception

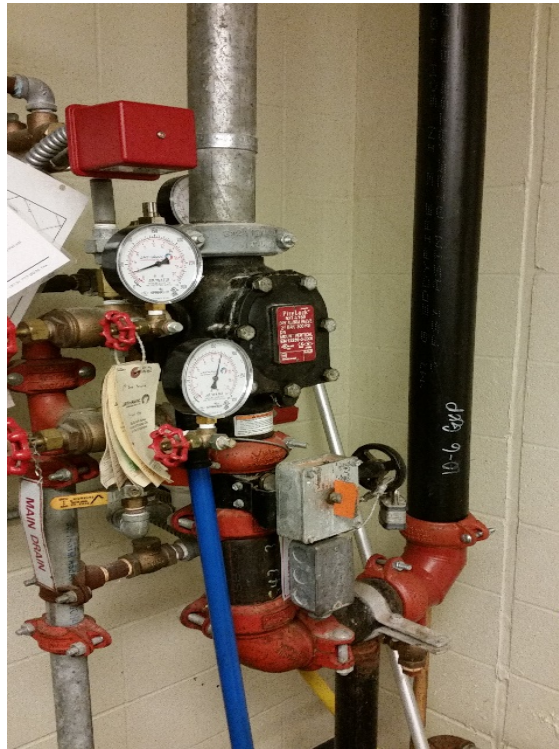
The kitchen and commissary, room 02.21.01, mechanical systems appeared to be in satisfactory condition. The dry pipe sprinkler piping noted in the 2016 report as severely corroded has been replaced, as shown in **Figure M-3**.

Figure M-3: Dry-Pipe Sprinkler Valve System
Location: Service Level – 02.21.01 Kitchen and Commissary

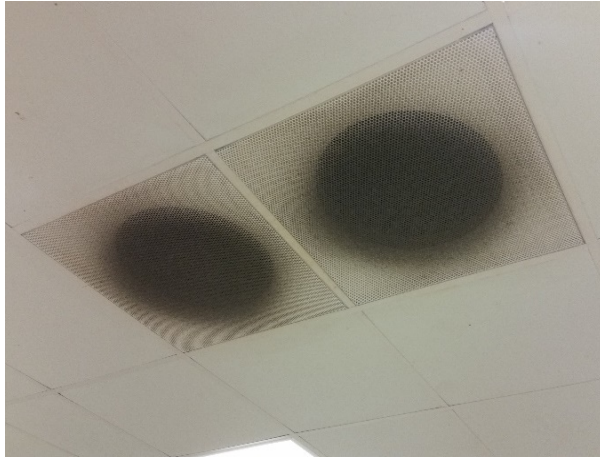
In all kitchen and concessions spaces, the HVAC grilles and diffusers are coated in a layer of dust and grease that may begin to restrict airflow, typical images are shown in **Figures M-4 and M5**. The dust should be cleaned off to prevent an impact on airflow performance.

Figure M-4: Dirty Grilles in Concessions Areas
Location: Service Level – 02.21.01 Kitchen
