Kauffman Stadium Assessment | 2014

JCSCA + Burns & McDonnell

This document contains information pertaining to the condition of Kauffman Stadium as documented by the Jackson County Sports Complex Authority, including descriptions, conditions, and exhibits which have been verified by Burns & McDonnell.

2 / 14 / 2014

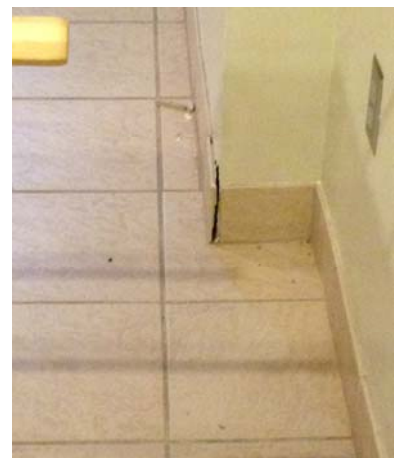
- Sealed or painted flooring appears to be in good condition with no visible chipping or flaking of finish.
- Ceramic tile floors appear to be in excellent condition, generally. Tile base boards were observed delaminating from the walls in a dugout level suite. Refer to Flooring Images: [Exhibit C1.2](#) (page 9). Consider replacing tile and grout in the near future to avoid further damage to adjacent floor/base tiles.
- Carpet, in general, is in excellent condition and does not show signs of rips, tears, or discoloration. Refer to Flooring Images: [Exhibit C1.3](#) (right) for typical condition.
