Kauffman Stadium Assessment | 2015

JCSCA + Burns & McDonnell

This document contains information pertaining to the condition of Kauffman Stadium as documented by the Jackson County Sports Complex Authority (JCSCA), including descriptions, conditions, and exhibits which have been verified by Burns & McDonnell.

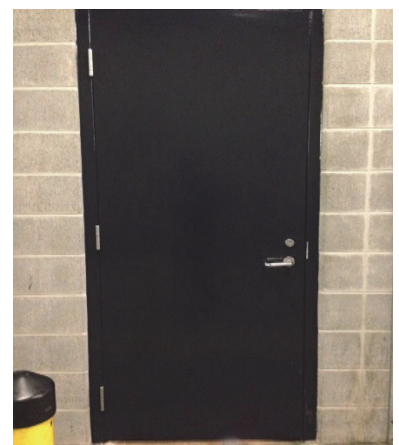
- All doors, in general, are in satisfactory condition.
- Painted hollow metal back of house doors are in generally satisfactory condition. Scuffed and scratched doors observed in the 2014 stadium assessments were repaired and painted as recommended. Refer to Door Images: [Exhibit C4.1](#) (page 12).
- Refer to Door Images: [Exhibit C4.2](#) (right) for typical conditions at aluminum framed doors.

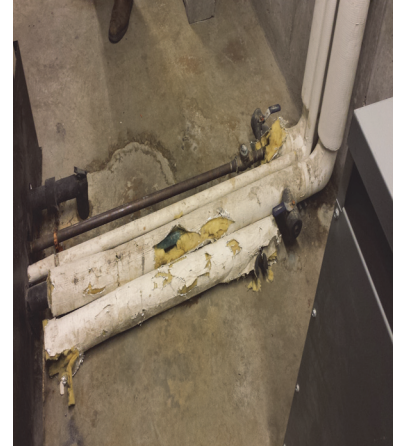
[Exhibit D1.3](#)

- Plumbing piping insulation in various areas of the facility are degrading and in need of repair. Reference Plumbing Images: [Exhibit D1.1](#), [D1.2](#) (right), and [D1.3](#) (Page 14).
- Plumbing piping is properly labeled with direction of flow and valves are clearly tagged.
- Several pipe hanging supports were missing their protective insulation shields. Over time, this will result in insulation damage. Reference Plumbing Images: [Exhibit D1.4](#) (page 14).
- Facility central PVI water heating boilers were observed to be in good condition. Reference Plumbing Images: [Exhibit D1.5](#) (page 14).
- Plumbing fixtures and associated flush valves,

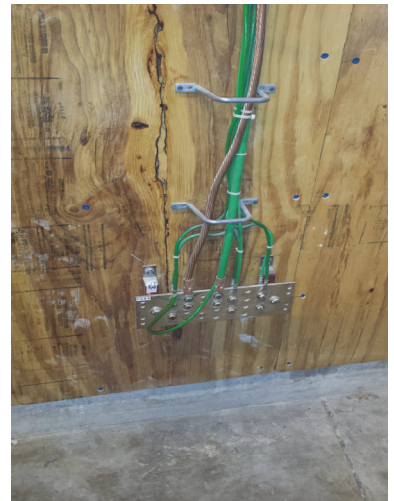
- Telecommunications rooms were observed to be organized and all cabling is secured to cable tray and racks labeled.
- Grounding conductors were observed to not be terminated on ground bus bar in Telecommunications room T140. See Electrical Images: [Exhibit D3.12](#) (page 20)
- An observed strobe light is damaged in corridor 02.20.02 on service level on first base quadrant.
