# Kauffman Stadium Assessment

## JCSCA + Burns & McDonnell

This document contains information pertaining to the condition of Kauffman Stadium as documented by the Jackson County Sports Complex Authority (JCSCA), including descriptions, conditions, and exhibits which have been reviewed by Burns & McDonnell and documented in this report.

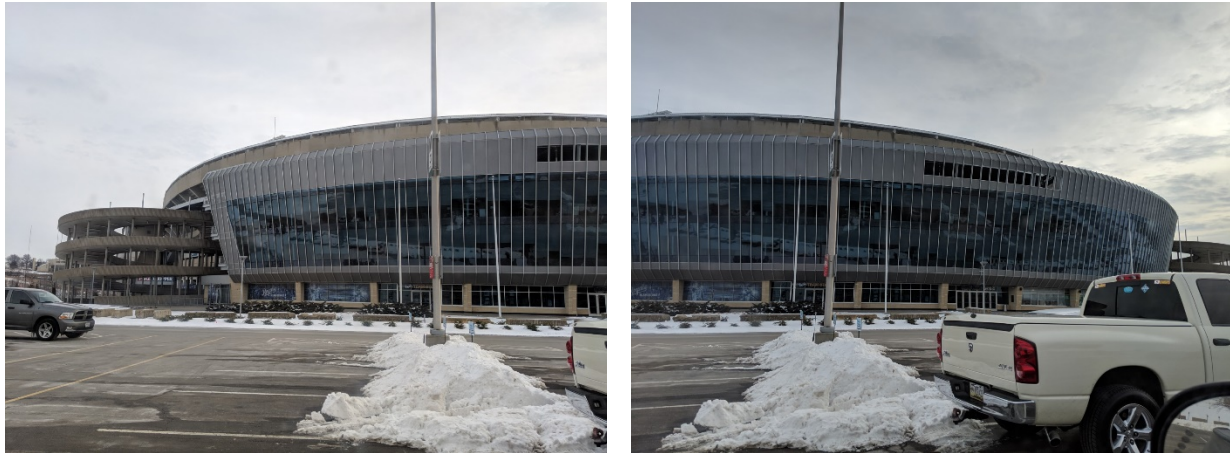
**Figure AF-1: Kauffman Stadium Overall Exterior**  
**Location: South-West Parking Lot**

Kauffman stadium incorporates a variety of finish materials that are used in the composition of the exterior façade, as shown in **Figure AF-1**. The primary surface materials include structural concrete, insulated metal panel, curtainwall, and patterned perforated metal panels on galvanized steel structure.

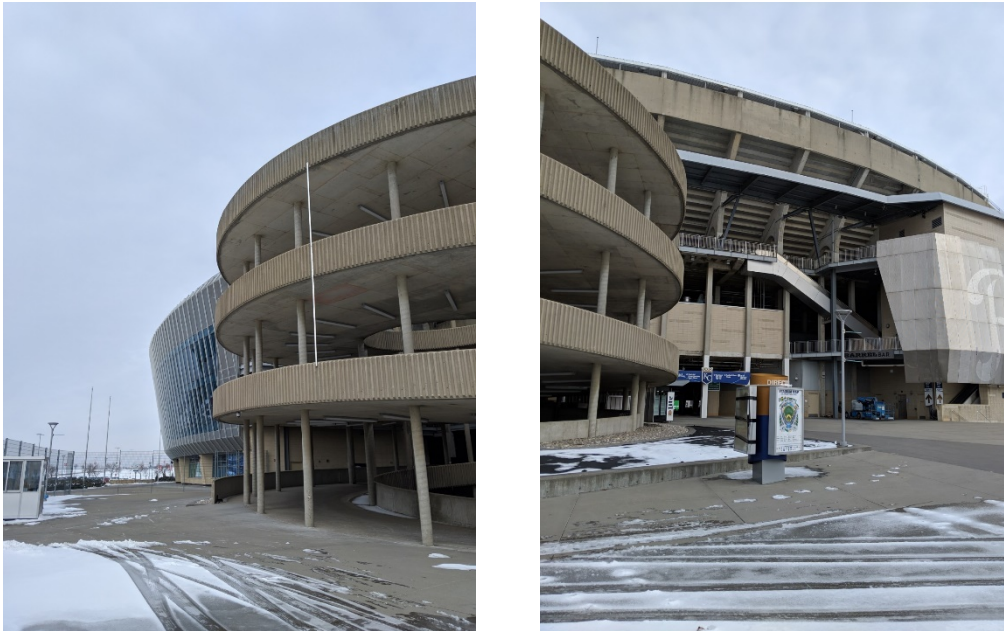
**Figure AF-2: Masonry Cladding Systems Exterior**  
**Location:** Kauffman Stadium Exterior at Dugout Concourse and Concessions at View Level

Masonry cladding systems appear to be in satisfactory condition, as shown in [Figure AF-2](#). No chipping or staining of the stone or grout was observed.

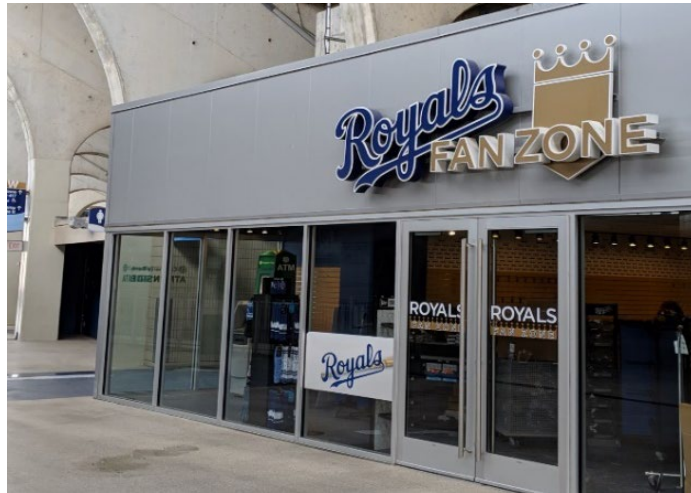
**Figure AF-3: Glass Storefront Systems**

Glass storefront systems appear to be in satisfactory conditions, as shown in [Figure AF-3](#). Aluminum frame and mullions were observed to be free of staining, fading, or degradation of any kind. Seals and flashing around storefront appear to be in satisfactory condition.

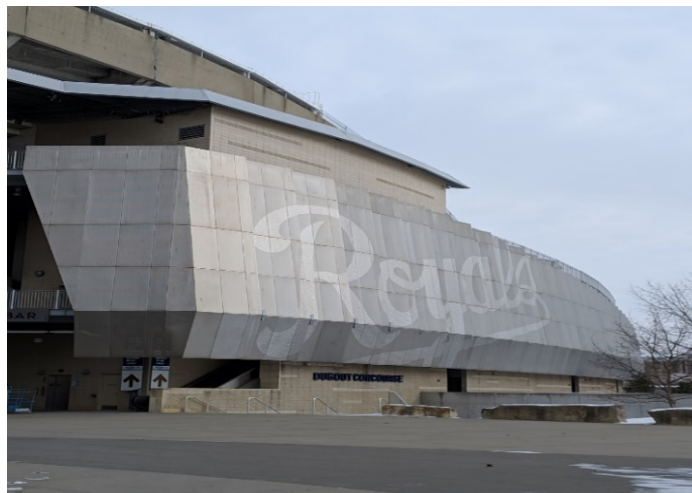
**Figure AF-7: Exterior Perforated Metal Panel System**  
**Location: Kauffman Stadium North-West Exterior**

Perforated metal panels and graphic mesh systems appear to be in satisfactory condition, as shown in [Figure AF-7](#). No oil canning, staining, or degradation of any kind was observed, and galvanized sub-structure appears to be free of corrosion or rust.

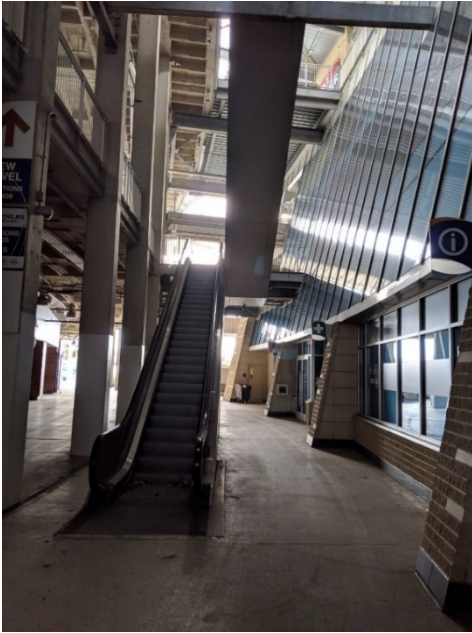
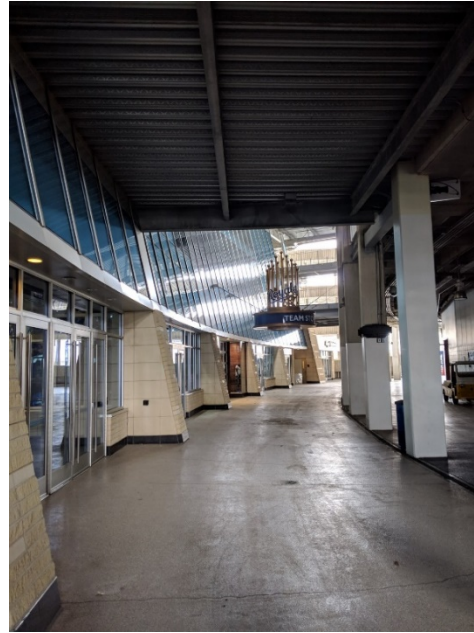
Interior finishes within Kauffman stadium encompass a broad range of materials for floors, walls, and ceilings. The primary flooring systems are composed of epoxy and sealed concrete, as shown in **Figure AI-1** and **AI-2**. These surfaces were observed to be in satisfactory condition, typically. Minor cracking was observed at various locations throughout the facility, which is considered normal given the expansion and contraction properties of the materials. No excessive cracking was observed during the walk-through.

**Figure AI-1: Typical Concourse Flooring**  
**Location:** Plaza Level 3 – South  
West Concourse

**Figure AI-2: Typical Concourse Flooring**  
**Location:** Plaza Level 3 – South  
West Concourse

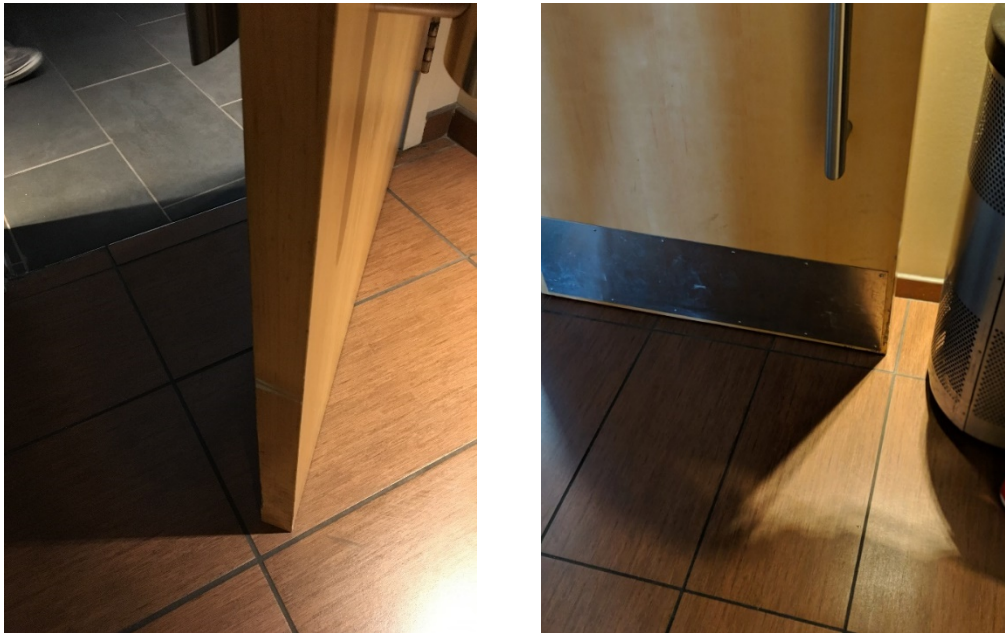
**Figure AI-4: Ceramic Tile Flooring**  
**Location: Plaza Level 3 - 03.23.01 Diamond Club Men's Restroom**

Porcelain/Ceramic tile flooring areas appear to be in satisfactory condition. No signs of grout discoloration or cracking were observed. However, it was noted in the 2017 report that the door to Men's Restroom 03.23.01 in the Diamond Club was slightly damaged, dragging on the floor when opening and had begun to wear on the tile flooring, as shown in [Figure AI-4](#). The issue has been resolved as the same conditions were not observed during the walk-through this year.

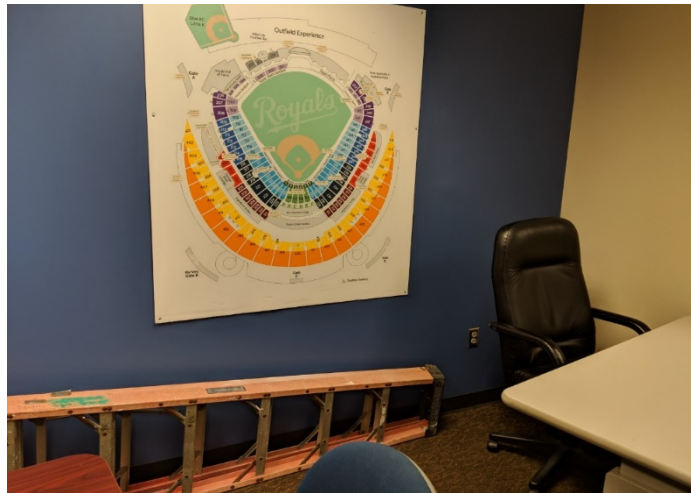
**Figure AI-5: Gypsum Board**  
**Location: Service Level 2 - 02.26.07 Police Open Office**

In general, interior wall surfaces were observed to be in satisfactory condition. Painted gypsum board walls appear to be in satisfactory condition. In general, no punctures, holes, or scratches were observed. It was noted in the 2017 report at the Police Open Office 02.26.07 a significant amount of damage to the gypsum board was observed, typically at standard chair heights. The walls within this space have since been painted with the same colors, as shown in [Figure AI-5](#).

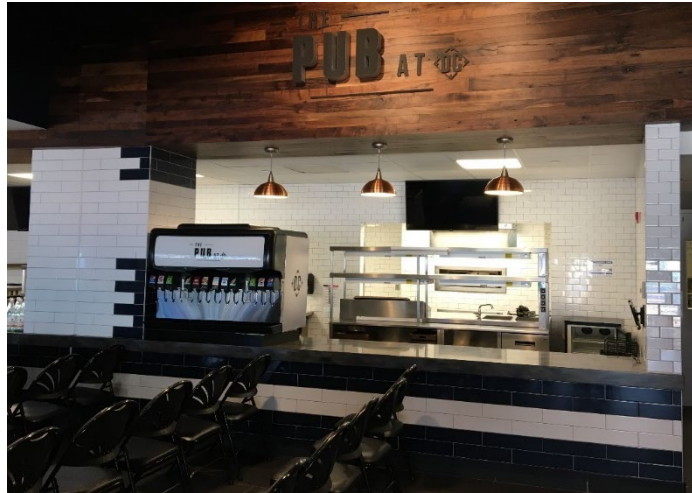
**Figure AI-6: Ceramic Tile**  
**Location:** Club Level 3 - 03.22.01 Diamond Club

Ceramic tile walls generally appear to be in satisfactory condition, as shown in [Figure AI-6](#). No visible chipping, flaking, or cracking of the tile or grout was observed.

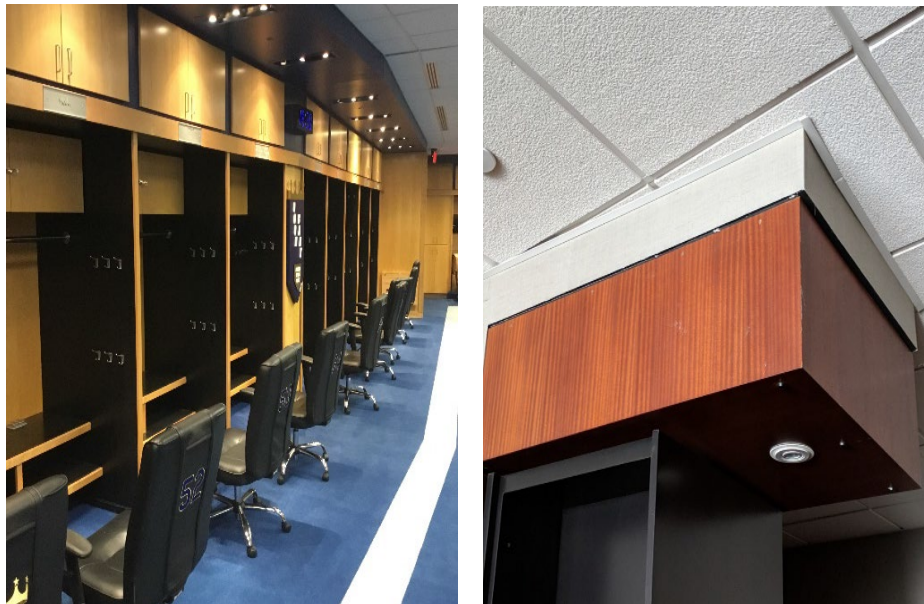
**Figure AI-7: Wood Veneer Panels**  
**Location (left):** Clubhouse Level 1 - 01.21.03 Royals Clubhouse  
**Location (right):** Plaza Level 3 - 03.51.02 Hall of Fame Suites

Wood paneling, typically, is in satisfactory condition. As shown in [Figure AI-7](#), no signs of scratching, fading, or deterioration of any kind were observed at the Hall of Fame Suites or the Royal's Clubhouse.

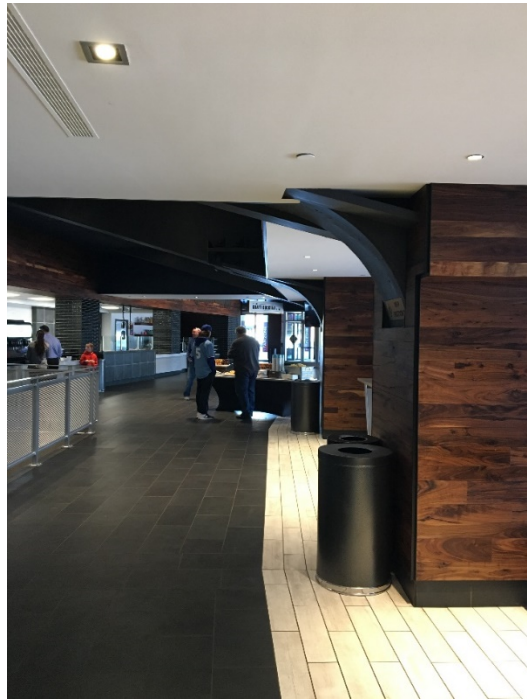
**Figure AI-9: Gypsum Board Ceilings**  
**Location: Club Level 3 - 03.22.01 Diamond Club**

Gypsum board ceilings appear to be in satisfactory condition, typically. No punctures, stains, scrapes, or tears were observed. Refer to **Figure AI-9** for typical condition.

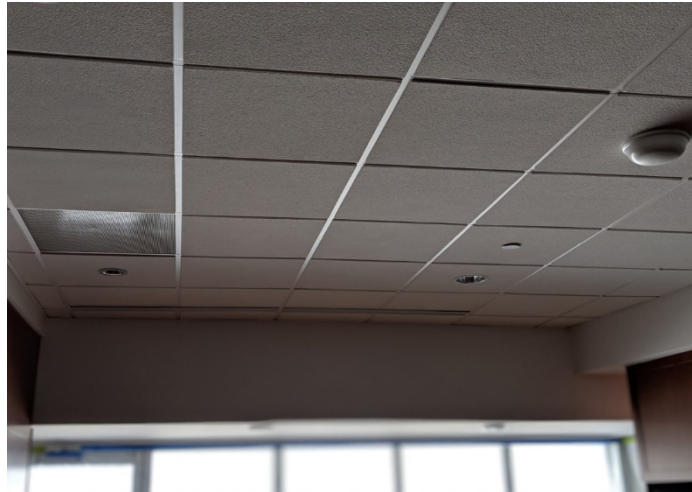
**Figure AI-10: Acoustic Ceiling Tile**  
**Location:** Plaza Level 3 - 03.51.02 Hall of Fame Suites

Acoustical ceiling tile is the primary material used for interior spaces. The typical condition of the acoustical ceiling tile appears to be in satisfactory condition. Refer to **Figure AI-10** for typical condition at observed interior ACT ceilings. Previously noted in the 2017 report, locations in the Dugout Concourse 02.11.02 were observed to have been stained, as shown in **Figure AI-11, right & left**.

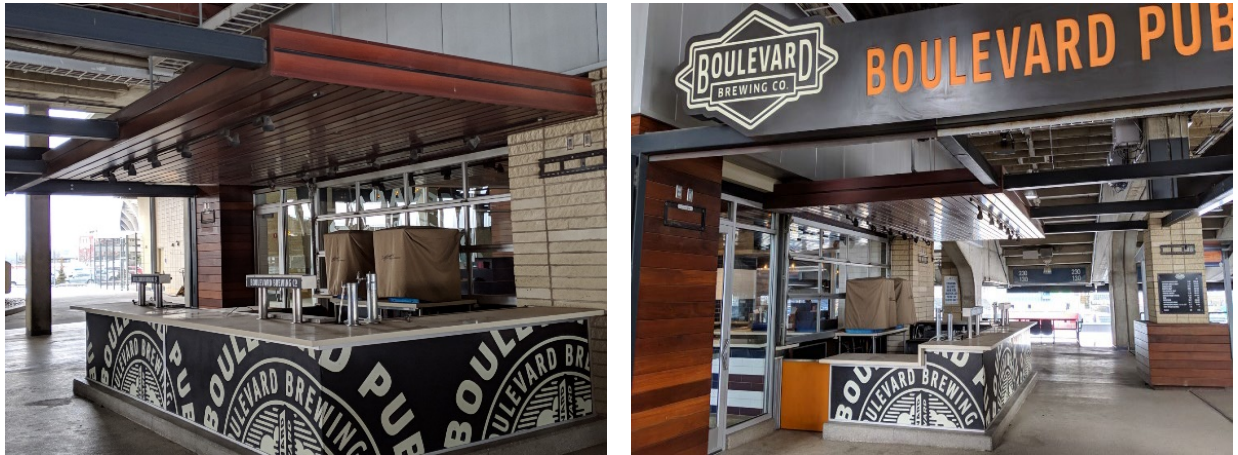
**Figure AI-12: Wood Plank Ceilings and Accents**  
**Location:** Plaza Level 3 - 03.20.01 Boulevard Concessions

Wood ceiling panels, where present, were observed to be in satisfactory condition. Surface conditions appear to be new and are free of scuffs, scratches, warps, or deterioration as shown in [Figure AI-12](#).

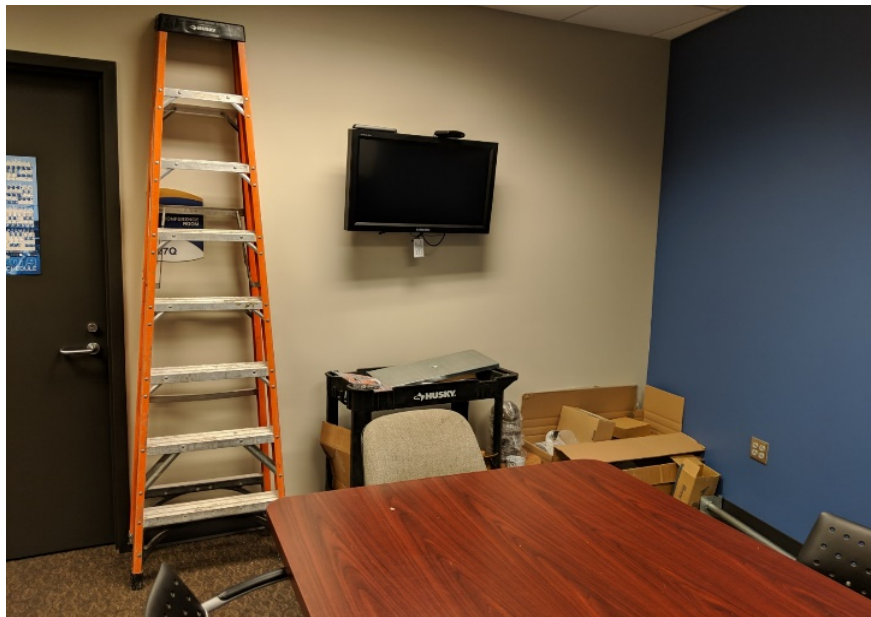
**Figure AI-13: Hollow Metal Door**  
**Location: Service Level 2 - 02.26.07 Police Open Office**

Generally, painted hollow metal doors were observed to be in satisfactory condition. The Police Open Office 02.26.07 had been noted with a damaged door in the 2017 report at the entrance. The door appeared to have been replaced and functioning properly with an updated card reader. All doors in the Open Office appeared to have updates upon walking through. Example as shown in [Figure AI-13](#).

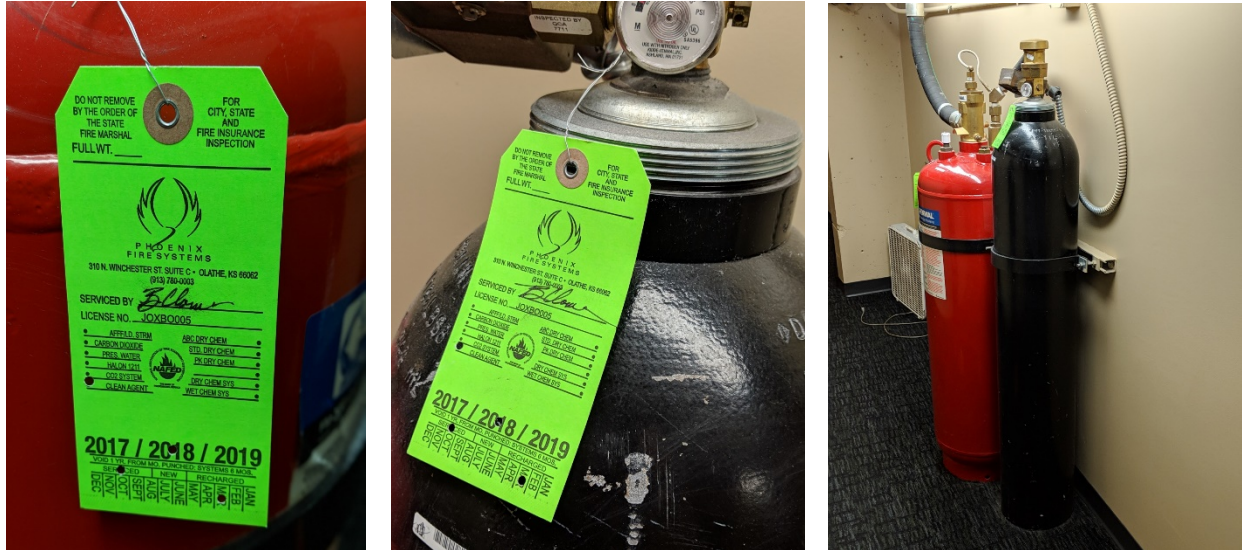
**Figure AMI-2: Fire Extinguisher Inspection Tags**  
**Location: Broadcast Level 4 - 04.21.03 Corridor**

Several fire extinguishers were checked throughout the facility for verification of updated inspection tags in order to maintain current fire safety protocol. All fire extinguishers observed upon walk-through were inspected and punched within the last year, as shown in **Figure AMI-2**.

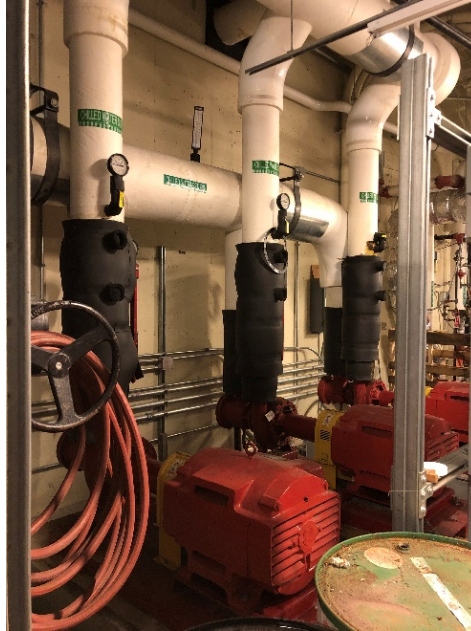
**Figure M-8: Chilled Water Pumps**  
**Location: Service Level – 02.26.03 Boiler Room**

Last year's report from 2017 noted a leaking union and a missing belt guard in Boiler Room 02.26.03. The union has been repaired and the lime-scale discharge cleaned. The belt guard on the fan has also been replaced. The chilled water pumps in the Boiler Room were also observed and in good condition, as shown in [Figure M-8](#).

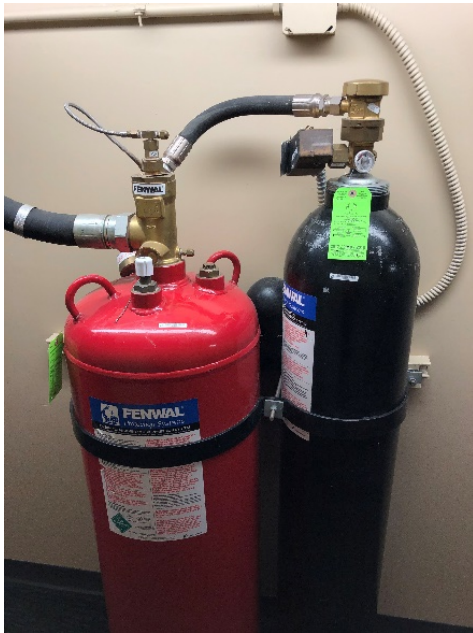
**Figure M-9: Halon System**  
**Location: Press Level – 04.21.03 Corridor**

Many fire protection systems were observed, and all had current inspection tags and appeared in good condition, as shown in **Figures M-9, M-10, M-11**.

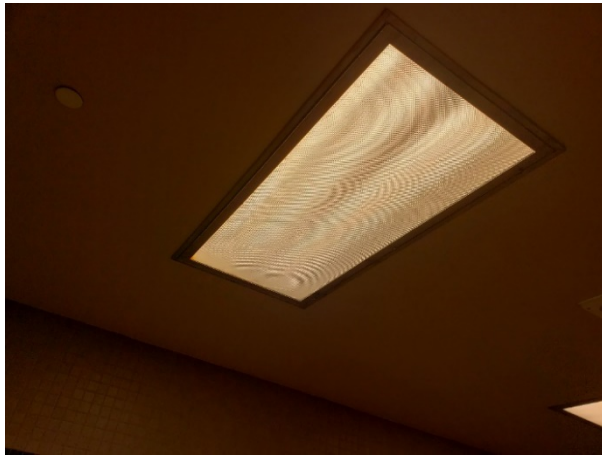
**Figure E-1: Royals Shower**  
**Location:** Clubhouse Shower Room 01.19.04

In the Clubhouse level shower rooms, 01.19.04 and 01.29.07, as shown in **Figures E-1 and E-2**, existing light fixture trims are rusted. These fixtures should be replaced with a fixture that is UL wet-listed.

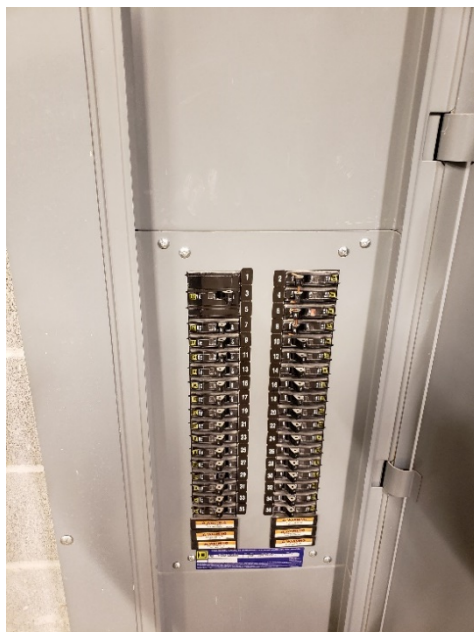
**Figure E-6: Panel B1C1A1**  
**Location:** Electrical Room 02.09.04

On the service level electrical room 02.09.04 (E137), as shown in **Figure E-6**, panel schedule for panel B1C1A was observed to no have all breakers labeled, and as shown in **Figure E-7**, indicating load description and spare breakers.

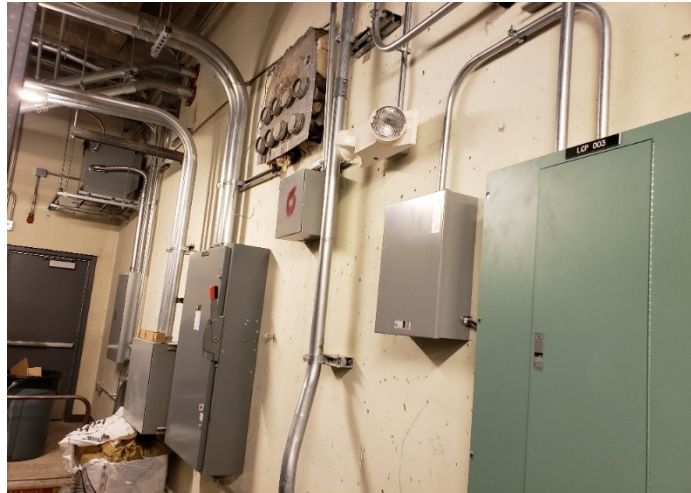
**Figure E-8: Egress Lighting**  
**Location: Boiler Room 02.26.03**

Emergency bug eye light in boiler room 02.26.03, as shown in **Figure E-8**, is not functioning with the intended design in mind.

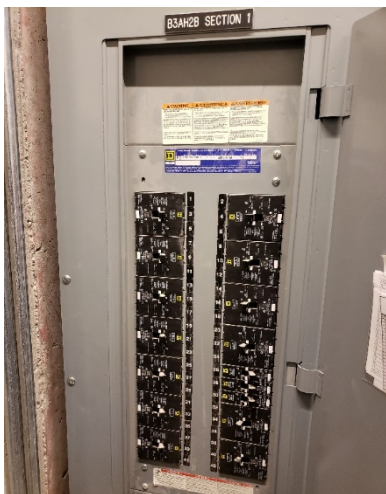
**Figure E-9: B3AH2B Section 1 Panel**  
**Location: Electrical Room 02.20.05**

In electrical room 02.20.05 Panel B3AH2B, as shown in **Figures E-9 and E-10**, the installation and schedule do not match. Three pole breakers are installed in locations that indicate a single pole breaker in the schedule.

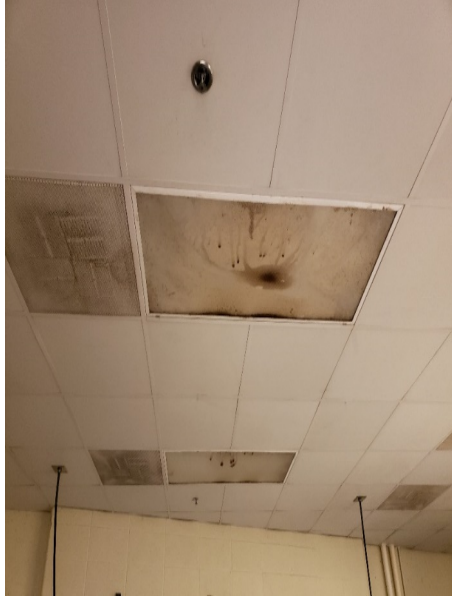
In vending commissary 02.04.01, as shown in [Figure E-11](#), the light lens is not clean. The panelboard B1C1A3 installation and the schedule do not match, as shown in [Figure E-12](#). Branch circuits 23,25,27 are installed as a 3-pole breaker while the schedule indicates (3) single pole branch circuit breakers.

**Figure E-11:** Replaced Light Lens  
**Location:** Vending Commissary 02.04.01
