# Kauffman Stadium Assessment

## JCSCA + Burns & McDonnell

This document contains information pertaining to the condition of Kauffman Stadium as documented by the Jackson County Sports Complex Authority (JCSCA), including descriptions, conditions, and exhibits which have been reviewed by Burns & McDonnell and documented in this report.

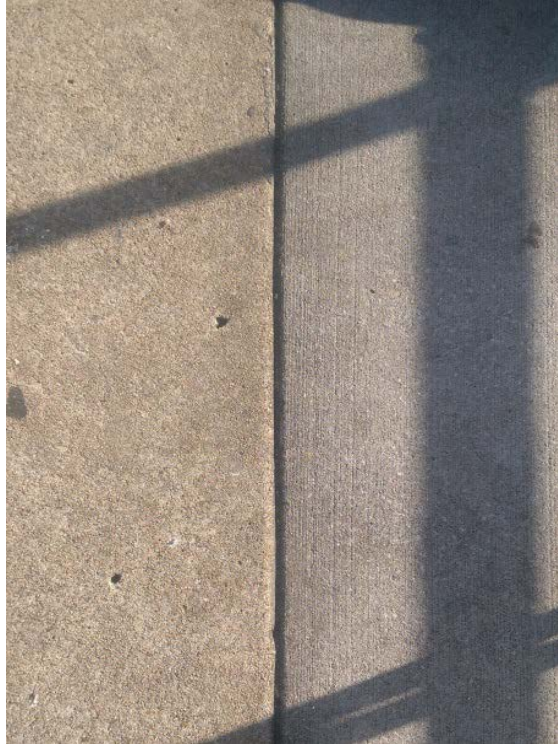
**Figure S-1: Slab-on-Grade Control Joint**

No significant settlement of the structure was observed. The slab-on-grade is primarily in satisfactory condition. No major cracks or spalling of the concrete were observed. Control joints and expansion joints are in satisfactory condition as shown in [Figure S-1](#).

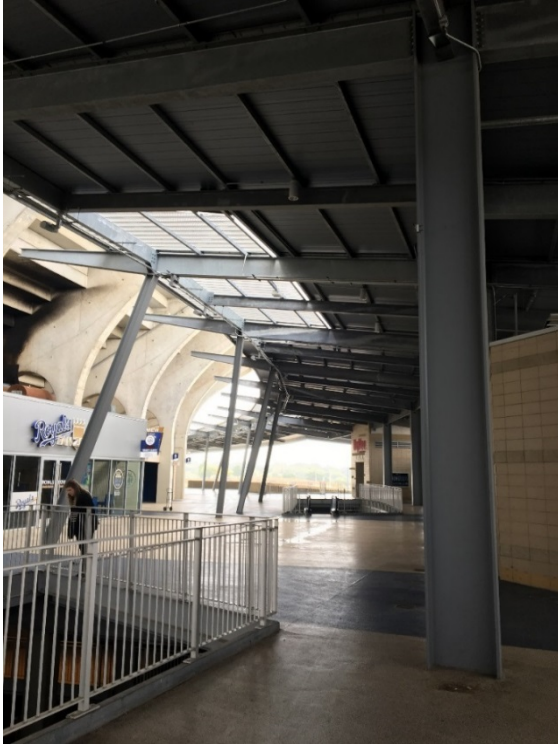
**Figure S-3: Plaza Level Steel Framing**

The reinforced concrete walls of the renovation stage are in satisfactory condition. No major cracks or spalling was observed and the vertical wall surface is flat and smooth. The steel beams and connections of the renovation stage are generally in satisfactory condition. No corrosion or deflection was observed, as shown in [Figure S-3](#). Concrete anchors are not fully embedded in a few locations as shown in [Figure S-4](#). This image was captured outside of the broadcast booths at the Press Level. This appears to be an installation issue rather than a maintenance concern.

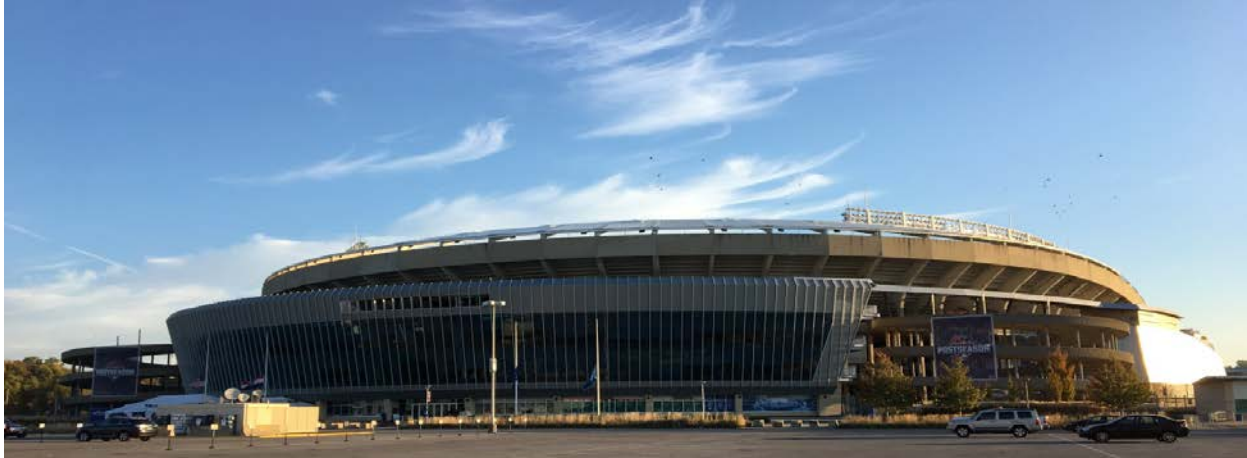
**Figure AF-1:** Kauffman Stadium Overall Exterior

Kauffman stadium incorporates a variety of finish materials that are used in the composition of the exterior façade, as shown in [Figure AF-1](#). The primary surface materials include structural concrete, insulated metal panel, curtainwall, and patterned perforated metal panels on cold formed steel structure.

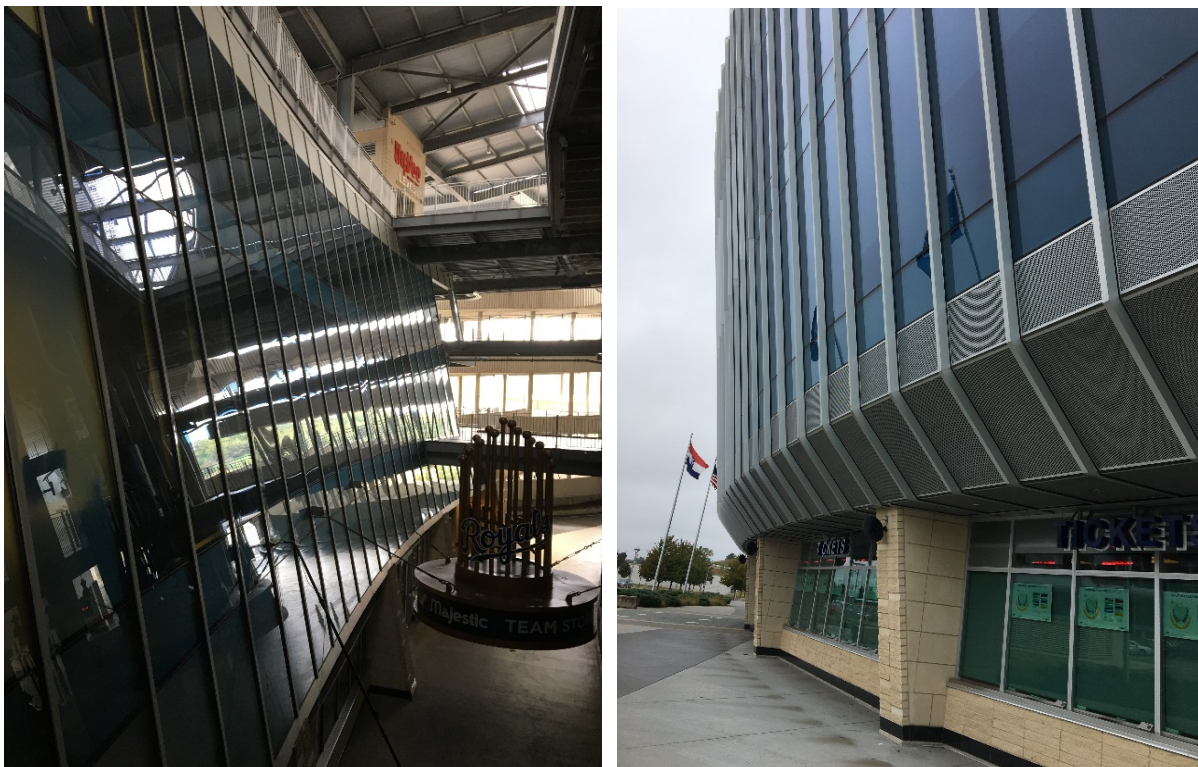
**Figure AF-2:** External (left) and Internal (right) Storefront, Curtainwall, and Stone Veneer

All facades, in general, appear to be in satisfactory condition. Glass storefronts and curtainwall systems appear to be in satisfactory condition, as shown in **Figures AF-2**. Aluminum frame and mullions were observed to be free of staining, fading, or degradation of any kind. Seals and flashing around storefront appear to be in satisfactory condition. Interior curtainwall systems were being cleaned during the assessment.

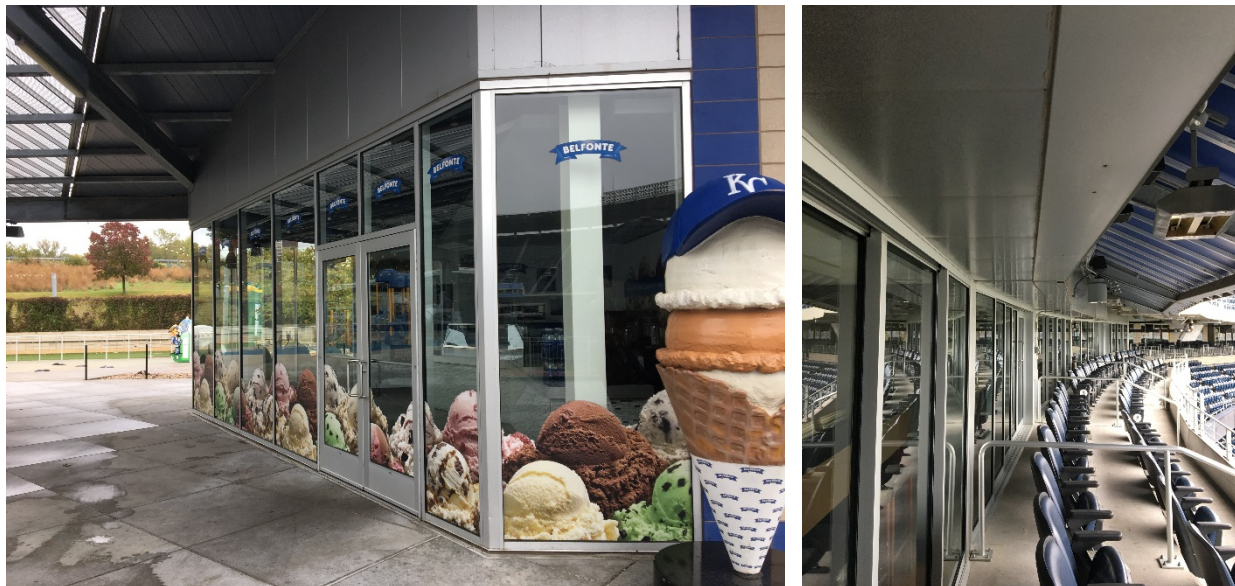
**Figure AF-5: Metal Panel and Storefront Systems at Outfield Experience (left) and TC Suites (right)**

Insulated metal panels and storefront systems at the Belfonte ice cream shop in the Outfield Experience were observed to be in satisfactory condition, as shown in **Figure AF-5** (left). No oil canning, staining, or degradation of any kind was observed. Aluminum frame and mullions were observed to be free of staining, fading, or degradation of any kind. Seals and flashing around storefront appear to be in satisfactory condition. Similarly, the sliding glass wall system and metal panels at the Triple Crown Suites were observed to be in satisfactory condition, as shown in **Figure AF-5** (right). No signs of scratches were noticeable on the frames, glass appeared to be free of cracks or chips, and operable tracks were free of dirt and grime that would prevent the door from smooth operation.

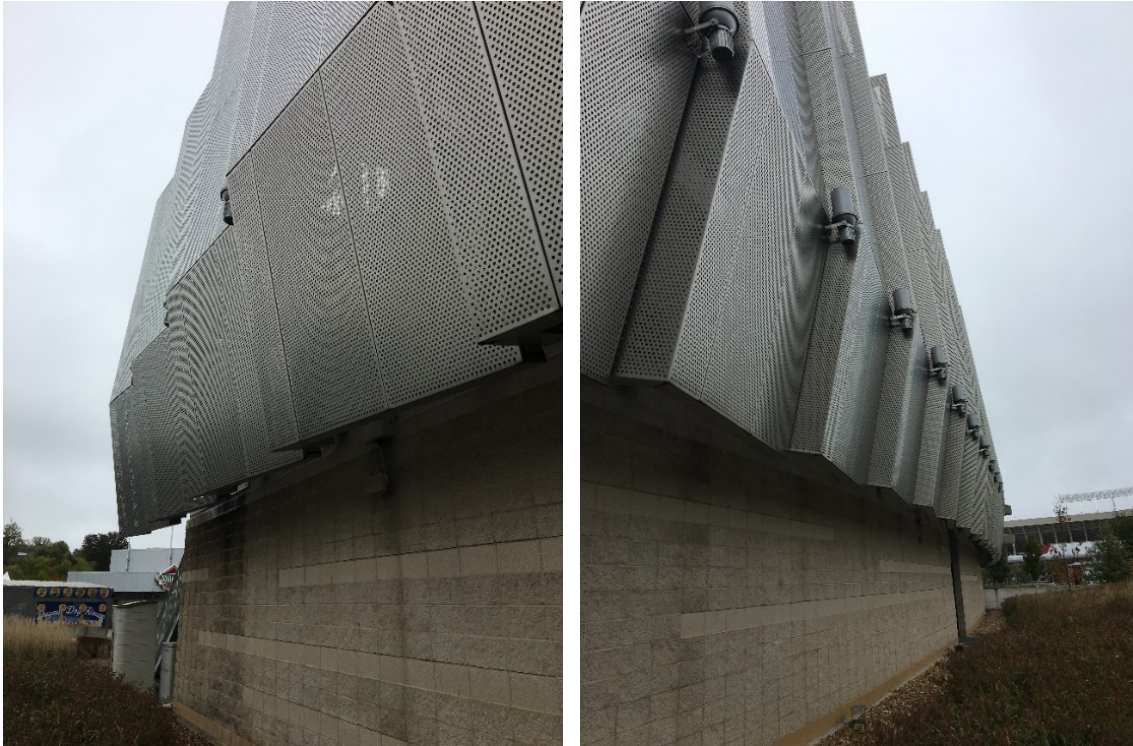
**Figure AF-6: External Perforated Metal Panel Systems**

Perforated metal panels and graphic mesh systems appear to be in satisfactory condition, as shown in [Figures AF-6](#). No oil canning, staining, or degradation of any kind was observed.

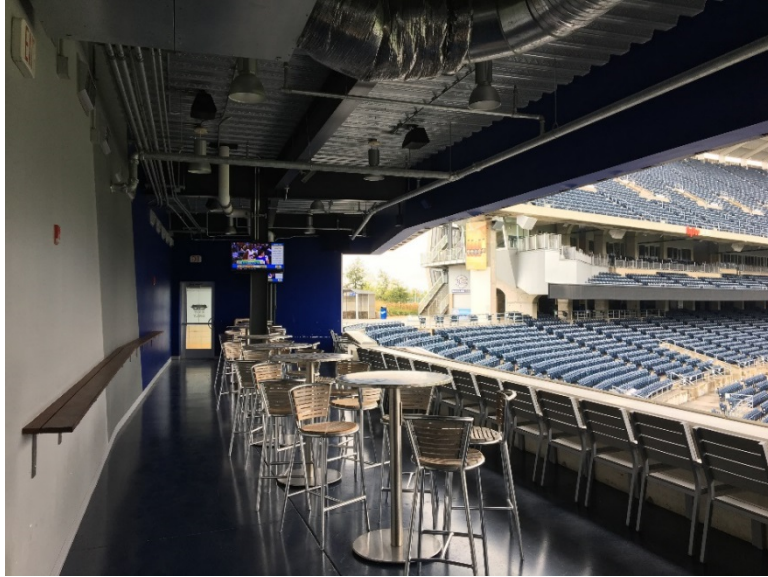
**Figure AI-1:** Sealed Concrete Floor at the Bullpen Bar

Interior finishes within Kauffman stadium encompass a broad range of materials for floors, walls, and ceilings. The primary flooring systems are composed of epoxy and sealed concrete, as shown in [Figures AI-1](#) and [AI-2](#). These surfaces were observed to be in satisfactory condition, typically. Minor cracking was observed at various locations throughout the facility, which is considered normal given the expansion and contraction properties of the materials. No excessive cracking was observed during the walk-through.

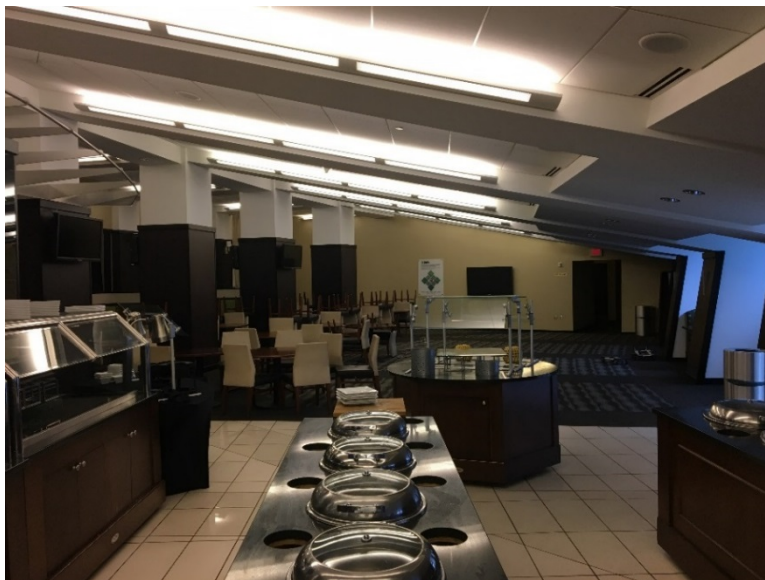
**Figure AI-5: Ceramic Tile Flooring at Dugout Suite**

Porcelain/Ceramic tile flooring areas appear to be in satisfactory condition, as shown in **Figure AI-5**. No signs of grout discoloration or cracking were observed.

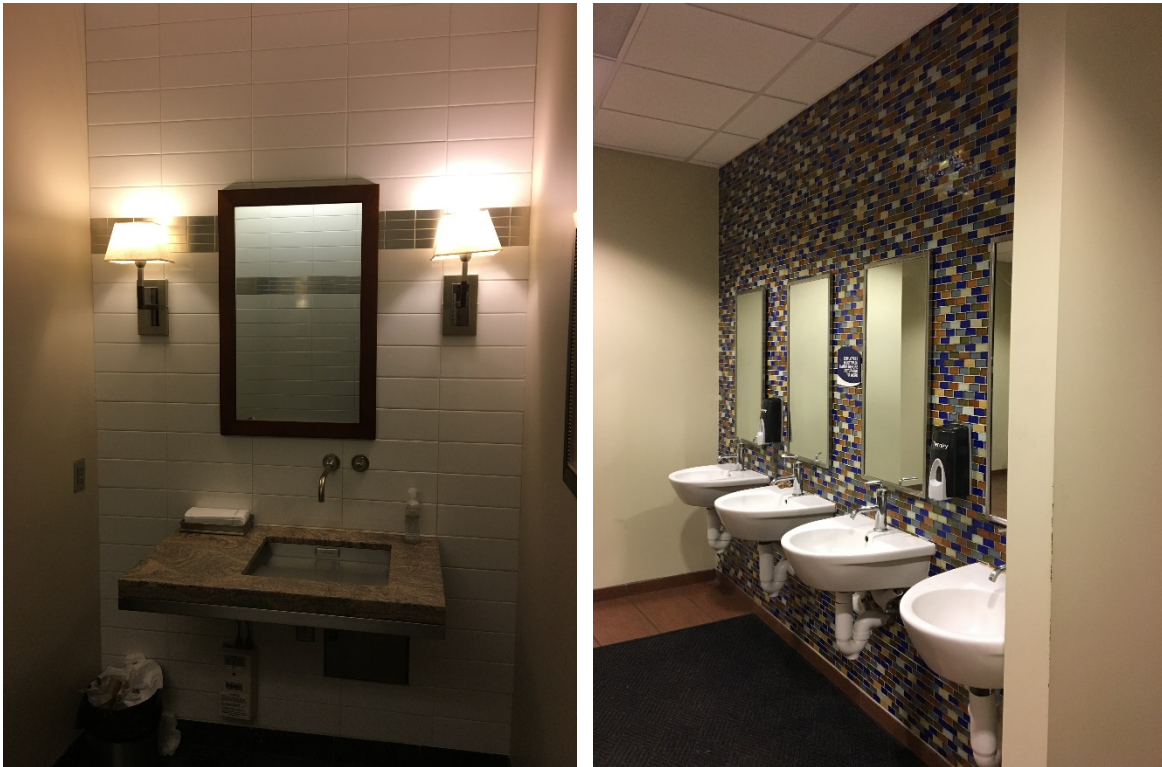
**Figure AI-6:** Ceramic Tile and Gypsum Board Walls

Ceramic tile walls appear to be in satisfactory condition, as shown in [Figure AI-6](#). No visible chipping, flaking, or cracking of the tile or grout was observed.

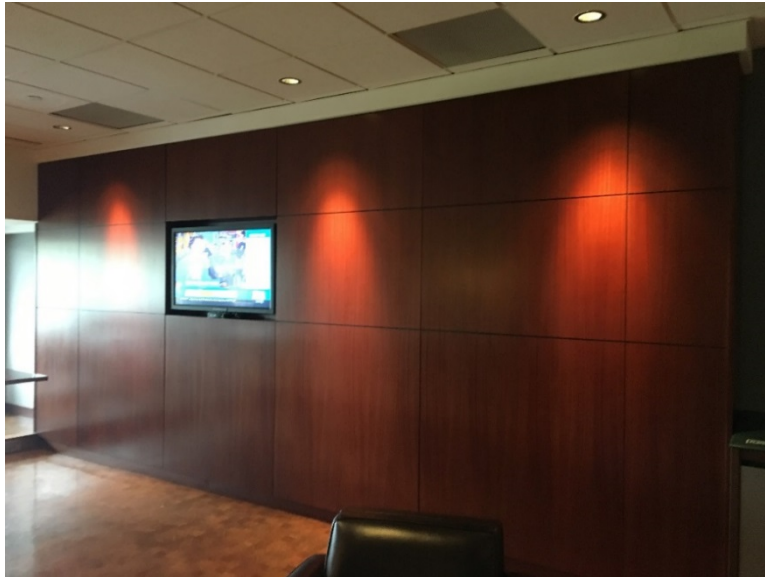
**Figure AI-7: Wood Veneer Panel Wall at Triple Crown Suite**

Wood paneling, typically, is in satisfactory condition. As shown in [Figure AI-7](#), no signs of scratching, fading, or deterioration of any kind were observed at the Triple Crown Suites.

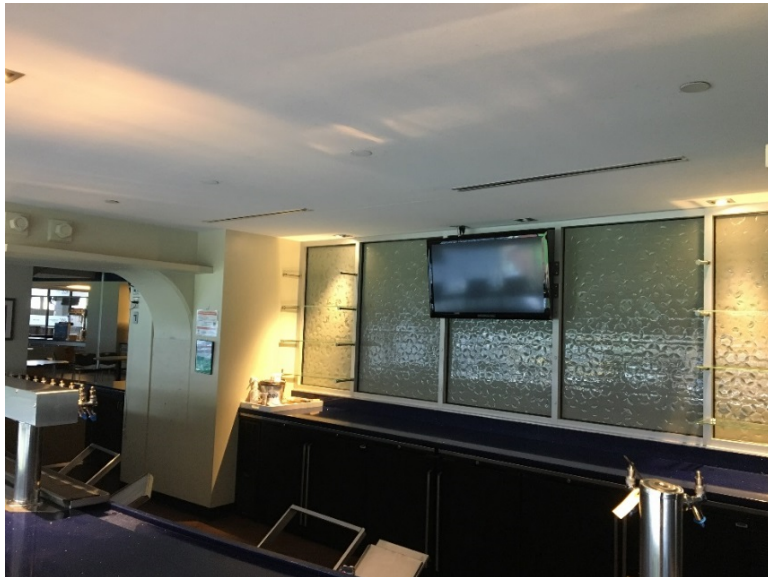
**Figure AI-9: Gypsum Board Ceilings at Diamond Club Area**

Gypsum board ceilings appear to be in satisfactory condition, typically. No punctures, stains, scrapes, or tears were observed. Refer to [Figure AI-9](#) for typical condition.

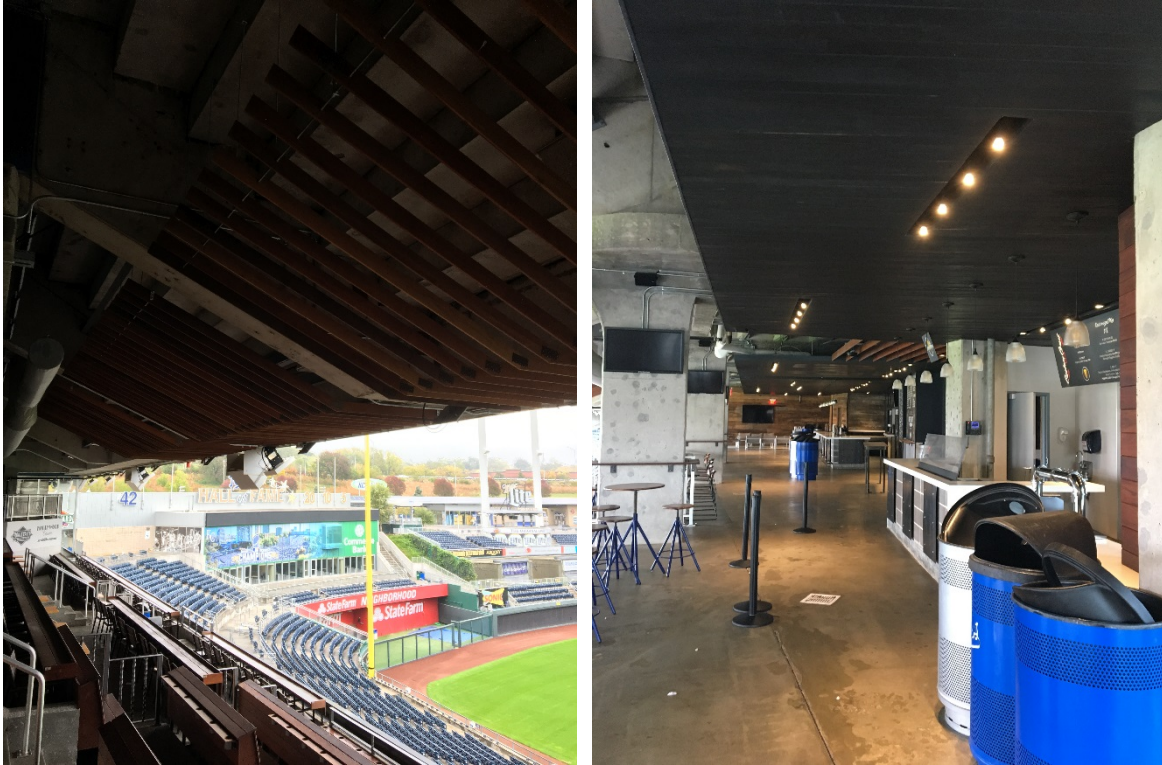
**Figure AI-11: Wood Plank Ceilings at Craft & Draft Area**

Wood ceiling panels, where present, were observed to be in satisfactory condition. Surface conditions appear to be new and are free of scuffs, scratches, warps, or deterioration as shown in **Figure AI-11**.

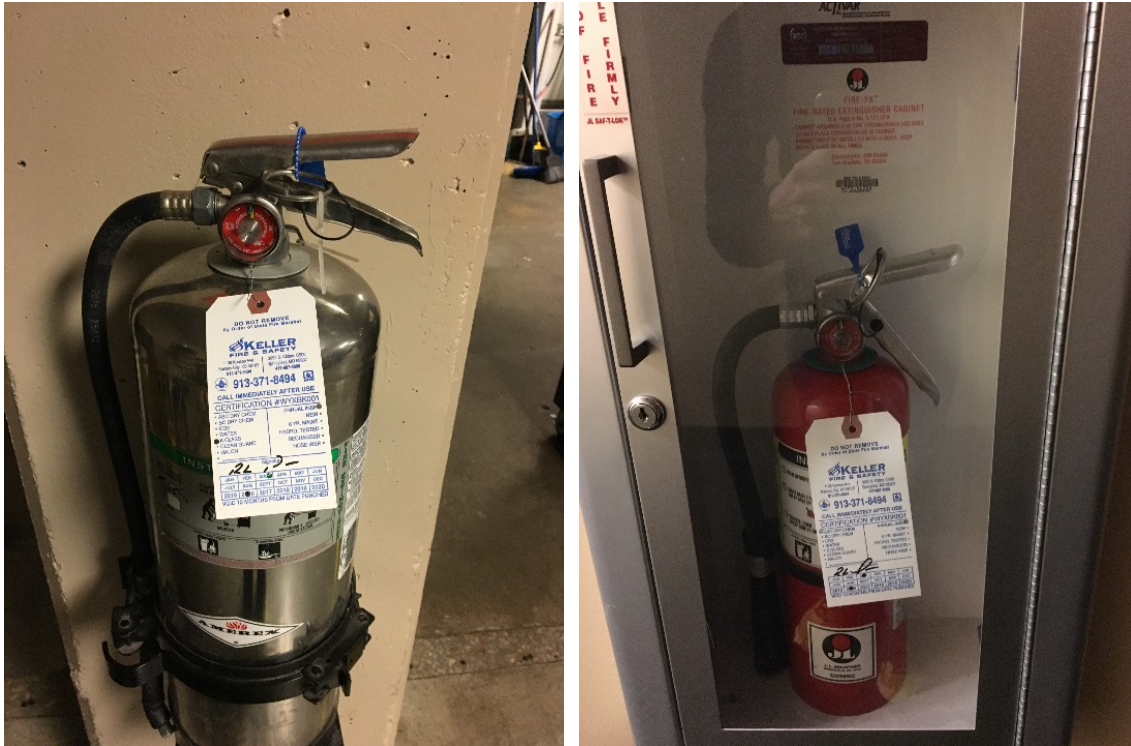
**Figure AMI-2: Fire Extinguisher Inspection Tags**

Several fire extinguishers were checked for verification of updated inspection tags. All fire extinguishers observed were inspected and punched within the last year, as shown in **Figure AMI-2**.

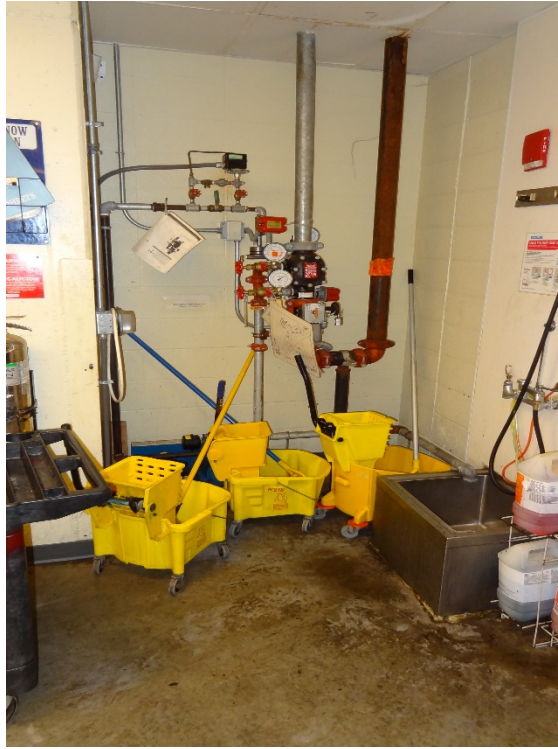
**Figure M-3: Dry-Pipe sprinkler Valve System**

The main kitchen mechanical systems appeared to be in satisfactory condition. Located in the back corner of the main kitchen is a dry-pipe sprinkler valve, shown in **Figure M-3**. The valve itself appears to be in satisfactory condition and had a current year inspection tag.
