# Arrowhead Stadium Assessment

## JCSCA + Burns & McDonnell

This document contains information pertaining to the condition of Arrowhead Stadium as documented by the Jackson County Sports Complex Authority (JCSCA), including descriptions, conditions, and exhibits which have been reviewed by Burns & McDonnell and documented in this report.

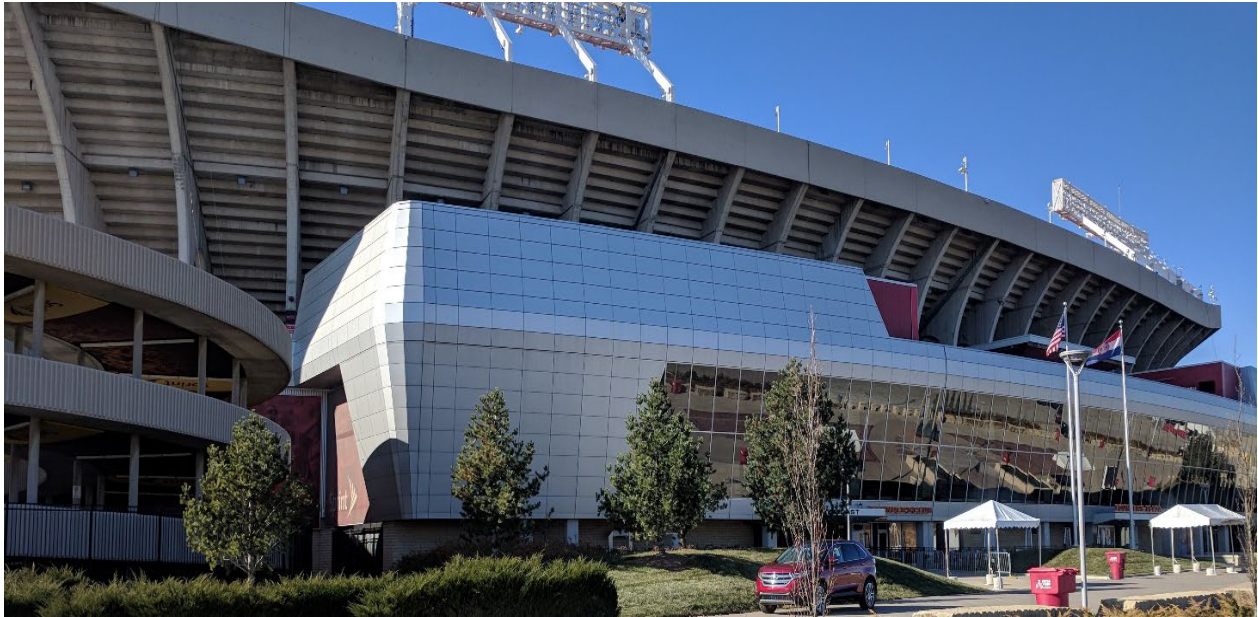
**Figure AF-1: Arrowhead Stadium Overall Exterior**  
**Location: North East Parking**

Arrowhead Stadium incorporates a variety of finish materials that are used in the composition of the exterior façade, as shown in **Figure AF-1**. The primary surface materials include structural concrete, insulated metal panel, curtainwalls, and graphic mesh fabric on galvanized steel framing.

All facades, in general, appear to be in satisfactory condition. Glass storefronts and curtainwall systems appear to be in satisfactory condition. Aluminum frame and mullions were observed to be free of staining, fading, or degradation of any kind. Seals and flashing around storefronts appear to be in satisfactory condition. Glazing was observed to be free of defects, including cracking or chipping.

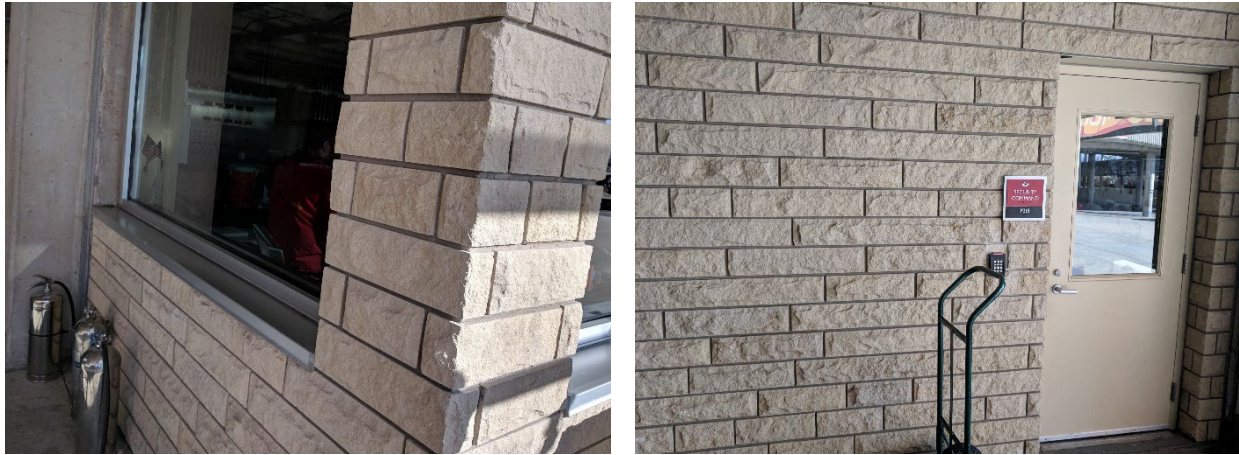
**Figure AF-2: Stone Veneer Wall**  
**Location: Plaza Level 3 – 03.54.02 Security & Fire Command**

Stone cladding systems appear to be in satisfactory condition, as shown in **Figure AF-2**. No chipping or staining of the stone or grout was observed.

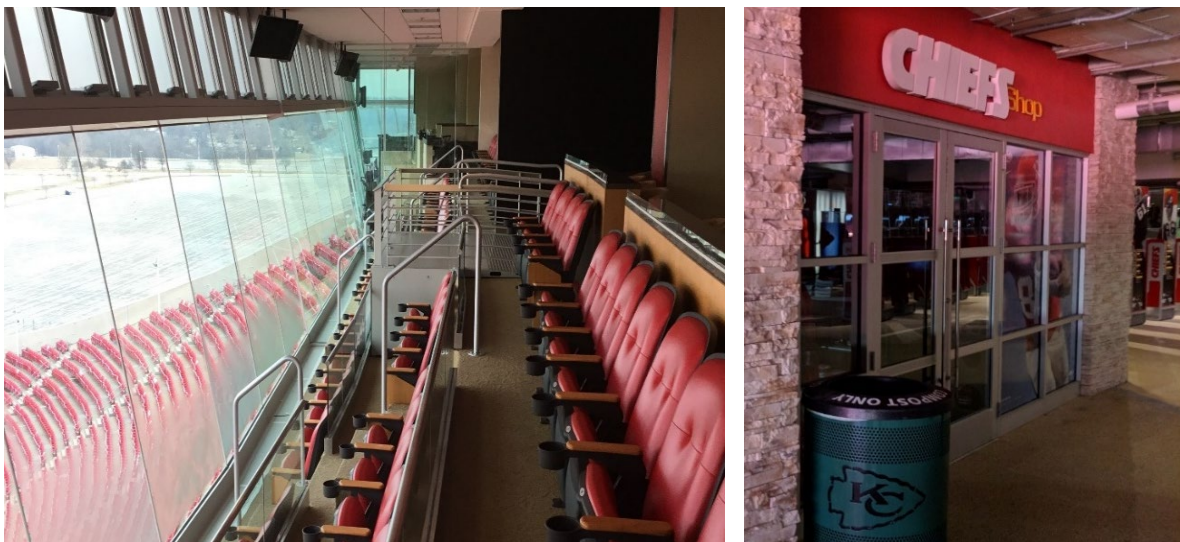
**Figure AF-3: Windows, Storefront, and Sliding Glass Wall System**  
**Location: Press Level 9 - 09.17.01 Cabaret Seating**

Internal storefront and glass wall systems appear to be in satisfactory condition, as shown in **Figure AF-3**. Aluminum frame and mullions were observed to be free of staining, fading, or degradation of any kind. Seals and flashing around storefronts appear to be in satisfactory condition. Glazing was observed to be free of defects, including cracking or chipping.
